# YOUR INSPECTION REPORT

1 INSPECTION WAY

Thursday, September 21, 2023

Report No. 3484, v.2

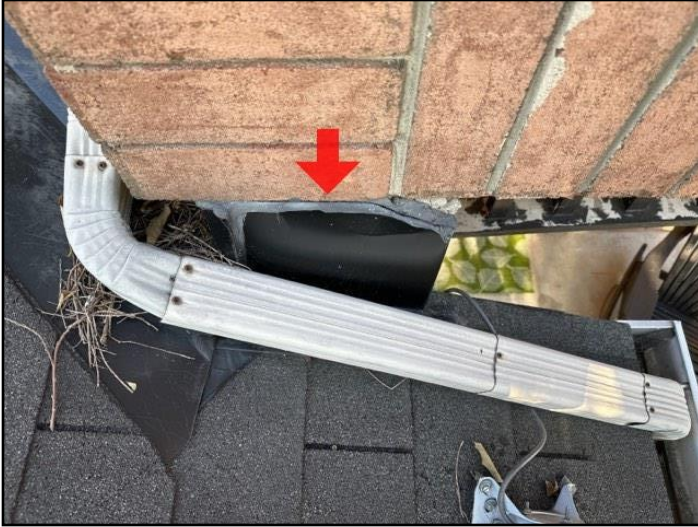
5. Damage, loose, open seams, patched

3. Condition: • [Damage, loose, open seams, patched](#)

**Task:** Repair

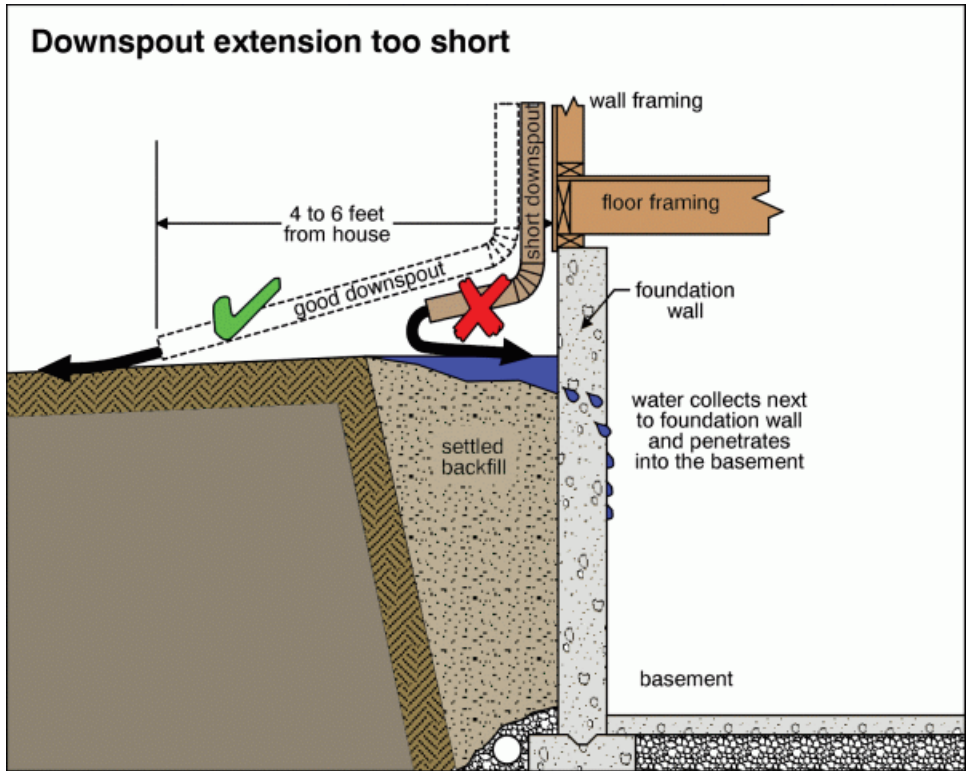
7. Should discharge 6 feet from building

**4. Condition:** • [Should discharge 6 feet from building](#)

The downspouts at the front and rear of the house should discharge a minimum of 6 feet from the foundation wall.

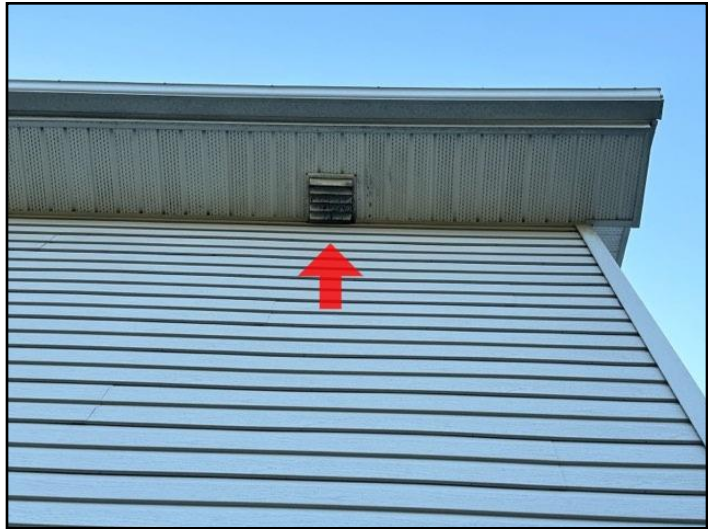
9. Vents - ineffective / missing

5. Condition: • [Vents - ineffective / missing](#)

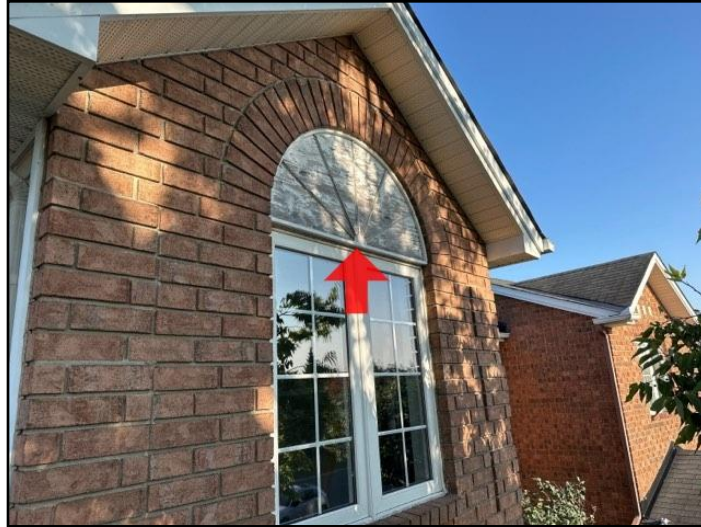
10. *Paint or stain needed*

6. Condition: • Paint or stain needed

Sand, prime and paint the decorative arch above the front second floor window. Repair any wood rot after sanding and before priming.

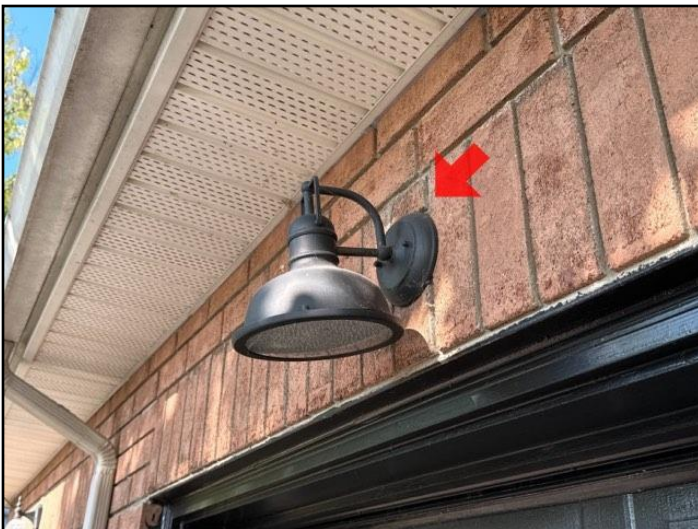
11. *Caulking missing or ineffective*

**7. Condition:** • [Caulking missing or ineffective](#)

Provide the missing caulking on the top and side of the light fixtures. Replace any of the loose and cracked caulking on the exterior of the house.

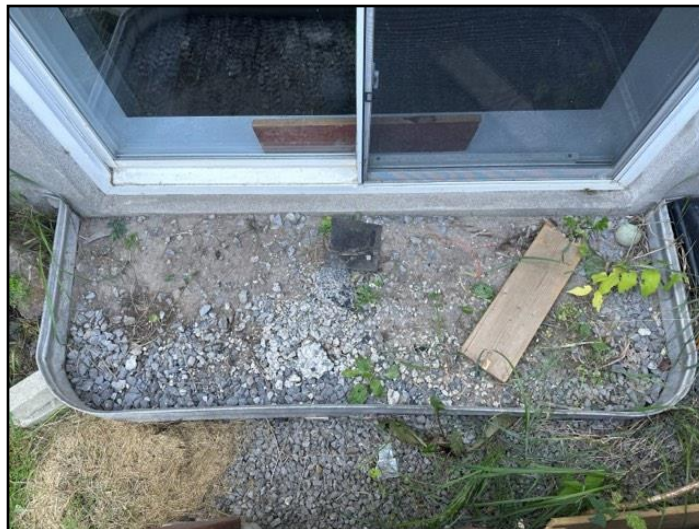
14. Remove all debris from window well.

**8. Condition:** • Remove all debris from window well.

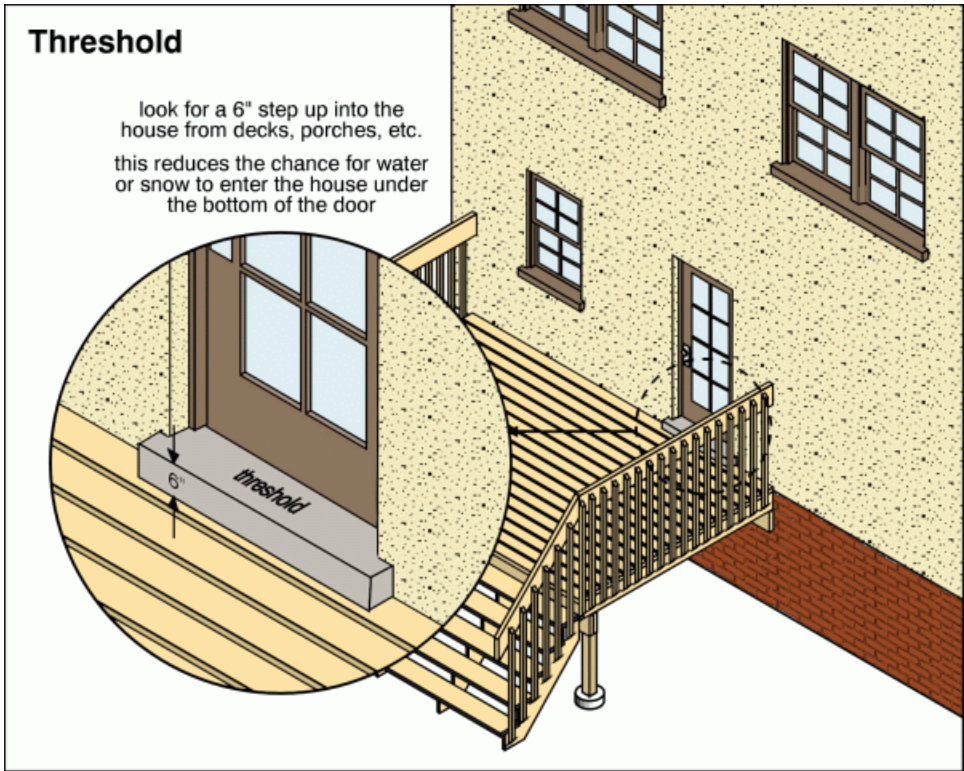
16. No step up into building

### **10. Condition:** • [No step up into building](#)

Due to the limited clearance between the deck and the door sill, water could leak into the house. Keep the snow and ice cleared away from the door sill during the winter months. The kick plate below the patio door has been patched with a water-resistant membrane, which may indicate they have already had some water infiltration.

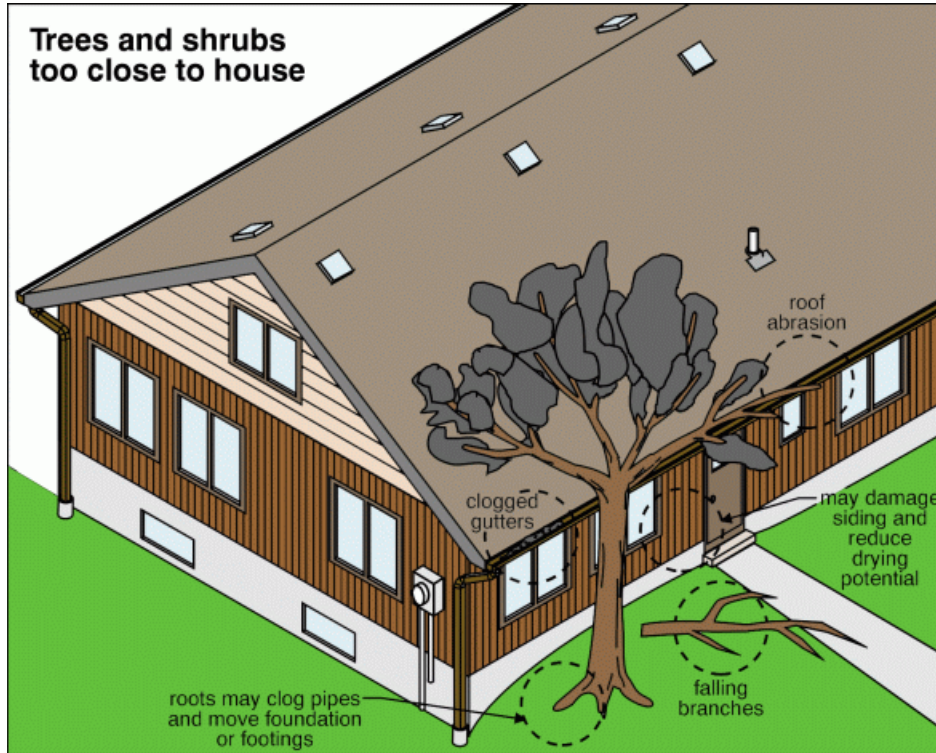
18. Trees or shrubs too close to building

11. Condition: • [Trees or shrubs too close to building](#)

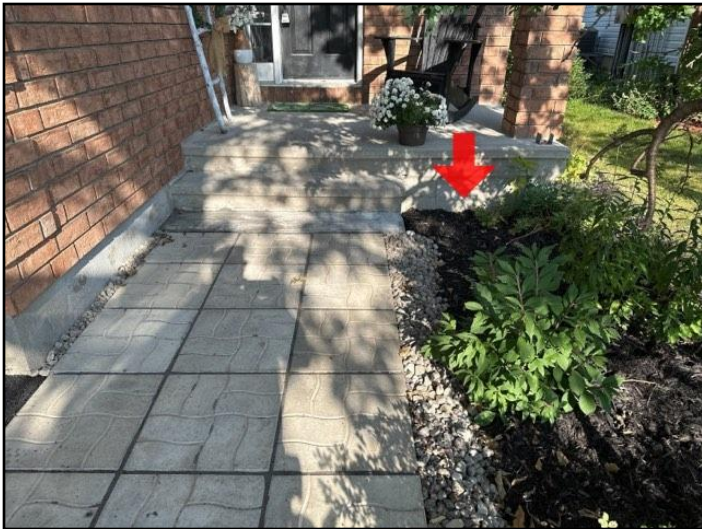
25. Improper slope or drainage

### 12. Condition: • [Improper slope or drainage](#)

Repair the slope of the ground around the house to limit the amount of water that accumulates against the foundation walls.

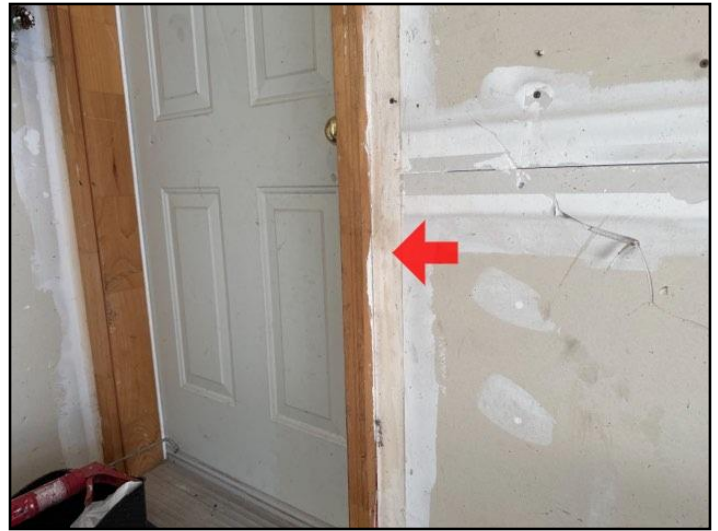
31. Not gastight

**13. Condition:** • Not gastight

Seal around the garage door frame to the house. Seal the drywall at the foundation walls to the house. Repair any holes in the drywall and any loose drywall tape and mudding on the walls and ceiling. Seal between the studs on the ceiling of the garage.

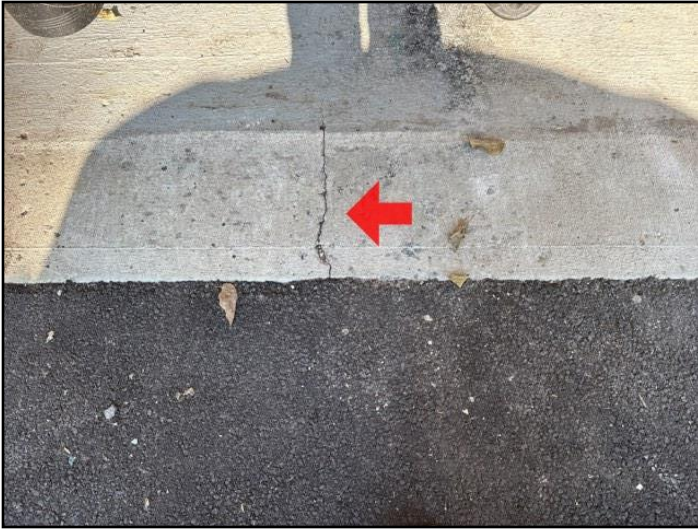
38. Cracked

### 14. Condition: • [Cracked](#)

Monitor the hairline crack in the garage floor slab. The crack is wide enough to insert a 2.5 mm allen key. If the crack increase to 6 mm in width, it will need to be repaired.

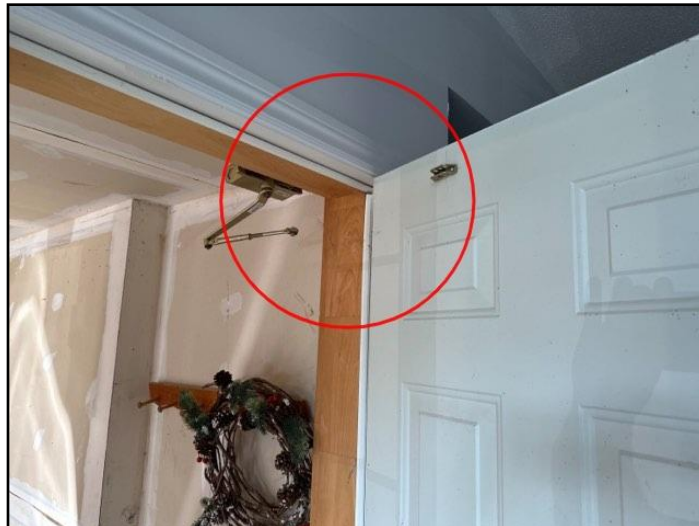
40. Does not close fully

15. Condition: • [Does not close fully](#)

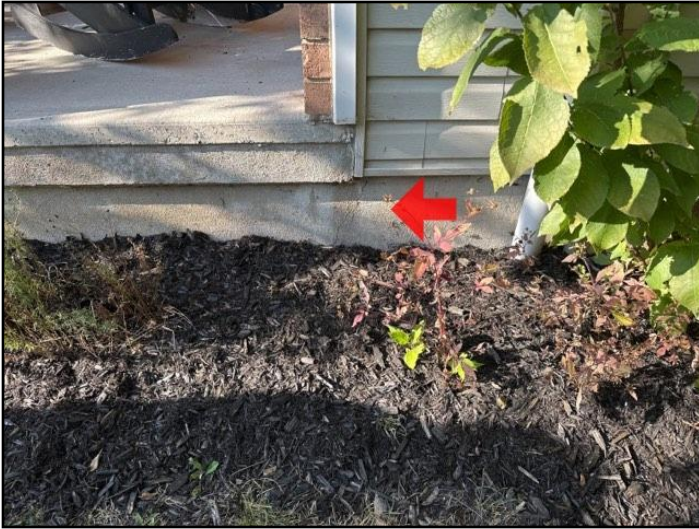
41. Typical minor cracks

**16. Condition:** • Typical minor cracks

Monitor the hairline shrinkage crack in the south foundation wall of the house. The crack was not wide enough to insert a 2.0 mm allen key. If the crack increases to 6.0 mm in width, or starts to leak, it will need to be repaired.

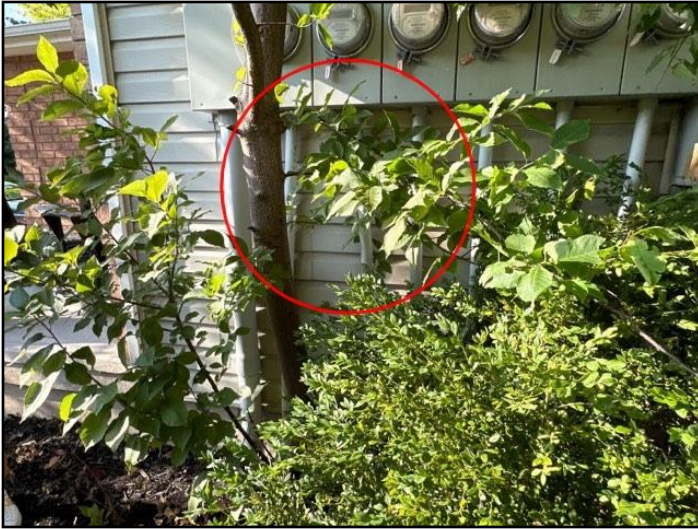
43. Conduit or cable damaged

**17. Condition:** • [Conduit or cable damaged](#)

The tree growing against the south foundation wall has damaged the hydro conduits below the meter base. Contact hydro about repairing the conduit.

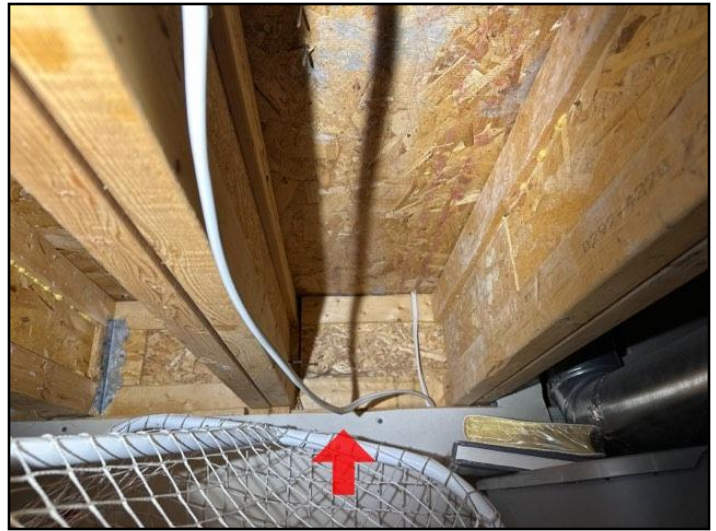
50. Modified or added wiring

### 19. Condition: • [Modified or added wiring](#)

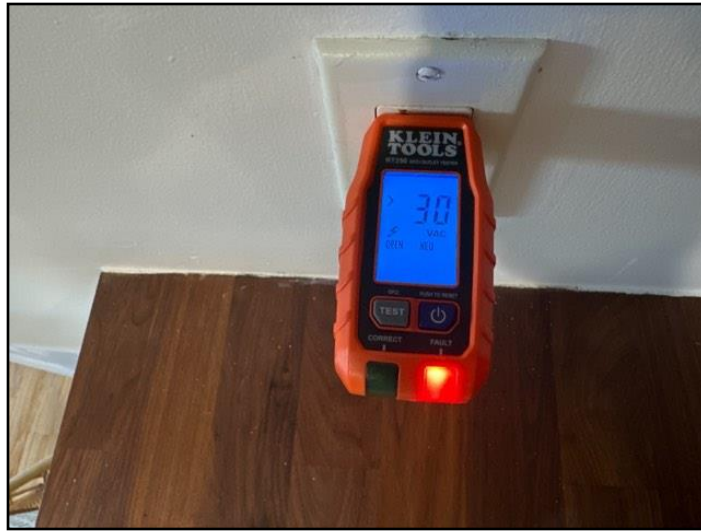
56. Open neutral

**20. Condition:** • [Open neutral](#)

Repair the GFCI in the kitchen that is not wired properly.

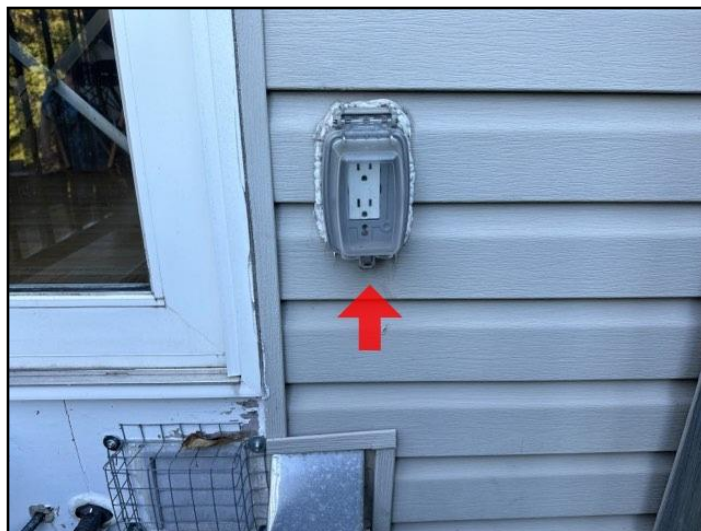
57. Loose

**21. Condition:** • [Loose](#)

Repair the loose outlet t the rear of the house.

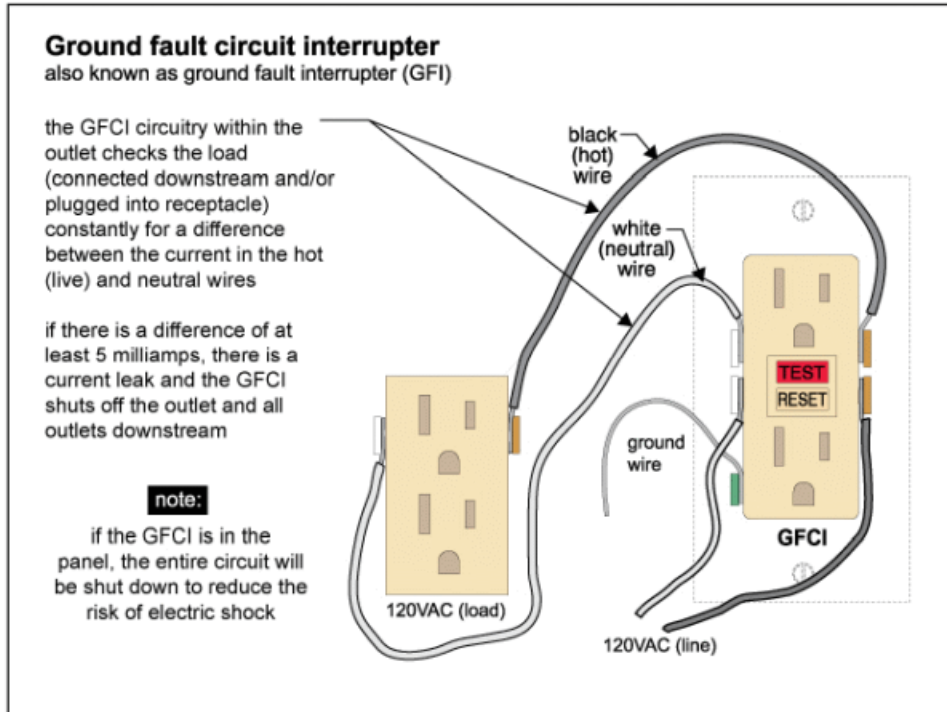
58. GFCI/GFI needed (Ground Fault Circuit...

**22. Condition:** • [GFCI/GFI needed \(Ground Fault Circuit Interrupter\)](#)

Provide the missing GFCI outlet for the basement bathroom.

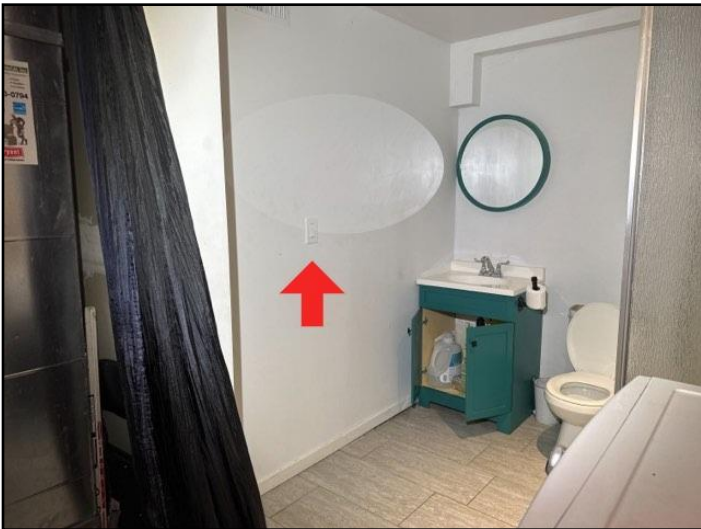
59. 3-way not working as intended

**23. Condition:** • 3-way not working as intended

Repair the switches in the basement bathroom. The 3-way switch is not wired correctly and there is not a switch that is accessible within 5 feet of the door opening.

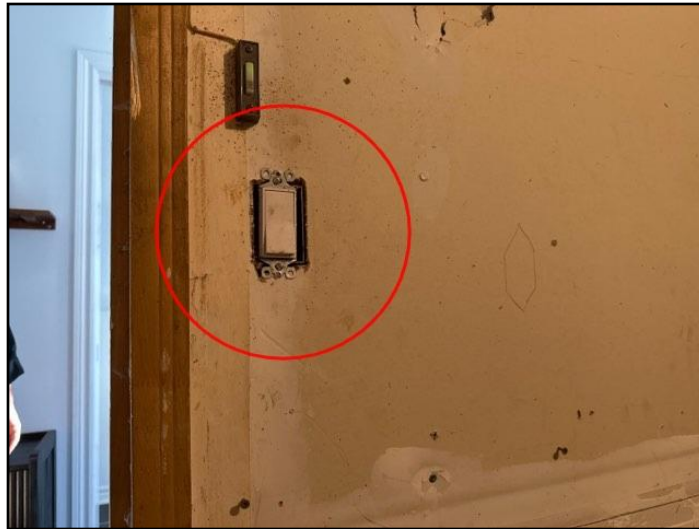
61. Missing

24. Condition: • [Missing](#)

Provide the missing switch cover plate in the garage.

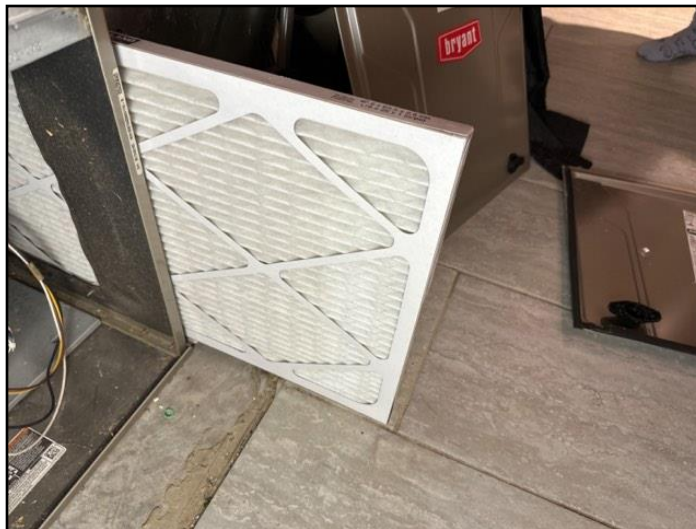
69. Dirty

**27. Condition:** • [Dirty](#)

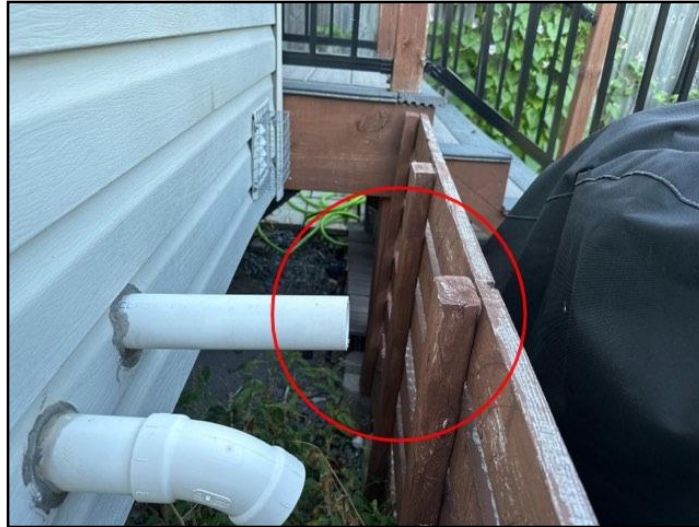
72. Rust, dirty, obstructed

**29. Condition:** • Rust, dirty, obstructed

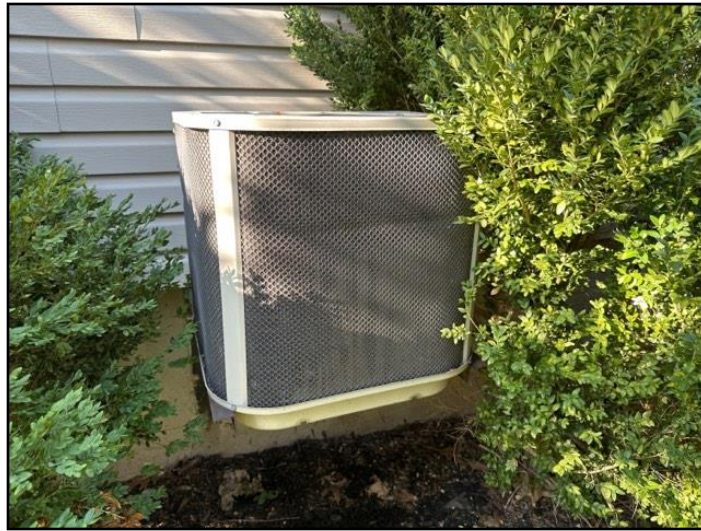
75. Near end of life expectancy

31. Condition: • [Near end of life expectancy](#)

The A/C system should be budgeted for replacement due to the age and condition of the unit.

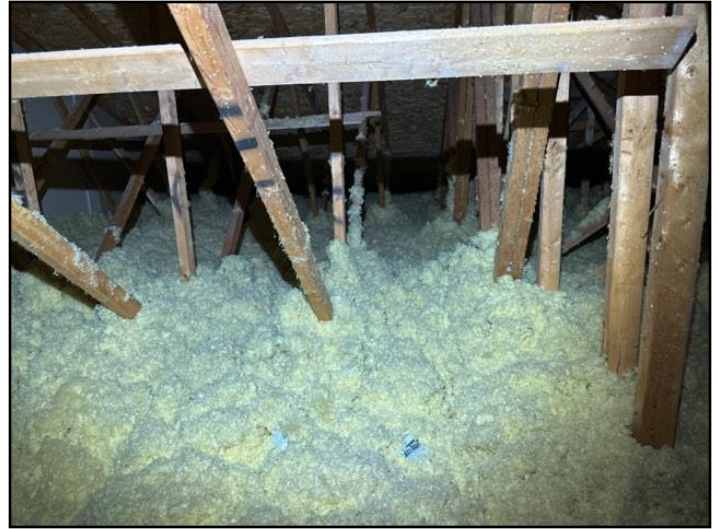
78. Compressed

**33. Condition:** • [Compressed](#)

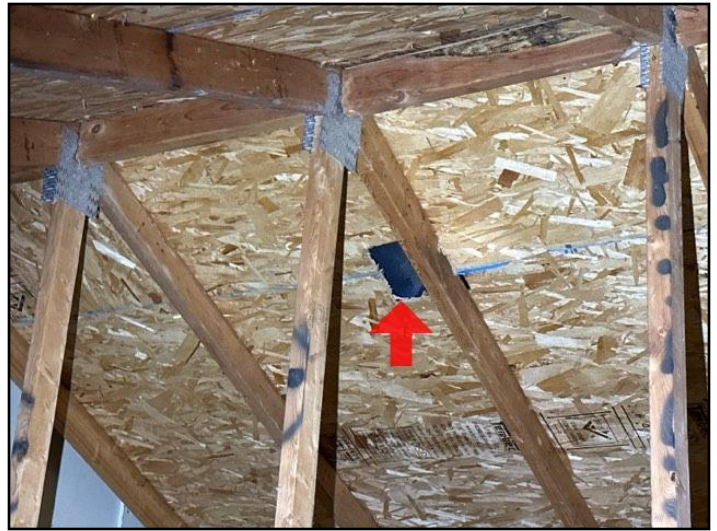
81. *Obstructed*

34. Condition: • [Obstructed](#)

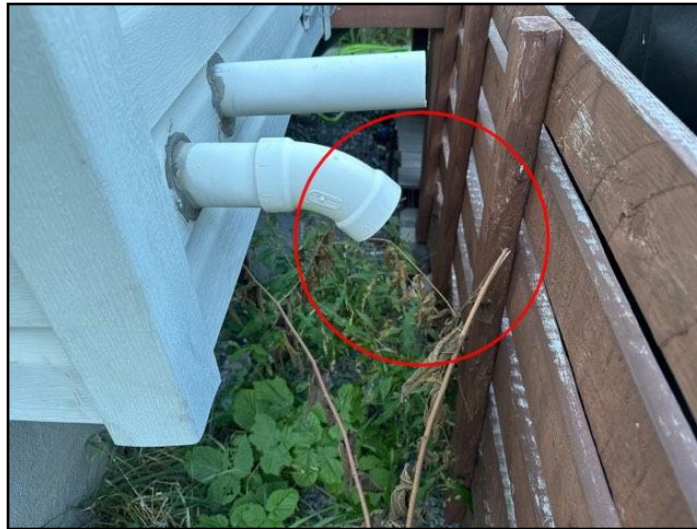
84. Rust, dirty, obstructed

**36. Condition:** • [Rust, dirty, obstructed](#)

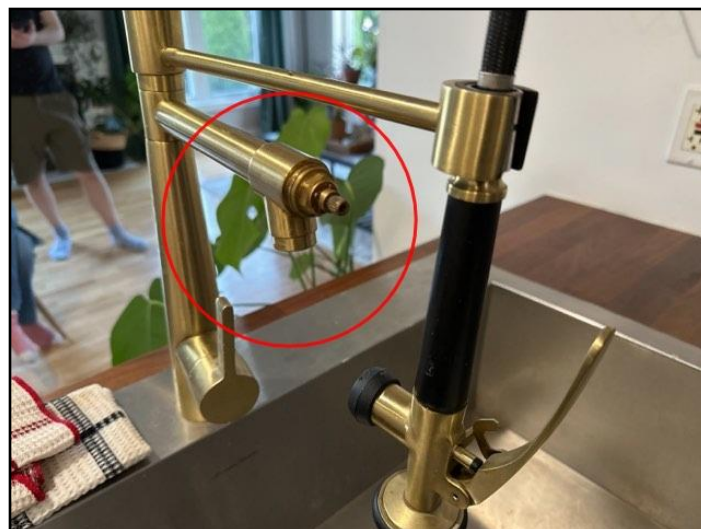
87. Missing

**39. Condition:** • Missing

Provide the missing handle for the kitchen faucet.

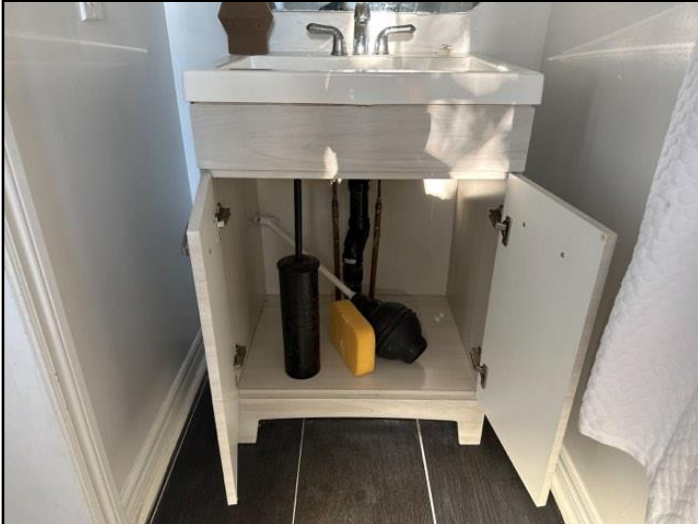
88. Leak

**40. Condition:** • [Leak](#)

Repair the leak from the faucets in the first floor bathroom. The leak is going down into the basement.

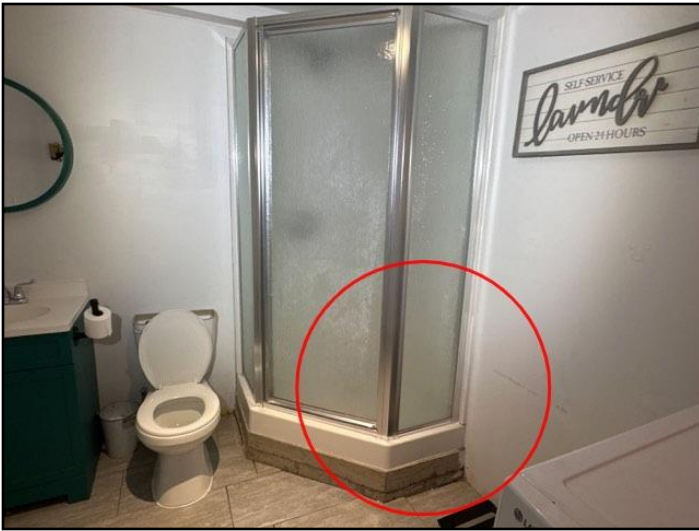
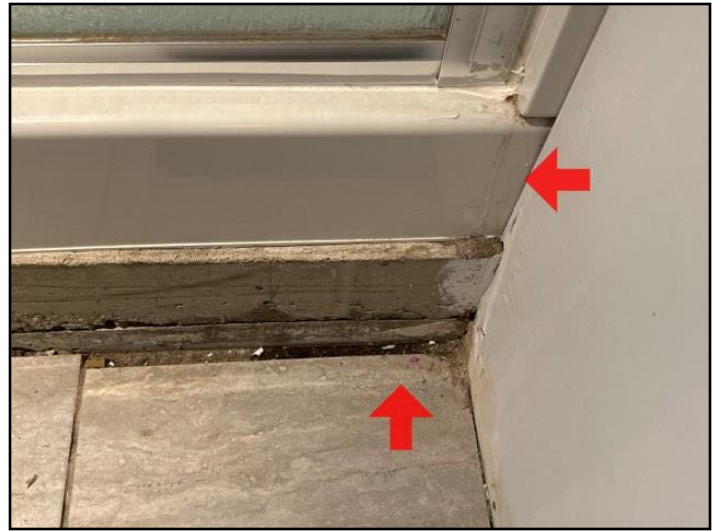
**41. Condition:** • [Leak](#)

Repair the leak from the basement bathroom shower stall before using.

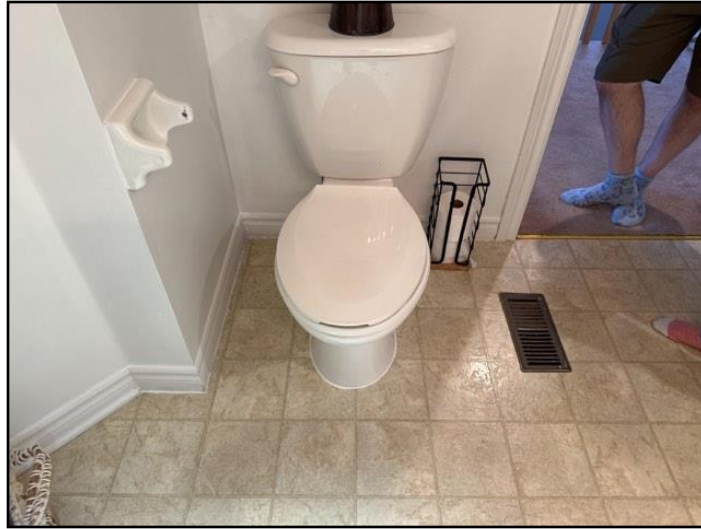
93. Loose

42. Condition: • [Loose](#)

Repair the loose toilet in the second floor bathroom. When repairing the toilet, the seal should be replaced.

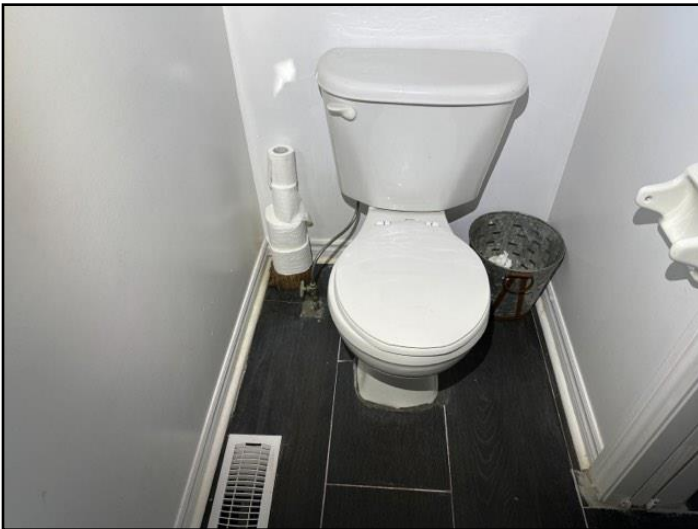
94. Floor damage suspected

**43. Condition:** • [Floor damage suspected](#)

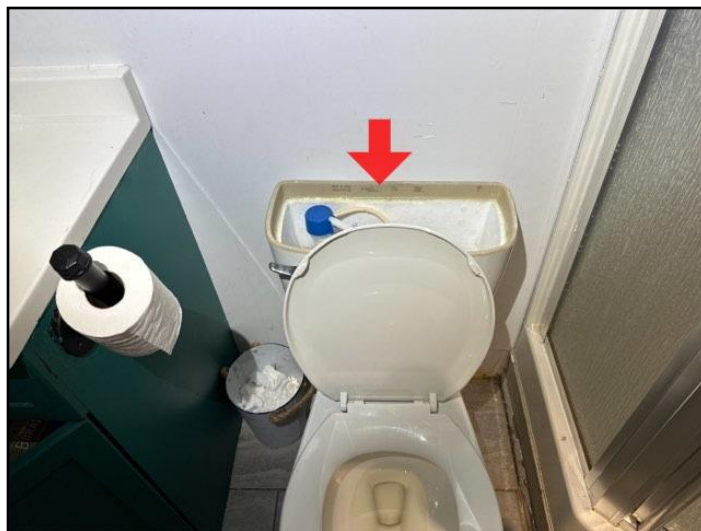
97. Broken or cracked tank lids, bowls or seats

**44. Condition:** • [Broken or cracked tank lids, bowls or seats](#)

Provide the missing lid for the basement bathroom toilet water closet.

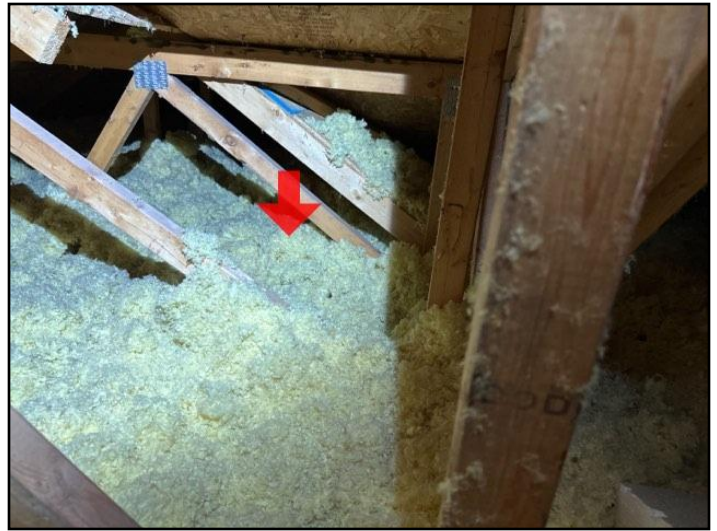
123. Pest activity evident

#### **45. Condition:** • [Pest activity evident](#)

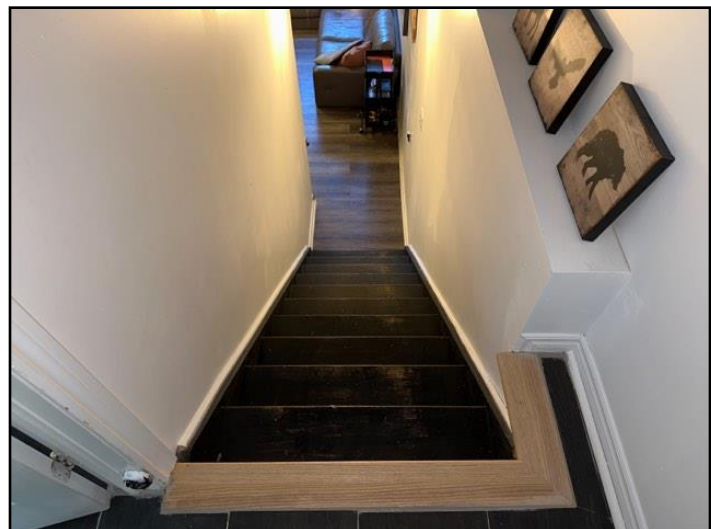
130. Missing

47. Condition: • [Missing](#)

Install the missing handrail for the basement stairs.
