YOUR INSPECTION REPORT

1 INSPECTION WAY

Nepean, ON

Wednesday, November 22, 2023

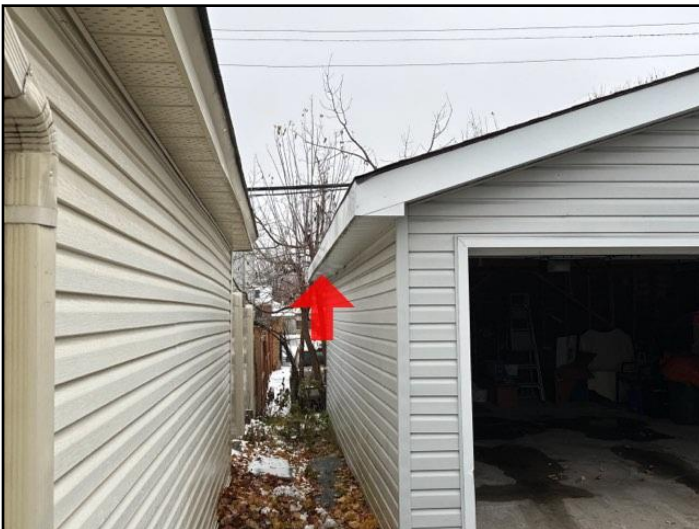
1. Missing

1. Condition: • [Missing](#)

Provide the missing gutters on the draining roof edges of the garage.

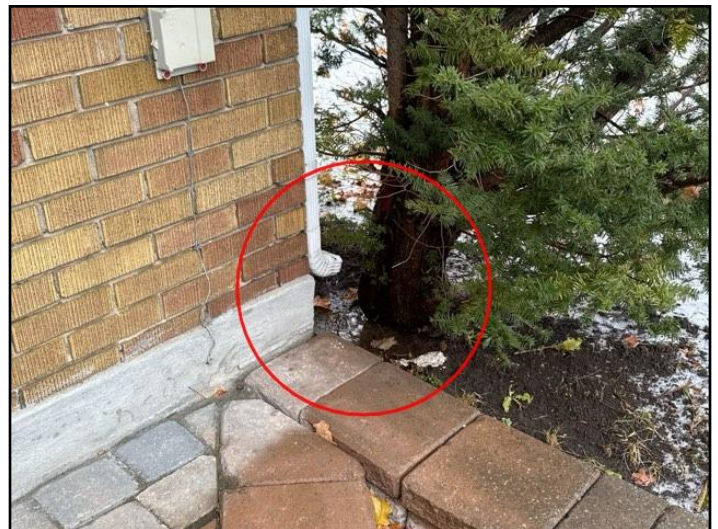
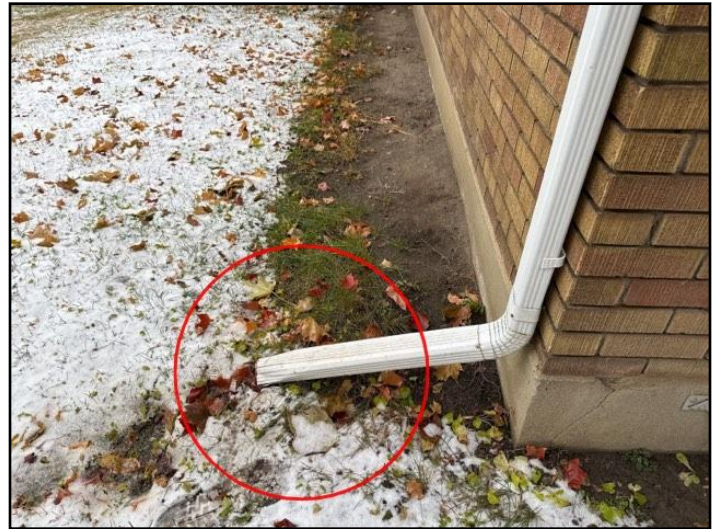
2. Condition: • [Should discharge 6 feet from building](#)

The downspouts should discharge a minimum of 6 feet from the foundation walls. This can be a contributing factor to basement moisture issues.

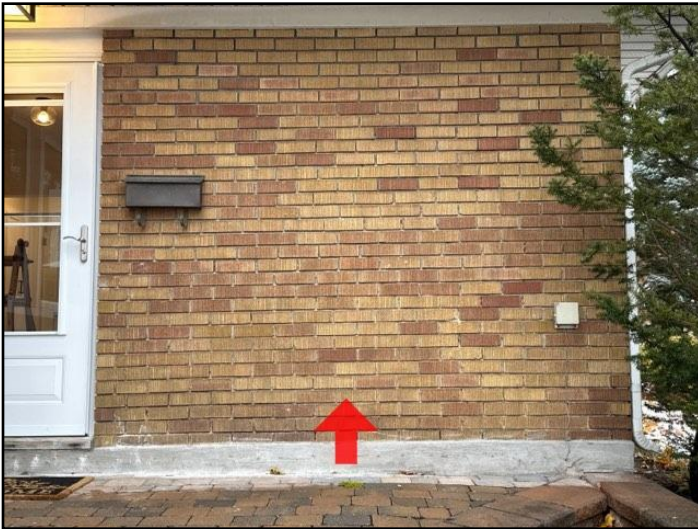
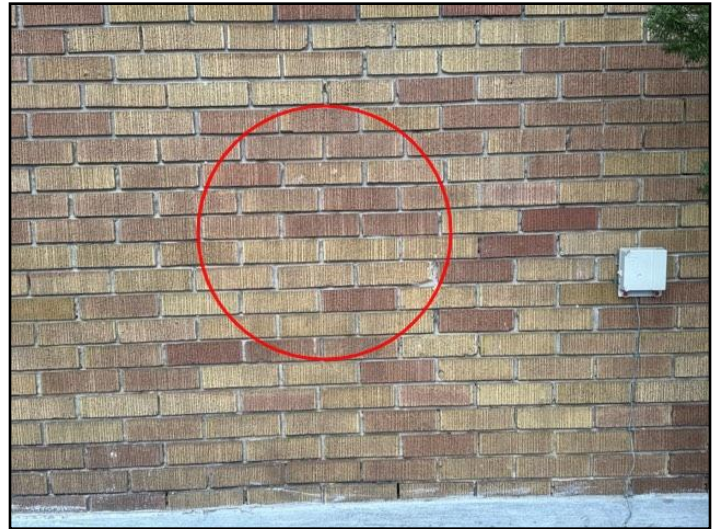
3. Condition: • [Mortar deterioration](#)

Repoint the loose mortar on the west facing brick veneer wall at the front of the house.

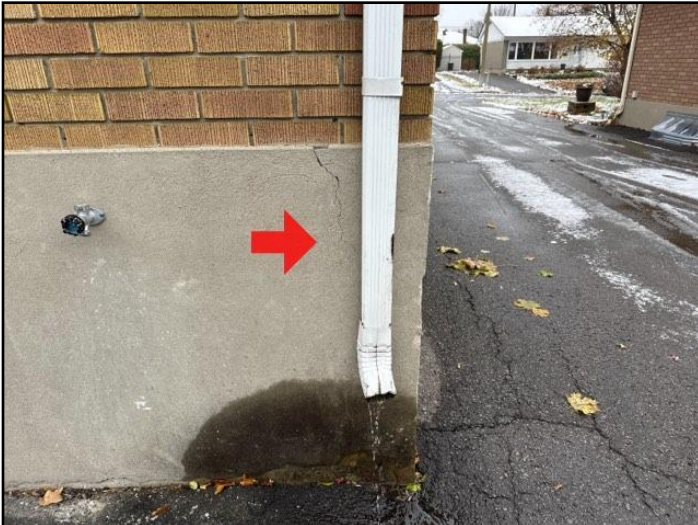
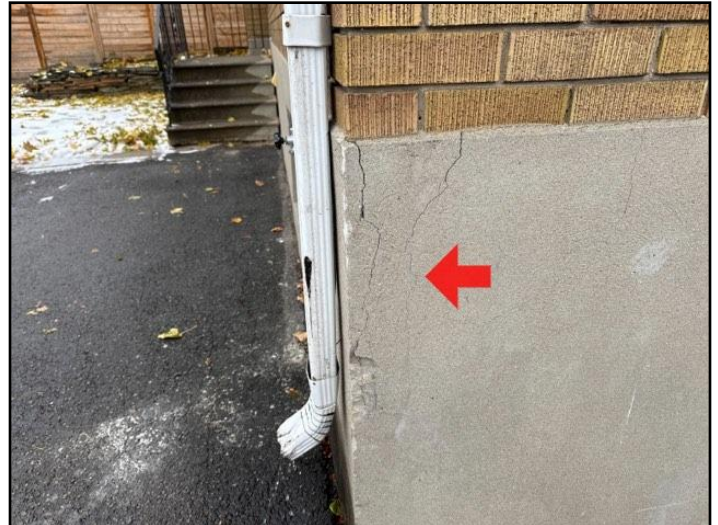
4. Condition: • [Parging damaged or missing](#)

Repair the cracked cosmetic parging at the northwest corner of the house foundation.

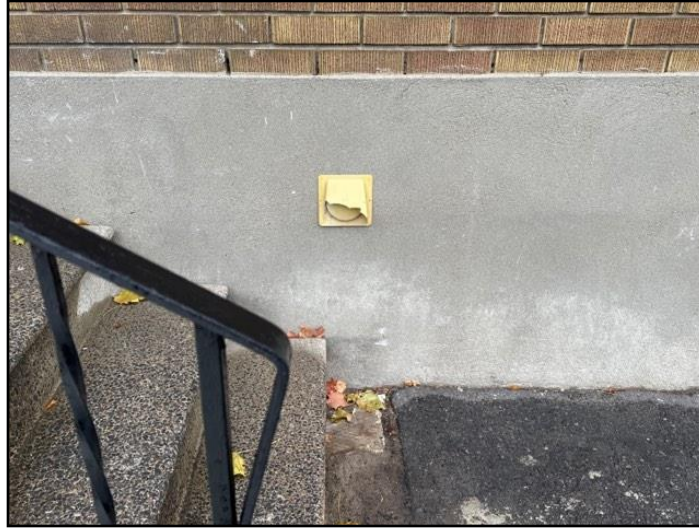
11. Cover damaged

5. Condition: • Cover damaged

Replace the damaged vent cover at the rear of the house. The vent can be sealed off. It was for the dryer, which has been relocated to the side of the house.

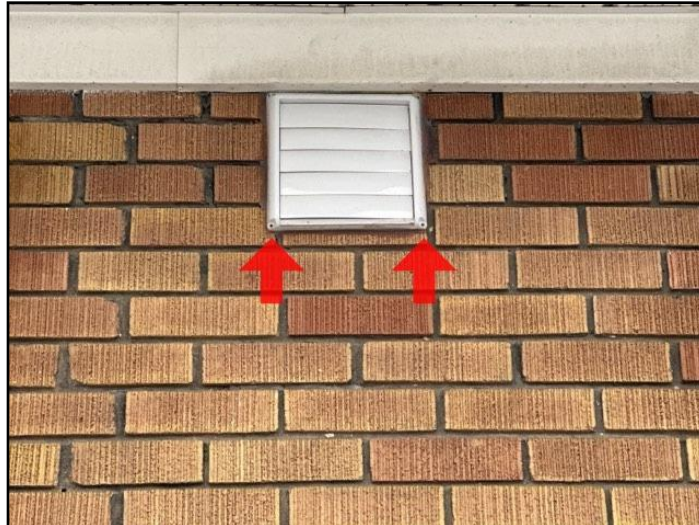
12. Loose

6. Condition: • Loose

Provide the fasteners for the new kitchen exhaust vent cover at the rear of the house.

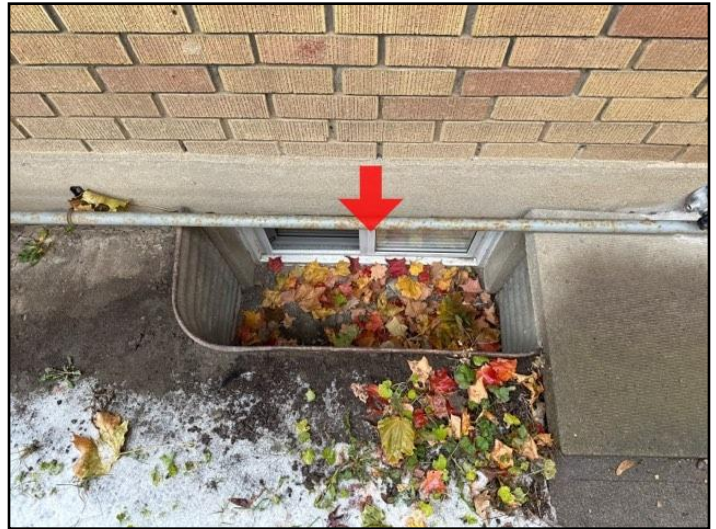
14. Clean window well

7. Condition: • Clean window well

The window wells should be cleaned regularly. They should be kept free of debris and not used for storage.

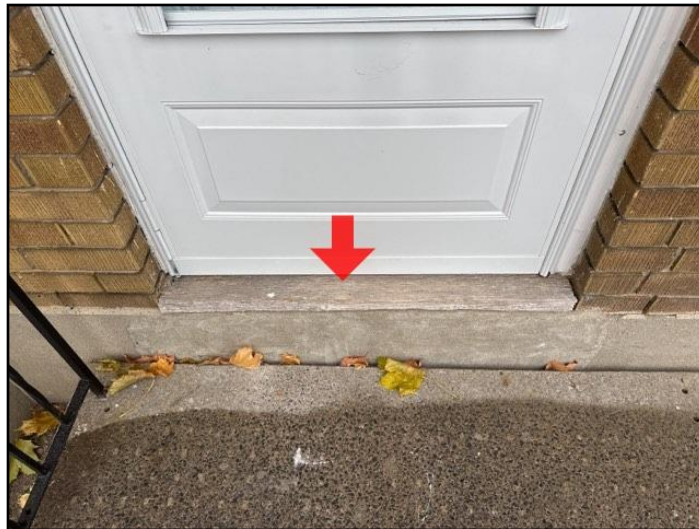
15. Paint or stain needed

8. Condition: • [Paint or stain needed](#)

The rear entrance door sill needs to be sanded, primed, and painted. Repair any damage to the door sill before priming.

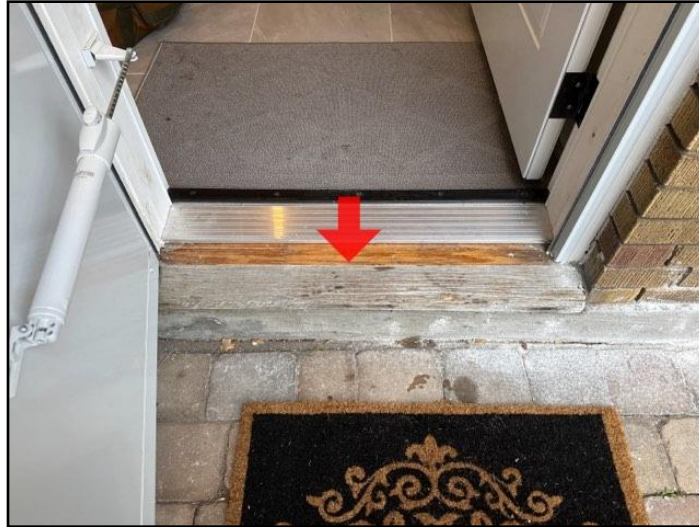
16. Paint or stain needed

9. Condition: • [Paint or stain needed](#)

The front entrance door sill needs to be sanded, primed, and painted. Repair any damage to the door sill before priming.

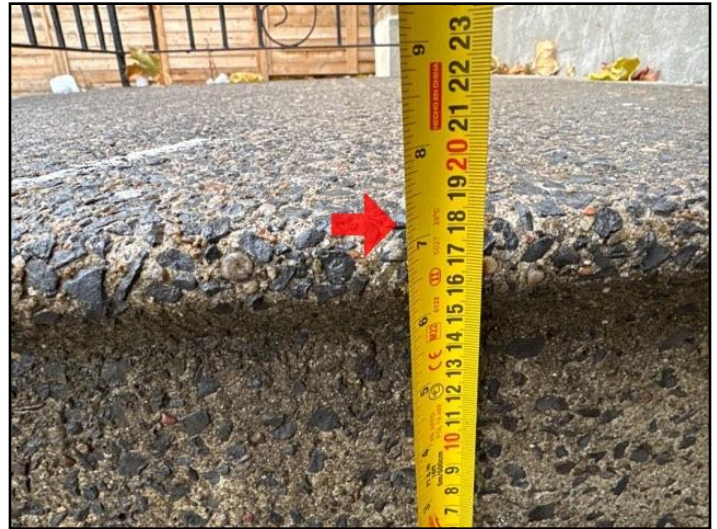
18. Stair rise too big or not uniform

10. Condition: • [Stair rise too big or not uniform](#)

The rise from the rear stair landing to the back door sill should not exceed 7-7/8".

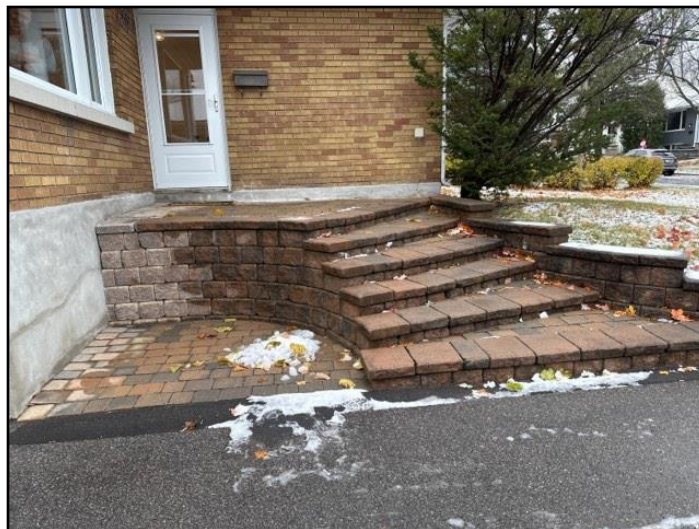
20. Missing

11. Condition: • [Missing](#)

Provide the missing handrail for the front entrance steps and landing.

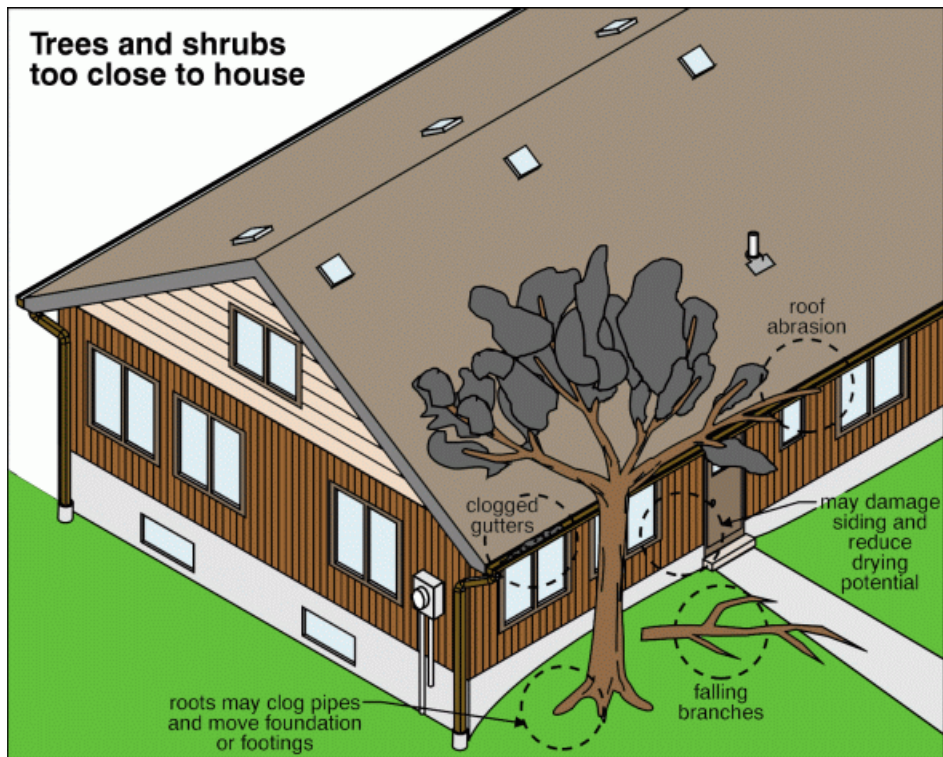
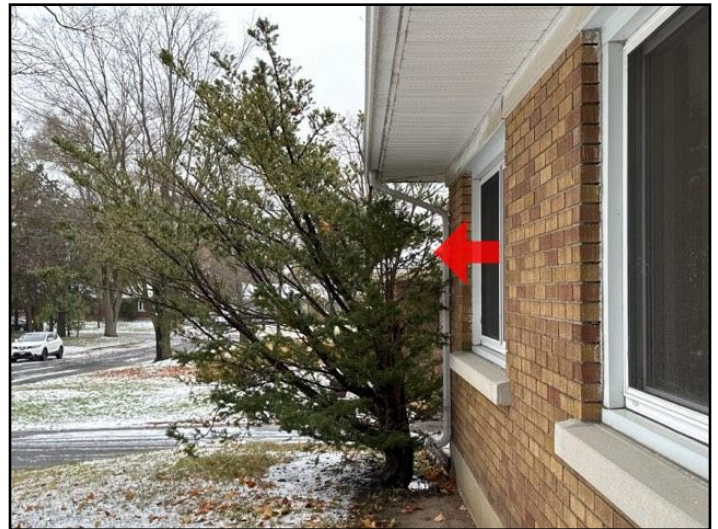
12. Condition: • [Trees or shrubs too close to building](#)

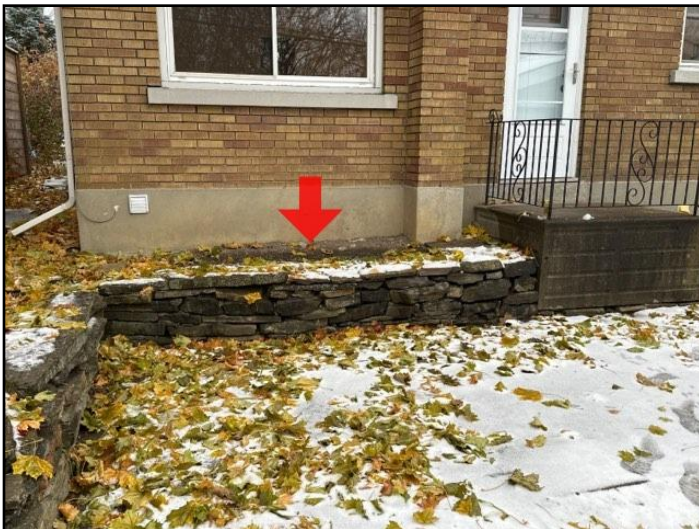
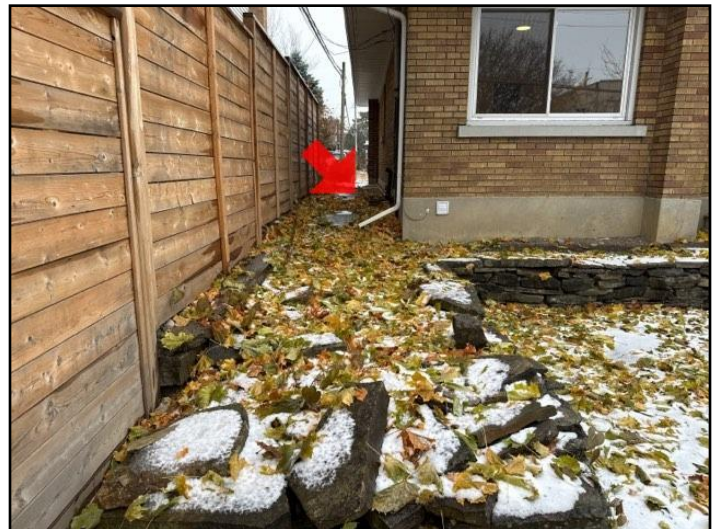
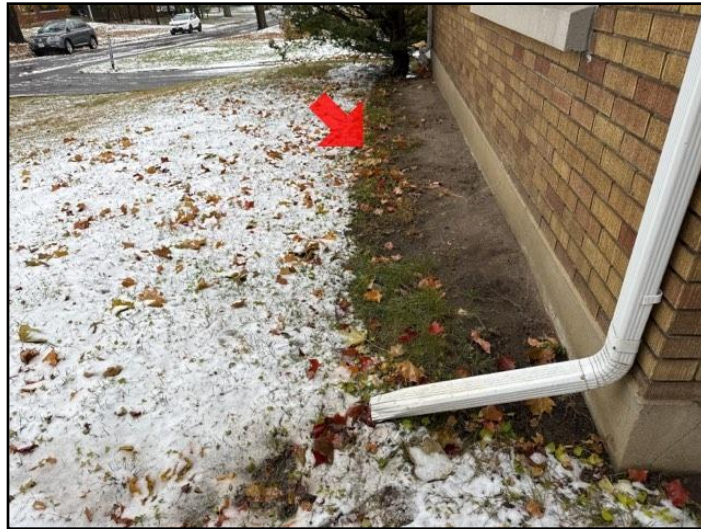
13. Condition: • [Improper slope or drainage](#)

Repair the slope of the ground around the house to limit the amount of water that accumulates against the foundation walls. The ground should slope away from the foundation. This can be a contributing factor to basement moisture issues.

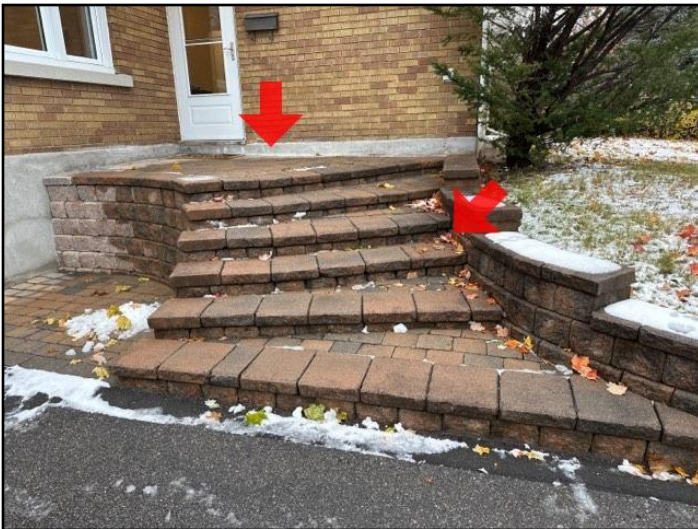
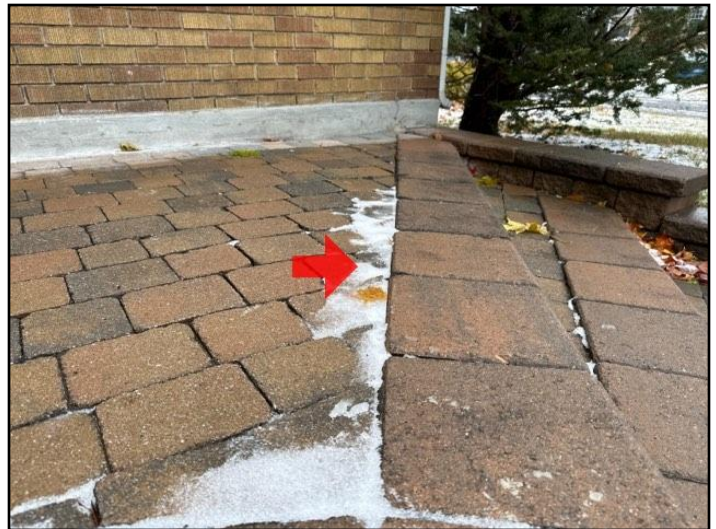
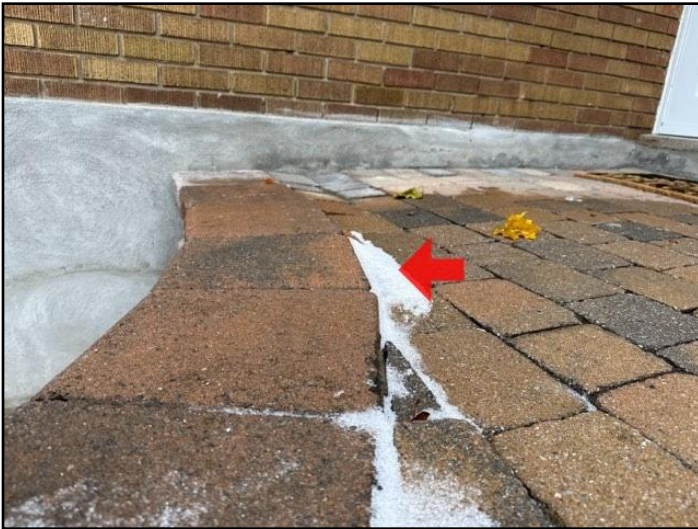
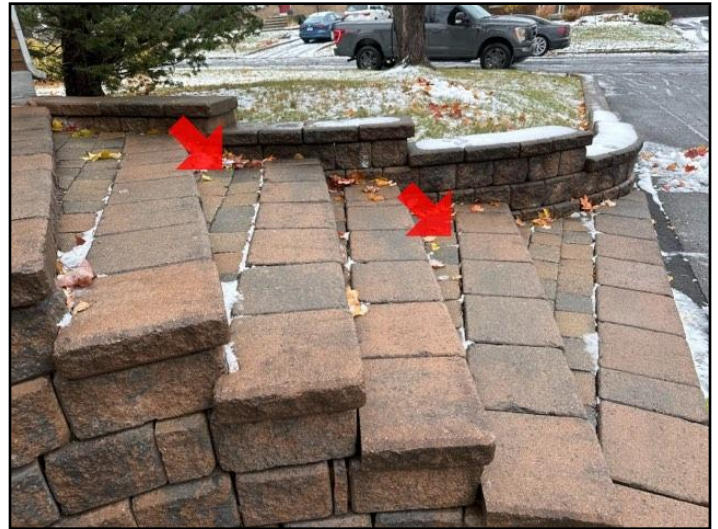
14. Condition: • [Uneven \(trip hazard\)](#)

The front walkway and step need to be repaired to correct the unevenness in the surface, which is currently a trip hazard.

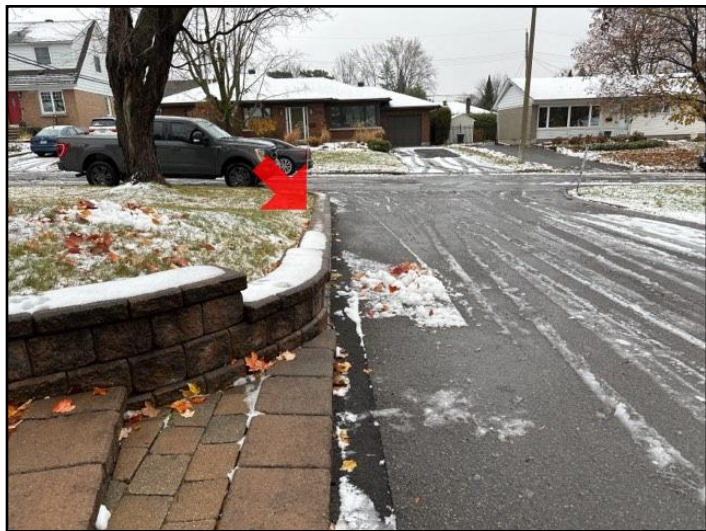
34. Leaning

16. Condition: • [Leaning](#)

Repair the retaining along the east side of the driveway as required.

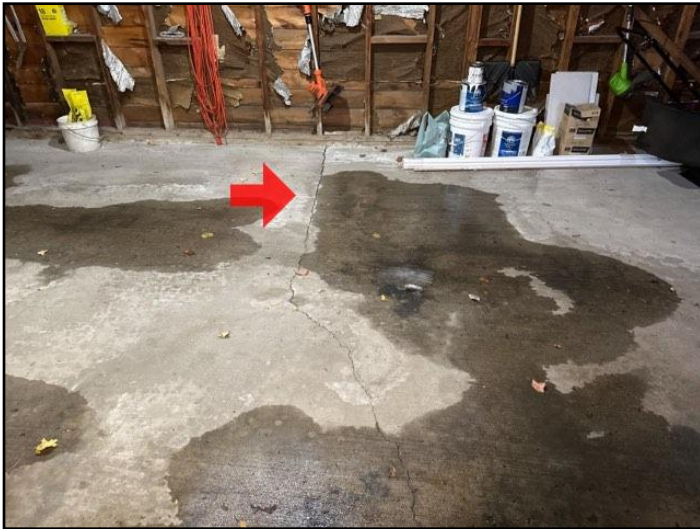
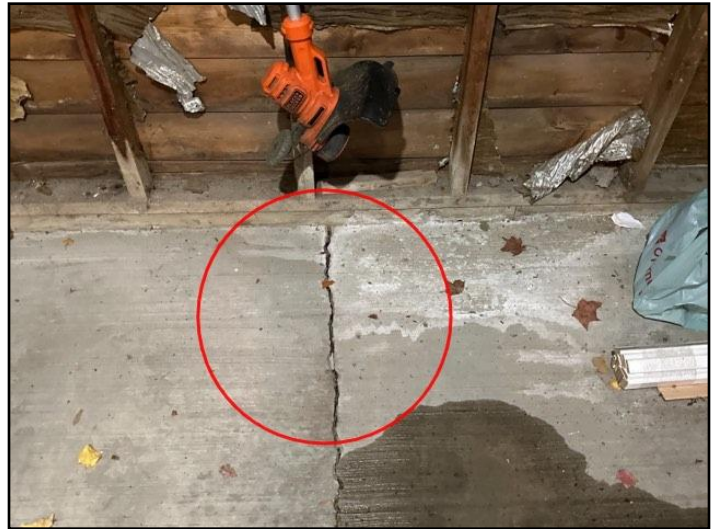
18. Condition: • [Cracked](#)

Monitor the crack in the garage floor slab for an increase in width.

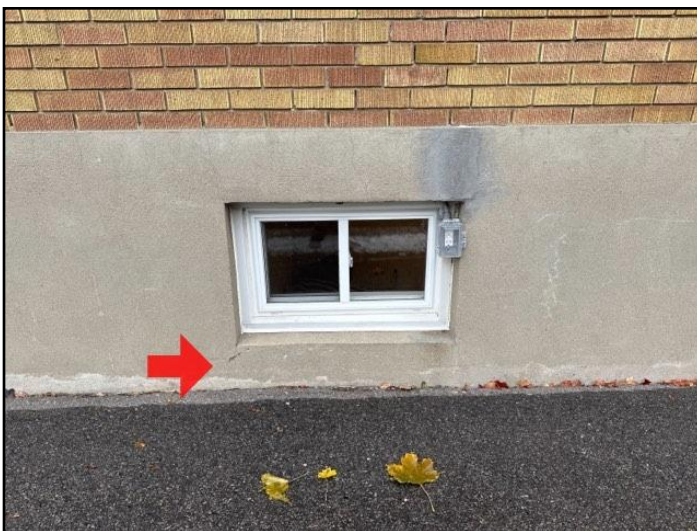
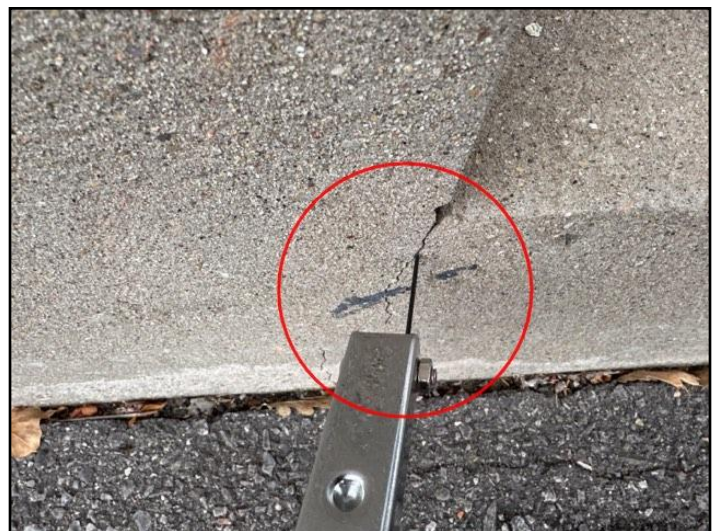
19. Condition: • Typical minor cracks

Monitor the hairline shrinkage crack in the west foundation wall of the house. The crack is not wide enough to insert a 1.5 mm allen key. It must be repaired if the crack increases to 6.0 mm in width or leaks.

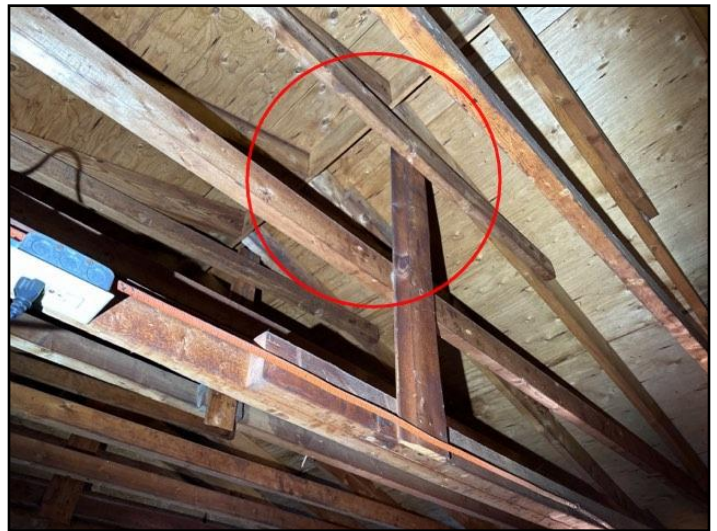
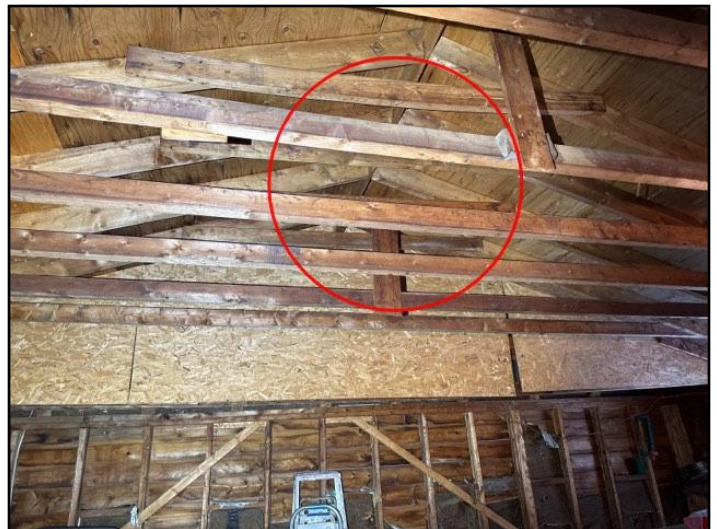
20. Condition: • [Too small or overspanned](#)

The framing for the garage roof is not standard, as it is overspanned. Minor deflection was observed in the framing members during the inspection. Monitor the roof framing for settlement and repair as required.

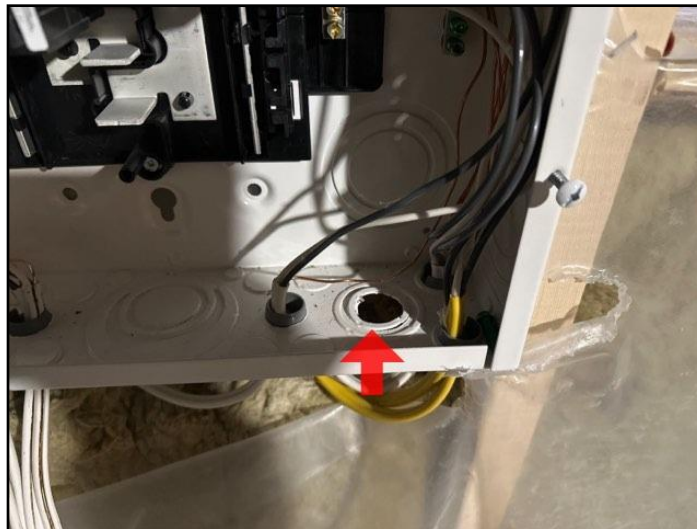
47. Openings in panel

22. Condition: • [Openings in panel](#)

Implication(s): Electric shock | Fire hazard

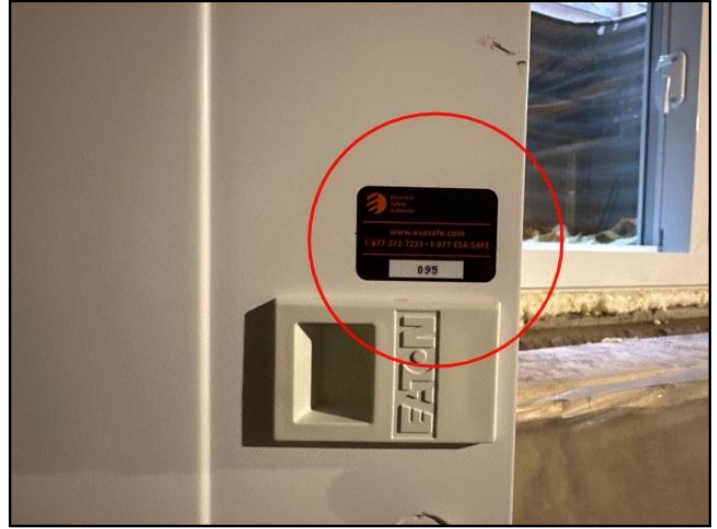
53. Modified or added wiring

25. Condition: • [Modified or added wiring](#)

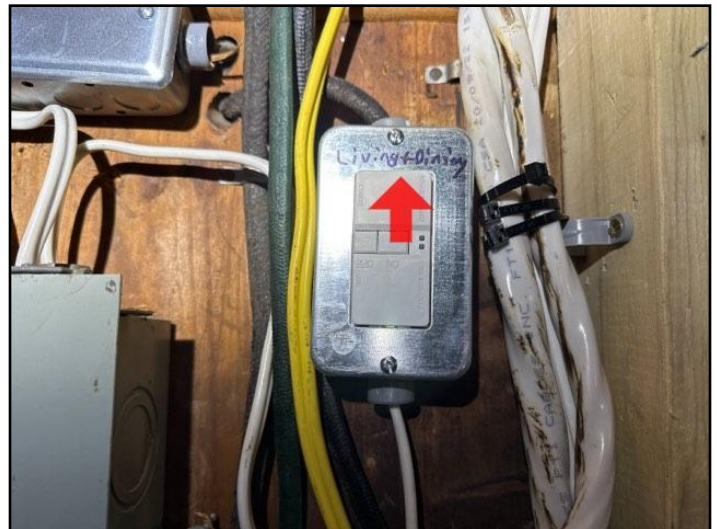
55. Ground needed for 3-slot outlet

26. Condition: • [Ground needed for 3-slot outlet](#)

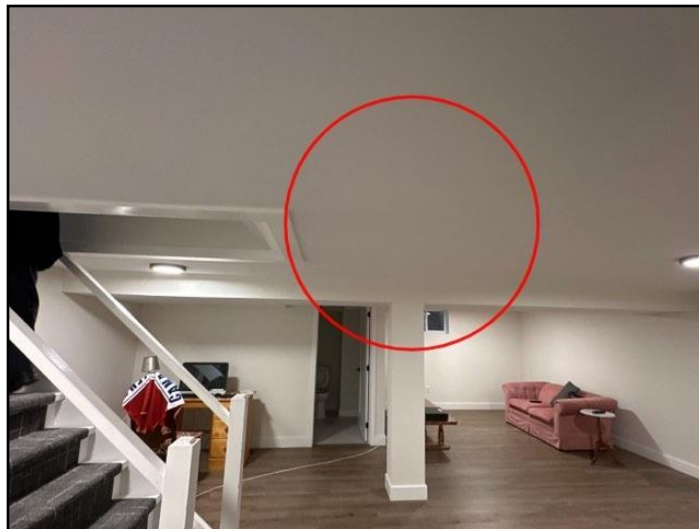
62. *Missing*

27. Condition: • Missing

Provide the missing smoke and CO detectors in the house upon possession.

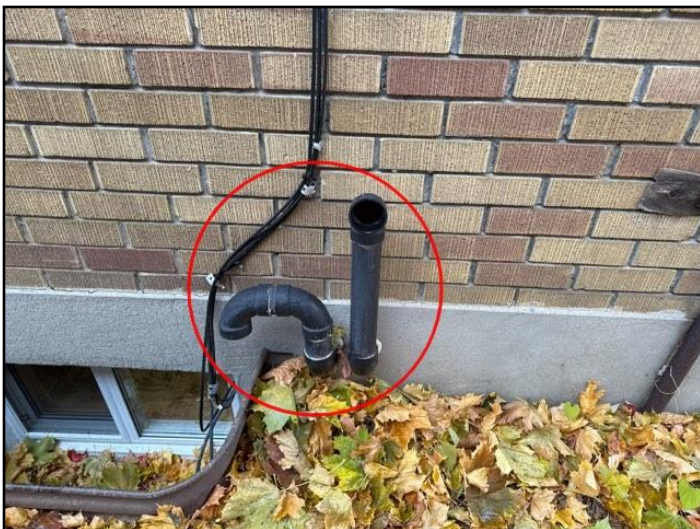
67. Near end of life expectancy

29. Condition: • [Near end of life expectancy](#)

The furnace should be budgeted for replacement due to the age and condition of the unit.

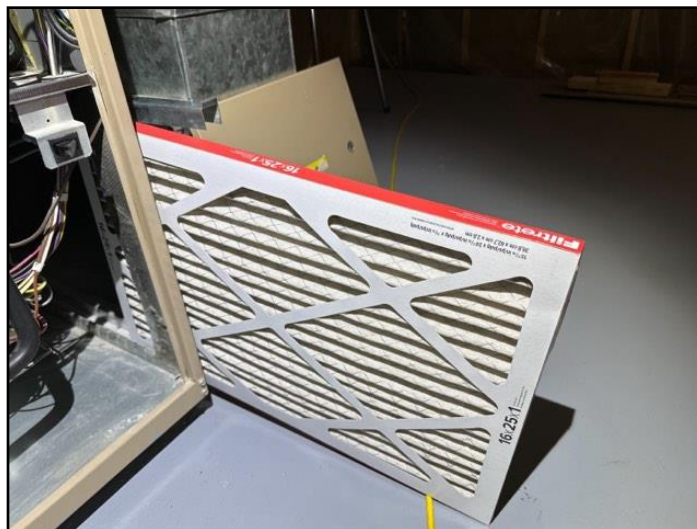
69. Dirty

30. Condition: • [Dirty](#)

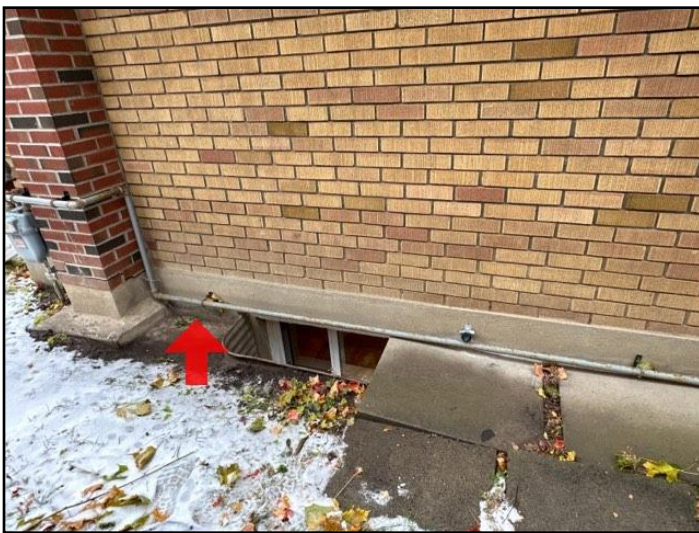
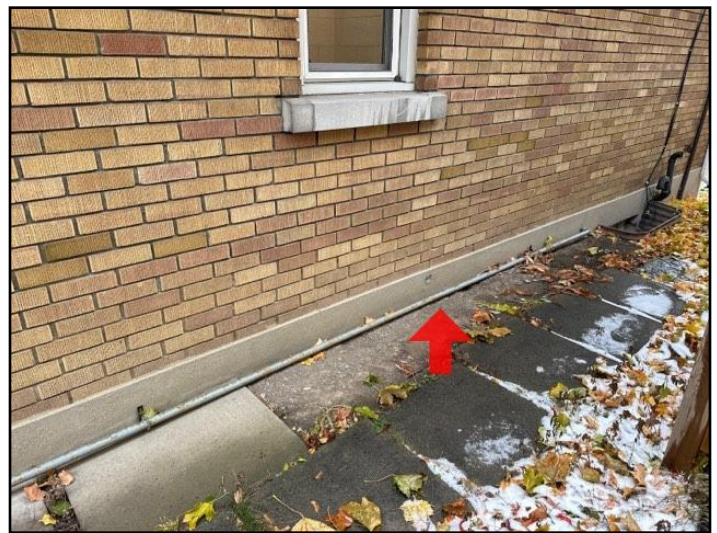
31. Condition: • [Inadequate support](#)

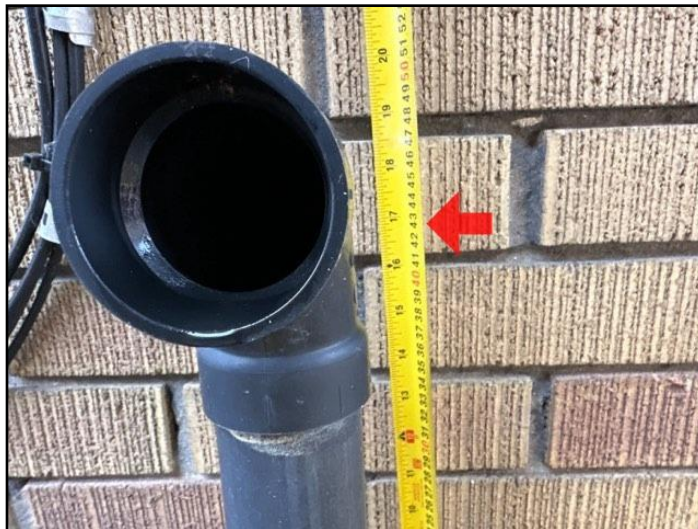
72. Exhaust vent missing insulation

32. Condition: • Exhaust vent missing insulation

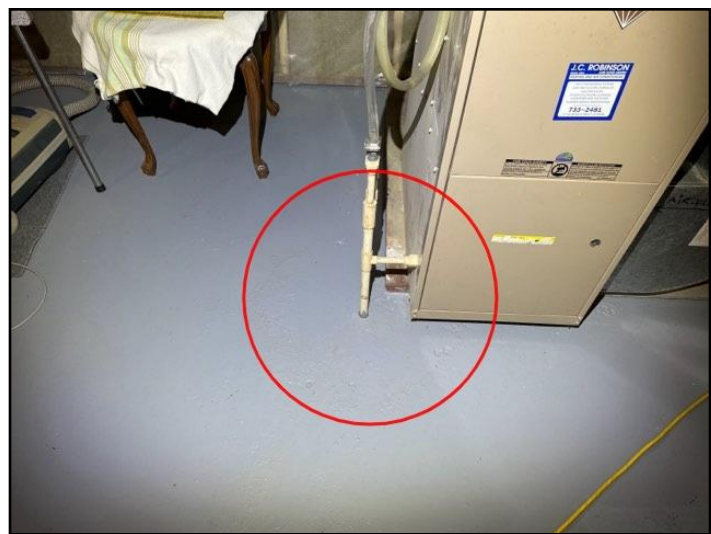
73. Condensate problems

33. Condition: • [Condensate problems](#)

Implication(s): Chance of water damage to structure, finishes and contents | Reduced system life expectancy

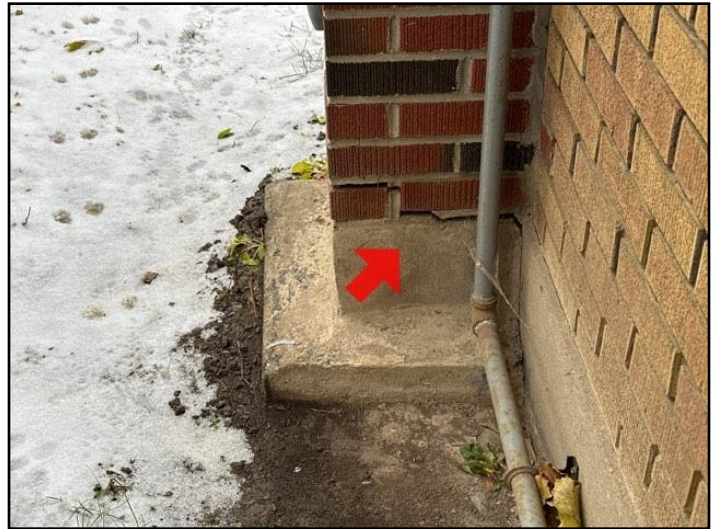
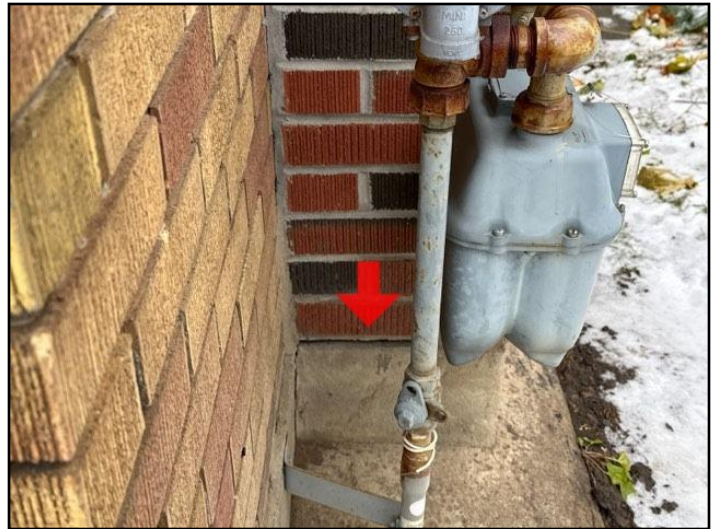
The chimney added on the east side of the house at the south corner is settling and leaning away from the home. The chimney should be removed, and the hole in the wall for the flue sealed.

34. Condition: • [Settling or leaning](#)

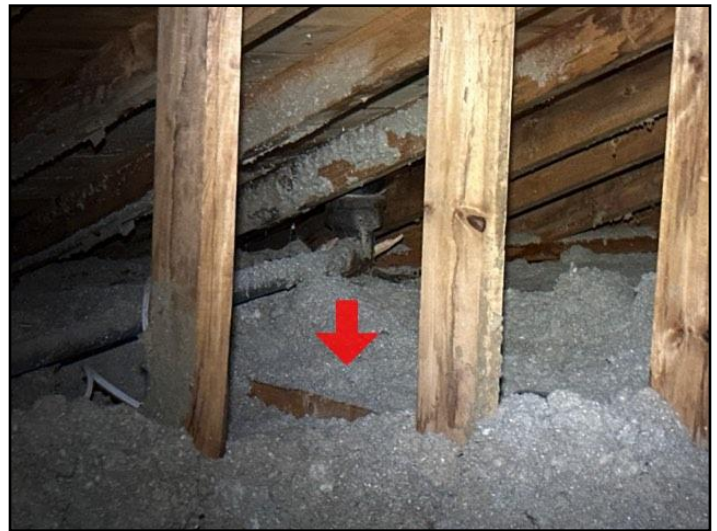
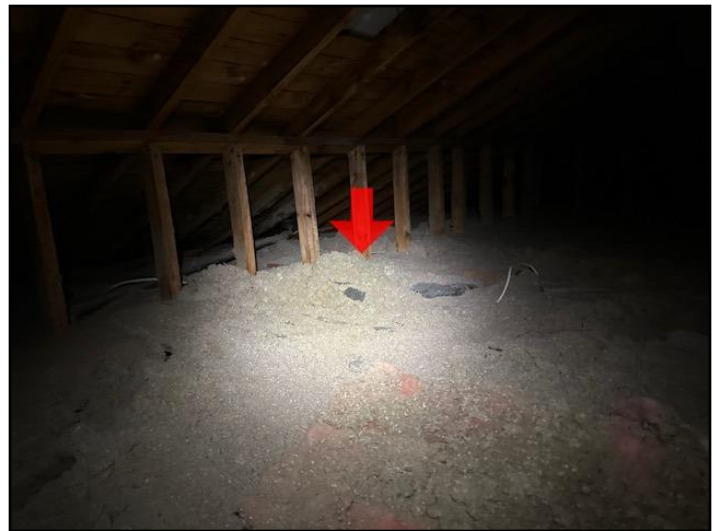
35. Condition: • [Compressed](#)

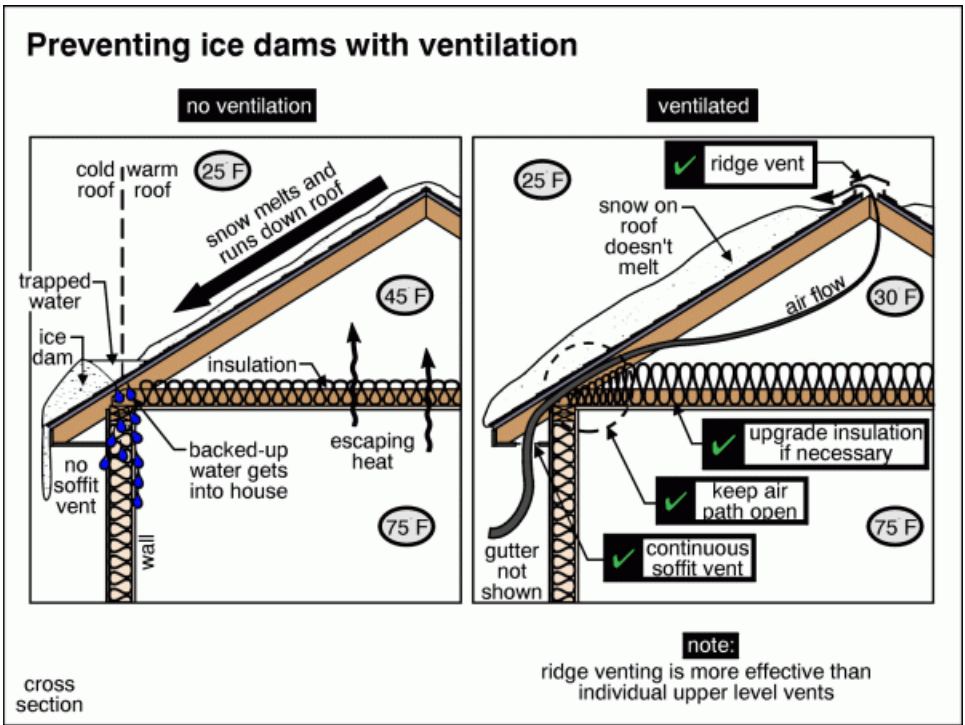
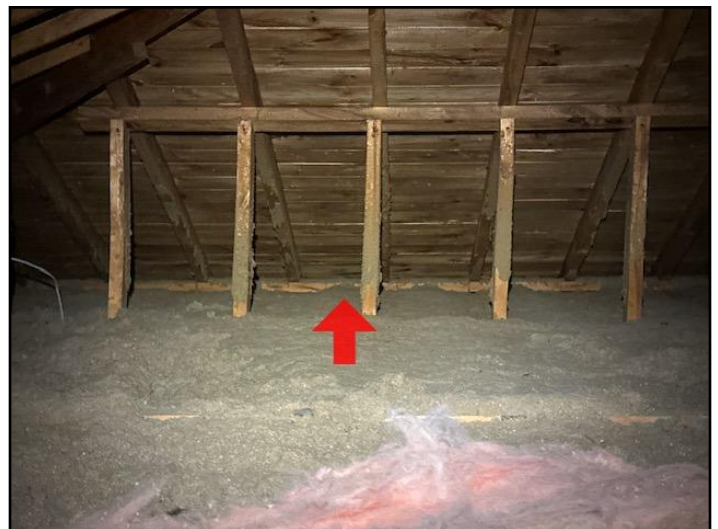
37. Condition: • [Obstructed](#)

The soffits are blocked and not providing the required air intake into the attic. Open the soffits on the exterior of the house and provide the missing insulation baffles for the soffits on the interior of the attic.

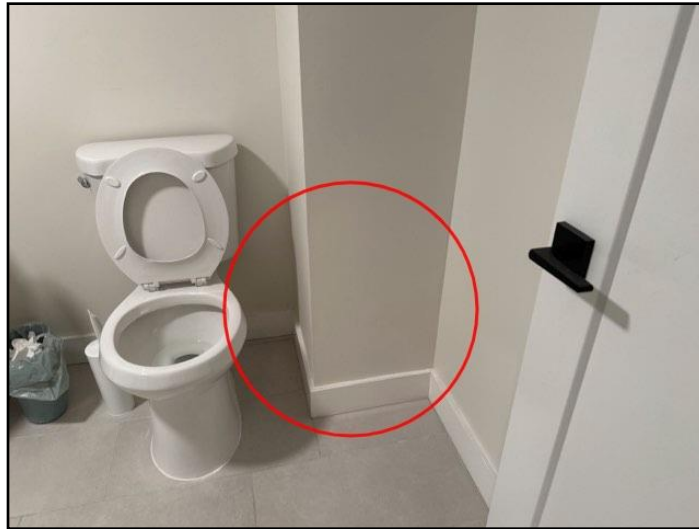
90. Clean-outs missing or inaccessible

38. Condition: • [Clean-outs missing or inaccessible](#)

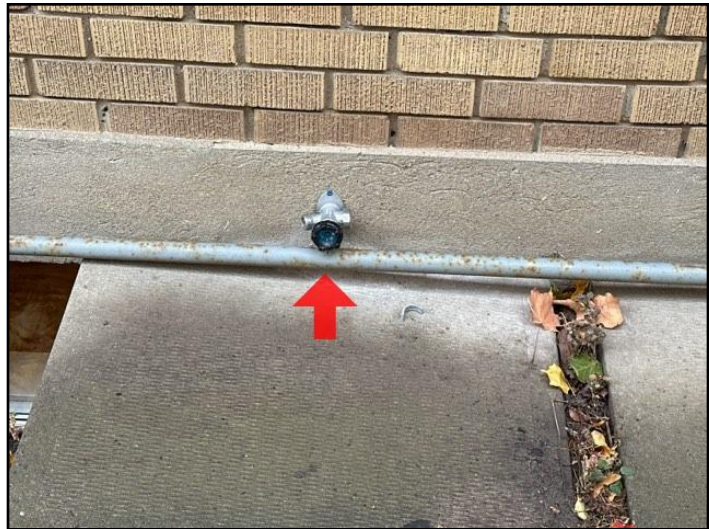
93. Poor slope on frost-free bib/bibb (outdoor...)

40. Condition: • [Poor slope on frost-free bib/bibb \(outdoor faucet\)](#)

The exterior hose bib on the east side of the house at the south corner has been installed horizontally instead of vertically. This will prevent the hose bib from draining correctly. Ensure that the interior shut-off valve is turned off and drained for the winter.

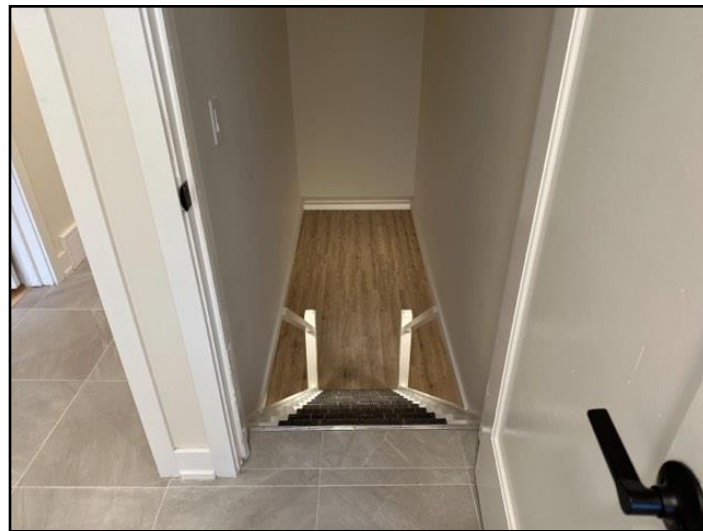
94. Missing

41. Condition: • [Missing](#)

Install the missing sections of the handrail for the basement stairs.

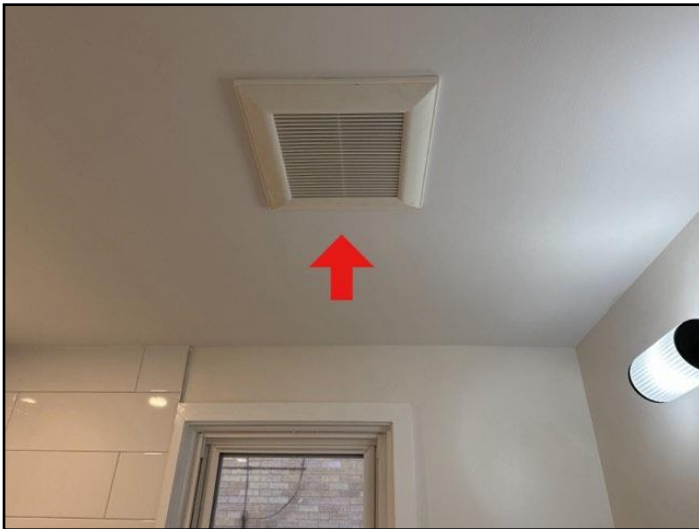
95. Inoperative

42. Condition: • Inoperative

Repair the first-floor bathroom exhaust fan that would not operate during the inspection and did not vent to the house's exterior.
