YOUR INSPECTION REPORT

1 INSPECTION WAY
Kanata, ON

Saturday, November 25, 2023

Report No. 3559, v.2

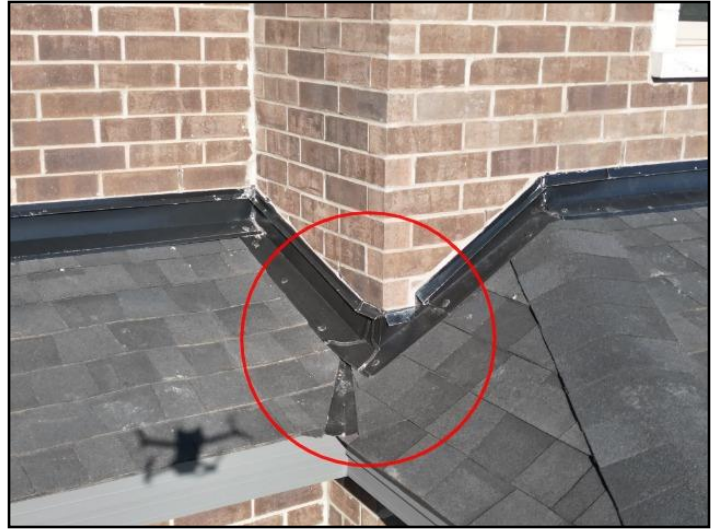
10. Damage, loose, open seams, patched

4. Condition: • [Damage, loose, open seams, patched](#)

Repair the loose and open seams in the roof-to-wall flashing on the garage and porch roofs. Repair the wall flashing at the transition from the garage to the porch roof that is not high enough above the porch roof.

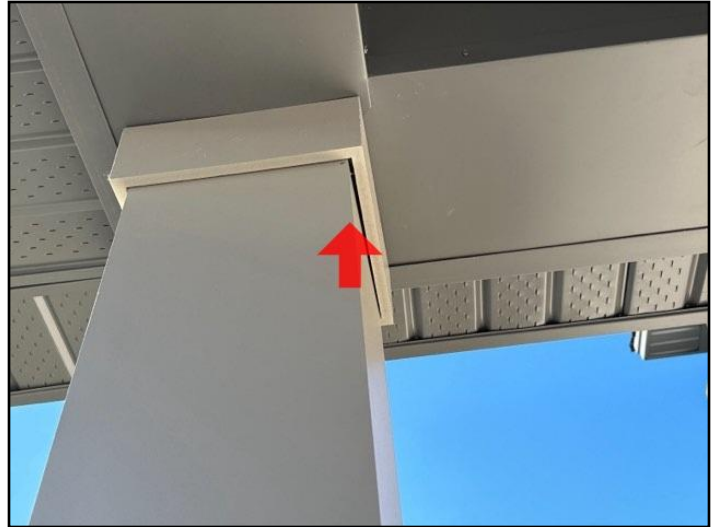
19. Loose

9. Condition: • [Loose](#)

Repair the loose trim at the top of the front porch columns.

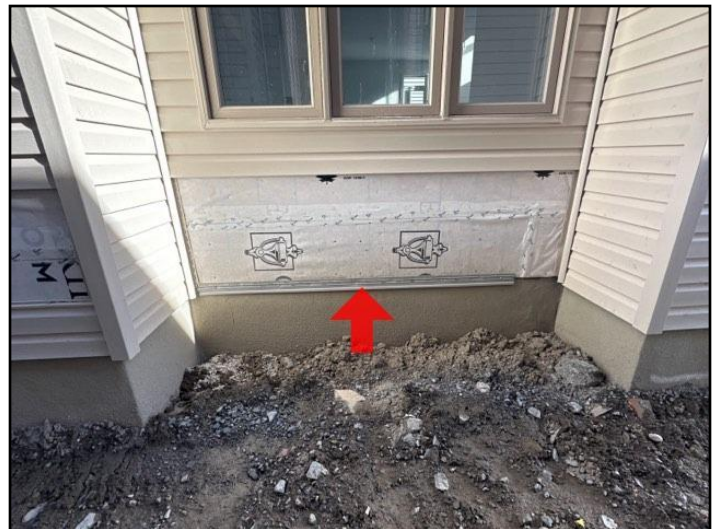
26. Loose or missing pieces

15. Condition: • [Loose or missing pieces](#)

Install the missing siding on the west wall of the house.

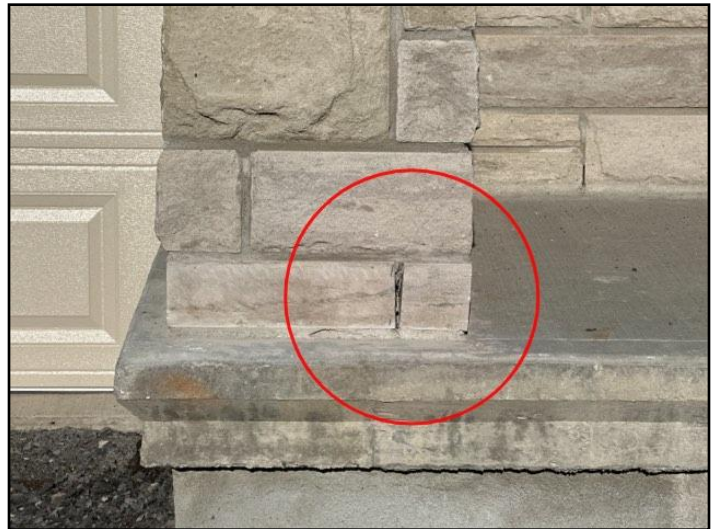
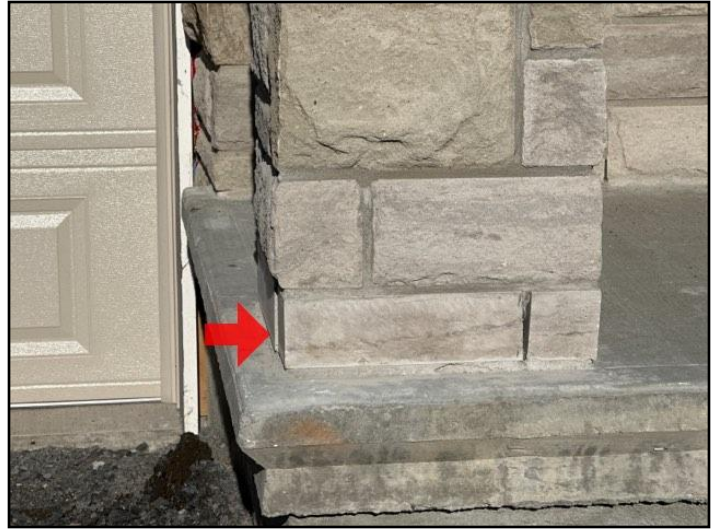
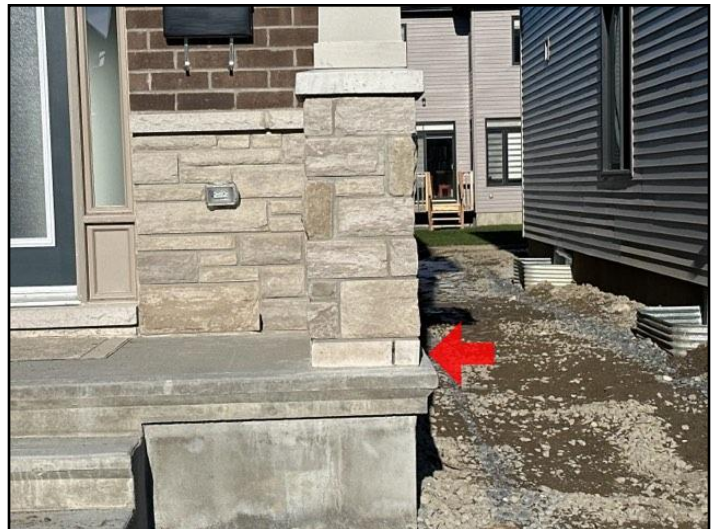
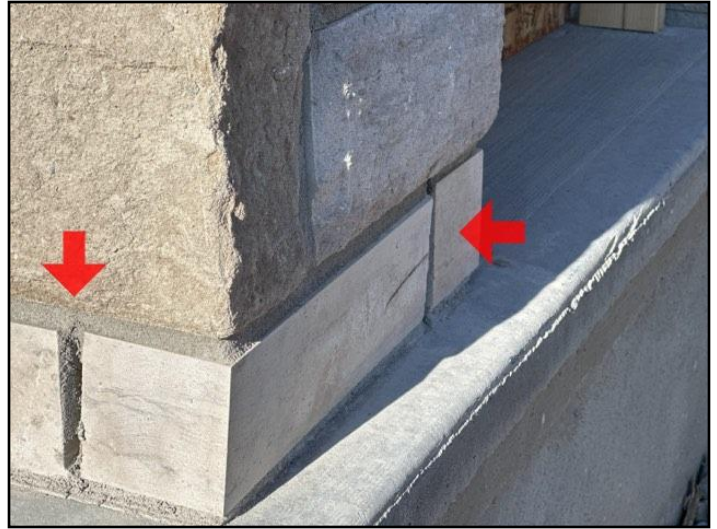
17. Condition: • [Masonry deterioration](#)

Repair the bricks at the base of the front porch columns that have not been installed level or plumb.

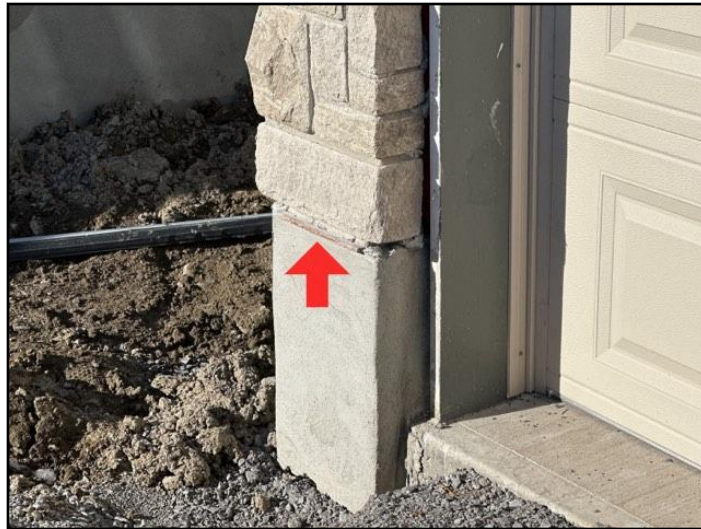
38. Masonry deterioration

18. Condition: • [Masonry deterioration](#)

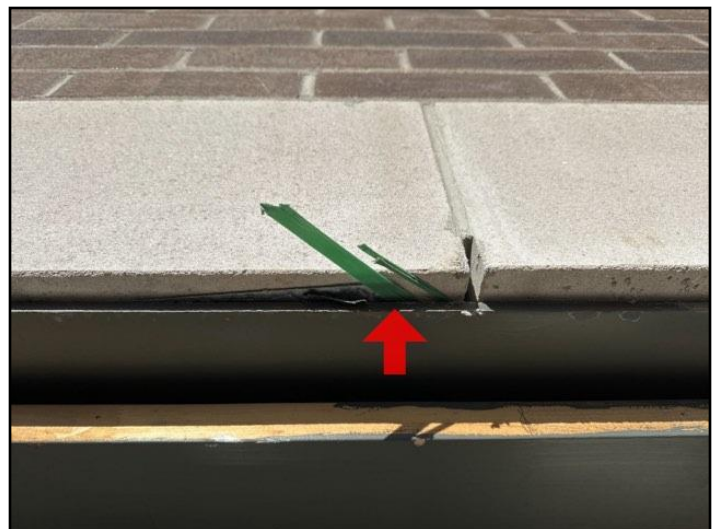
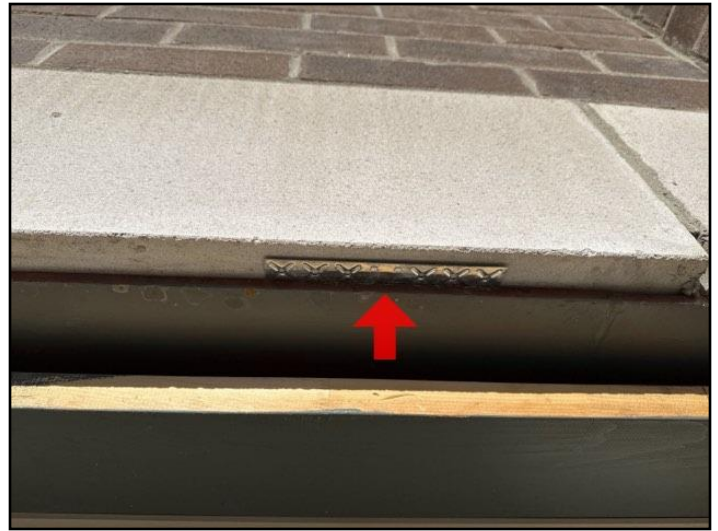
19. Condition: • [Masonry deterioration](#)

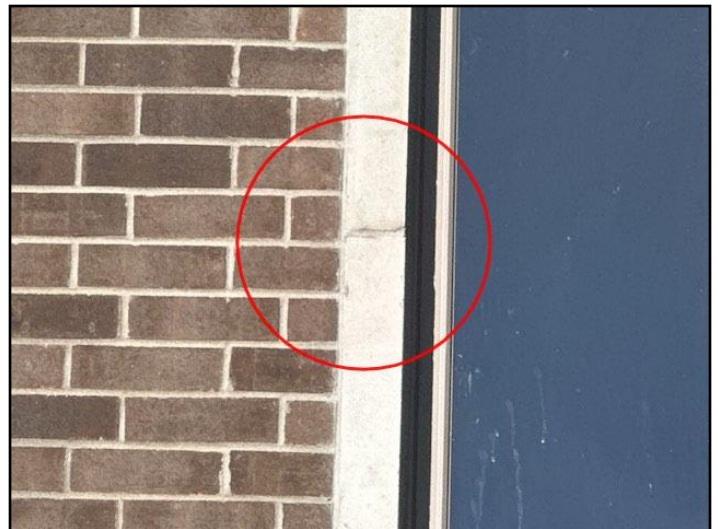
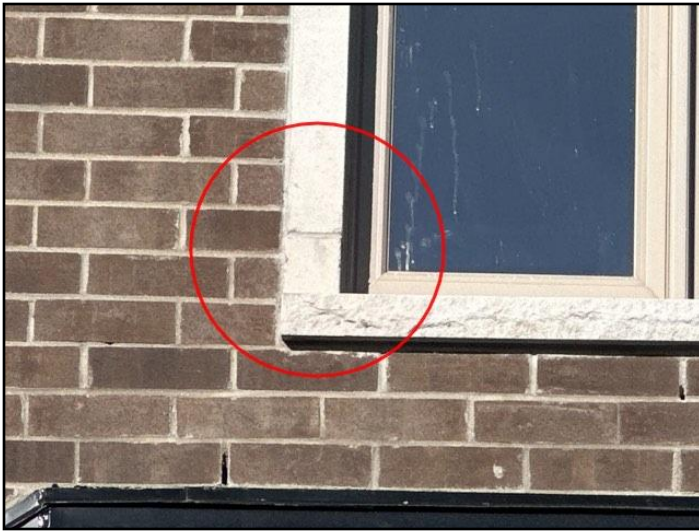
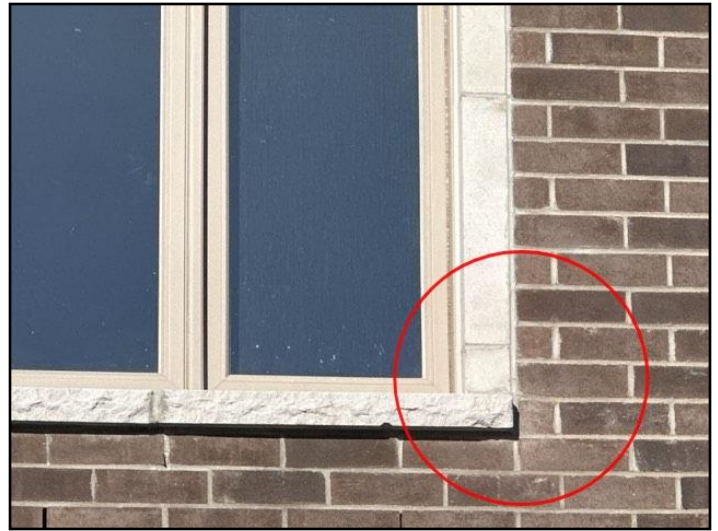
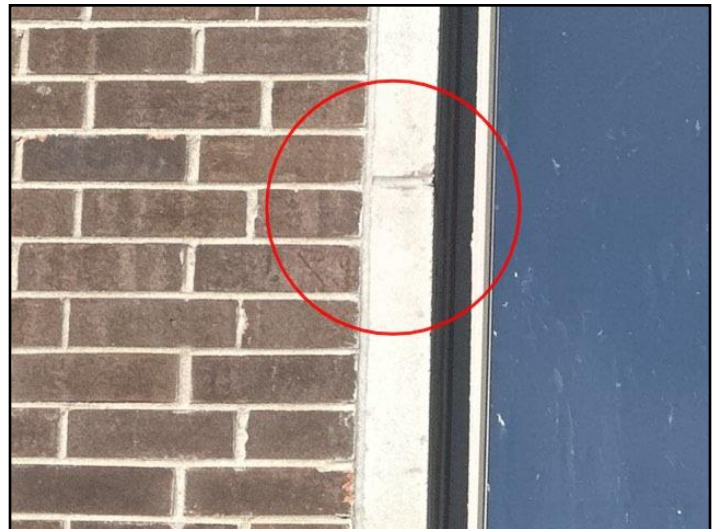
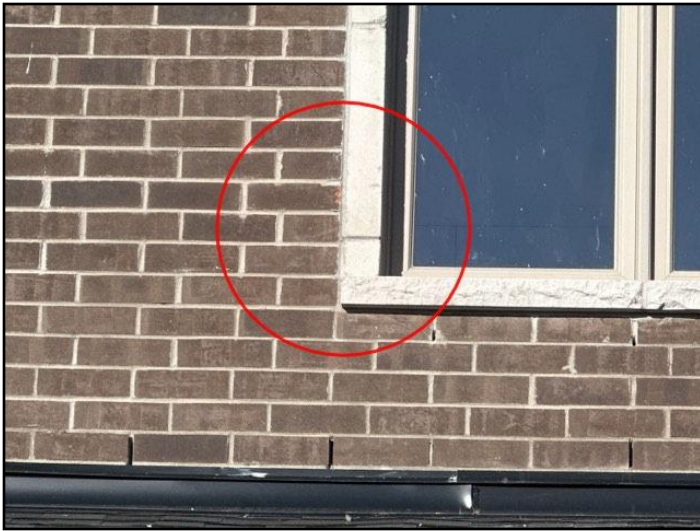
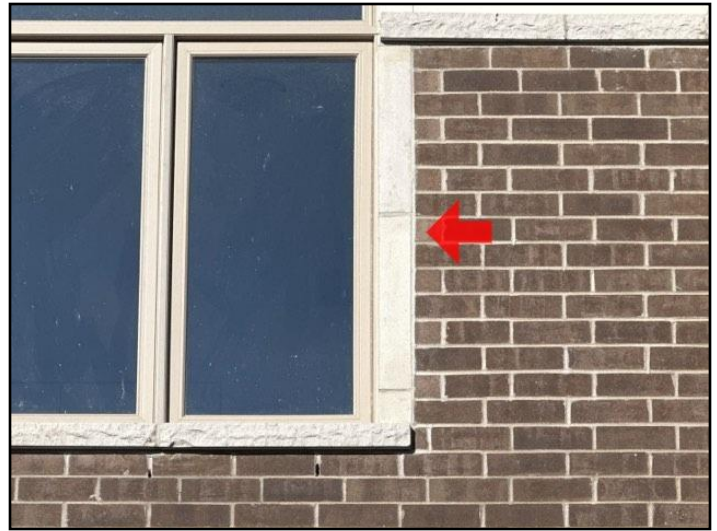
20. Condition: • [Masonry deterioration](#)

Repair the chipped and out of plumb block and brick veneer around the front second floor windows.

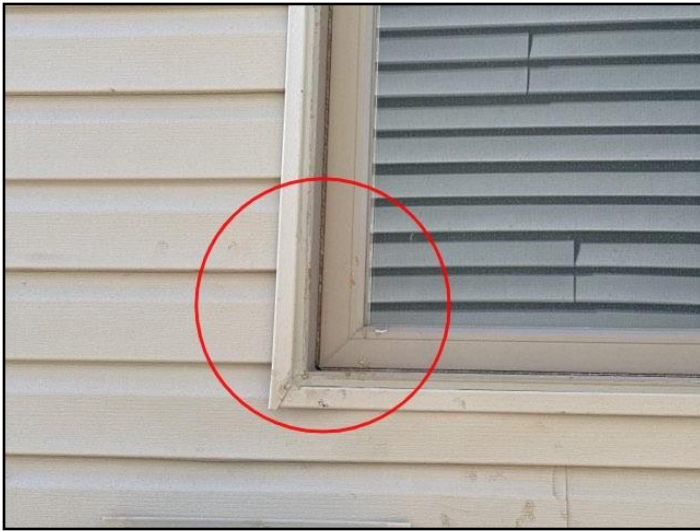
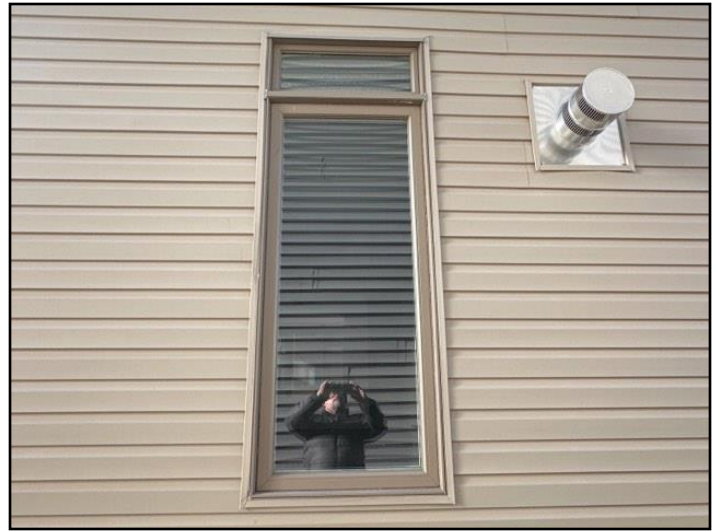
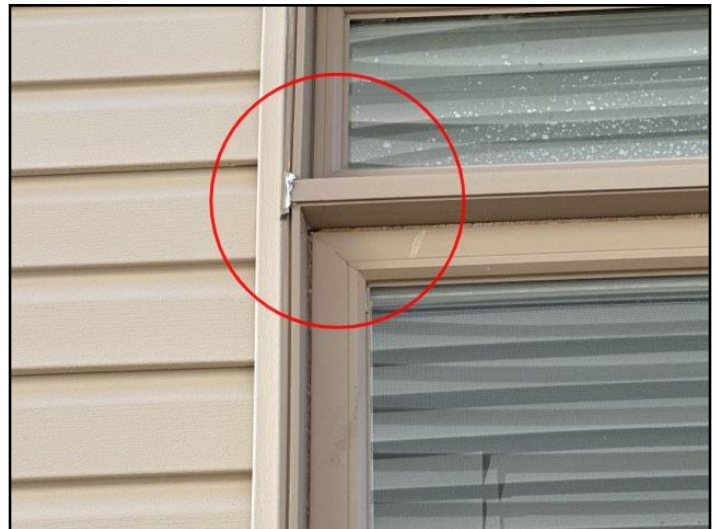
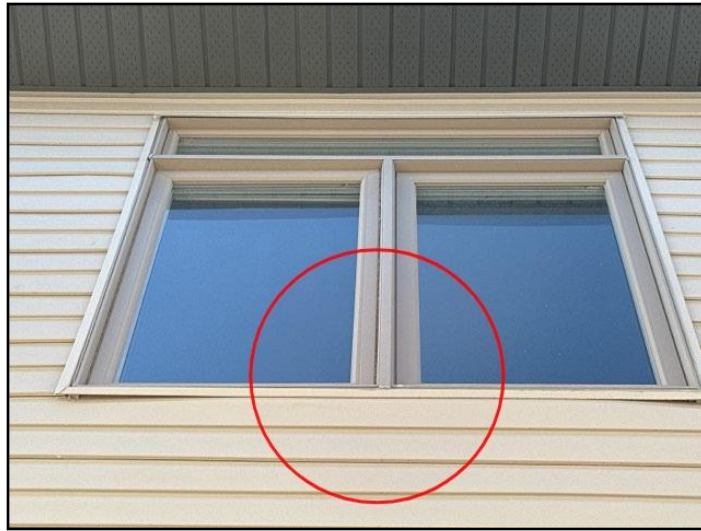
24. Condition: • Damage

Remove the spray foam and protective film from the windows on the east side of the house. Repair the scratches in the windows and frames.

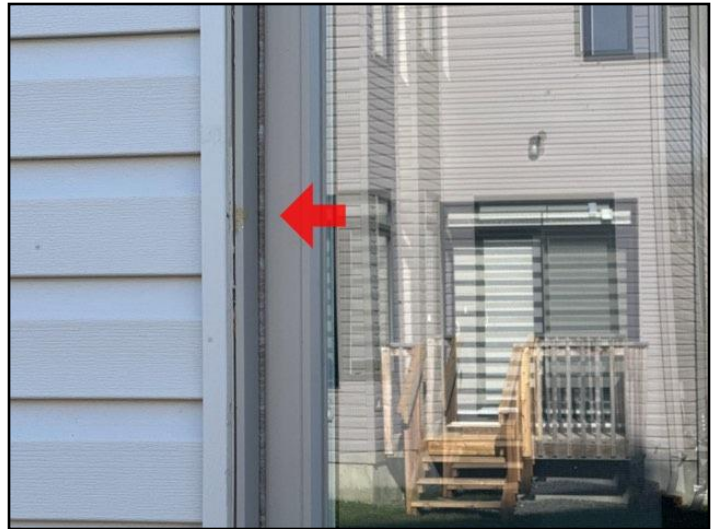
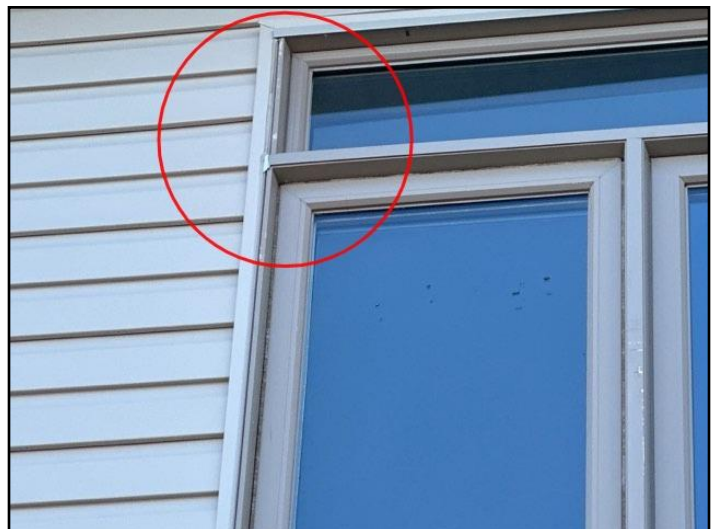
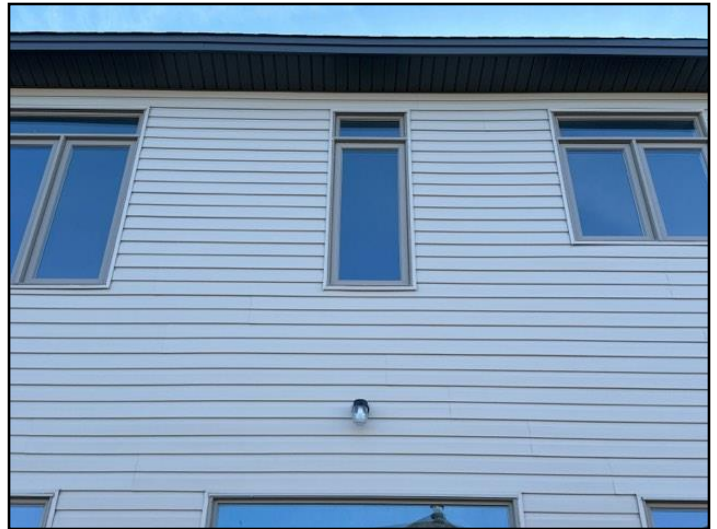
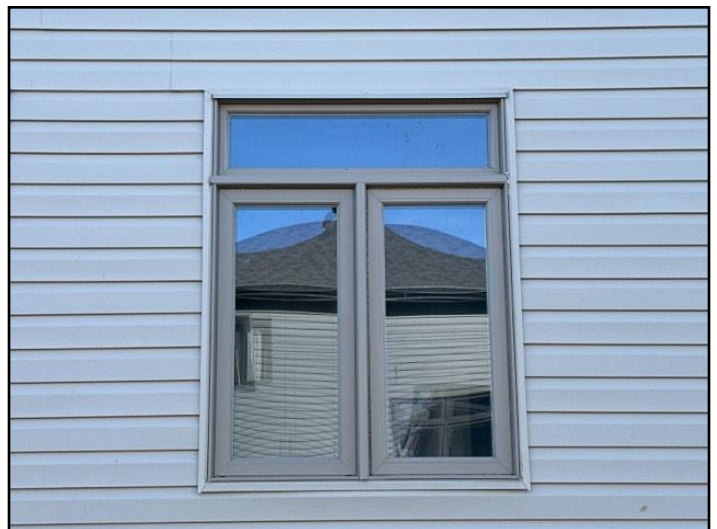
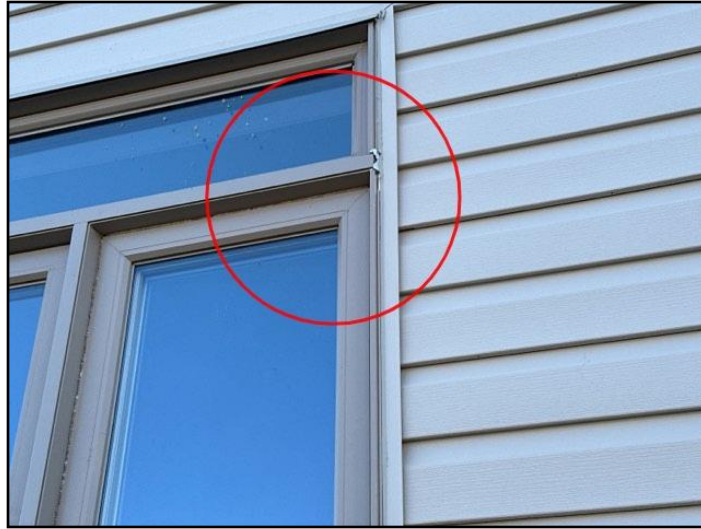
25. Condition: • Damage

Remove the spray foam, adhesive, and protective film from the windows on the north side of the house. Repair the scratches in the windows and frames.

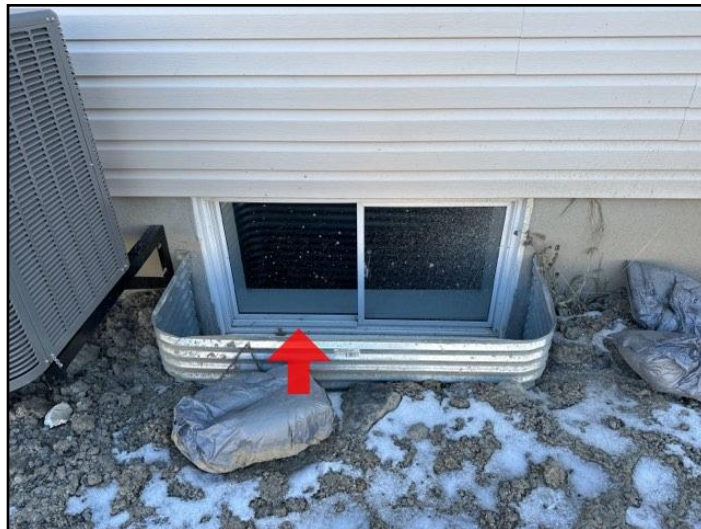
83. Missing

26. Condition: • [Missing](#)

Install the missing screen and track on the rear basement window beside the exterior A/C coil.

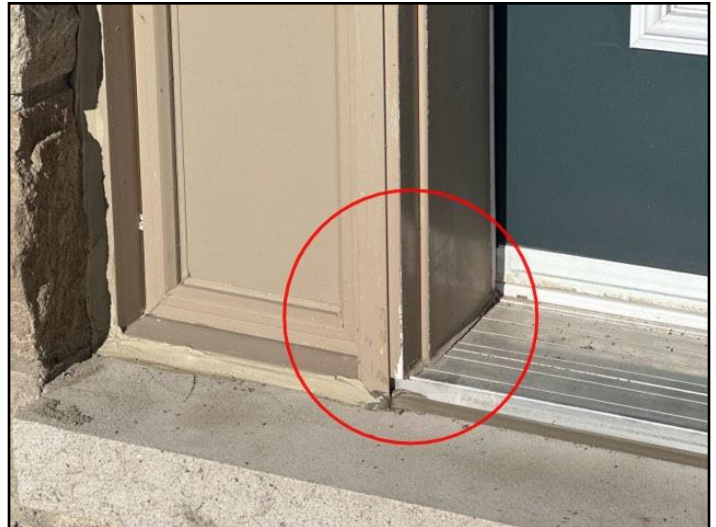
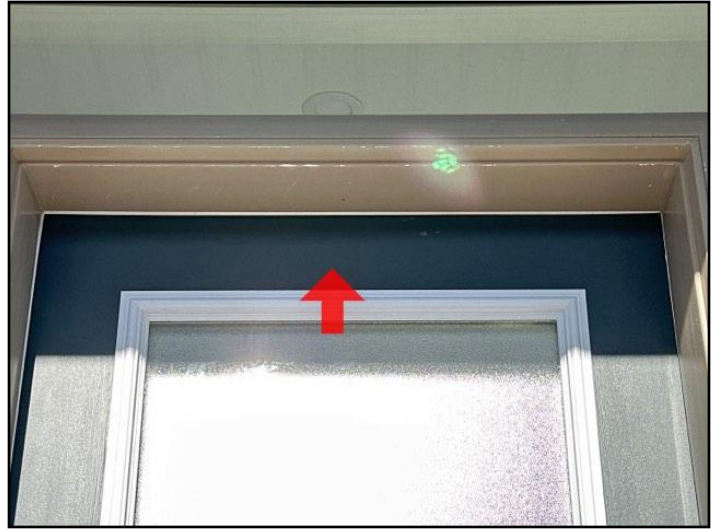
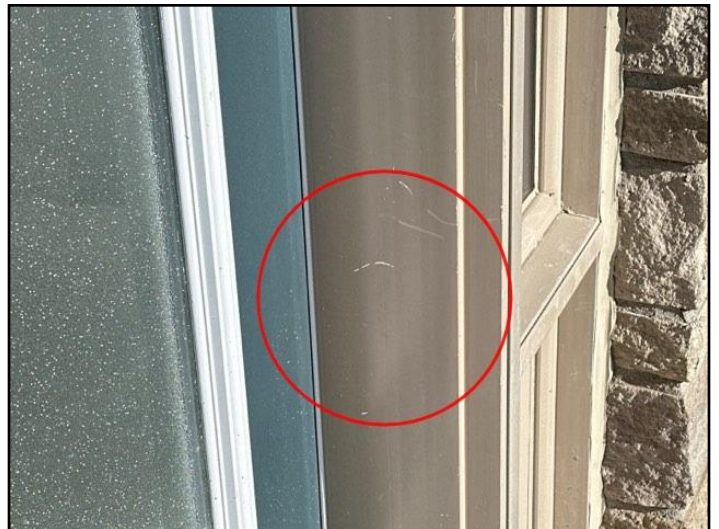
29. Condition: • [Damaged, cracked or loose](#)

Repair the scratches and chips in the front entrance door frame.

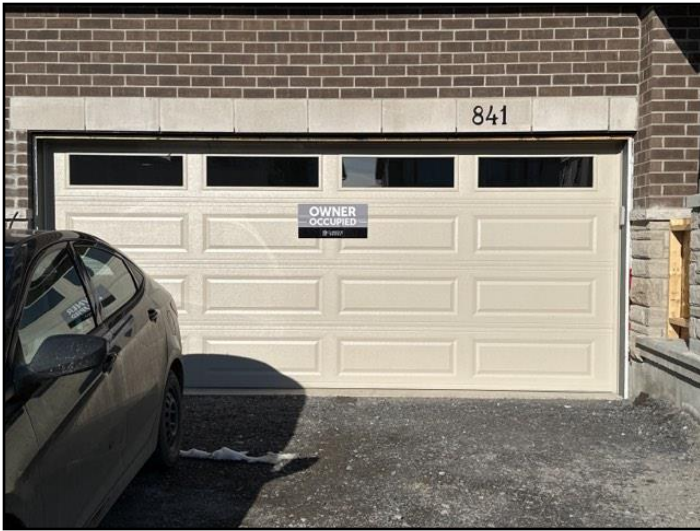
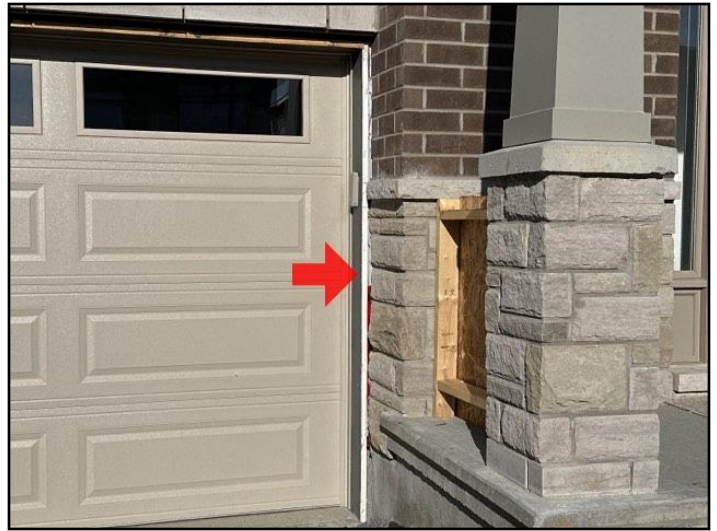
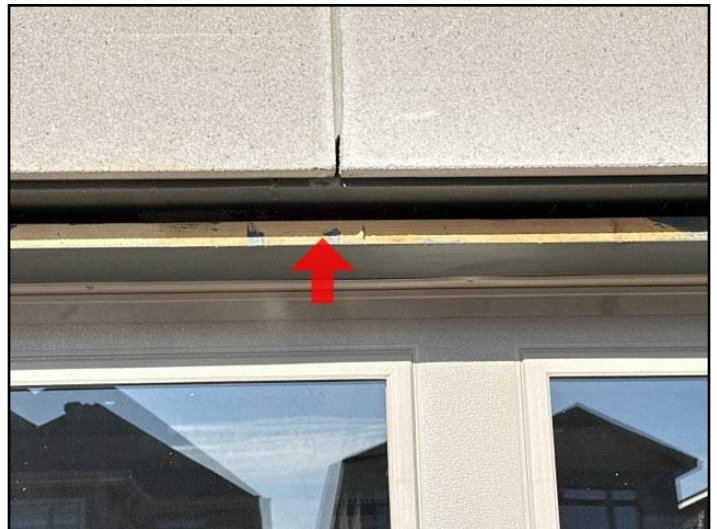
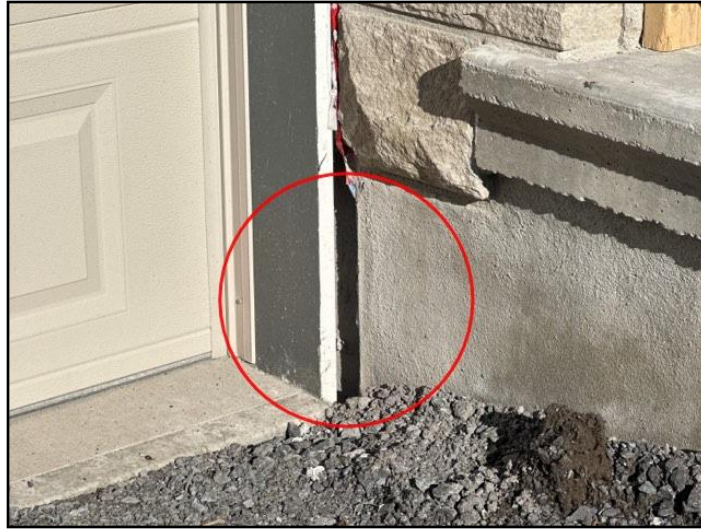
30. Condition: • [Missing](#)

Install the trim around the garage door frame. Cover the hole between the bottom east corner of the garage door frame and the foundation.

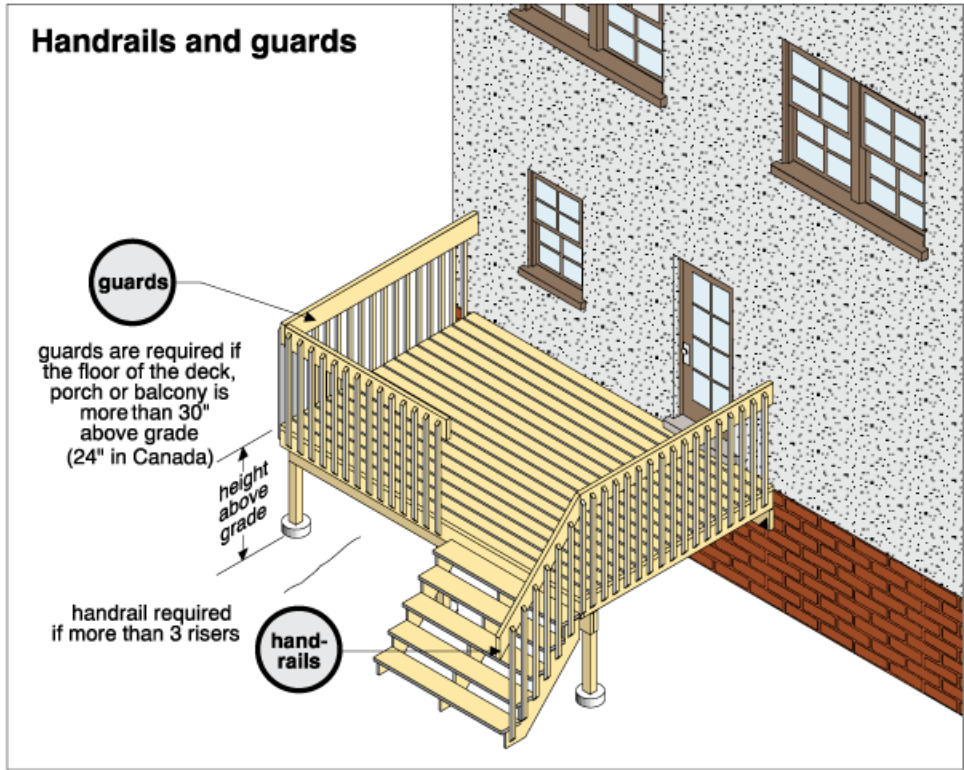
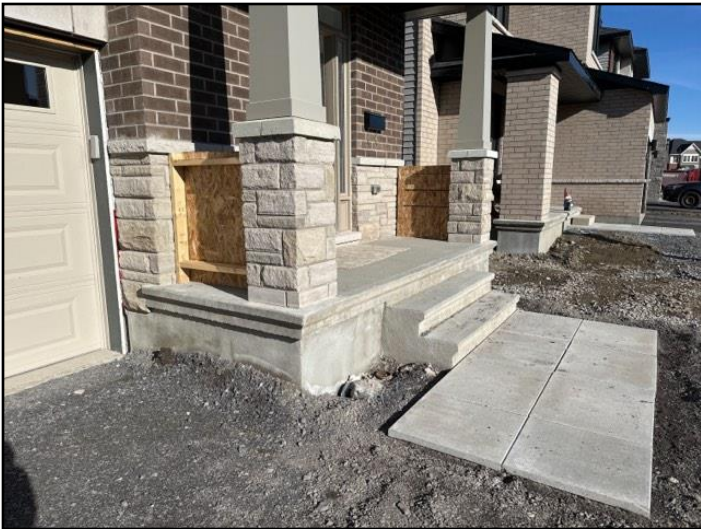
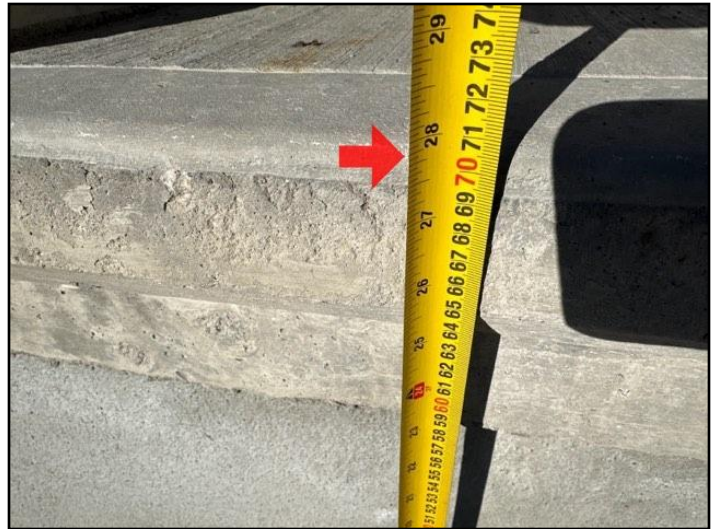
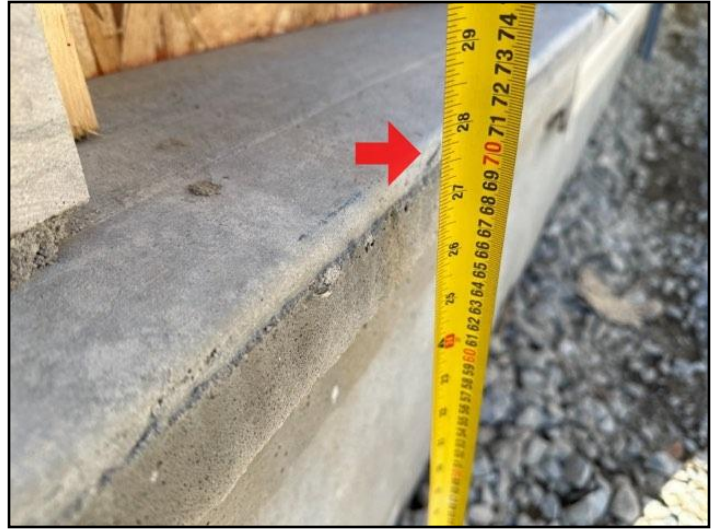
33. Condition: • [Missing](#)

Implication(s): Fall hazard

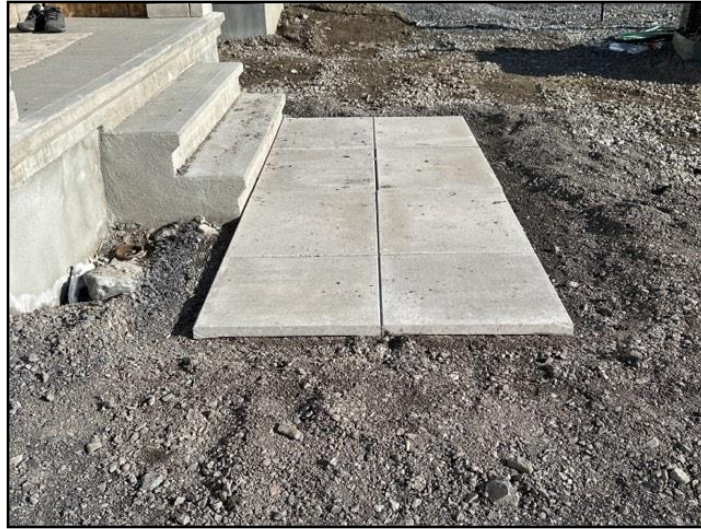
117. Uneven (trip hazard)

35. Condition: • [Uneven \(trip hazard\)](#)

Repair the unevenness in the front walkway that is currently a trip hazard.

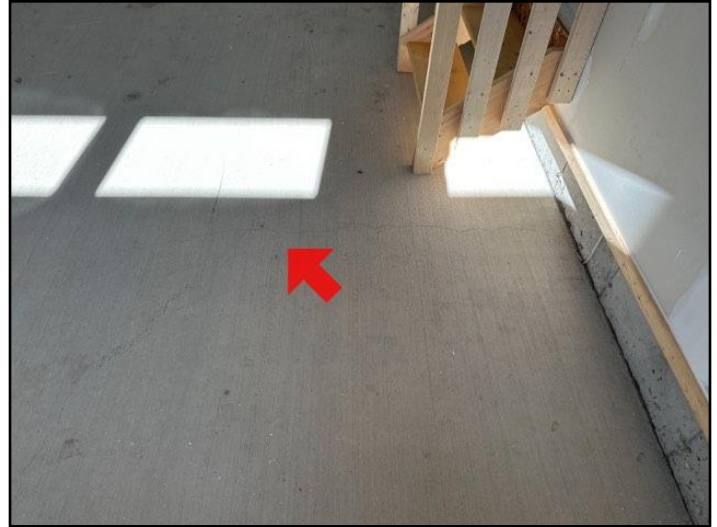
124. Cracked

38. Condition: • [Cracked](#)

Monitor the hairline shrinkage crack in the garage floor slab. The crack is not wide enough to insert a 1.5 mm allen key. If the width of the crack increases to 6 mm, they will need to be repaired.

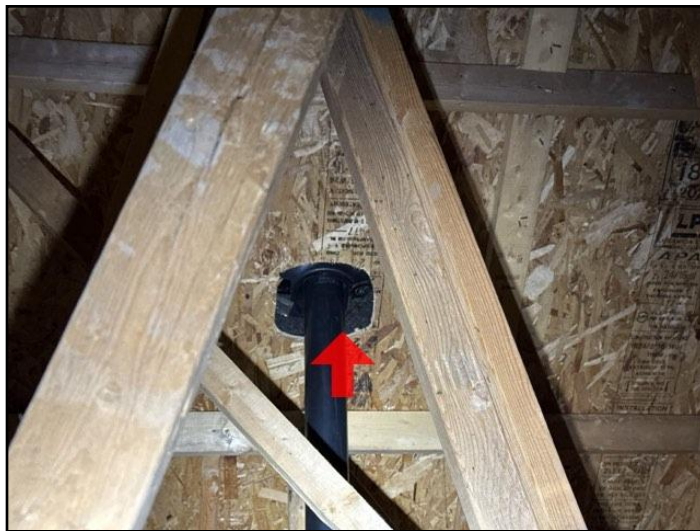
129. Edge support for sheathing

40. Condition: • Edge support for sheathing
The hole in the roof sheathing was cut too large and does not support the flexible plumbing stack flange.

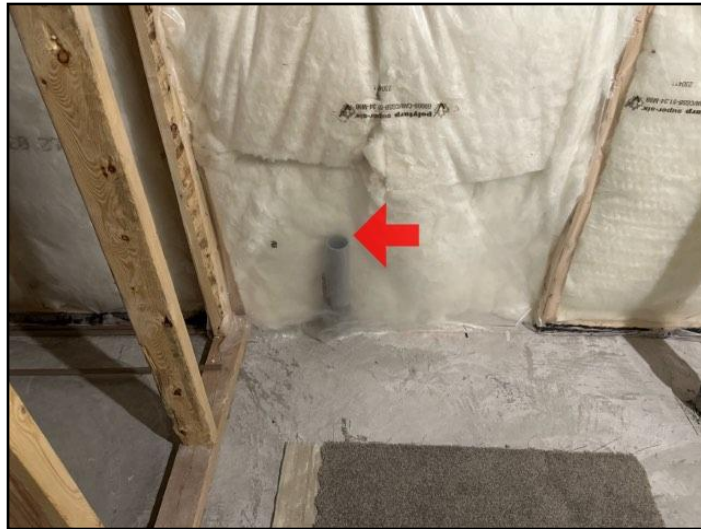
130. Abandoned

41. Condition: • Abandoned

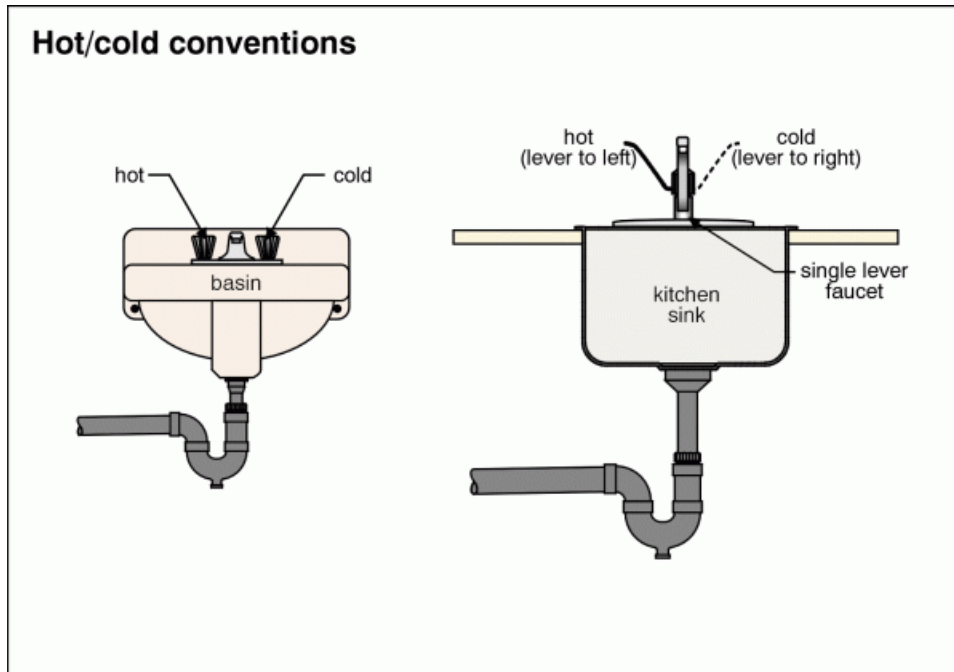
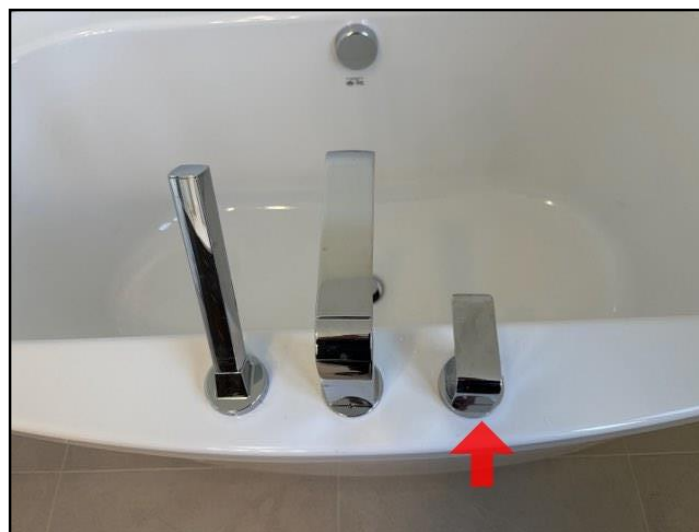
169. Hot and cold reversed

59. Condition: • [Hot and cold reversed](#)

Repair the water connections to the soaker tub faucet. Hot water comes from the faucet when you initially turn it on, not cold.

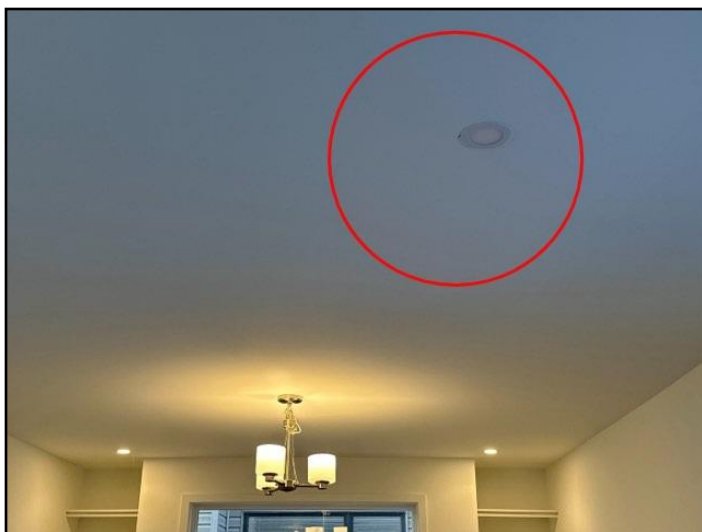
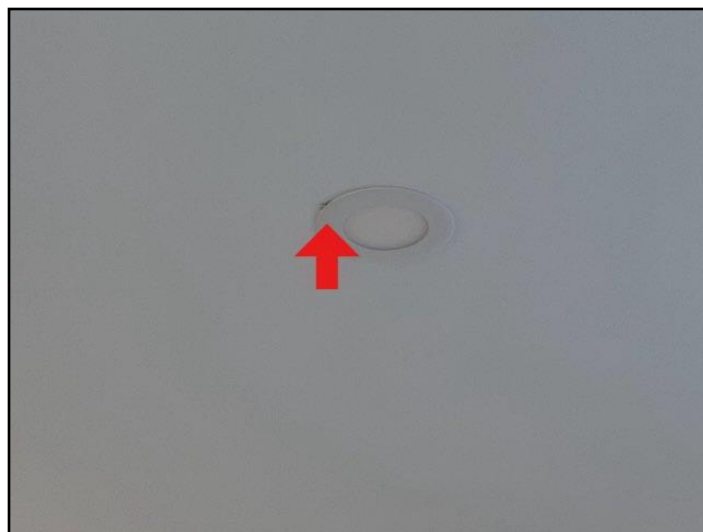
62. Condition: • Damage

Repair the damaged drywall at the pot light in the first floor hallway.

Implication(s): Damage or physical injury due to falling materials

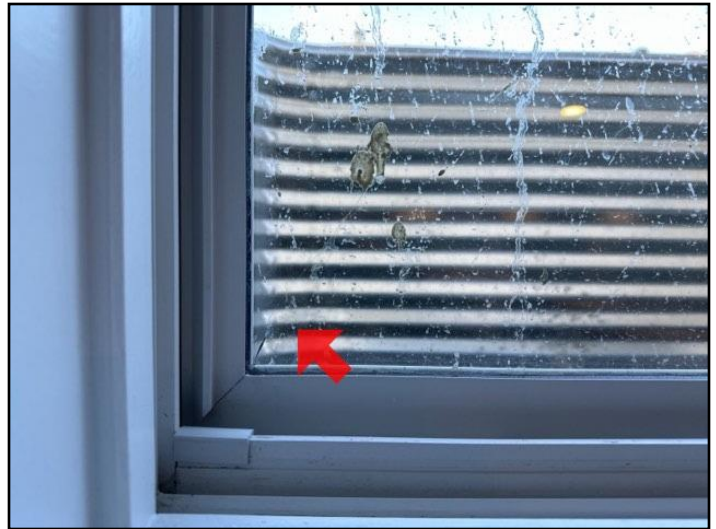
179. Cracked

65. Condition: • [Cracked](#)

Replace the cracked glass on the west side of the rear basement window on the west end of the north exterior wall.

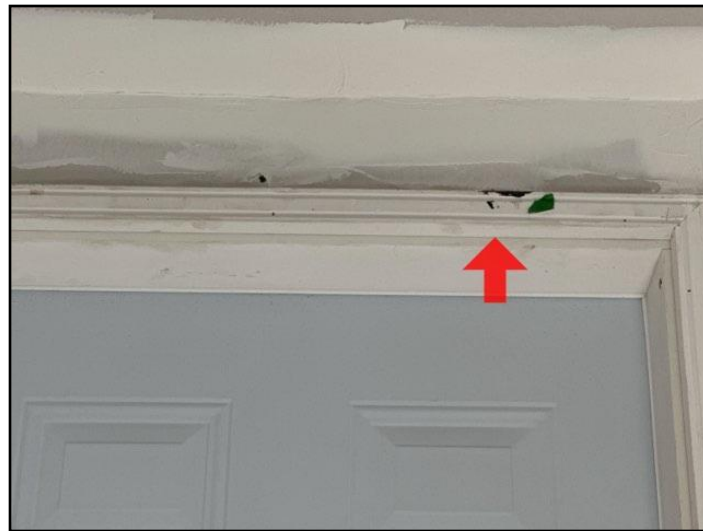
66. Condition: • Damage

Repair the dents and remove the adhesive and paint from the door and frame at the entrance to the house from the garage.

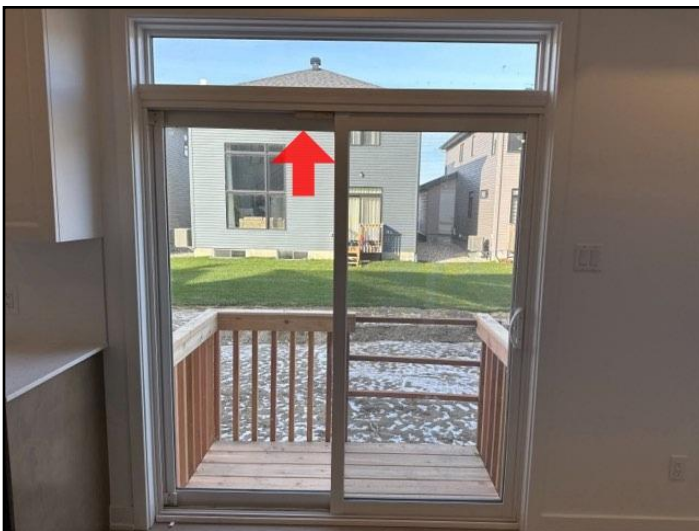
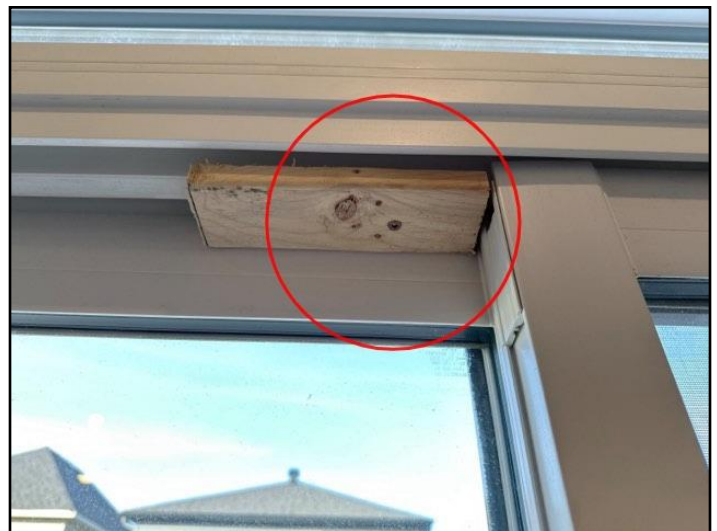
67. Condition: • [Damage](#)

Repair the screw hole in the patio door track where the wood block has been installed.

Implication(s): Increased heating and cooling costs | Reduced comfort | Material deterioration

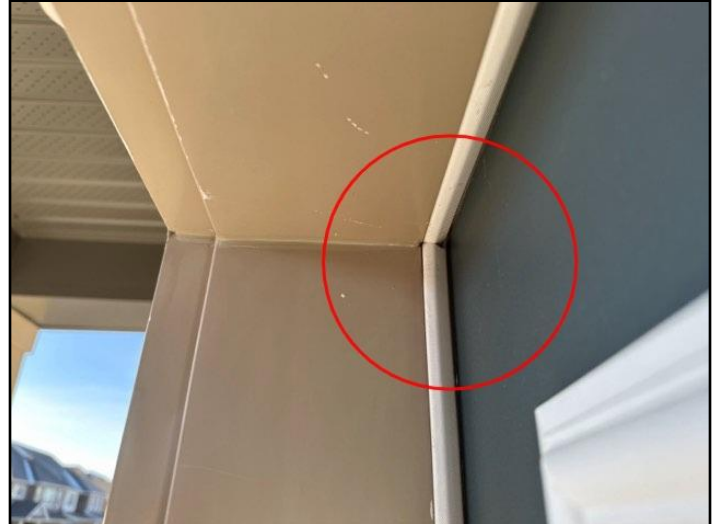
186. Weatherstripping missing or ineffective

68. Condition: • [Weatherstripping missing or ineffective](#)

Repair the front door that does not seal to the weatherstripping at the top west corner.
