# YOUR INSPECTION REPORT

1 INSPECTION WAY  
Arnprior, ON K7S 1X7

Friday, July 14, 2023

Report No. 3412, v.2

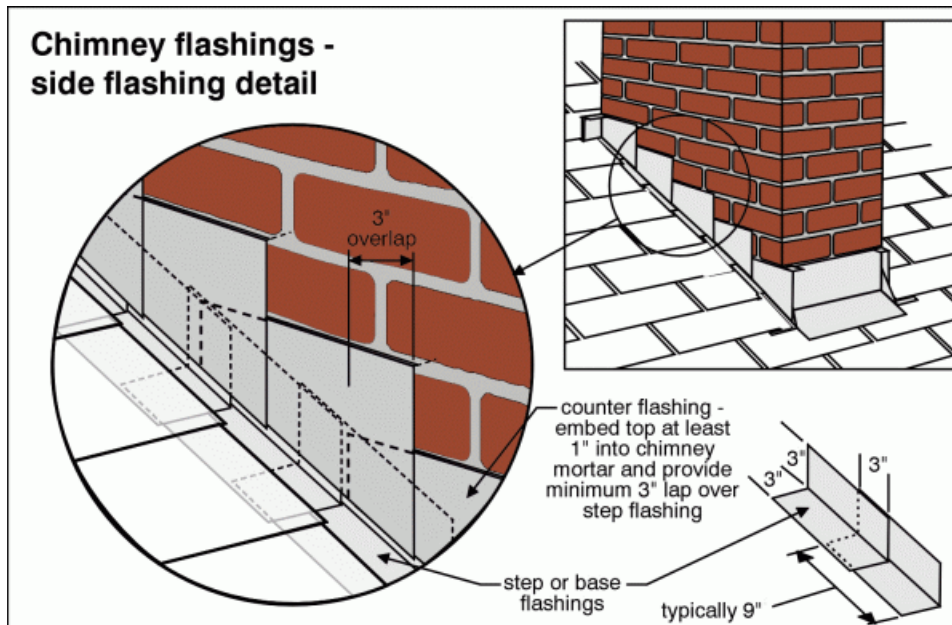
2. Not let into mortar joints

### 2. Condition: • [Not let into mortar joints](#)

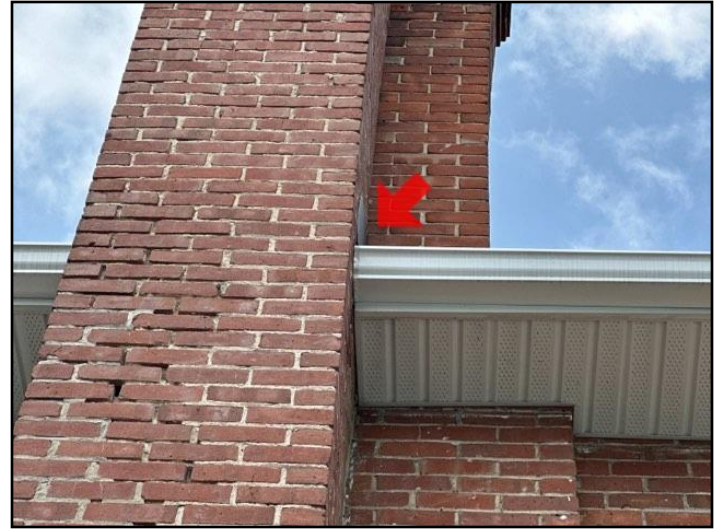
7. Kickout flashing - missing

### 4. Condition: • [Kickout flashing - missing](#)

Provide the missing kick-out flashing at the base of wall flashing on the sides of the abandoned boiler chimney.

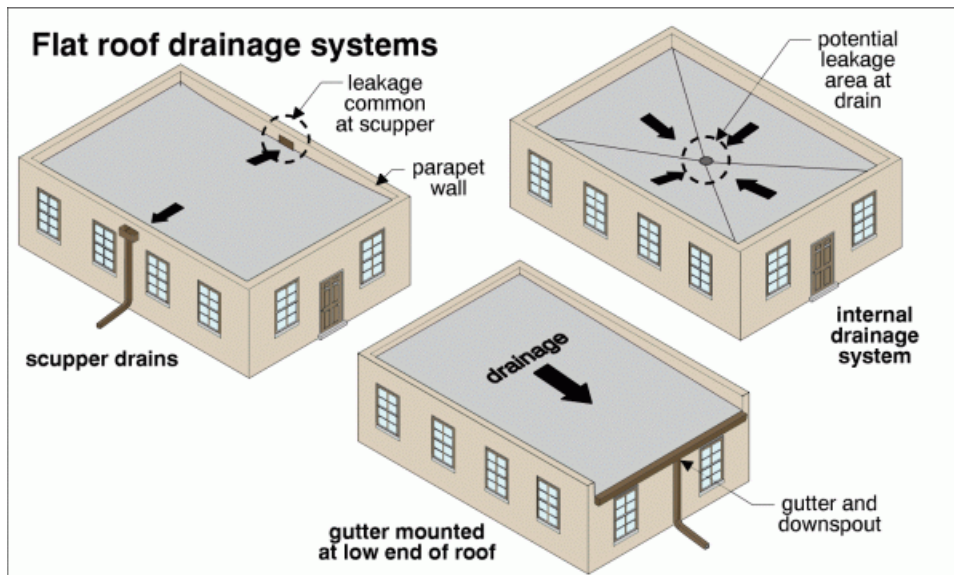
### 5. Condition: • [Ponding](#)

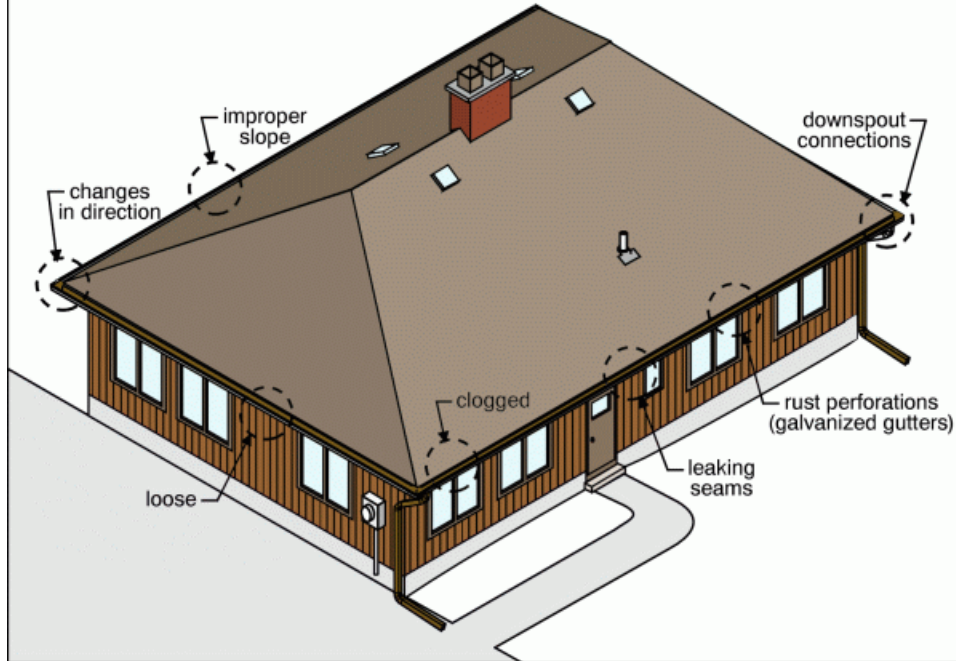
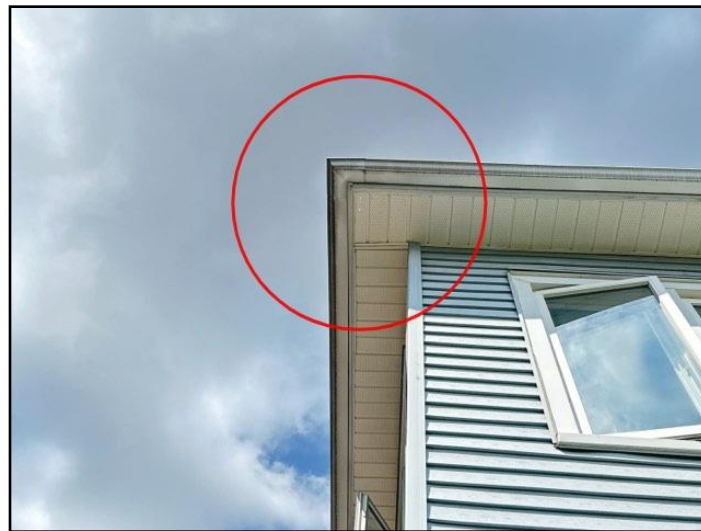
14. Leak

**6. Condition:** • [Leak](#)

Repair the leak from the second floor eavestrough at the rear corner of the second floor addition.

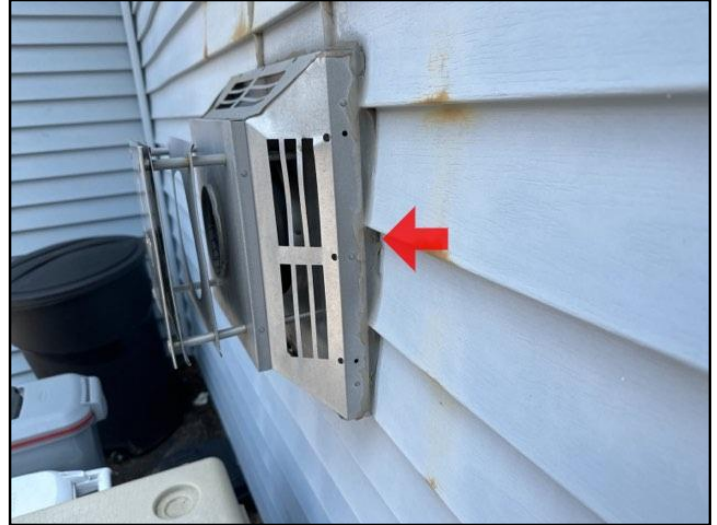
41. Loose or missing pieces

**13. Condition:** • [Loose or missing pieces](#)

Provide the missing "J" trim around the gas fireplace vent at the transition to the vinyl siding.

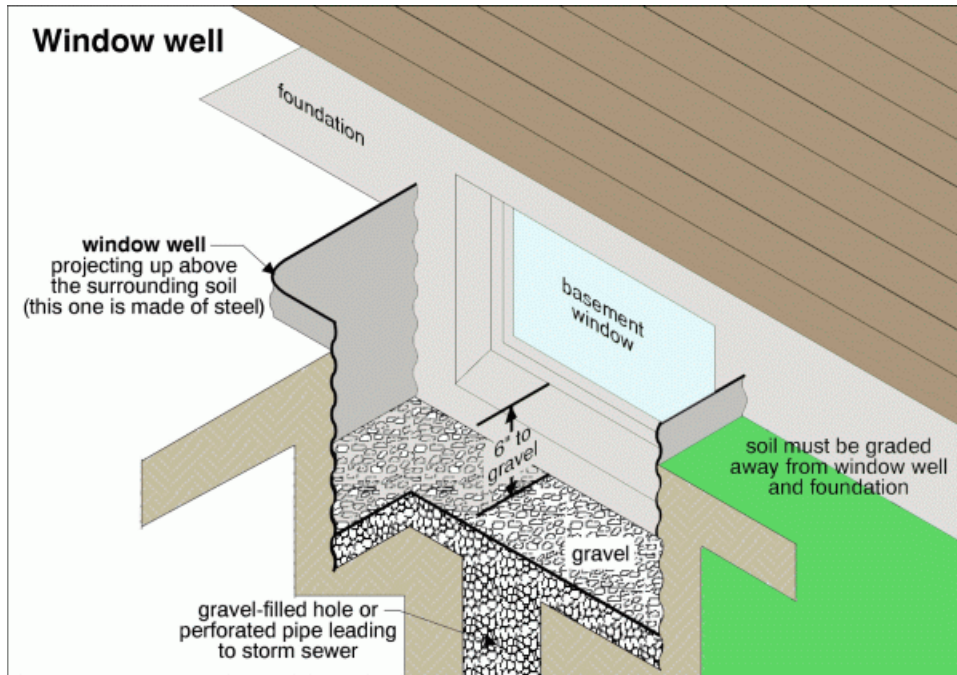
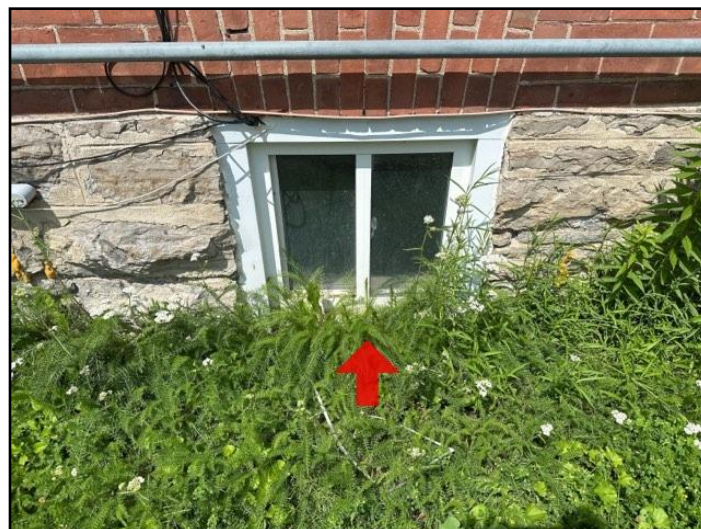
43. Missing

15. Condition: • [Missing](#)

Provide the missing window well on the east side of the house for the basement window that is within 5-7/8" of the ground. This can be a contributing factor to basement moisture issues.

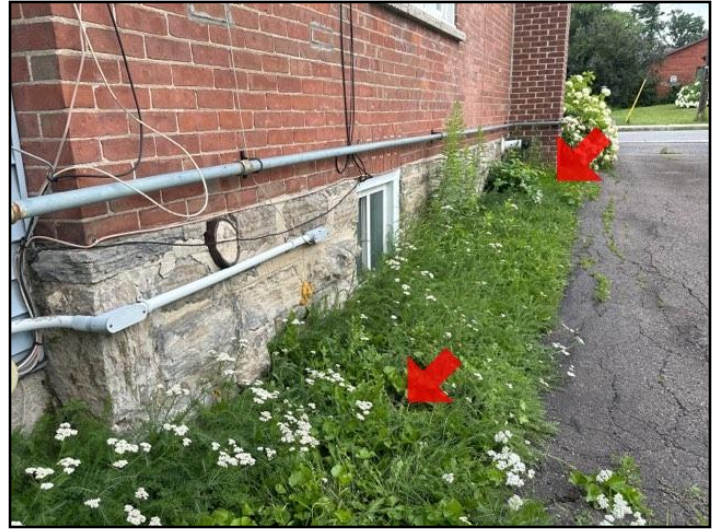
61. Improper slope or drainage

19. Condition: • [Improper slope or drainage](#)

Repair the slope of the ground along the east side of the house to limit the amount of water that accumulates against the foundation walls. This can be a contributing factor to basement moisture issues.

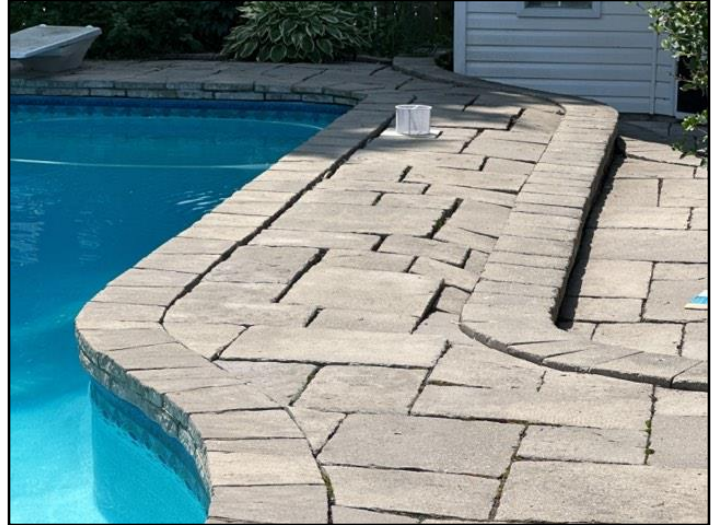
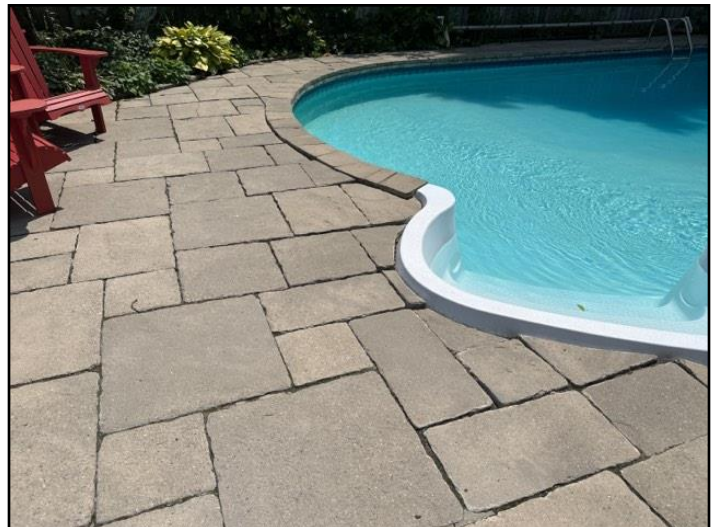
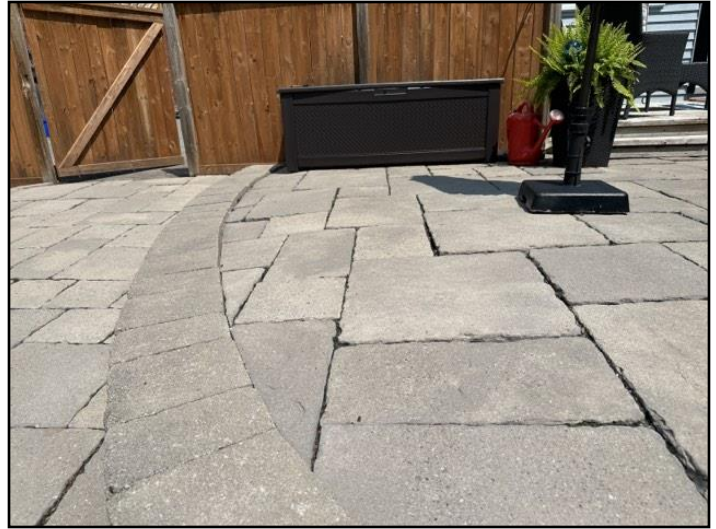
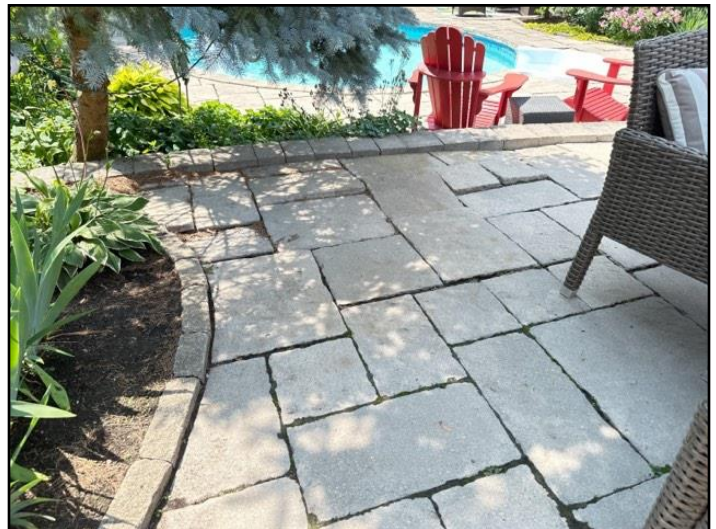
21. Condition: • Uneven (trip hazard)

The complete rear patio needs to be repaired to correct the unevenness in the surface, which is currently a trip hazard.

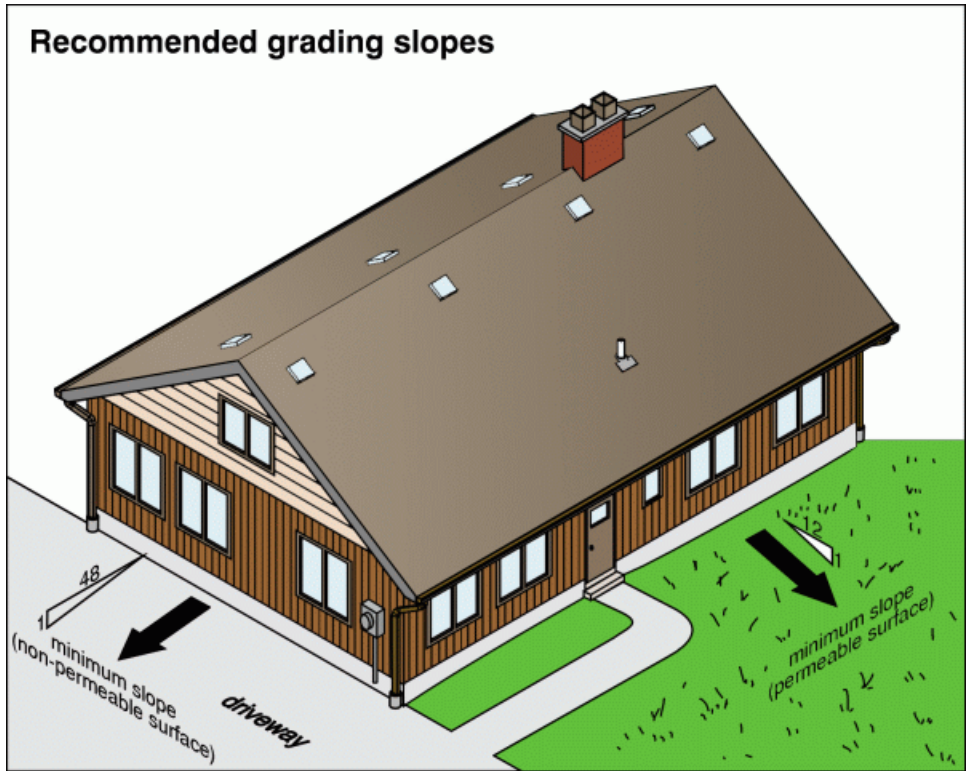
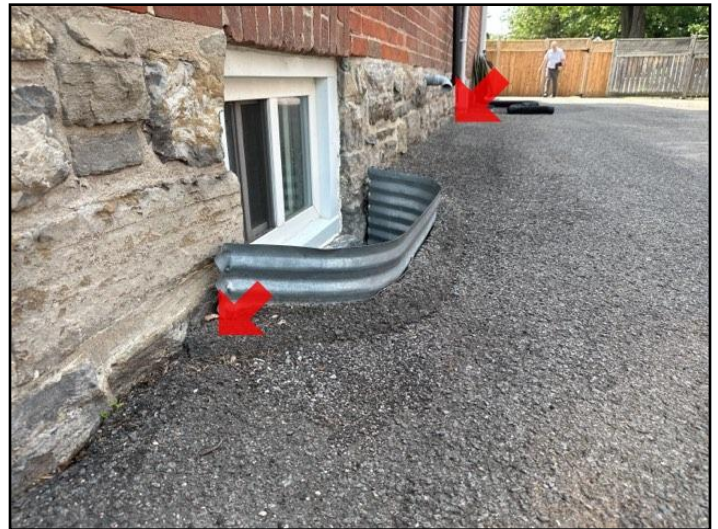
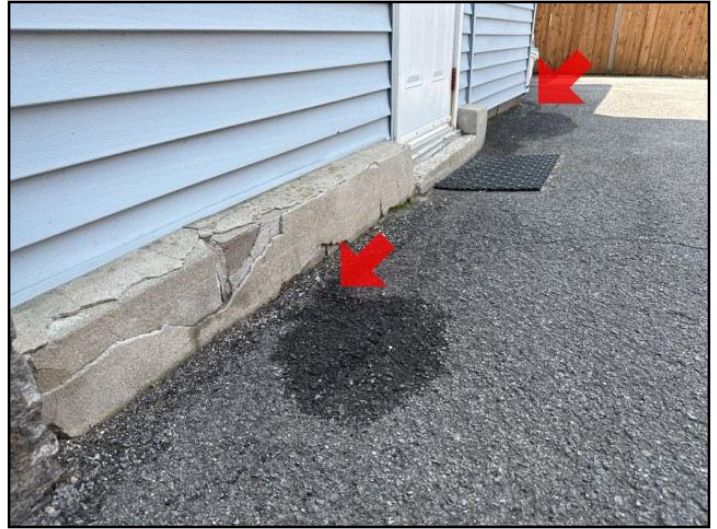
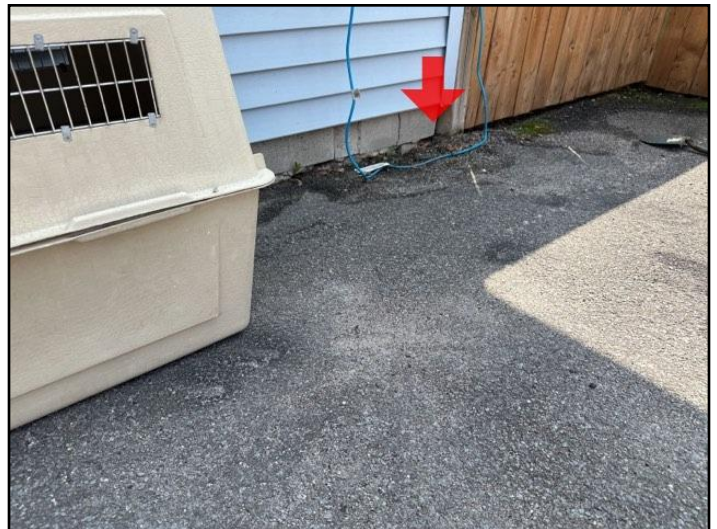
**22. Condition:** • [Improper slope or drainage](#)

Repair the slope of the driveway along the west foundation wall. Any gaps between the driveway and foundation need to be sealed. Correct the unevenness in the driveway, which is currently a trip hazard.

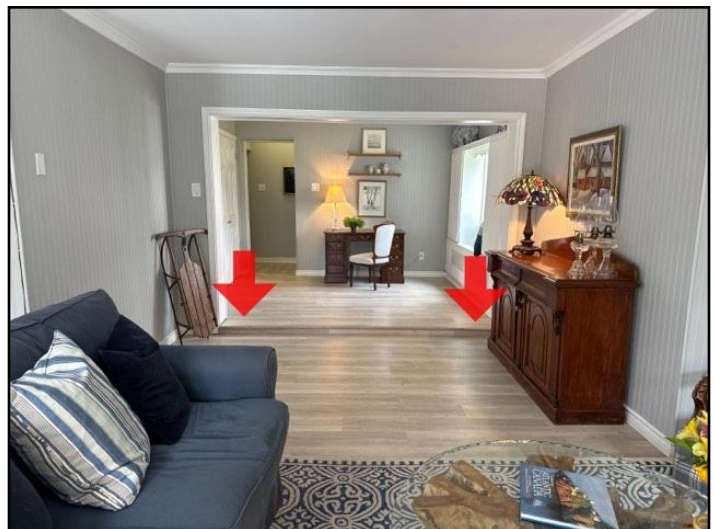
104. Settled

**23. Condition:** • [Settled](#)

Further evaluation required of the major settlement visible in the concrete block foundation of the additions to determine the cause, scope of work and the cost to repair the issue. There is shifting noted on the first and second floors of the additions.

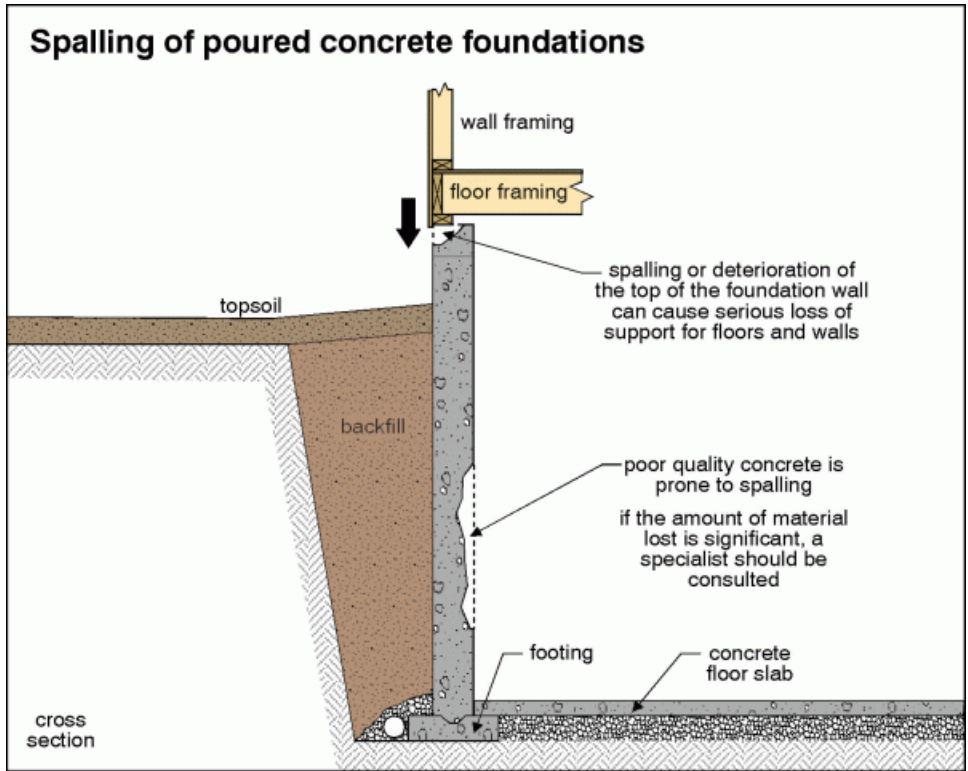
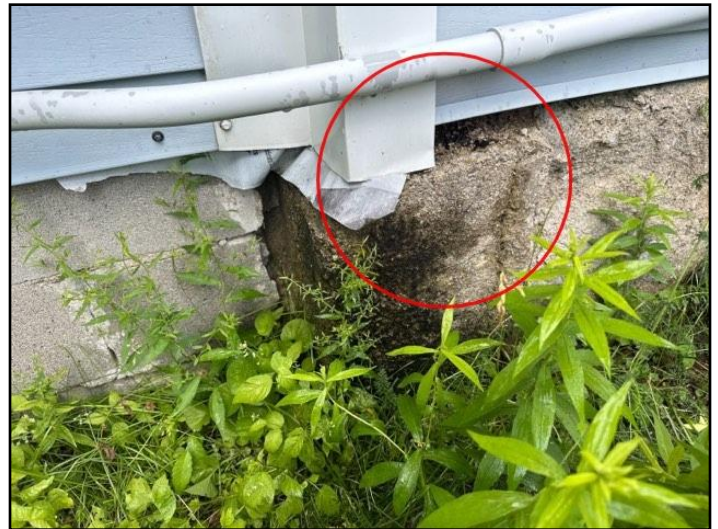
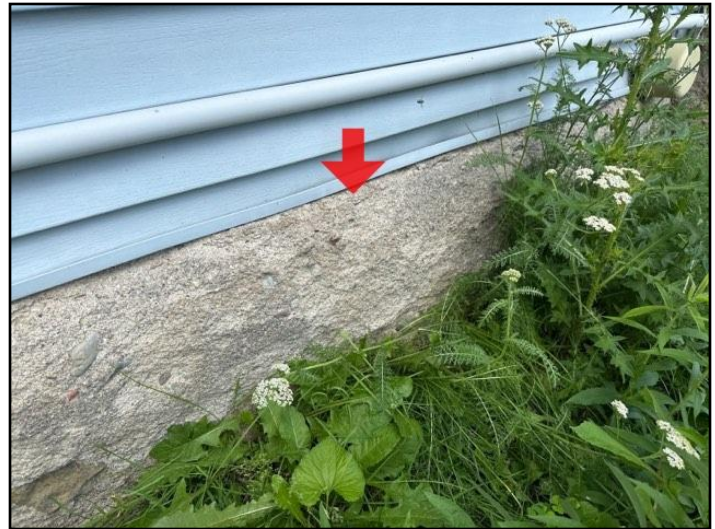
## 24. Condition: • [Spalling, crumbling or broken material](#)

Repair the spalling of the addition that is visible on the east side of the house. The foundation should be evaluated when the rear and side addition block foundations are being inspected.

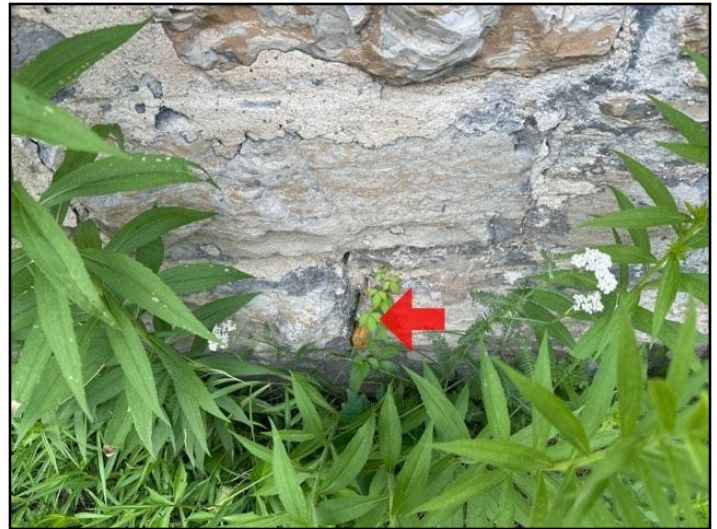
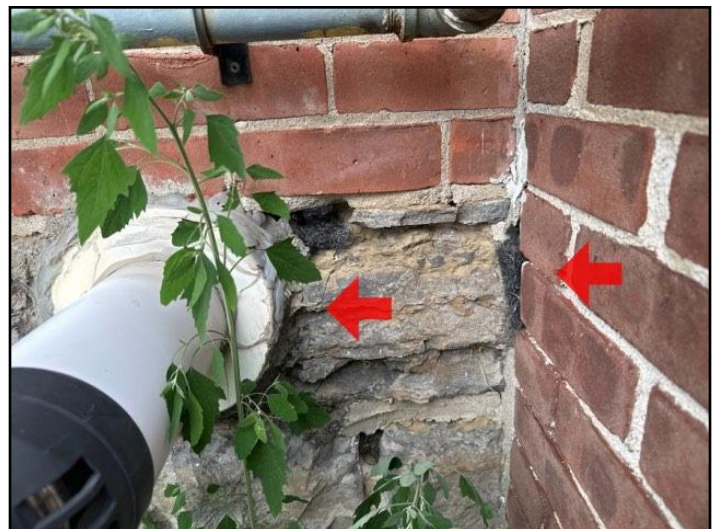
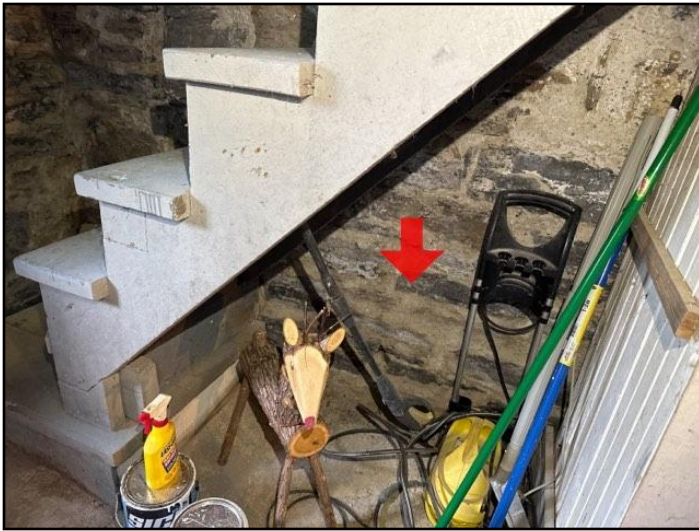
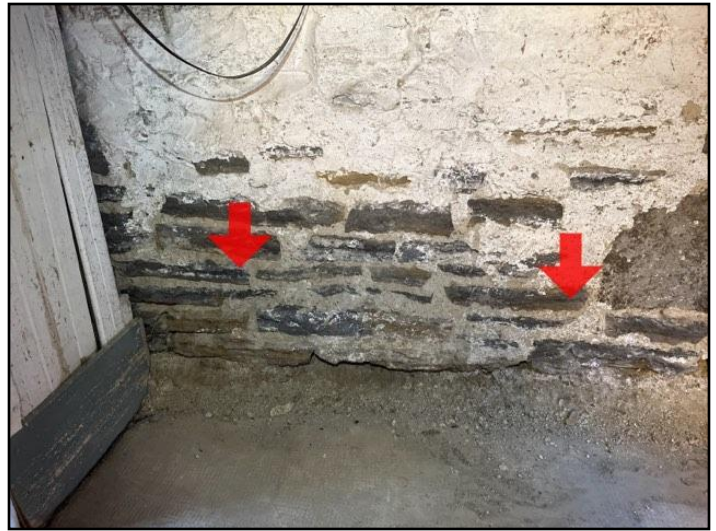
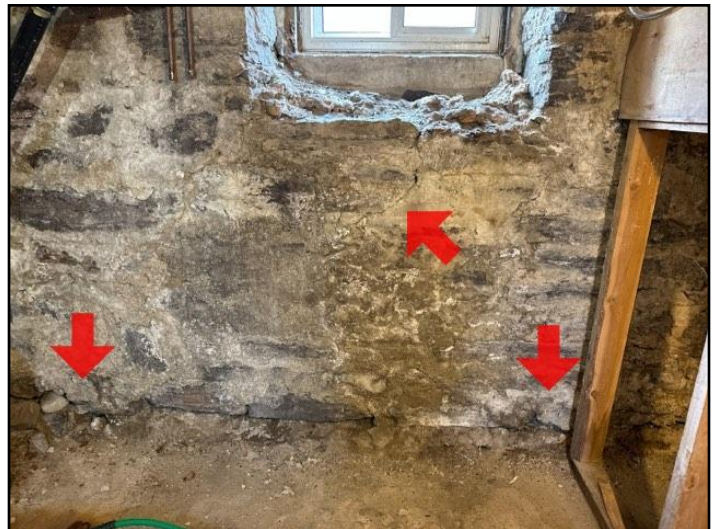
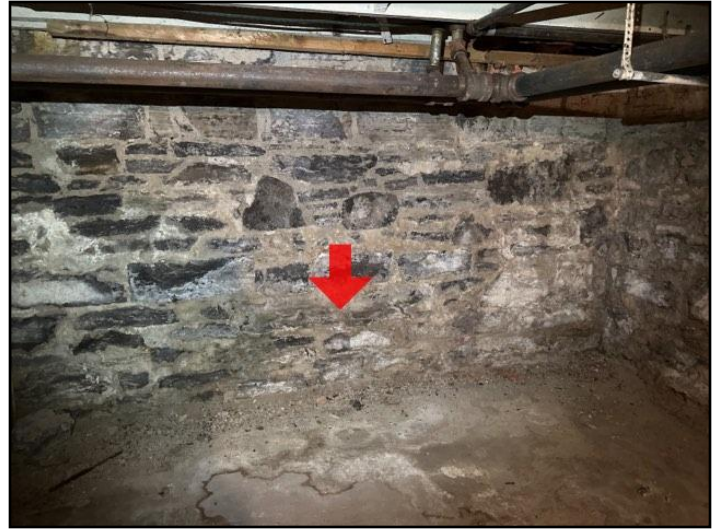
## 25. Condition: • [Mortar deteriorated or missing](#)

Areas of the stone foundation have loose or voids in the mortar joints. This is common for a stone foundation and is a regular occurrence. Stone foundation need ongoing maintenance/re-pointing of the mortar joints. There is some maintenance required of the stone foundation at this time. The foundation should be monitored for further maintenance.

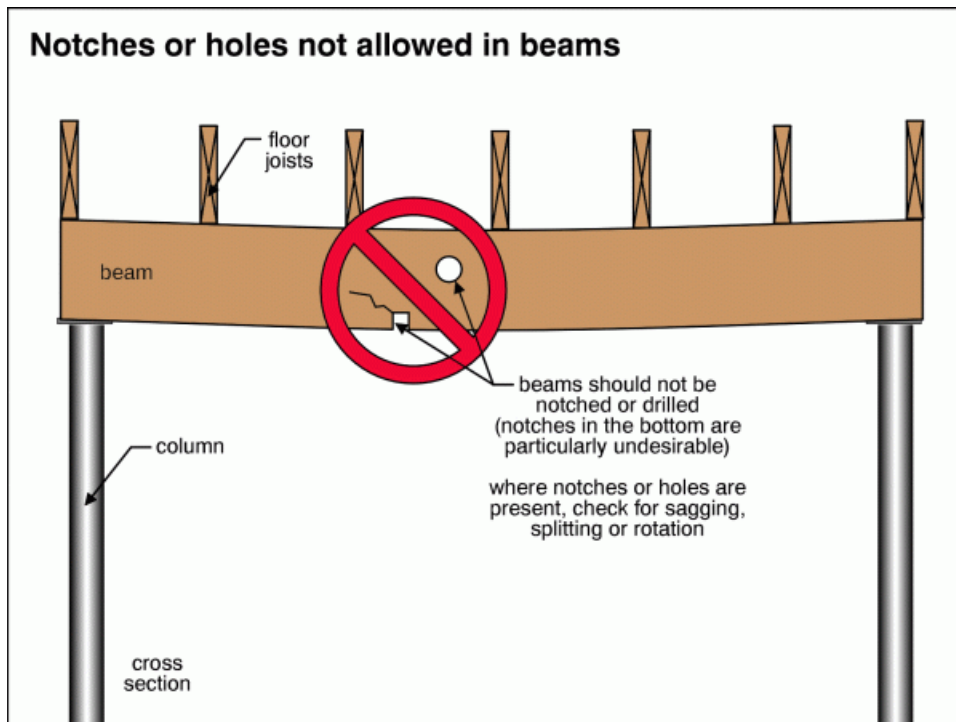
### 26. Condition: • [Notches or holes](#)

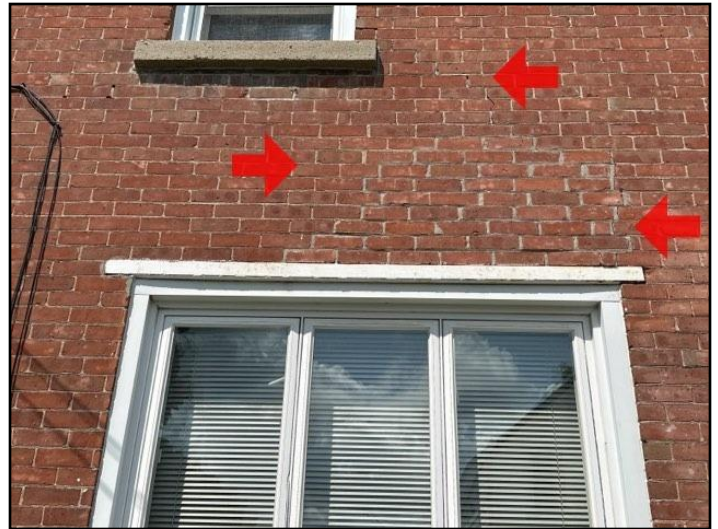
129. Lintel sagging

27. Condition: • [Lintel sagging](#)

Repair the sagging lintel over the first floor dining room window on the east side of the house.

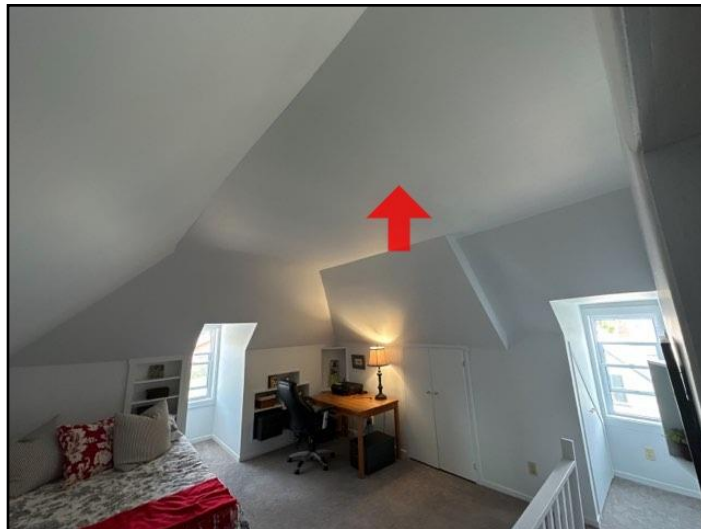
143. Missing

**36. Condition:** • Missing

Provide the missing smoke detector on the third floor of the house.

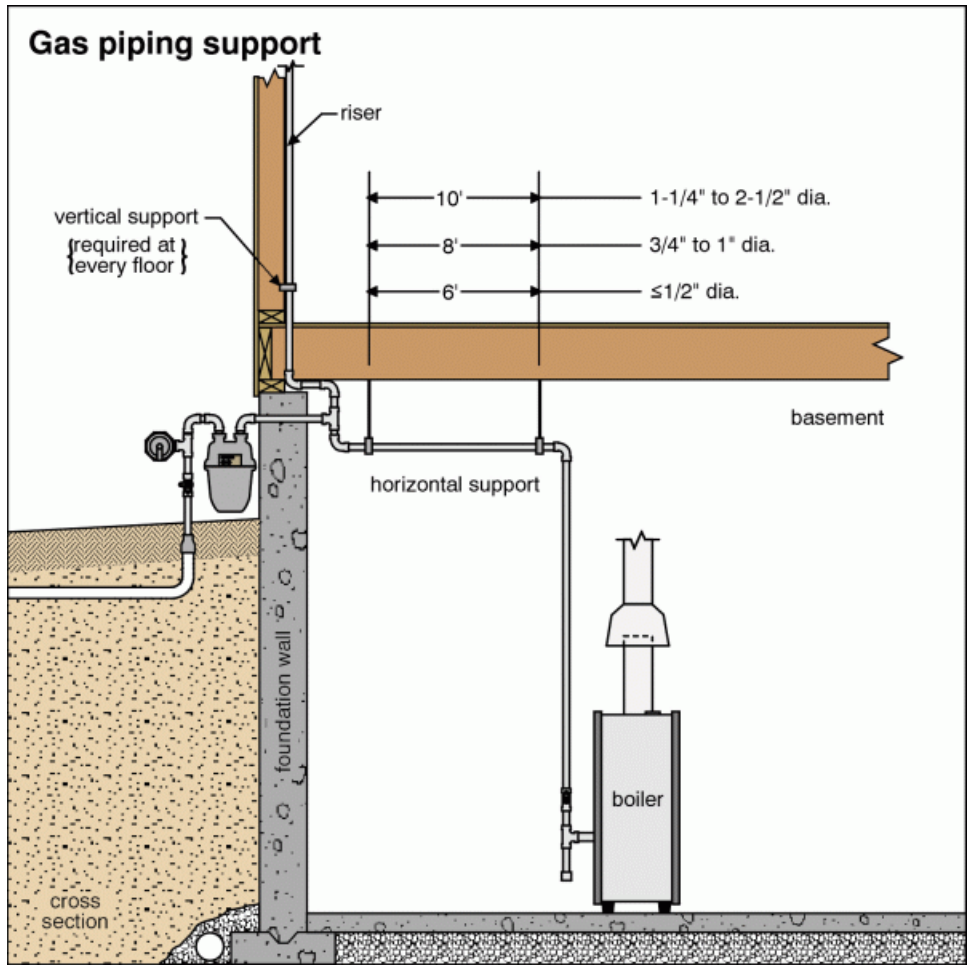
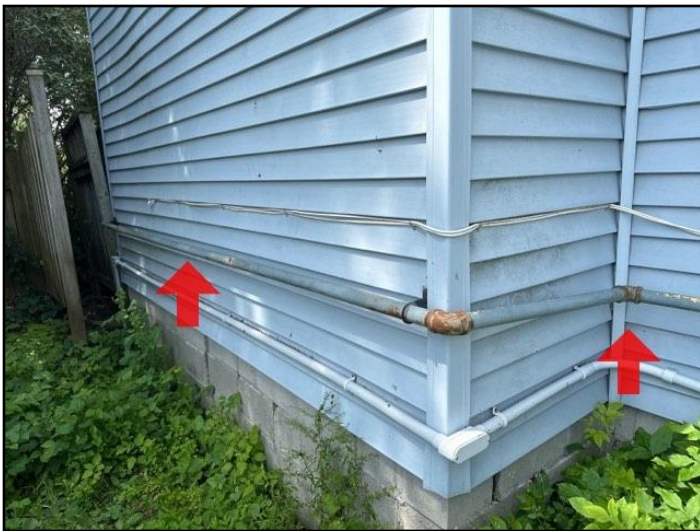
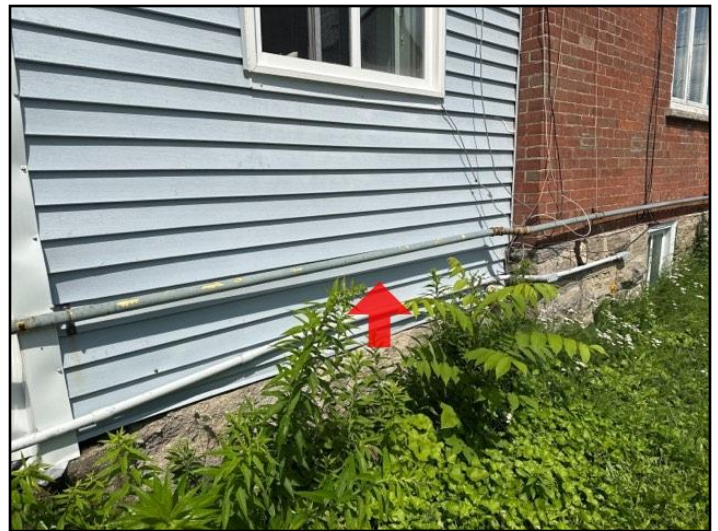
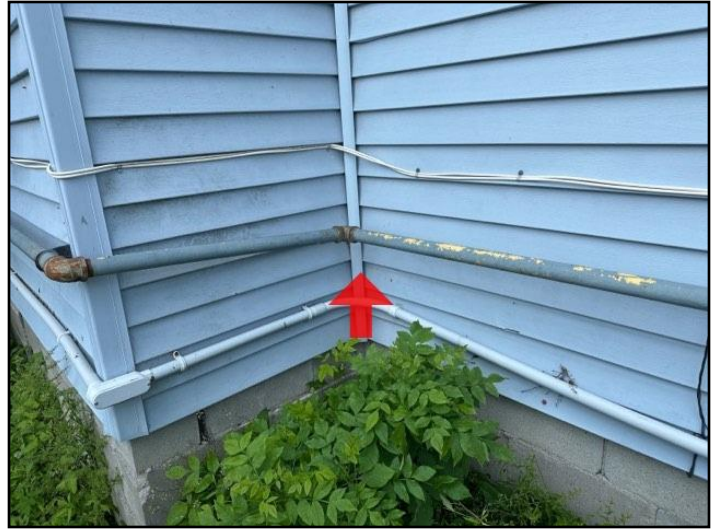
### **39. Condition:** • [Inadequate support](#)

Provide additional support for the loose gas supply line along the east side of the house. Supports are required every 10' on centre. The gas line is for the BBQ and pool heater.

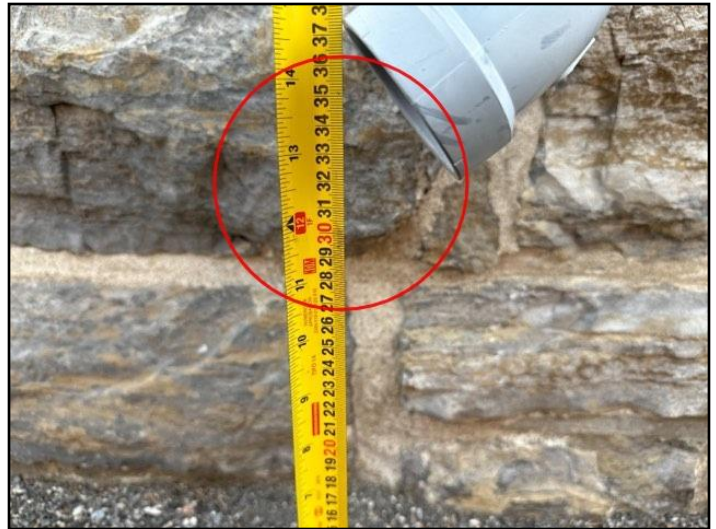
153. Rust, dirty, obstructed

**40. Condition:** • [Rust, dirty, obstructed](#)

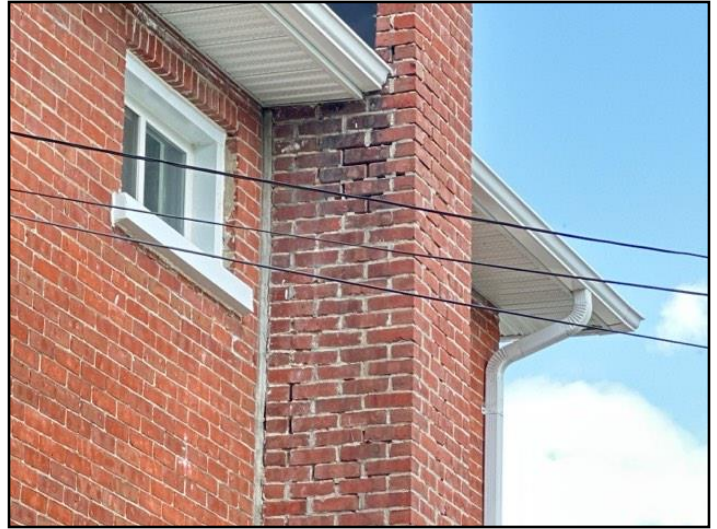
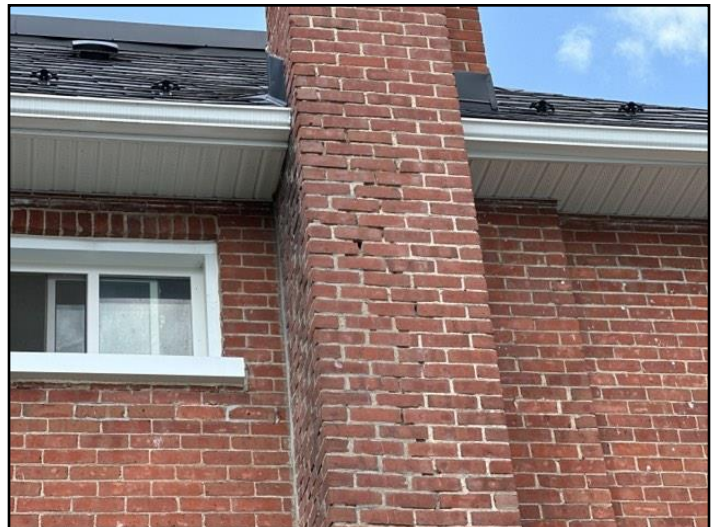
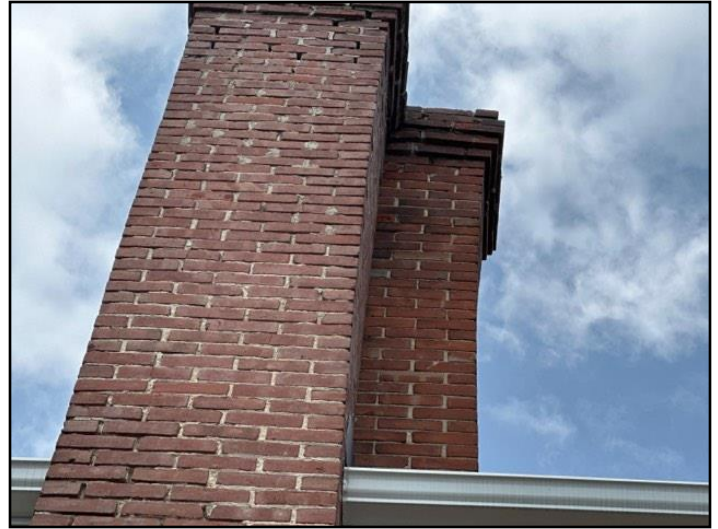
**45. Condition:** • [Loose, missing or deteriorated masonry](#)

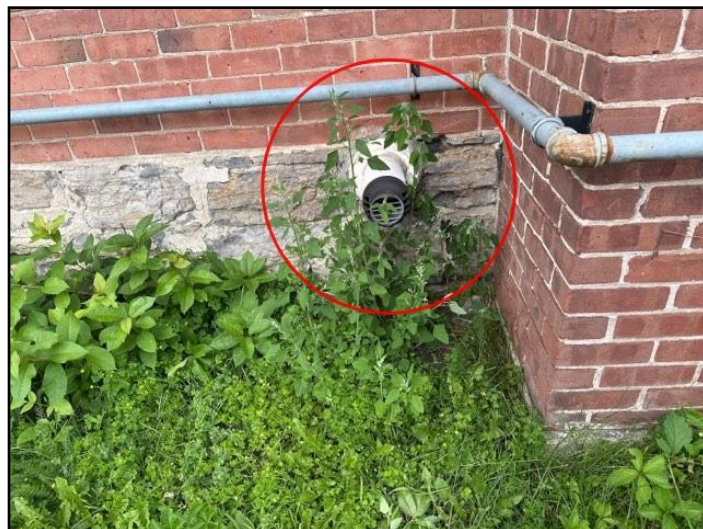
176. Rust, dirty, obstructed

49. Condition: • [Rust, dirty, obstructed](#)

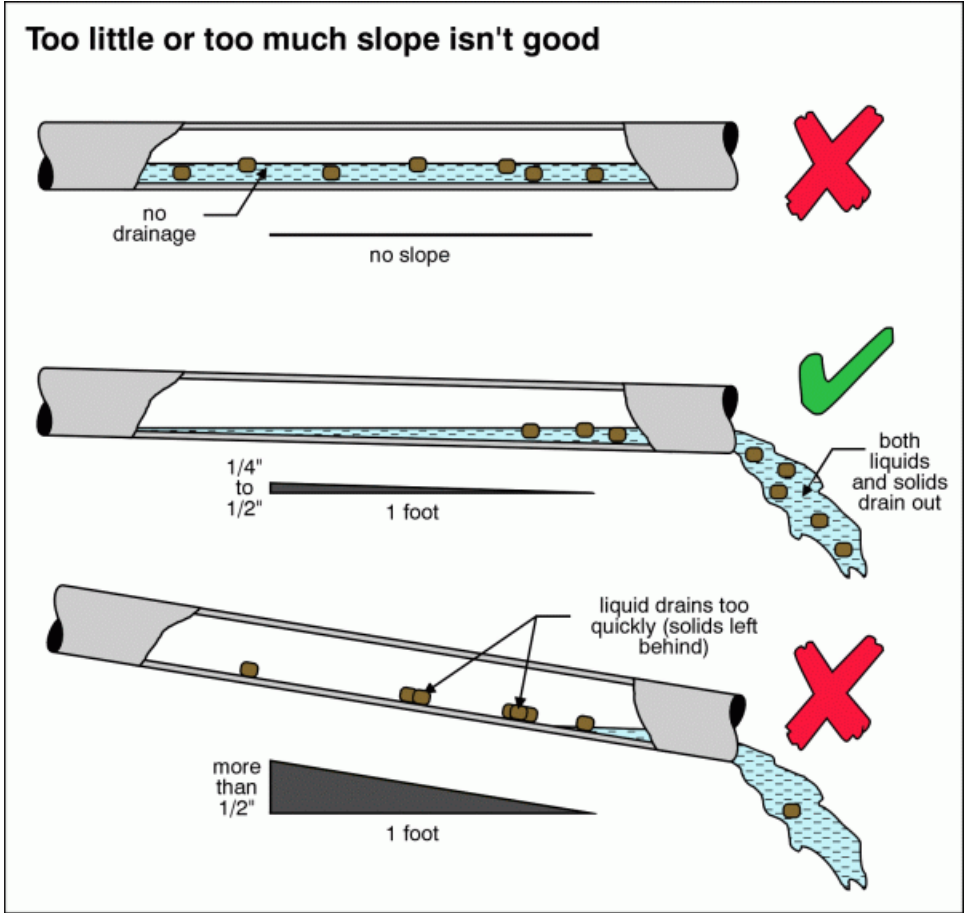
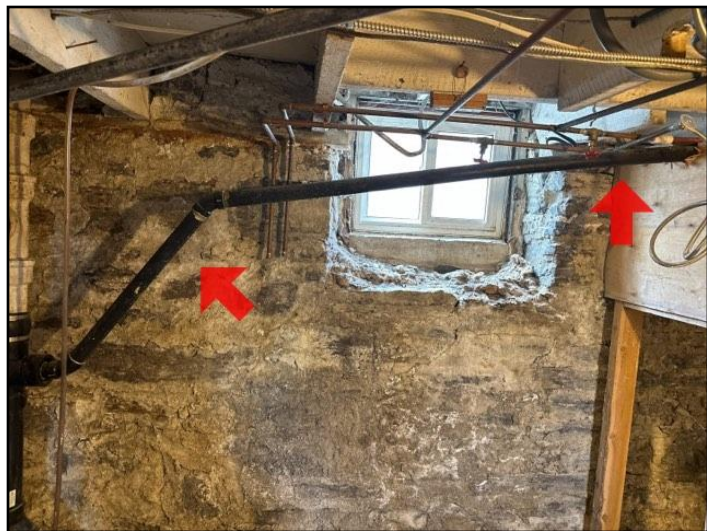
177. Poor slope

50. Condition: • [Poor slope](#)

Repair the steep slope of the kitchen sink drain line in the basement.

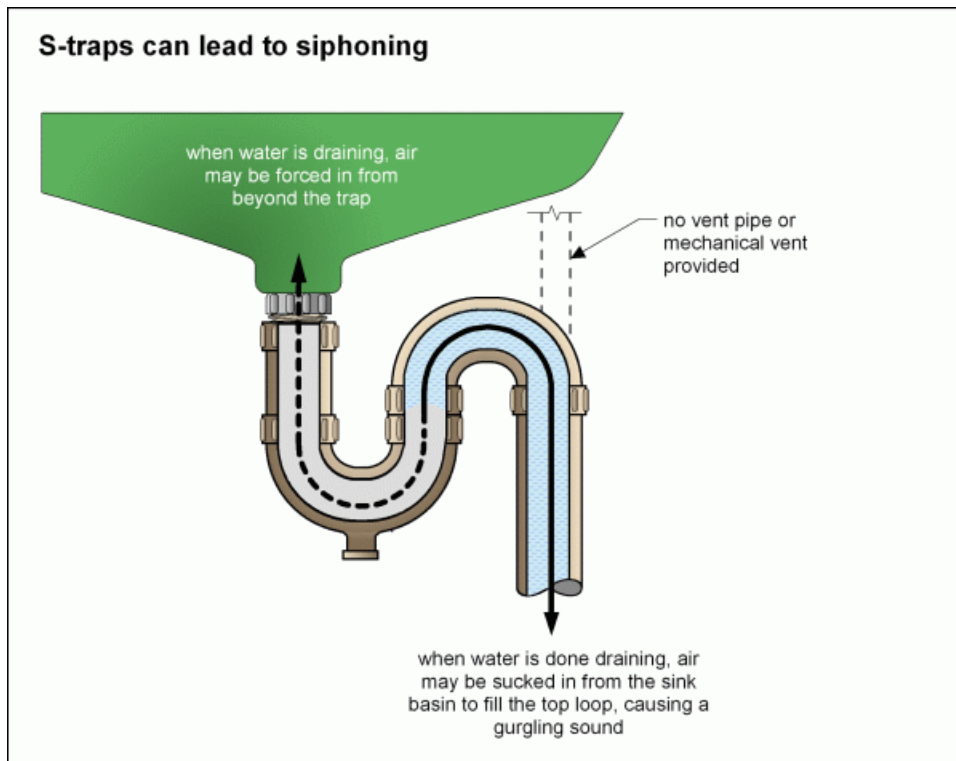
183. Wrong type

53. Condition: • [Wrong type](#)

Replace the "S" trap below the second floor bathroom sink with the proper "P" trap.

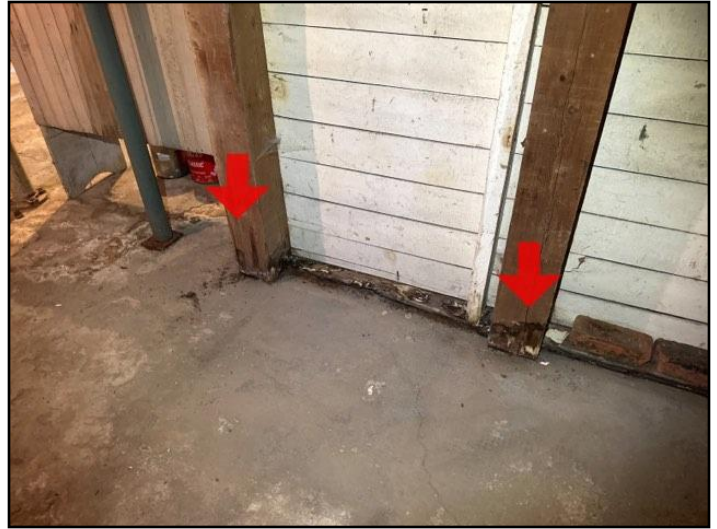
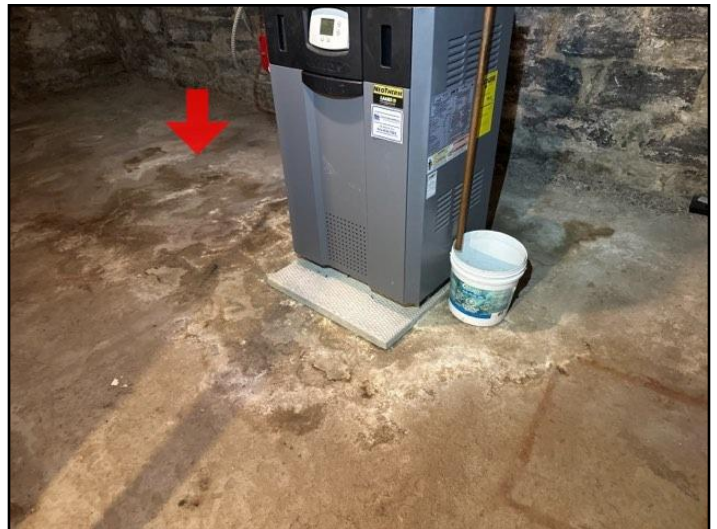
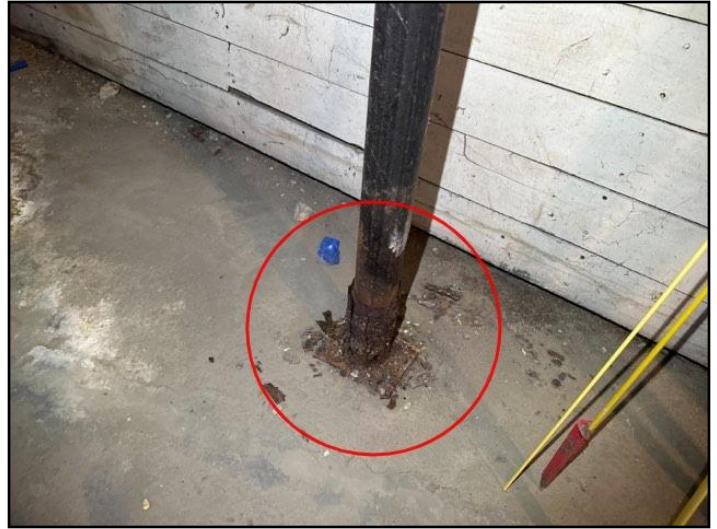
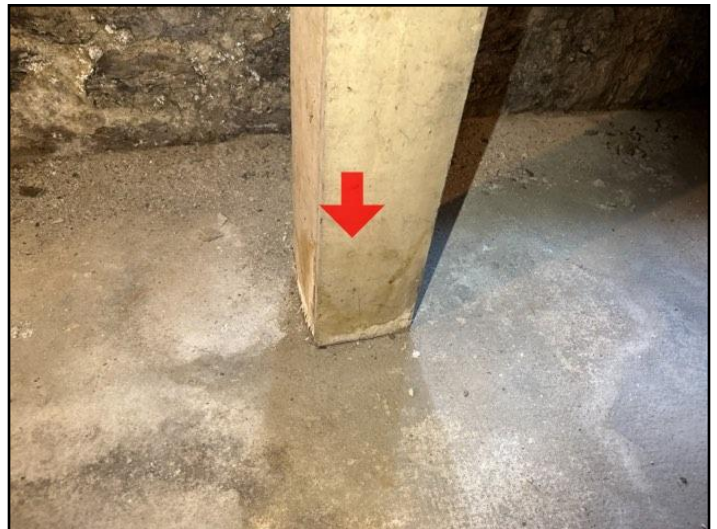
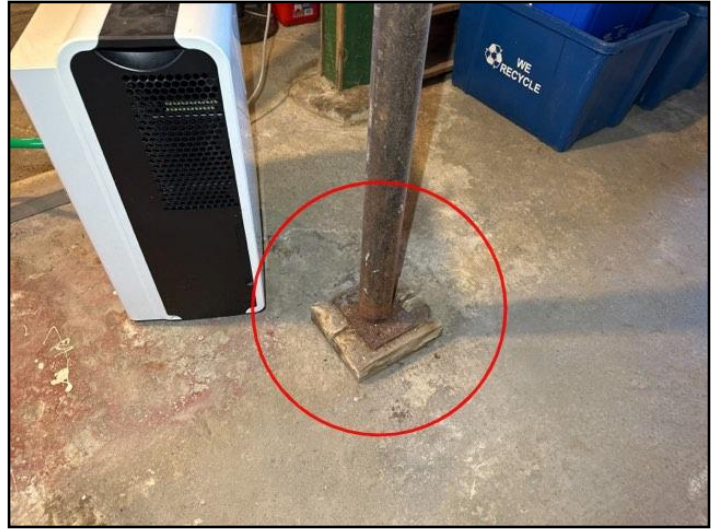
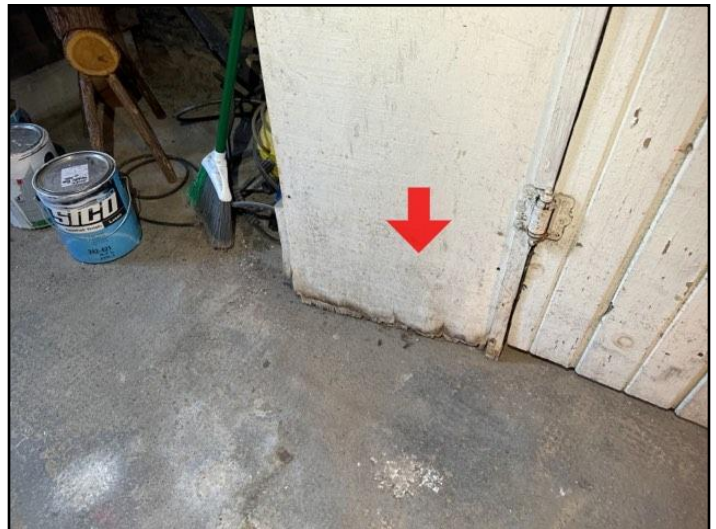
**Condition:** • [Stains](#)

There are signs of regular flooding in the basement. The basement should not be used for storage. The steel posts will need to be checked regularly for rust and required replacement. The basement will need constant airflow and a dehumidifier to remove some of the dampness. It is common to have water problems in a basement with a stone foundation.
