YOUR INSPECTION REPORT

1 INSPECTION WAY
Kanata, ON

Saturday, November 25, 2023

Report No. 3559, v.2

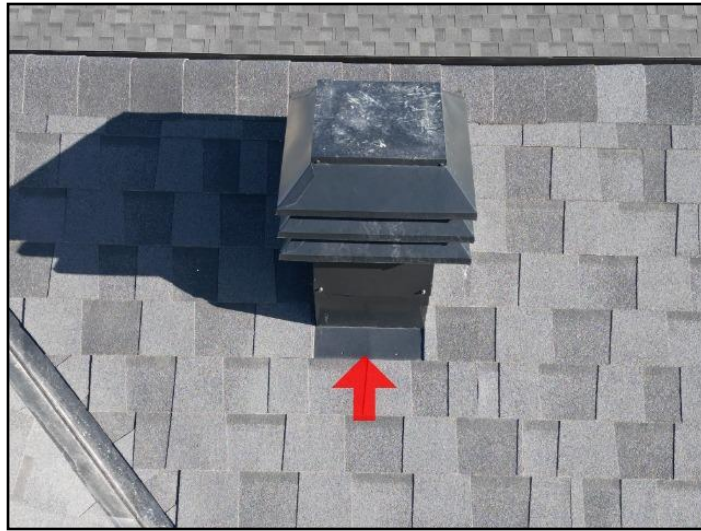
1. Condition: • [Exposed fasteners](#)

3. Exposed fasteners

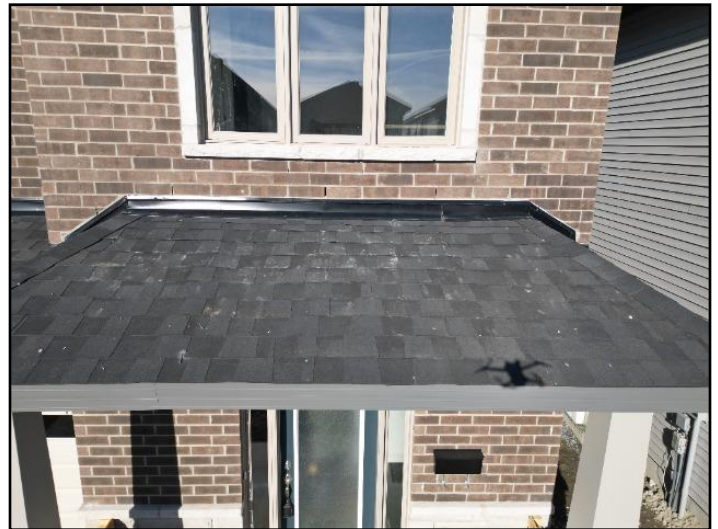
2. **Condition:** • Remove all loose debris from roof coverings.

5. Remove all loose debris from roof coverings.

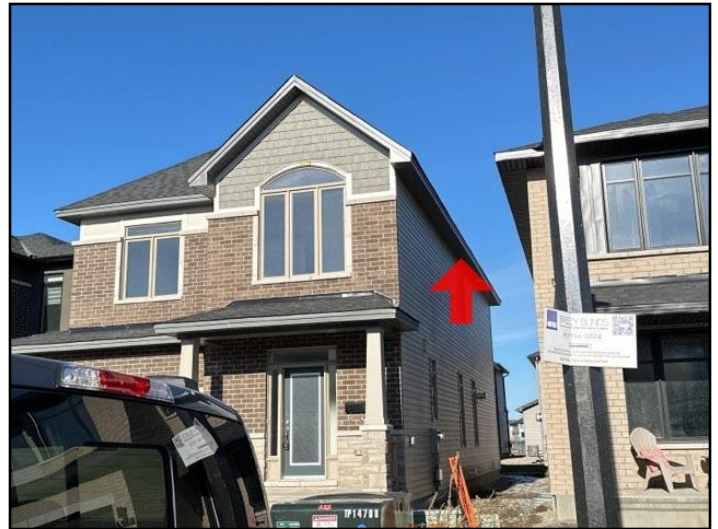
5. Condition: • [Missing](#)

14. Missing

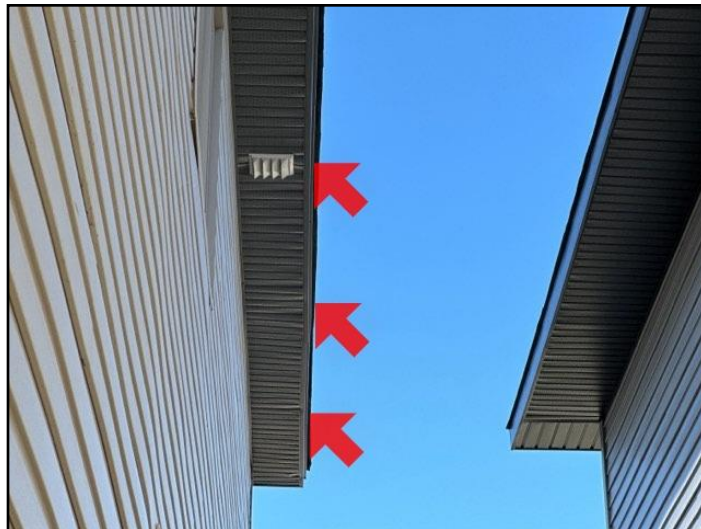
6. Condition: • [Damage](#)

Repair the dents in the soffit on the east side of the house.

16. Damage

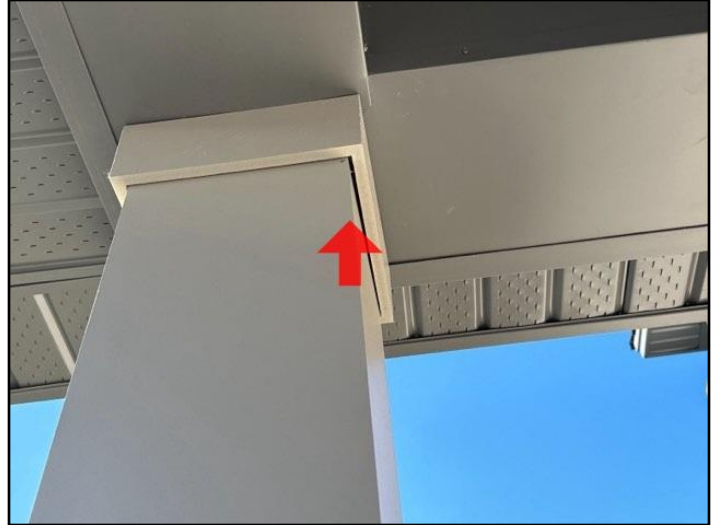
9. Condition: • [Loose](#)

Repair the loose trim at the top of the front porch columns.

20. Loose

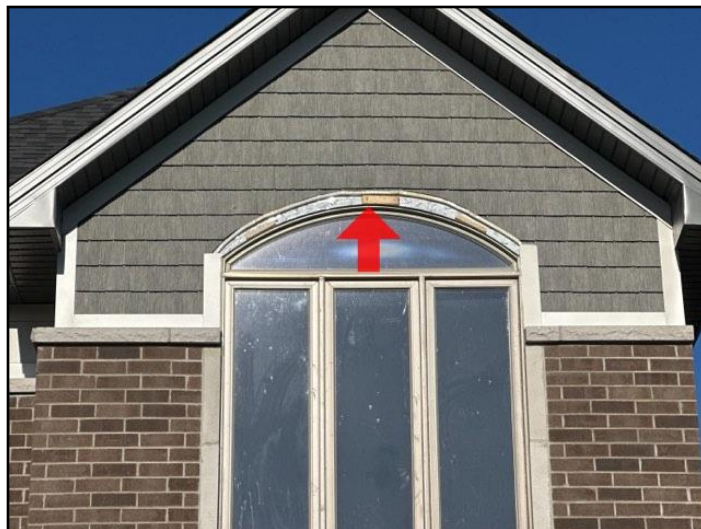
10. Condition: • [Missing](#)

Provide the missing trim above the front bedroom arched window.

21. Missing

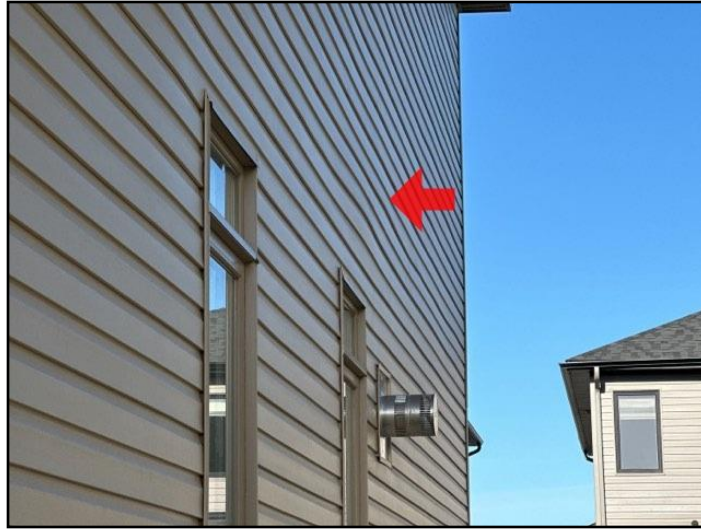
14. Condition: • [Buckled or wavy](#)

Repair the buckle in the vinyl siding on the east wall of the house above the dining room and gas fireplace exhaust vent area.

25. Buckled or wavy

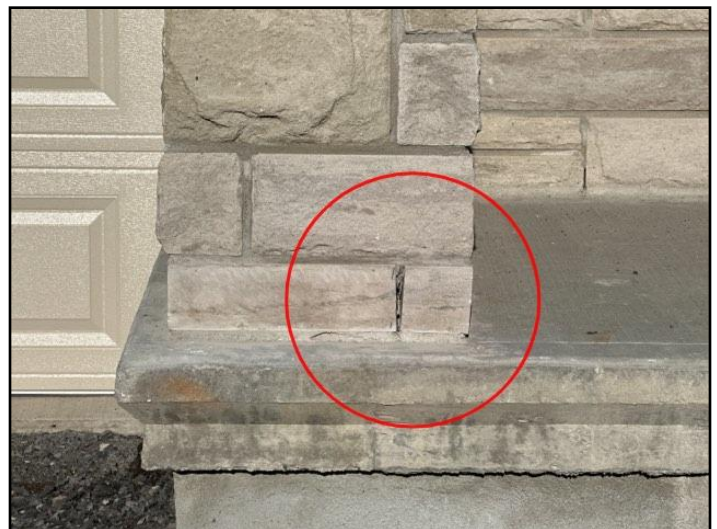
17. **Condition:** • [Masonry deterioration](#)

Repair the bricks at the base of the front porch columns that have not been installed level or plumb.

30. Masonry deterioration

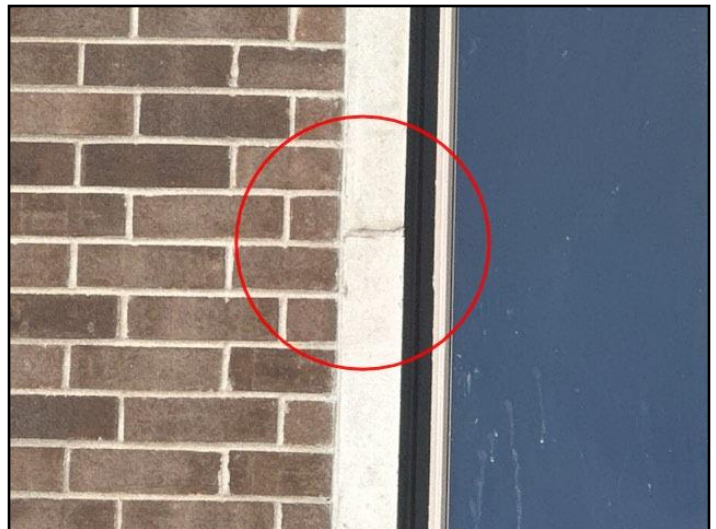
20. Condition: • [Masonry deterioration](#)

Repair the chipped and out of plumb block and brick veneer around the front second floor windows.

44. Masonry deterioration

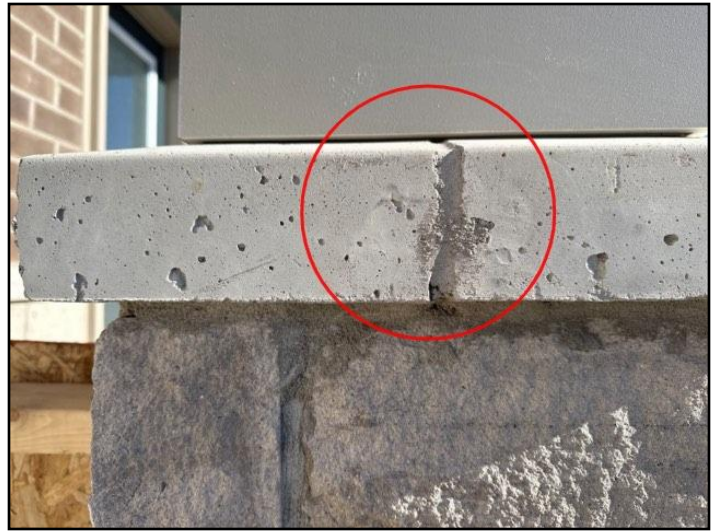
21. Condition: • Chipped

Repair the chipped concrete caps on the front porch columns.

58. Chipped

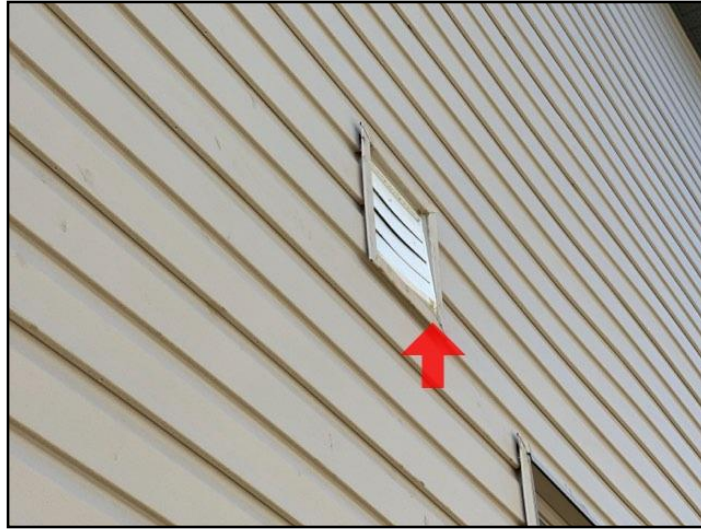
23. Condition: • Cover damaged

Repair the first floor bathroom exhaust vent on the east side of the house that has not been installed or flush with the wall.

64. Cover damaged

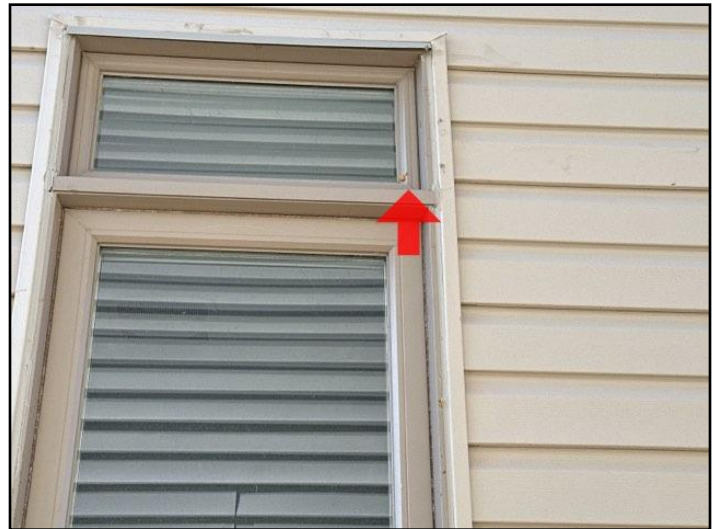
24. Condition: • Damage

Remove the spray foam and protective film from the windows on the east side of the house. Repair the scratches in the windows and frames.

66. Damage

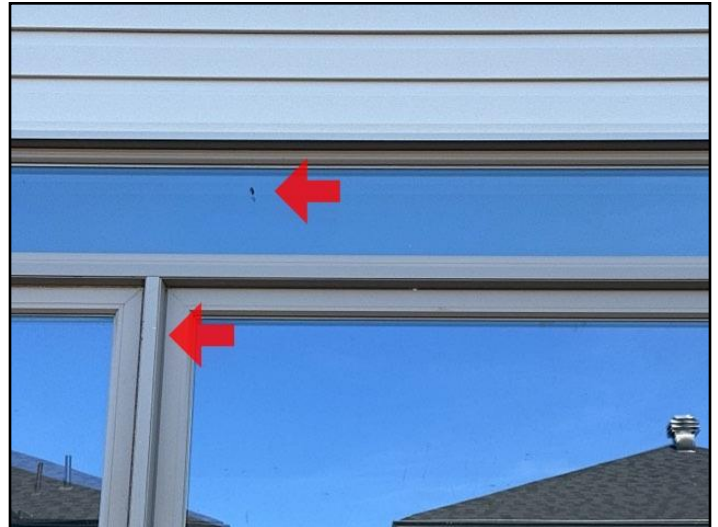
25. Condition: • Damage

Remove the spray foam, adhesive, and protective film from the windows on the north side of the house. Repair the scratches in the windows and frames.

73. Damage

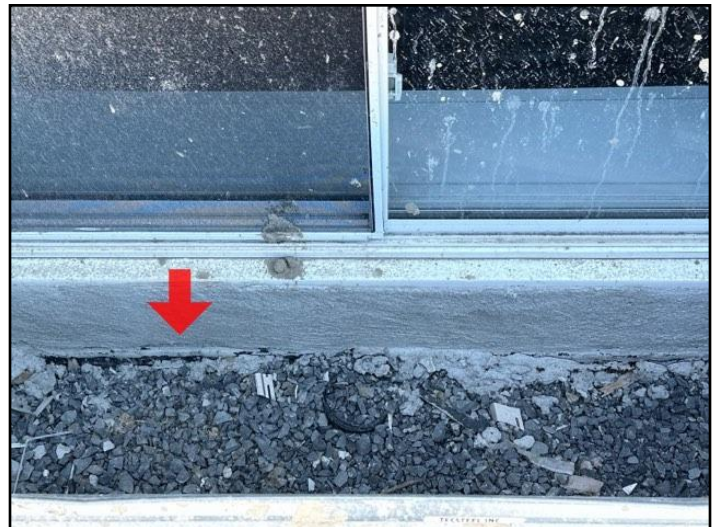
27. Condition: • Remove all debris from window well.

Remove the construction debris from the window wells. Ensure the window well drains are not blocked and drain freely. Provide the missing gravel in the wells and ensure the foundation membrane is fully covered.

87. Remove all debris from window well.

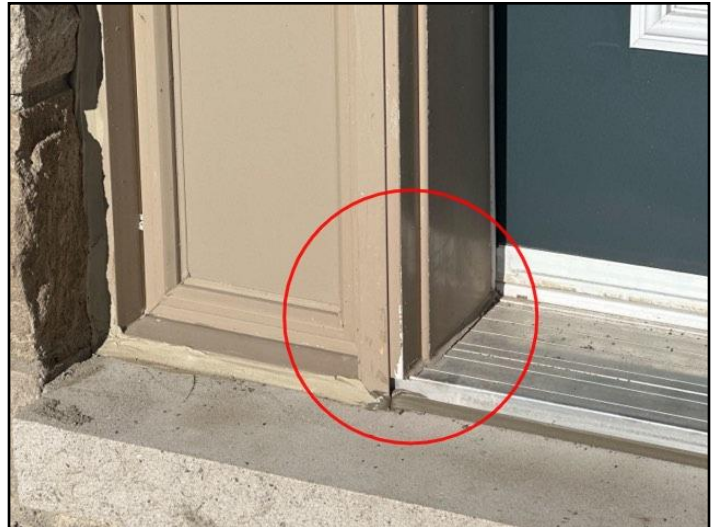
29. Condition: • [Damaged, cracked or loose](#)

Repair the scratches and chips in the front entrance door frame.

91. Damaged, cracked or loose

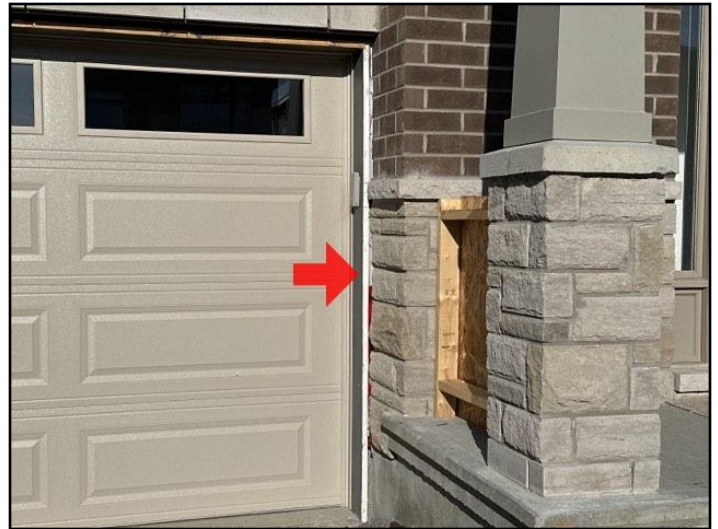
30. Condition: • [Missing](#)

Install the trim around the garage door frame. Cover the hole between the bottom east corner of the garage door frame and the foundation.

97. Missing

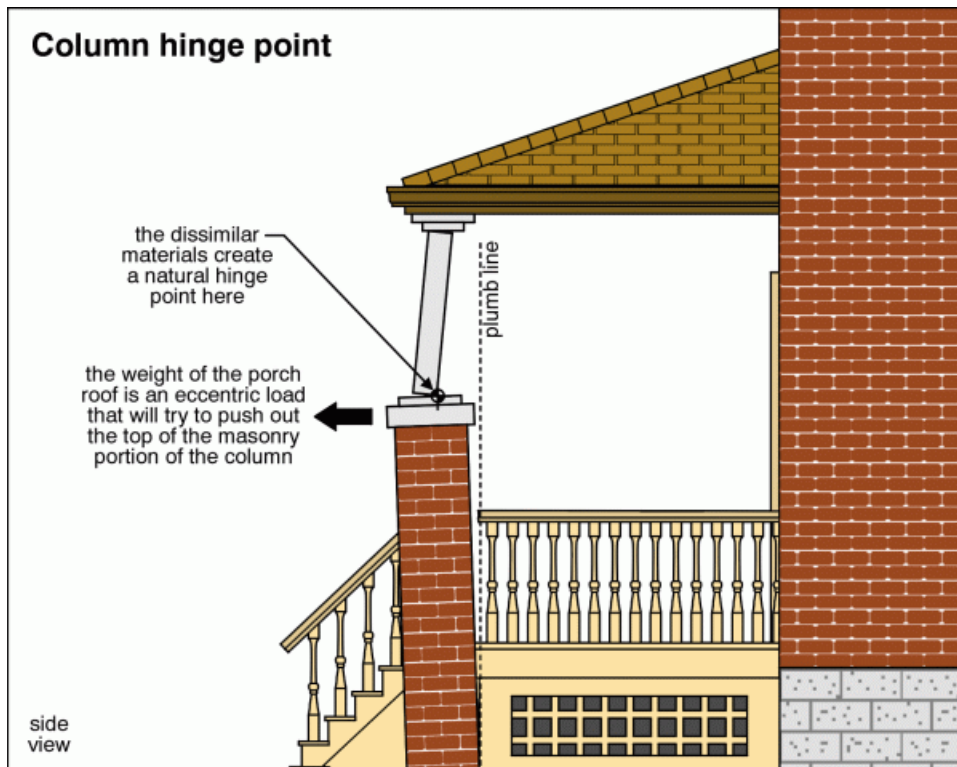
31. Condition: • [Leaning](#)

Repair the column at the southwest corner of the front porch installed out of plumb.

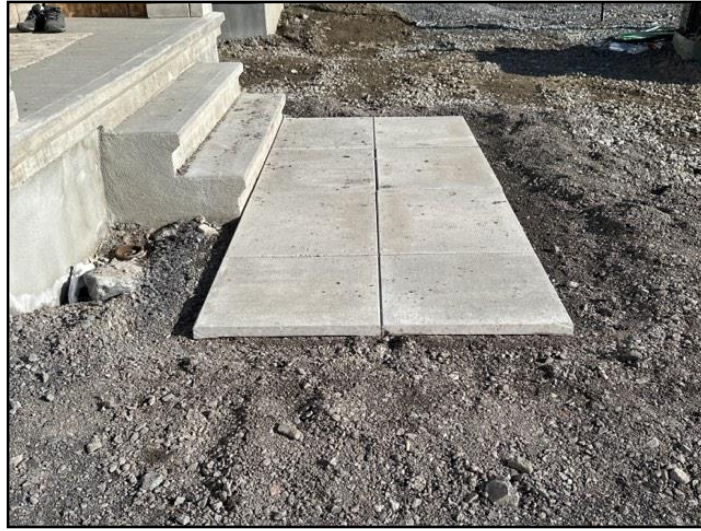
35. Condition: • [Uneven \(trip hazard\)](#)

Repair the unevenness in the front walkway that is currently a trip hazard.

117. Uneven (trip hazard)

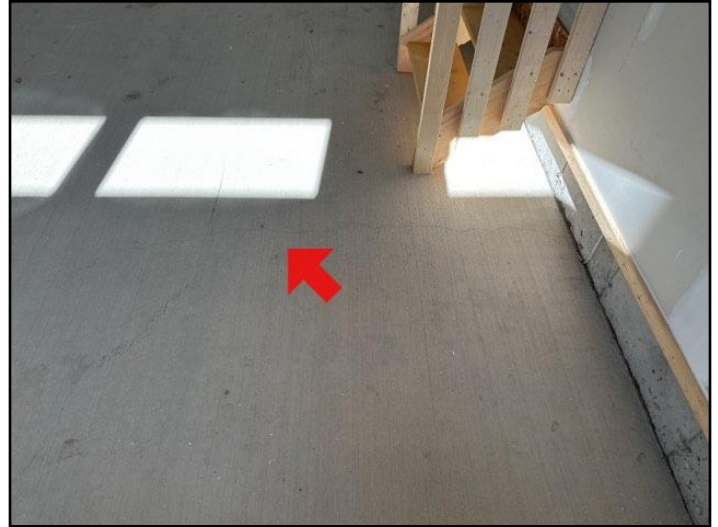
38. Condition: • [Cracked](#)

Monitor the hairline shrinkage crack in the garage floor slab. The crack is not wide enough to insert a 1.5 mm allen key. If the width of the crack increases to 6 mm, they will need to be repaired.

125. Cracked

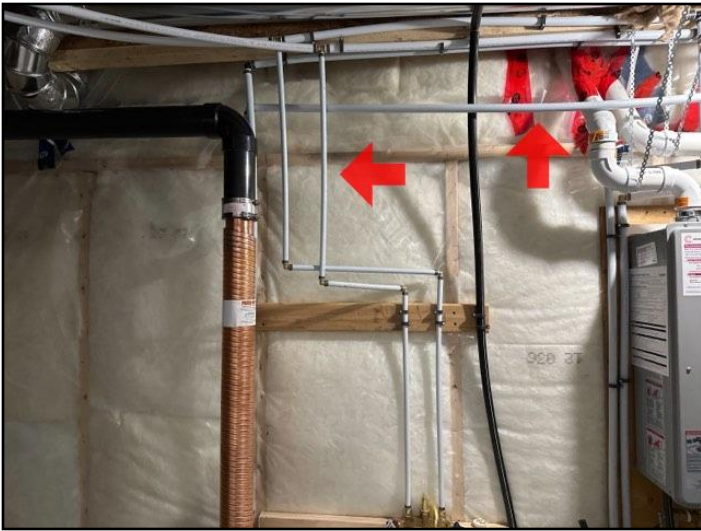
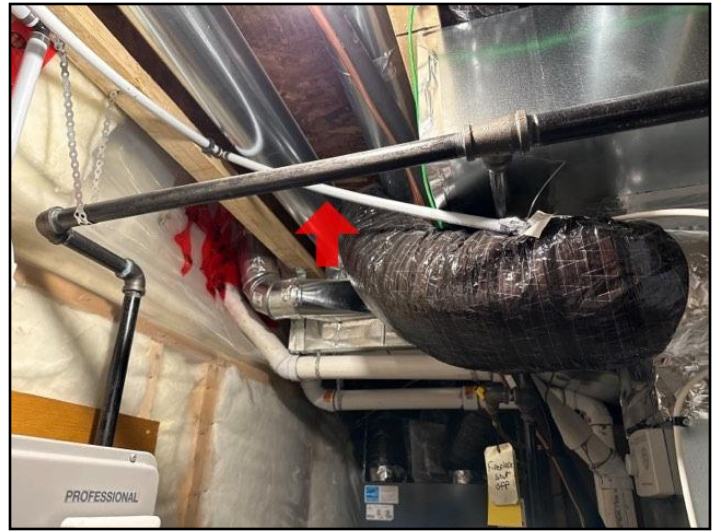
52. Condition: • [Poor support](#)

Secure the loose water supply lines above the basement utility sink and to the humidifier.

155. Poor support

156. Poor support

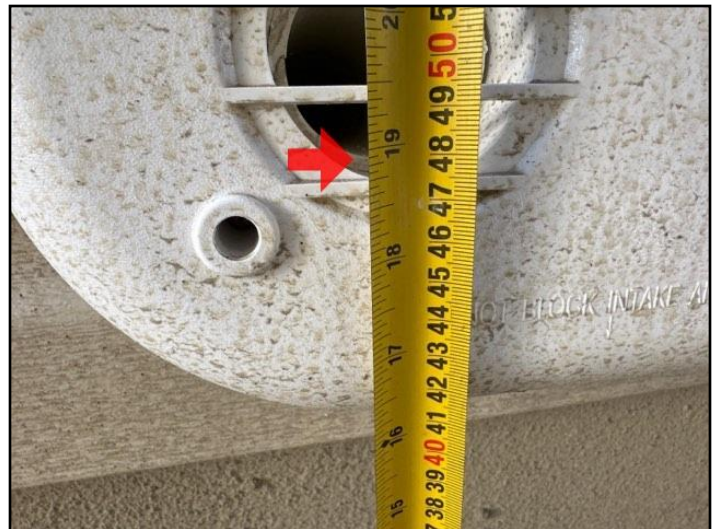
53. Condition: • Clearance to grade

157. Clearance to grade

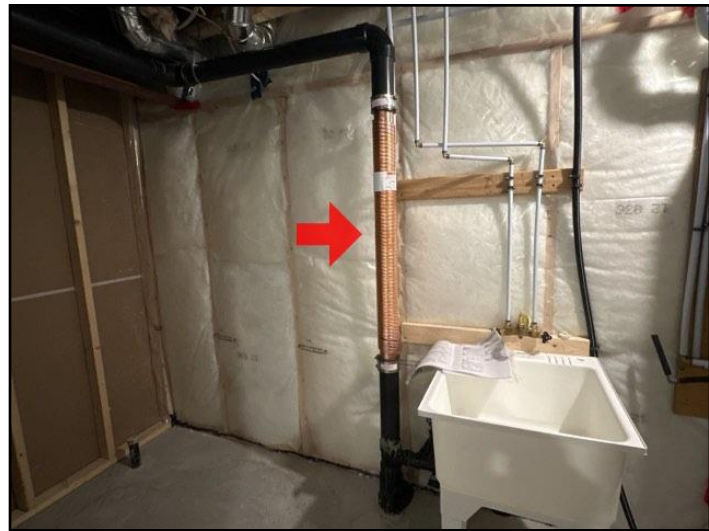
54. Condition: • [Poor support](#)

Secure the loose plumbing stack at the in-line heat exchanger.

160. Poor support

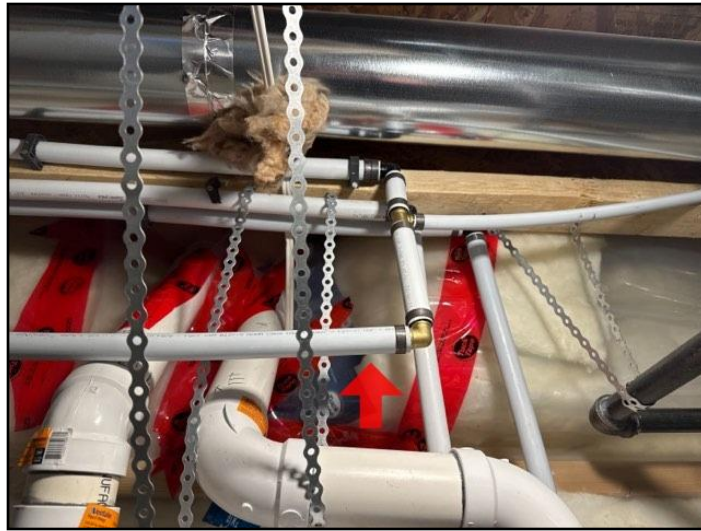
55. Condition: • [Cross connections](#)

Repair the water supply lines to the plumbing stack heat exchanger. The inlet line goes to the cold water supply to the water heater, and the outlet connects to the house's cold water lines.

165. Cross connections

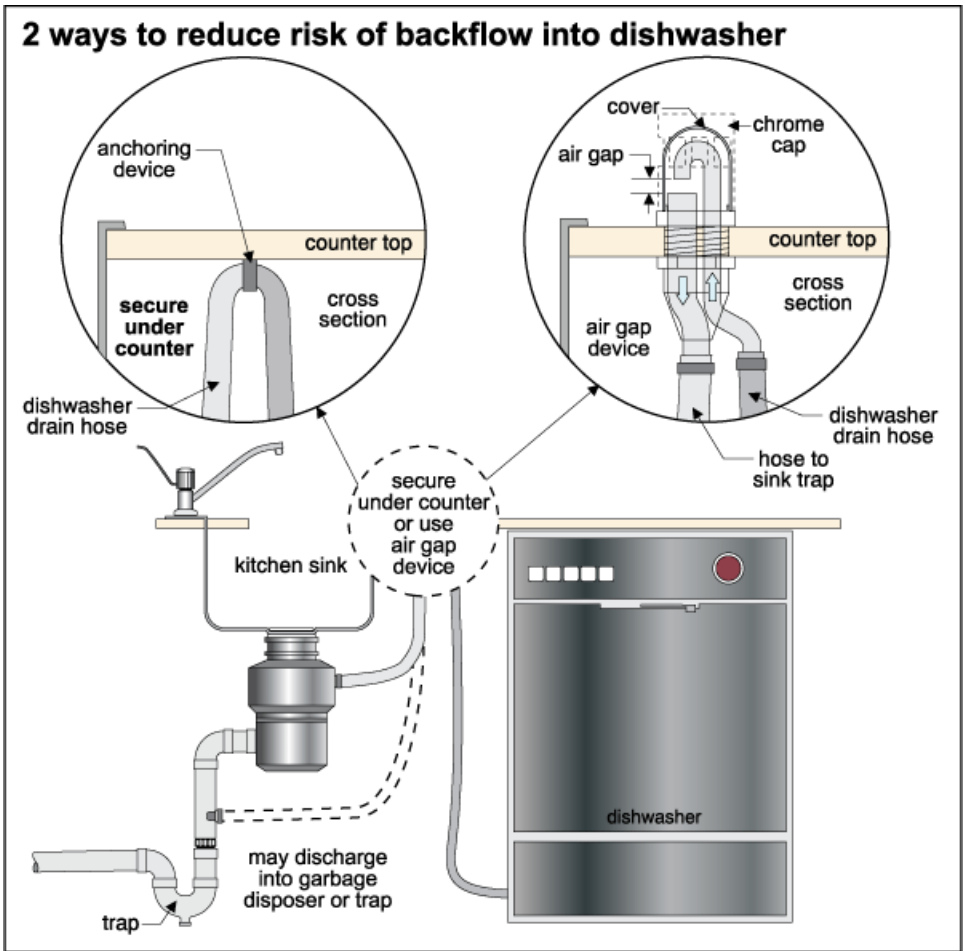
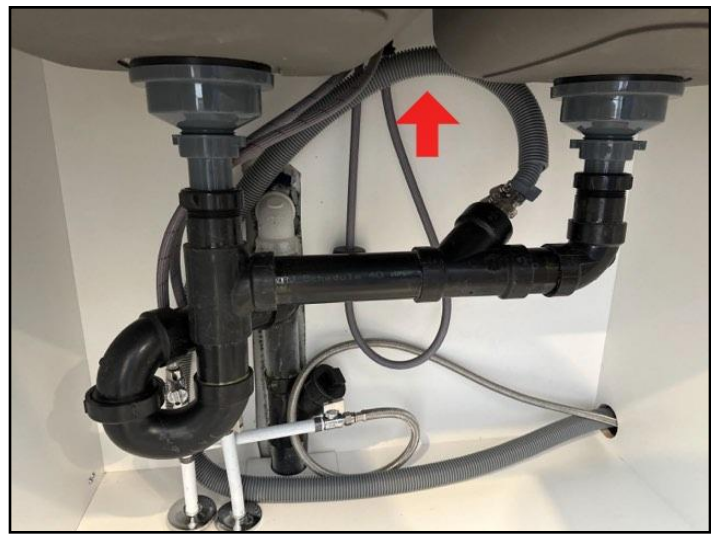
56. Condition: • [Dishwasher drain connections](#)

166. Dishwasher drain connections

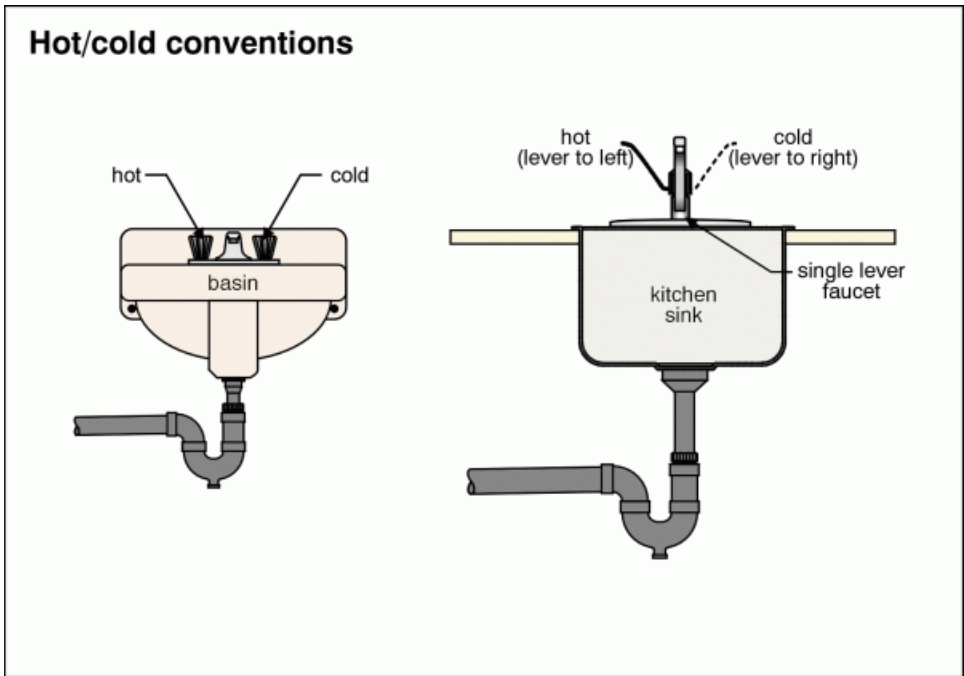
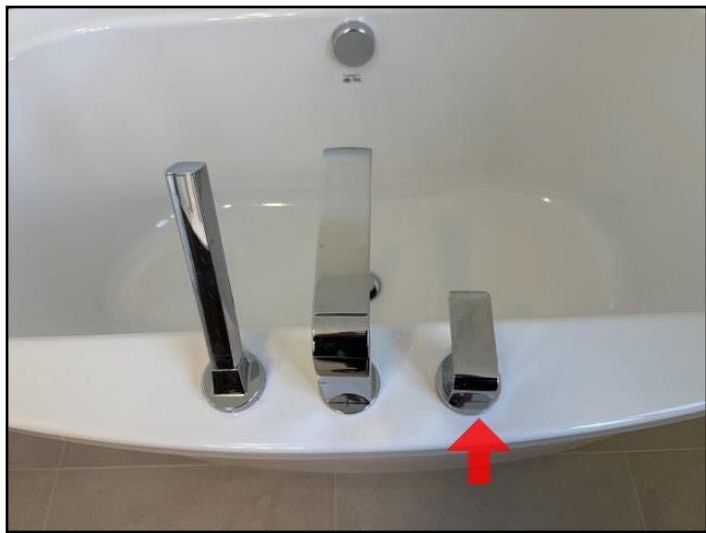
59. Condition: • [Hot and cold reversed](#)

Repair the water connections to the soaker tub faucet. Hot water comes from the faucet when you initially turn it on, not cold.

169. Hot and cold reversed

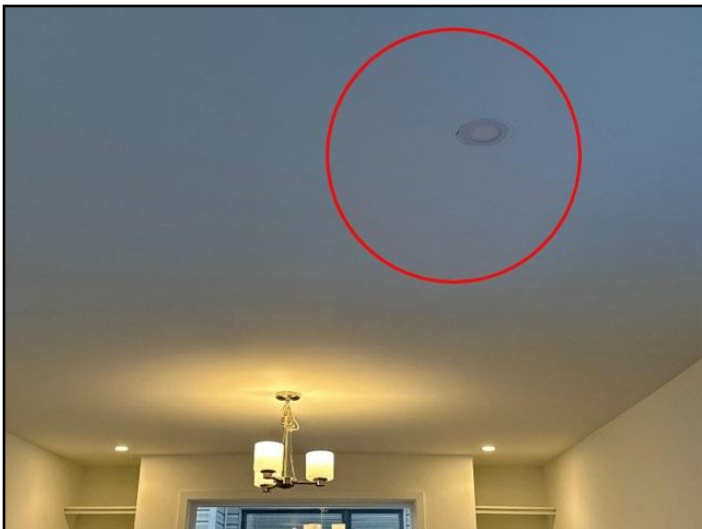
62. Condition: • Damage

Repair the damaged drywall at the pot light in the first floor hallway.

172. Damage

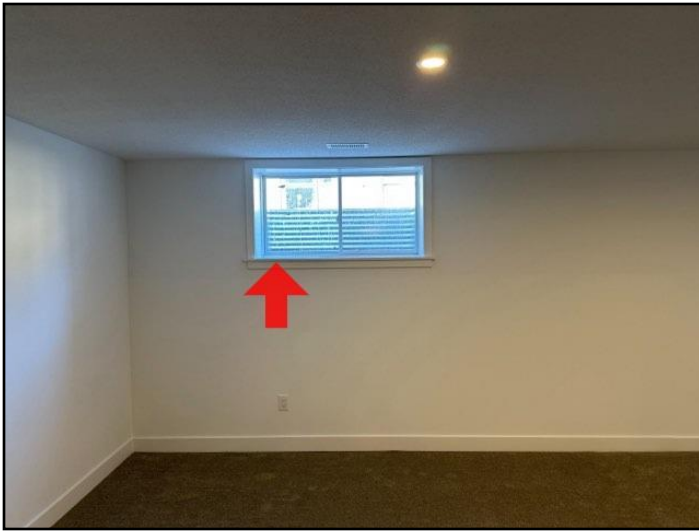
65. Condition: • [Cracked](#)

Replace the cracked glass on the west side of the rear basement window on the west end of the north exterior wall.

179. Cracked

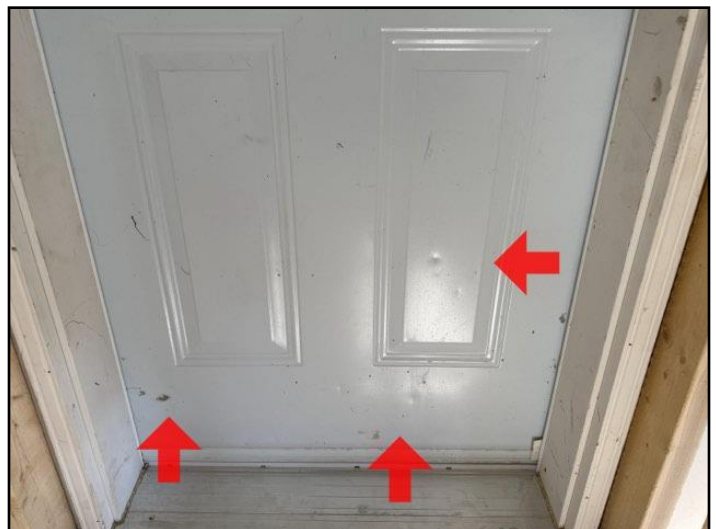
66. Condition: • Damage

Repair the dents and remove the adhesive and paint from the door and frame at the entrance to the house from the garage.

182. Damage

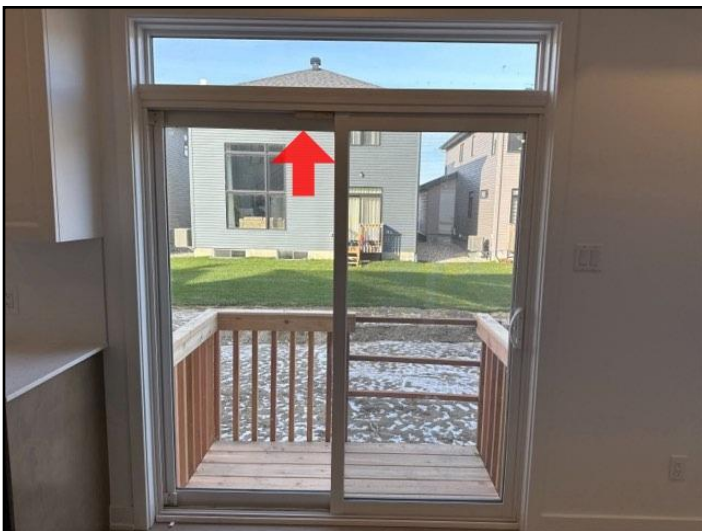
67. Condition: • [Damage](#)

Repair the screw hole in the patio door track where the wood block has been installed.

184. Damage

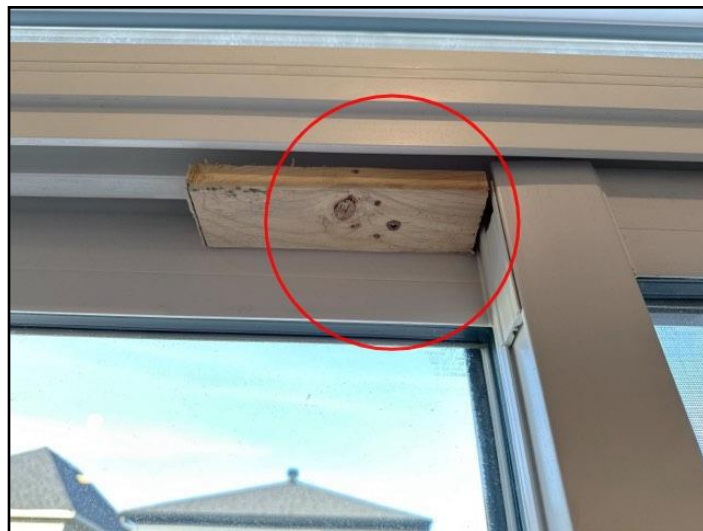
185. Damage

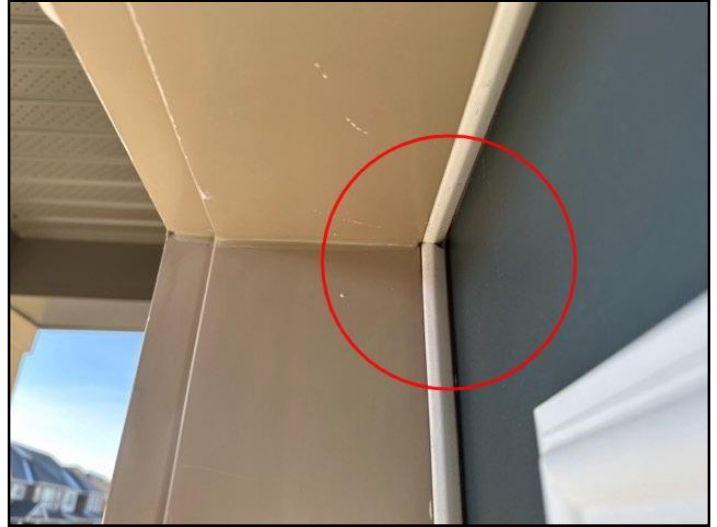
68. Condition: • [Weatherstripping missing or ineffective](#)

Repair the front door that does not seal to the weatherstripping at the top west corner.

187. Weatherstripping missing or ineffective
