# YOUR INSPECTION REPORT

1 INSPECTION WAY

Thursday, September 21, 2023

Report No. 3484, v.2

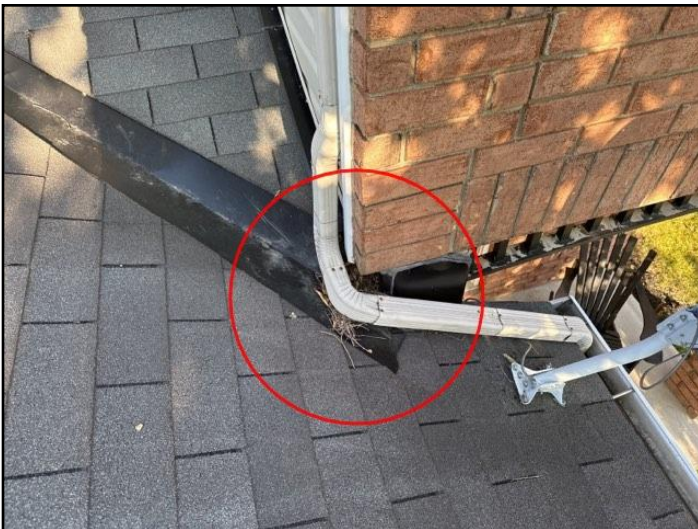
3. Wood joints break into valley

2. Condition: • [Wood joints break into valley](#)

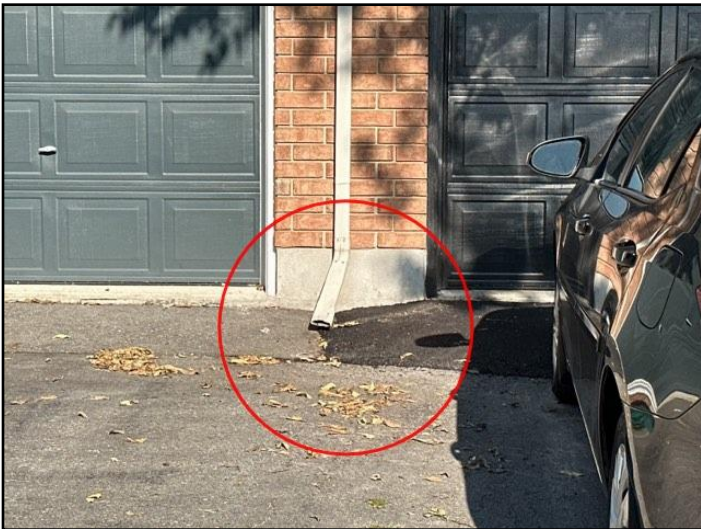
7. Should discharge 6 feet from building

**4. Condition:** • [Should discharge 6 feet from building](#)

The downspouts at the front and rear of the house should discharge a minimum of 6 feet from the foundation wall.

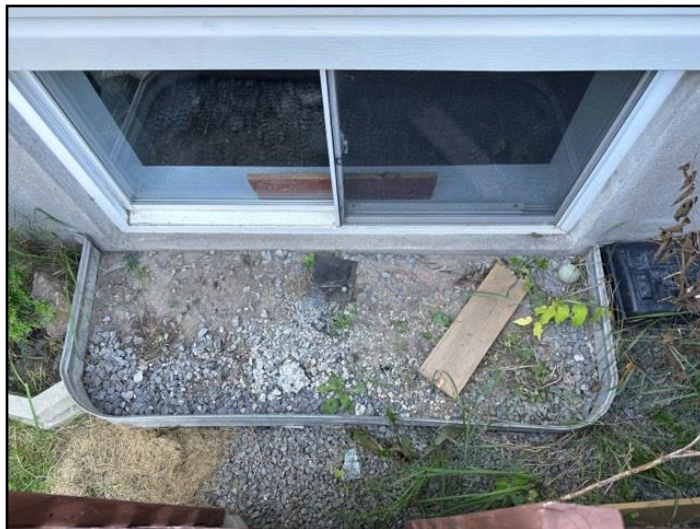
15. Clean window well

**9. Condition:** • Clean window well

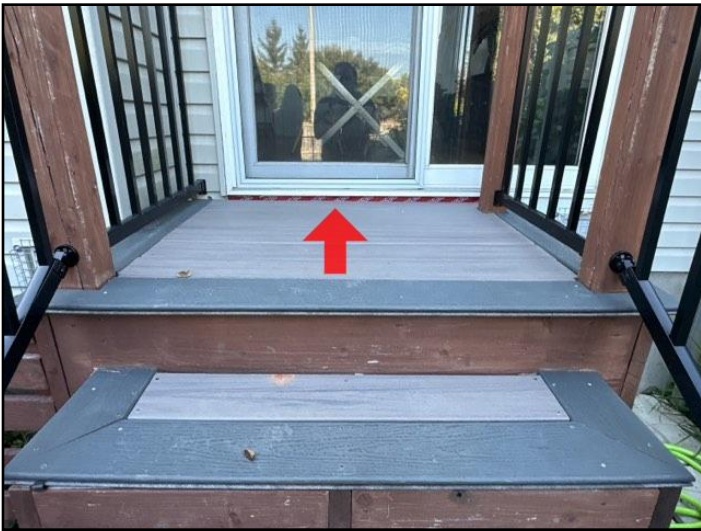
16. No step up into building

### **10. Condition:** • [No step up into building](#)

Due to the limited clearance between the deck and the door sill, water could leak into the house. Keep the snow and ice cleared away from the door sill during the winter months. The kick plate below the patio door has been patched with a water-resistant membrane, which may indicate they have already had some water infiltration.

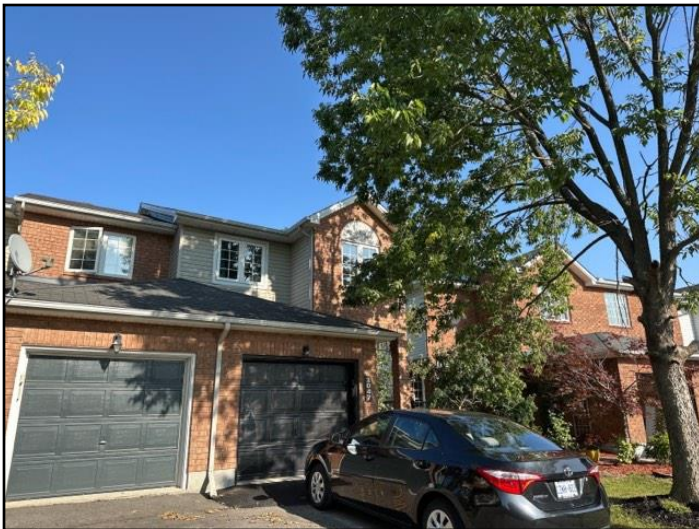
18. Trees or shrubs too close to building

11. Condition: • [Trees or shrubs too close to building](#)

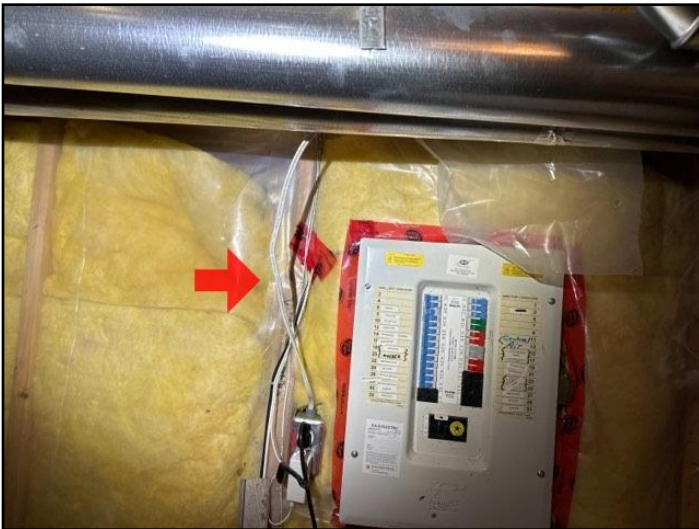
47. Modified or added wiring

**Condition:** • [Modified or added wiring](#)

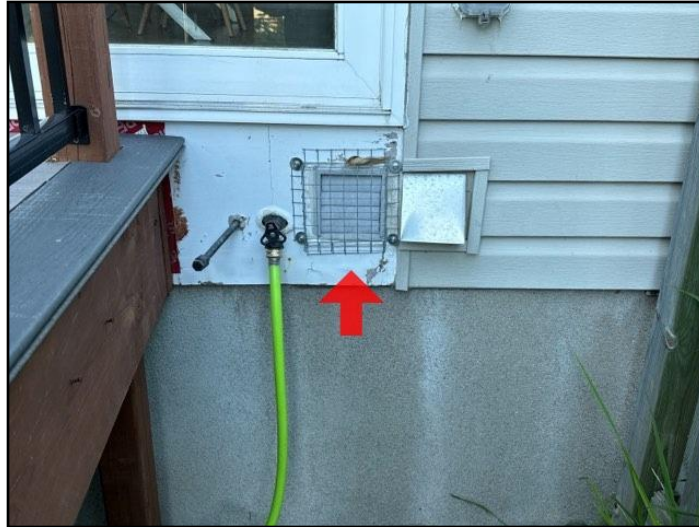
48. Condition: • Clean dryer vent

131. Clean dryer vent

**Task:** Regular maintenance
