YOUR INSPECTION REPORT

1 INSPECTION WAY

Nepean, ON

Wednesday, November 22, 2023

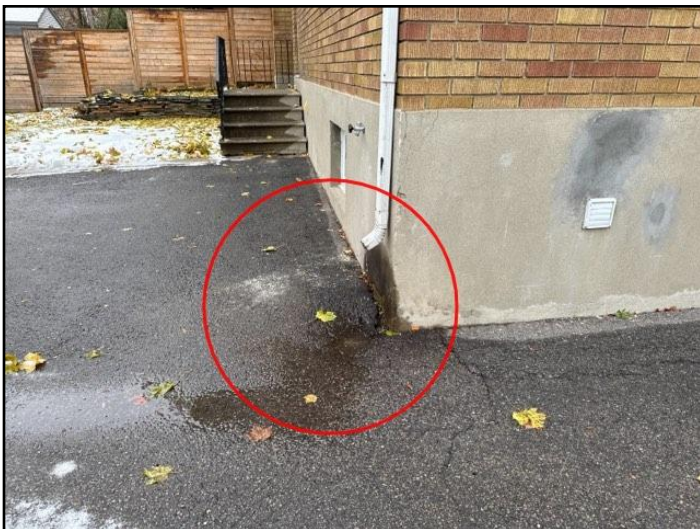
2. Condition: • [Should discharge 6 feet from building](#)

The downspouts should discharge a minimum of 6 feet from the foundation walls. This can be a contributing factor to basement moisture issues.

3. Should discharge 6 feet from building

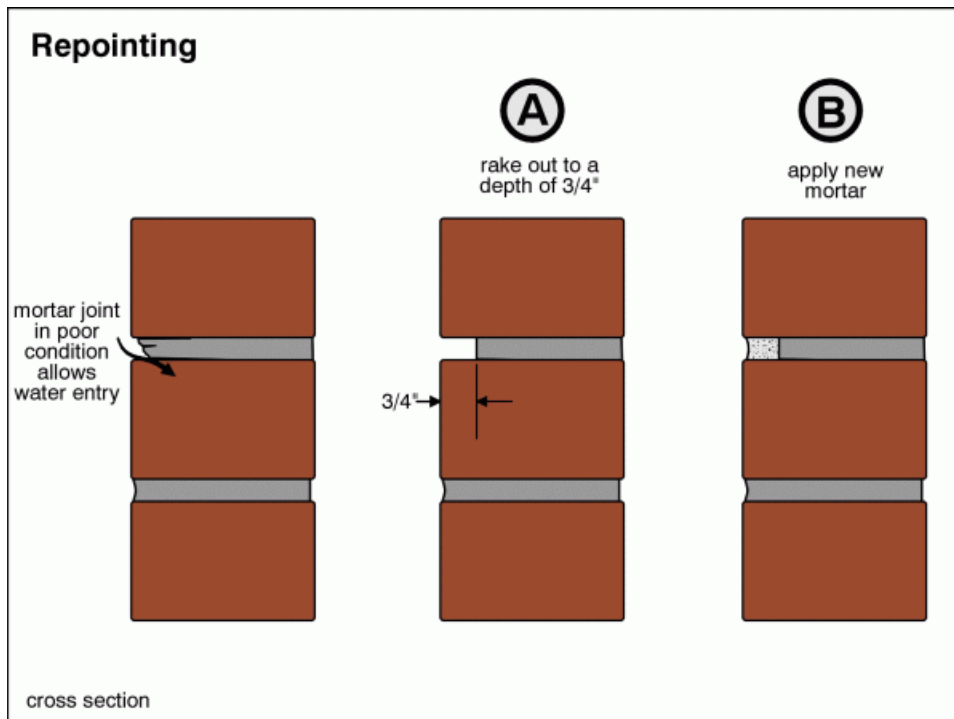
3. Condition: • [Mortar deterioration](#)

Repoint the loose mortar on the west facing brick veneer wall at the front of the house.

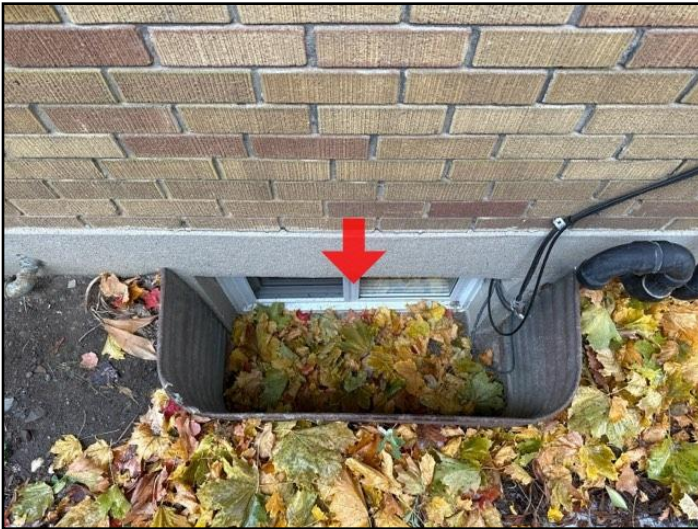
13. Clean window well

7. Condition: • Clean window well

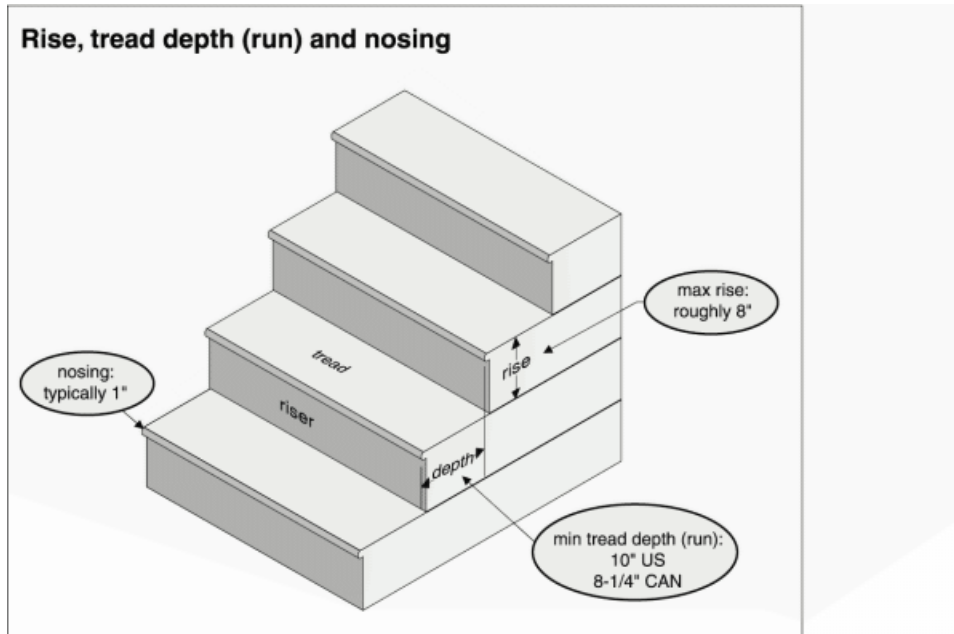
10. Condition: • [Stair rise too big or not uniform](#)

Implication(s): Trip or fall hazard

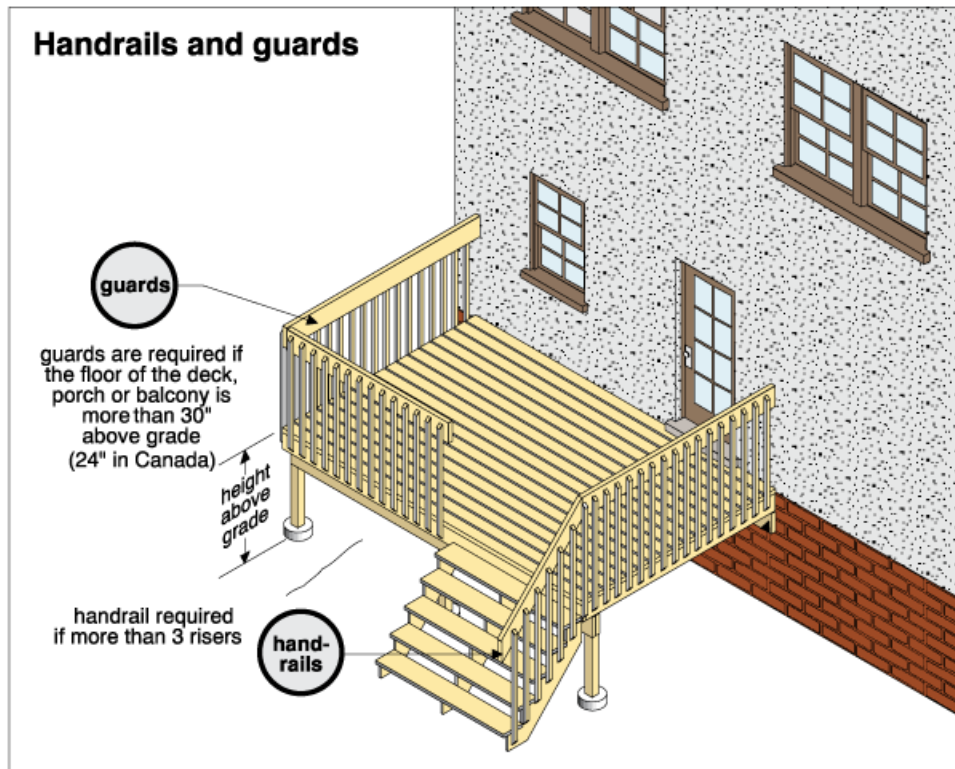
20. Missing

11. Condition: • [Missing](#)

Provide the missing handrail for the front entrance steps and landing.

Implication(s): Fall hazard

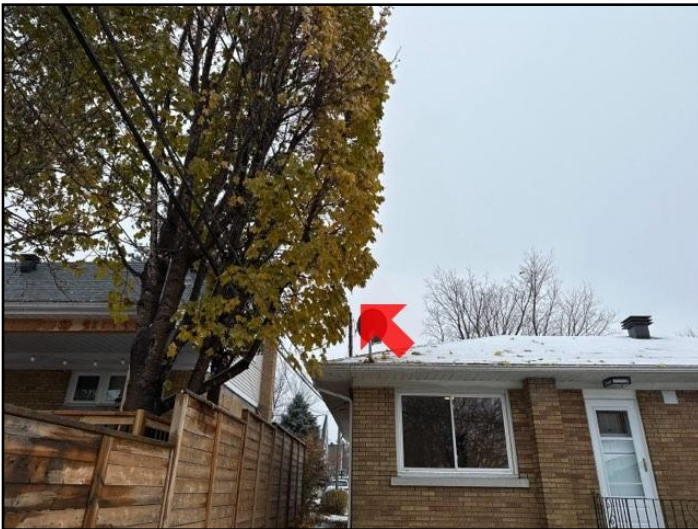
21. Trees or shrubs too close to building

12. Condition: • [Trees or shrubs too close to building](#)

Implication(s): Chance of water damage to structure, finishes and contents | Chance of pests entering building | Material deterioration

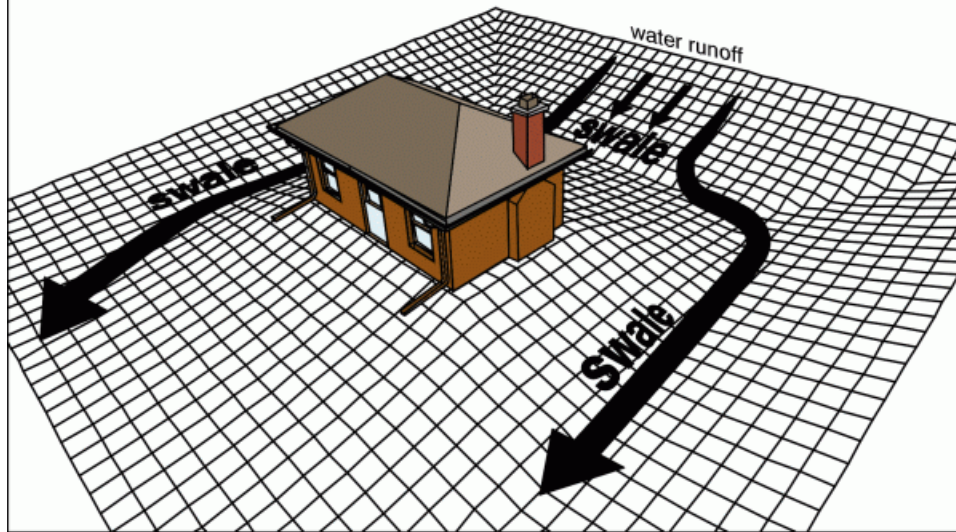
23. Improper slope or drainage

13. Condition: • [Improper slope or drainage](#)

Repair the slope of the ground around the house to limit the amount of water that accumulates against the foundation walls. The ground should slope away from the foundation. This can be a contributing factor to basement moisture issues.

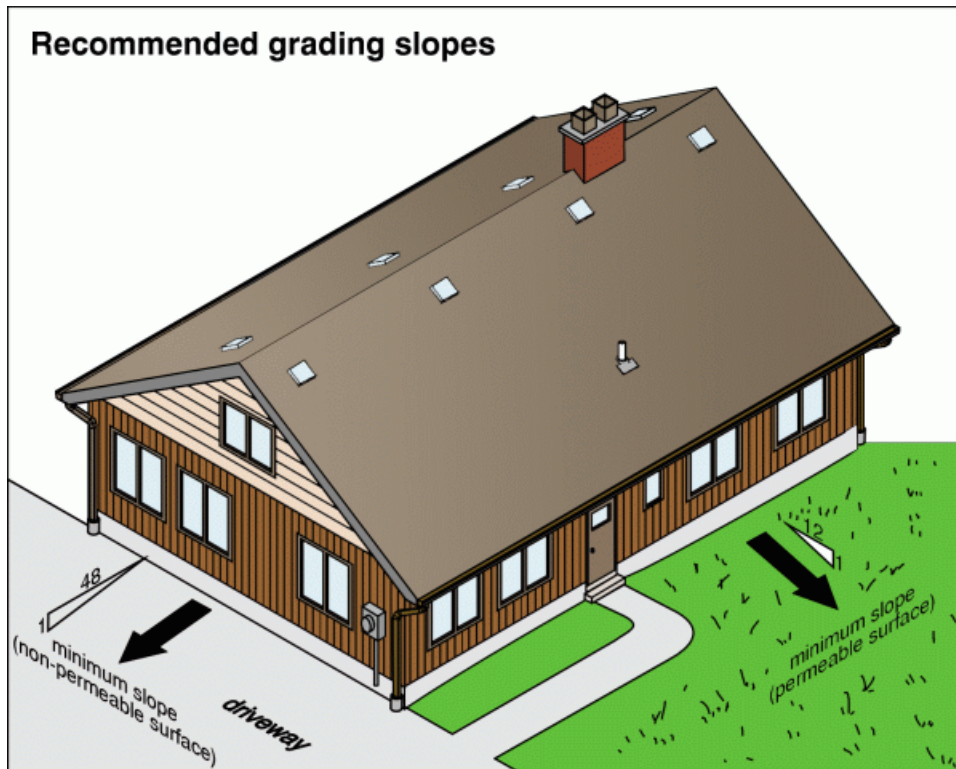
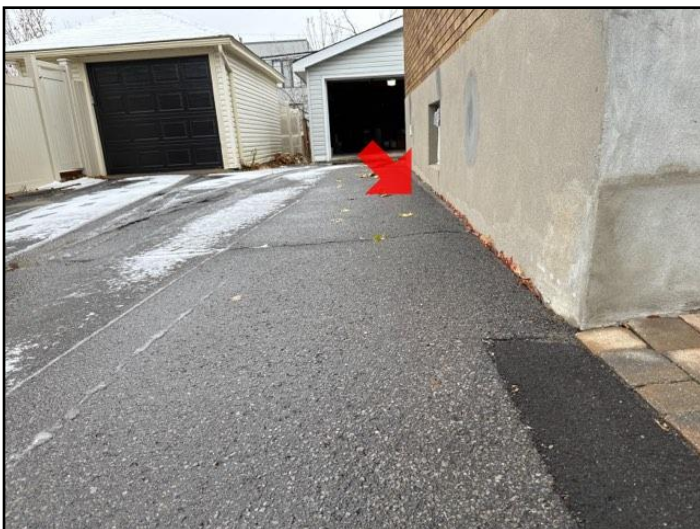
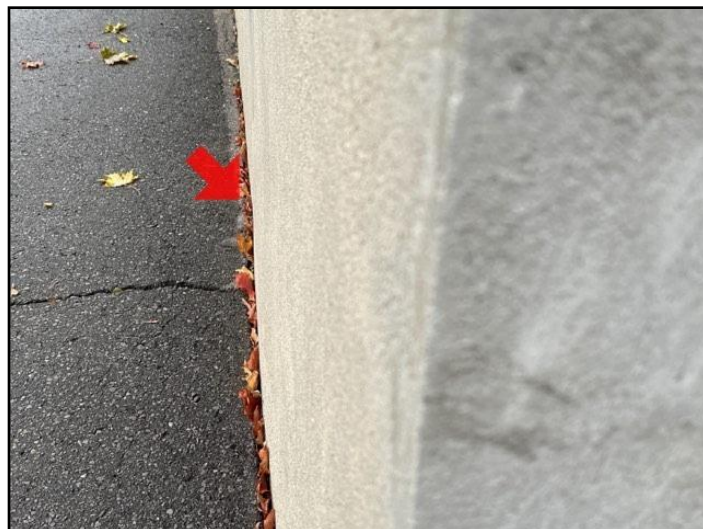
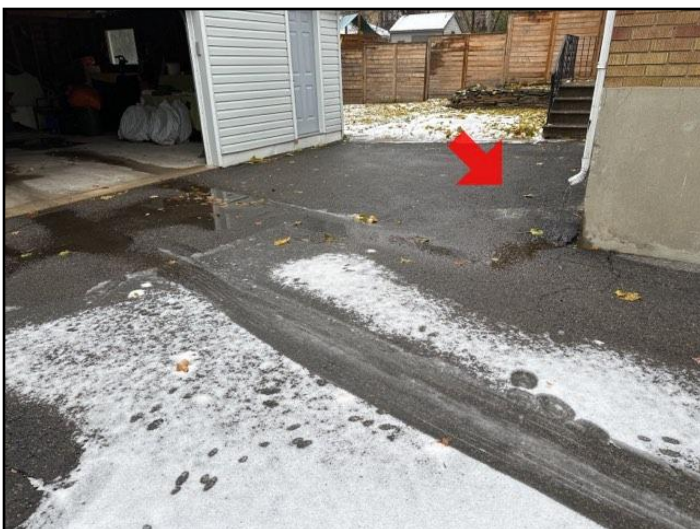
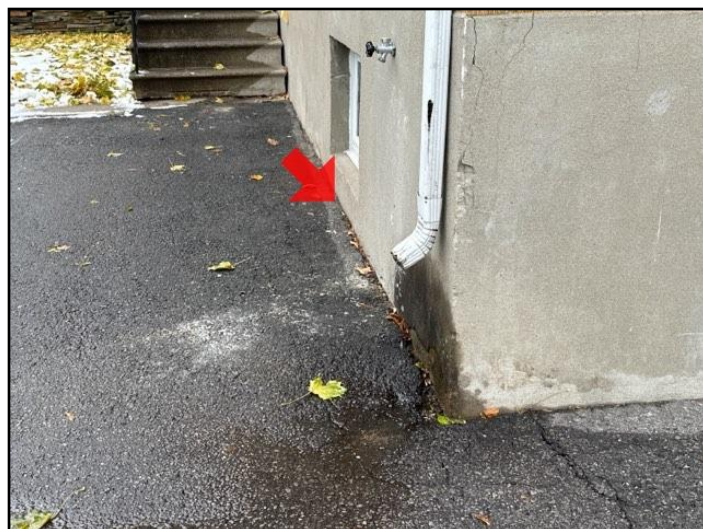
15. Condition: • [Improper slope or drainage](#)

Repair the driveway slope on the west and north sides of the house at the foundation. Any gaps between the driveway and the foundation should be sealed.

Implication(s): Chance of water damage to structure, finishes and contents

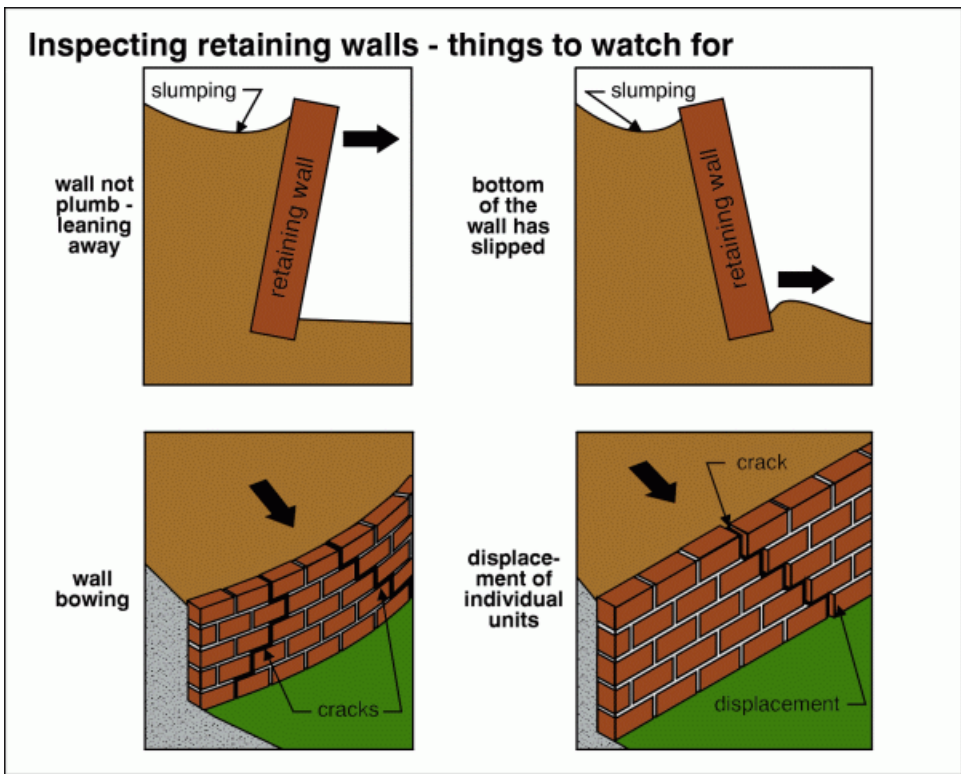
34. Leaning

16. Condition: • [Leaning](#)

Repair the retaining along the east side of the driveway as required.

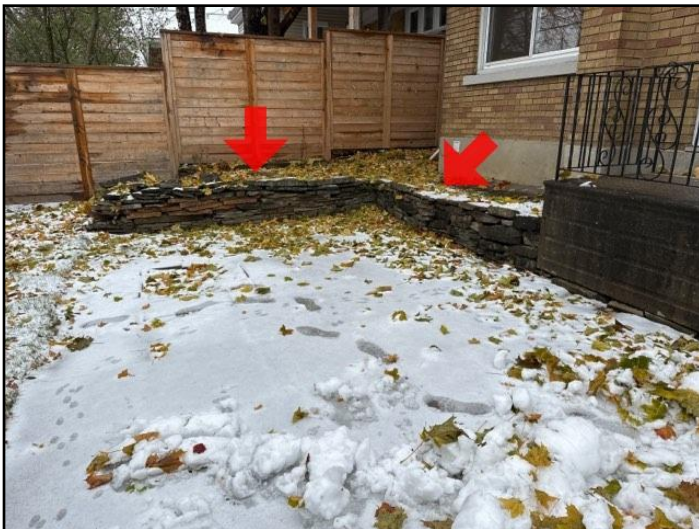
35. Leaning

17. Condition: • [Leaning](#)

Repair the dry-laid stone retaining wall at the rear of the house that has deteriorated and is leaning into the rear yard.

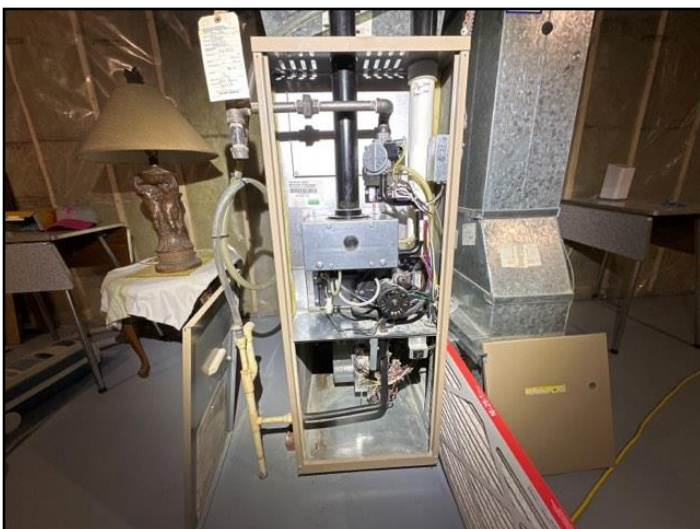
64. Service Furnace

28. Condition: • Service Furnace

Task: Service

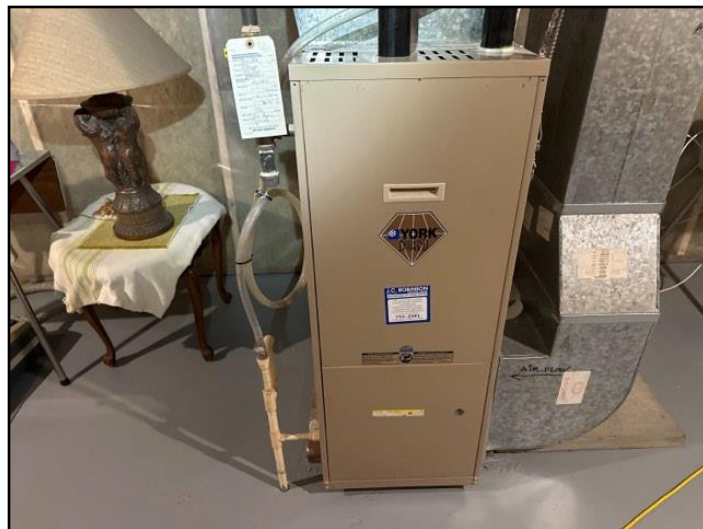
68. Near end of life expectancy

29. Condition: • [Near end of life expectancy](#)

The furnace should be budgeted for replacement due to the age and condition of the unit.

Implication(s): Equipment failure | No heat for building

Task: Replace

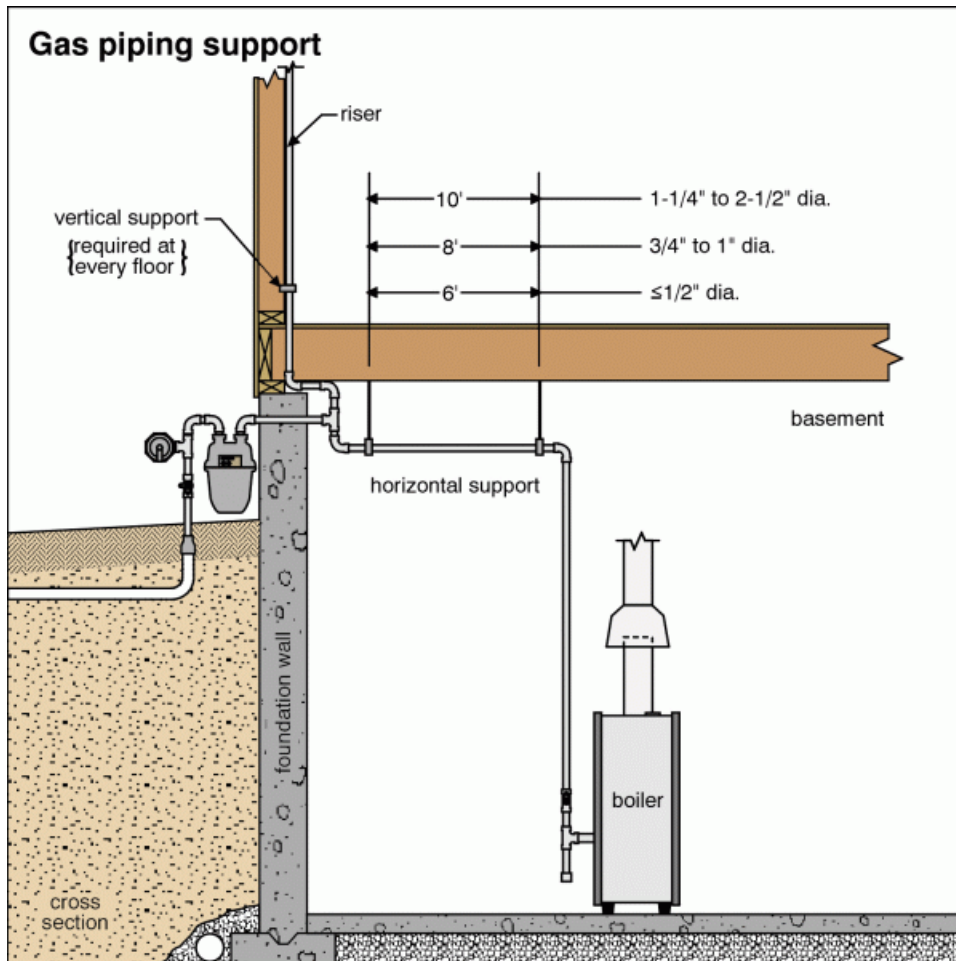
70. Inadequate support

31. Condition: • [Inadequate support](#)

Task: Improve/correct

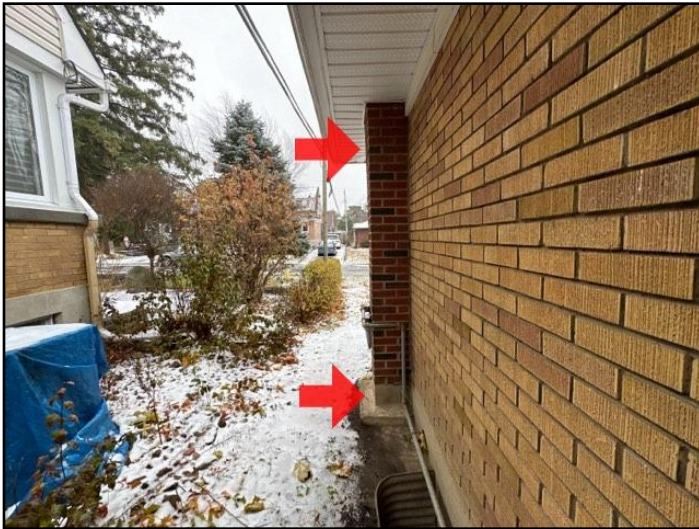
74. Settling or leaning

34. Condition: • [Settling or leaning](#)

Implication(s): Chance of water damage to structure, finishes and contents | Chance of chimney movement | Hazardous combustion products entering home

Task: Remove

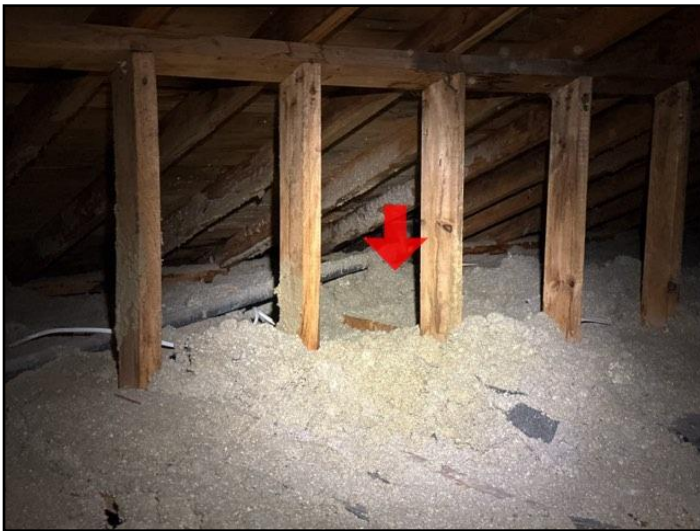
78. Compressed

35. Condition: • [Compressed](#)

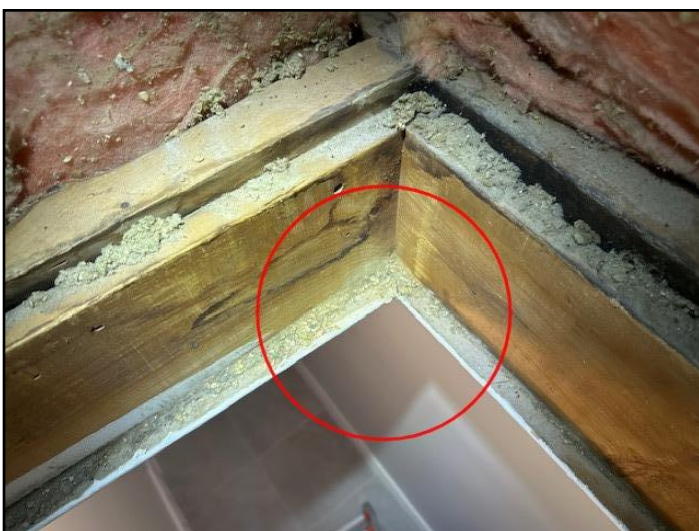
83. Not weatherstripped

36. Condition: • [Not weatherstripped](#)

Implication(s): Chance of condensation damage to finishes and/or structure | Increased heating and cooling costs

Task: Provide

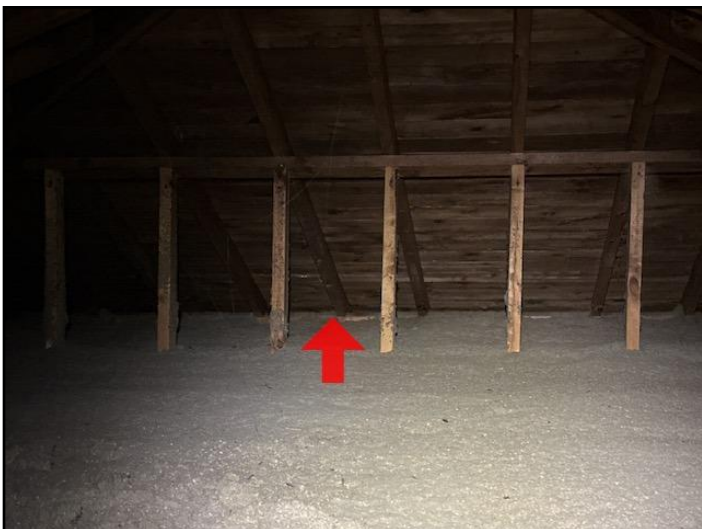
85. Obstructed

37. Condition: • [Obstructed](#)

The soffits are blocked and not providing the required air intake into the attic. Open the soffits on the exterior of the house and provide the missing insulation baffles for the soffits on the interior of the attic.

Implication(s): Chance of condensation damage to finishes and/or structure

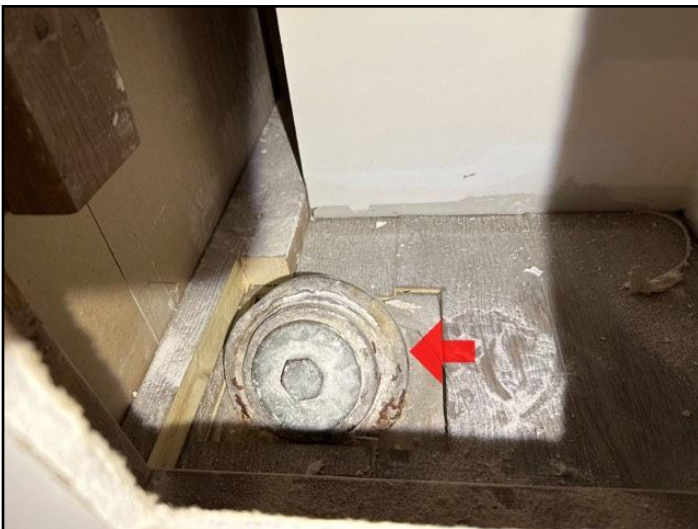
91. Old piping

39. Condition: • Old piping

Cast iron waste plumbing piping was used regularly in residential construction in the Ottawa area into the late 1960s. With the probability of the cast iron pipe deteriorating, some insurance companies are requiring it to be scoped when obtaining a new insurance policy. It is recommended to have the cast iron drain lines scoped at this time.

Task: Request disclosure from insurance provider

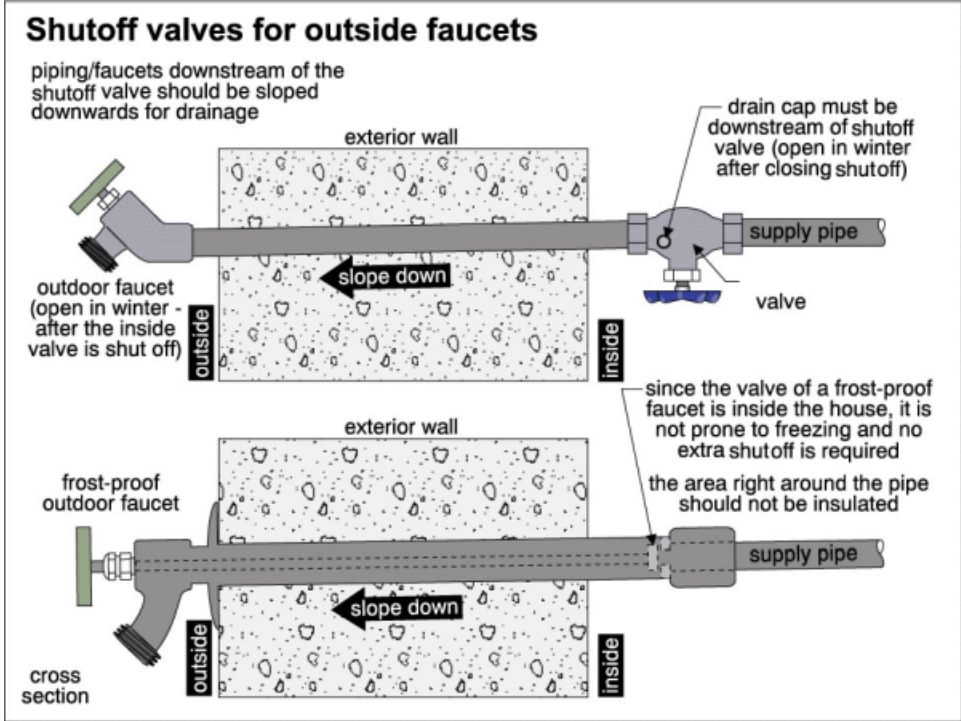
93. Poor slope on frost-free bib/bibb (outdoor...)

40. Condition: • [Poor slope on frost-free bib/bibb \(outdoor faucet\)](#)

The exterior hose bib on the east side of the house at the south corner has been installed horizontally instead of vertically. This will prevent the hose bib from draining correctly. Ensure that the interior shut-off valve is turned off and drained for the winter.

Implication(s): System inoperative
Location: East Foundation Exterior Wall
Task: Repair
Time: Before using

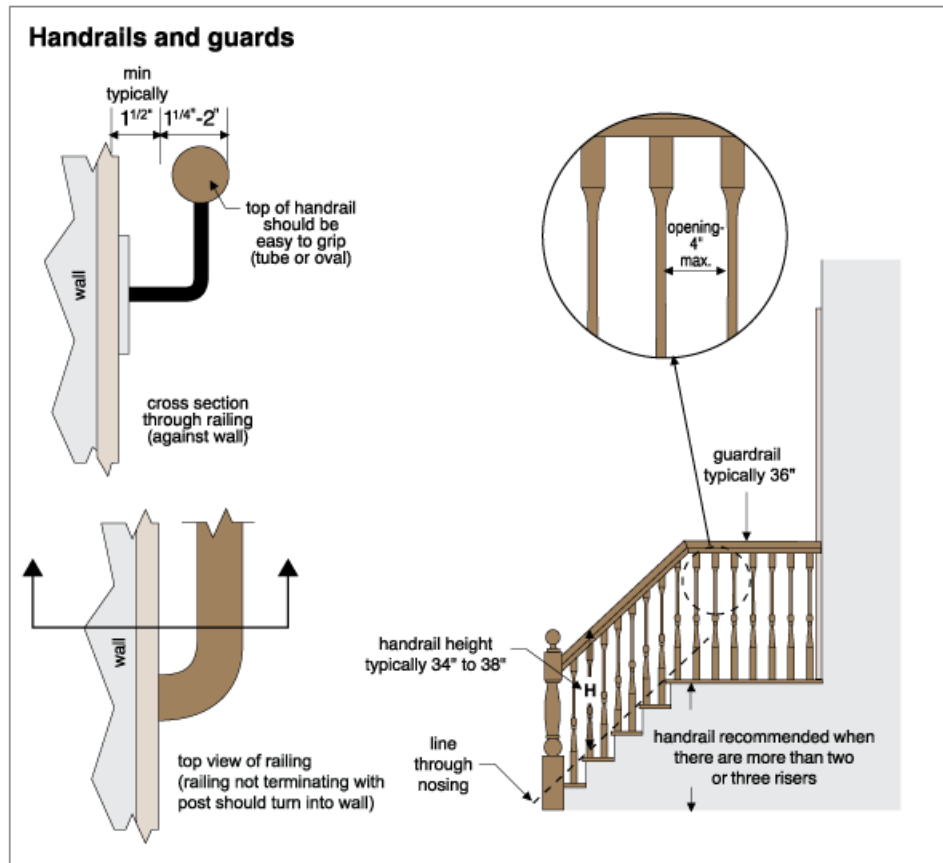
94. Missing

41. Condition: • [Missing](#)

Implication(s): Fall hazard

Install the missing sections of the handrail for the basement stairs.

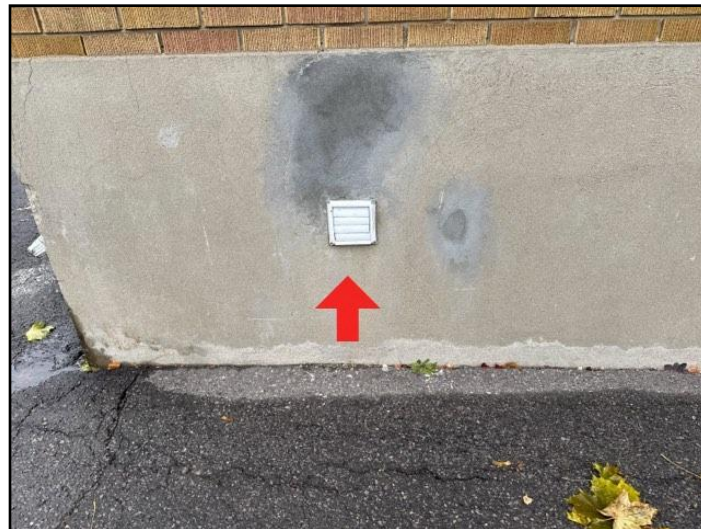
97. Clean dryer vent

43. Condition: • Clean dryer vent

Task: Regular maintenance
