YOUR INSPECTION REPORT

1 INSPECTION WAY
Kanata, ON

Saturday, November 25, 2023

Report No. 3559, v.2

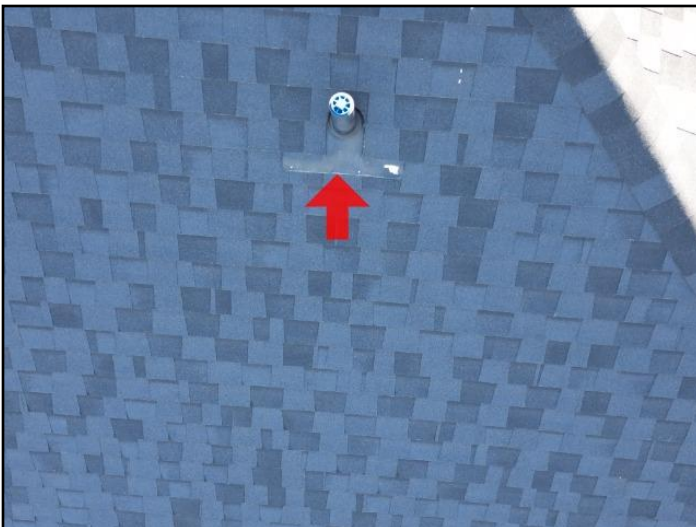
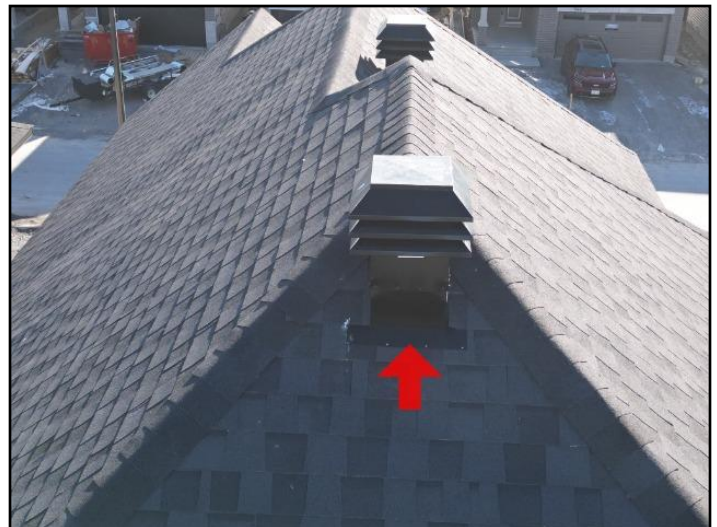
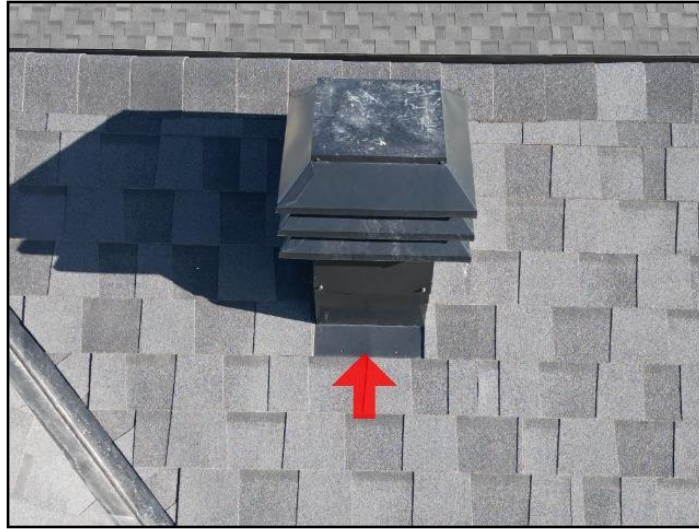
1. Condition: • [Exposed fasteners](#)

Implication(s): Chance of water damage to structure, finishes and contents

Task: Repair

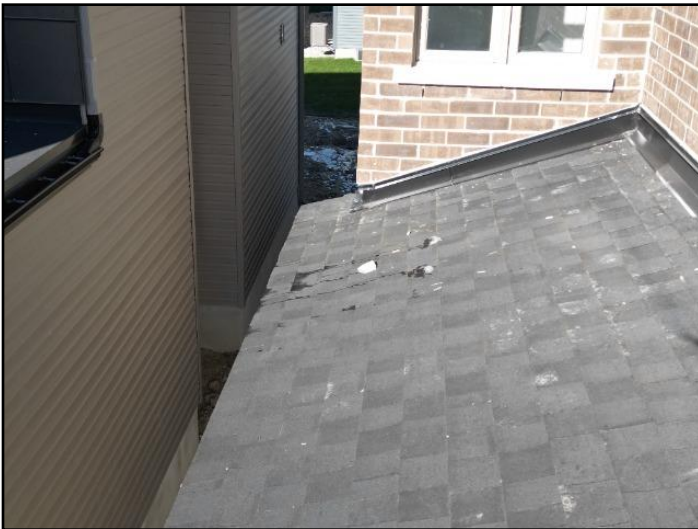
2. **Condition:** • Remove all loose debris from roof coverings.

4. Remove all loose debris from roof coverings.

Task: Repair

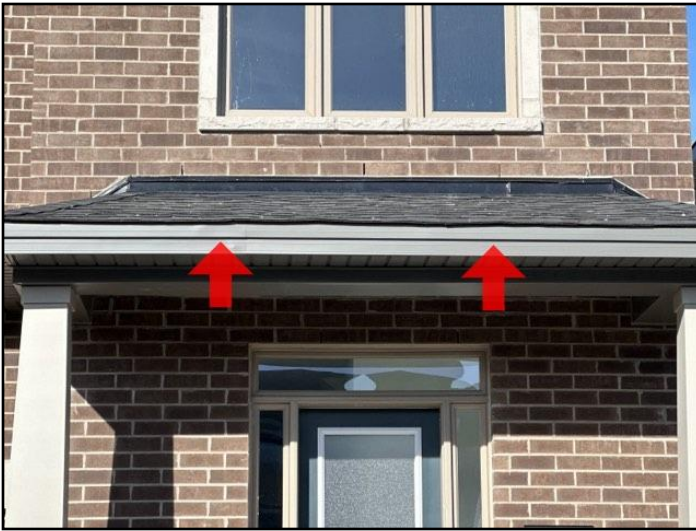
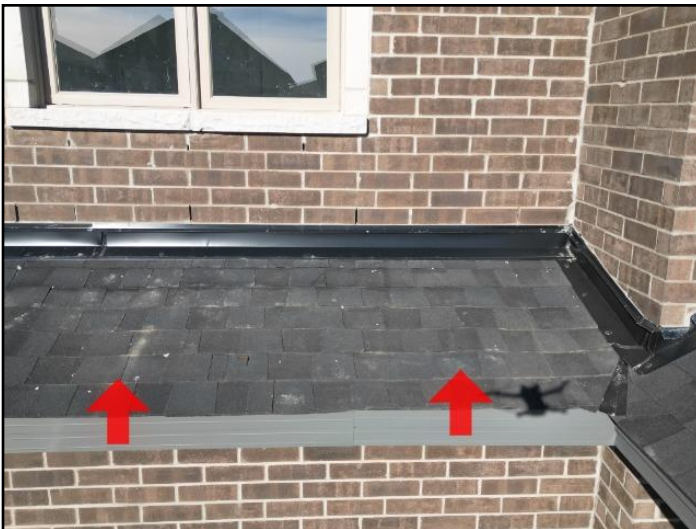
3. **Condition:** • Shingles uneven

6. Shingles uneven

Repair the visible ridges in the garage and porch roof shingles.

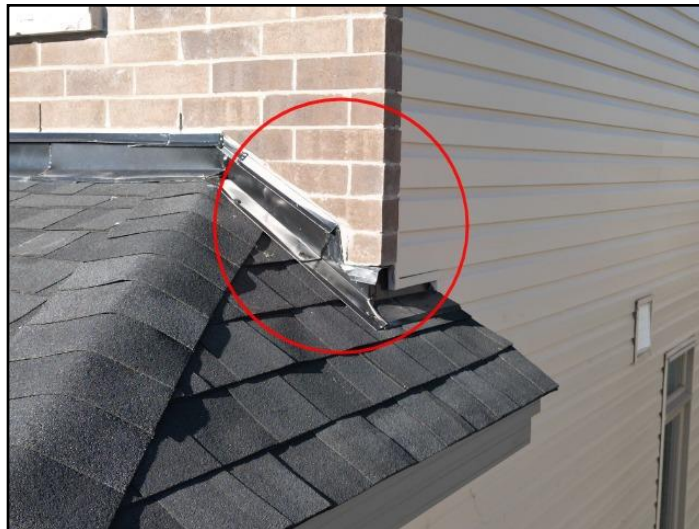
4. Condition: • [Damage, loose, open seams, patched](#)

Implication(s): Chance of water damage to structure, finishes and contents

10. Damage, loose, open seams, patched

Repair the loose and open seams in the roof-to-wall flashing on the garage and porch roofs. Repair the wall flashing at the transition from the garage to the porch roof that is not high enough above the porch roof.

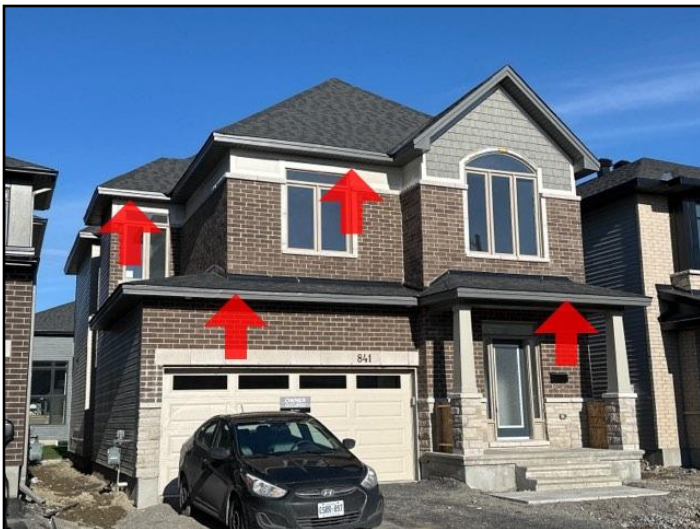
5. Condition: • [Missing](#)

Implication(s): Chance of water damage to structure, finishes and contents

13. Missing

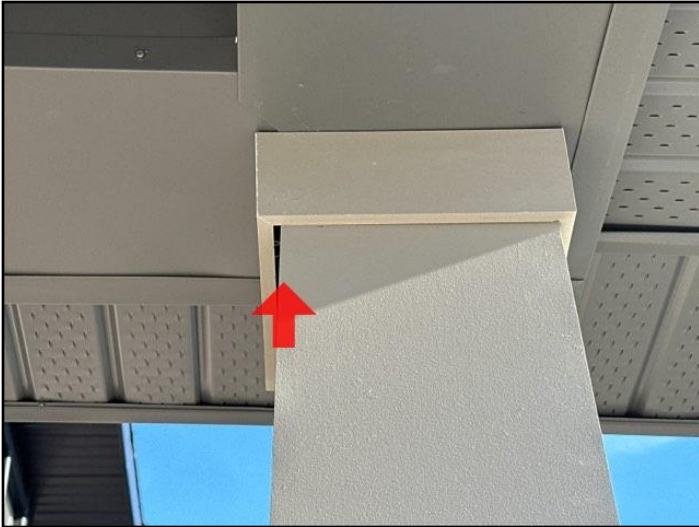
9. Condition: • [Loose](#)

Implication(s): Chance of water damage to structure, finishes and contents

19. Loose

Repair the loose trim at the top of the front porch columns.

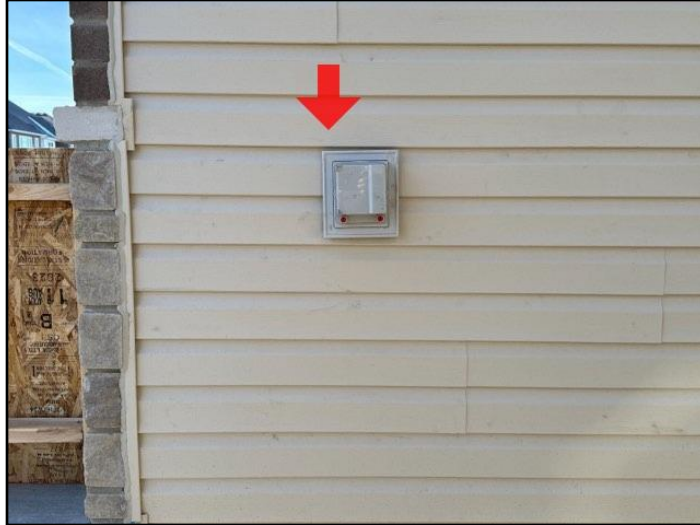
11. Condition: • Not level

22. Not level

Repair the water metre transmitter on the east side of the house at the south corner that has been installed out of level.

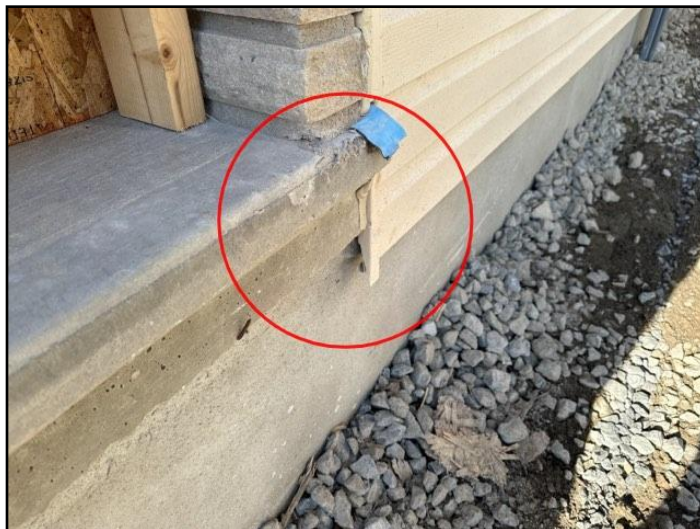
12. Condition: • [Caulking missing or ineffective](#)

Implication(s): Chance of water damage to structure, finishes and contents

23. Caulking missing or ineffective

Provide the missing caulking at the transition between the siding and foundation on the east side of the house below the front porch slab.

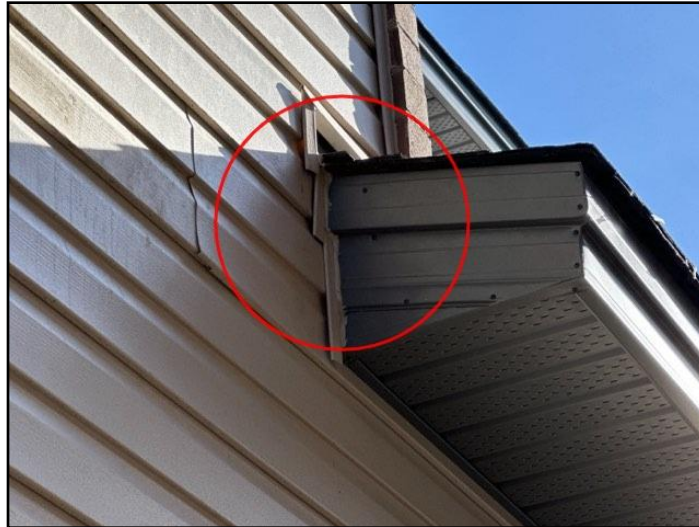
13. Condition: • [Mechanical damage](#)

Implication(s): Chance of water damage to structure, finishes and contents

24. Mechanical damage

Repair the uneven "J" trim on the west side of the house at the north face of the garage roof. Repair the gaps and unevenness in the "J".

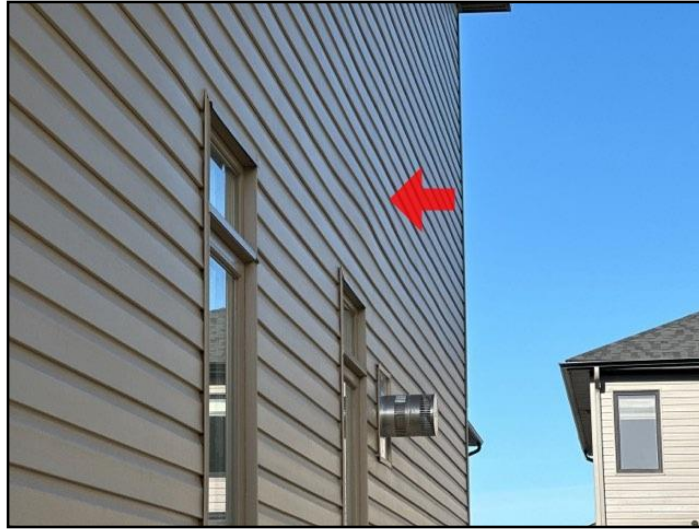
14. Condition: • [Buckled or wavy](#)

Implication(s): Chance of water damage to structure, finishes and contents

25. Buckled or wavy

Repair the buckle in the vinyl siding on the east wall of the house above the dining room and gas fireplace exhaust vent area.

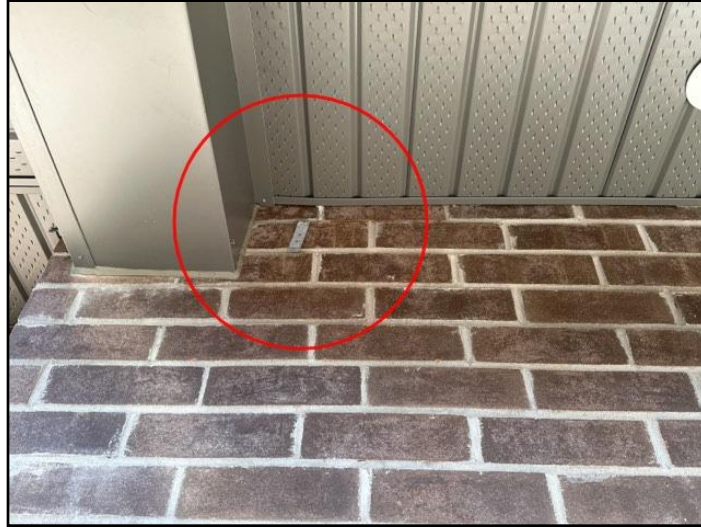
16. Condition: • [Mechanical damage](#)

28. Mechanical damage

Task: Repair

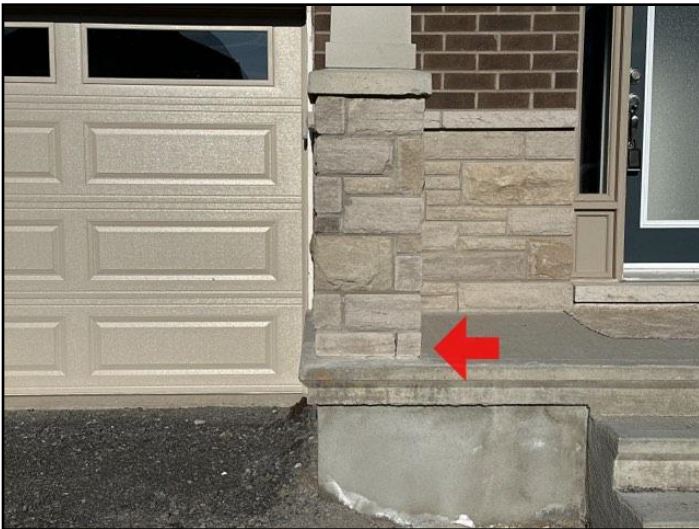
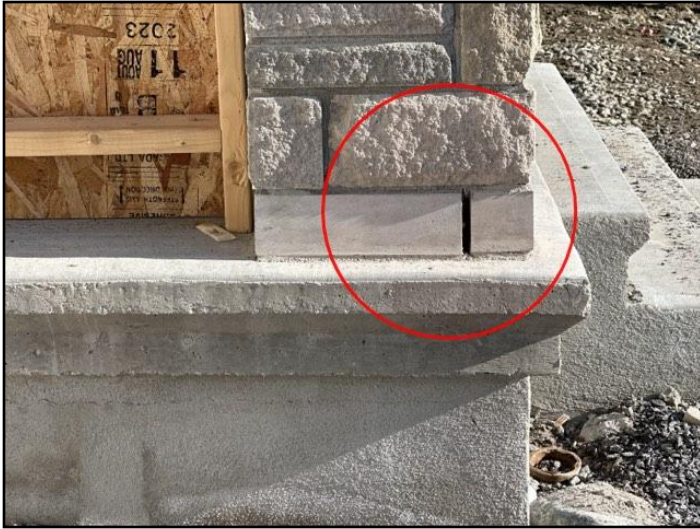
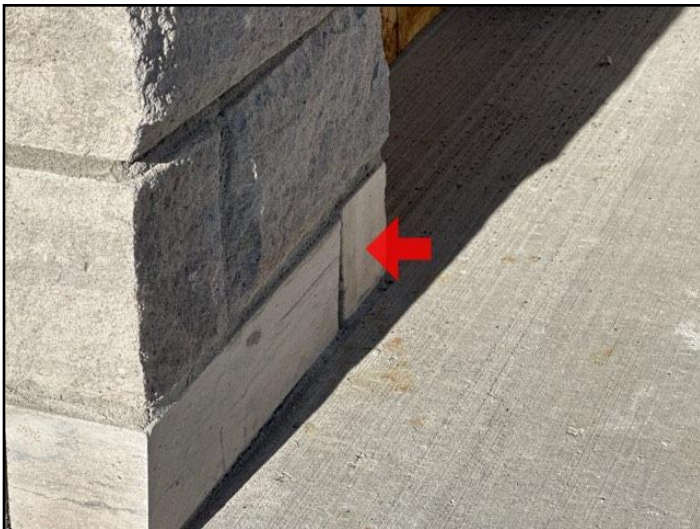
17. Condition: • [Masonry deterioration](#)

29. Masonry deterioration

Repair the bricks at the base of the front porch columns that have not been installed level or plumb.

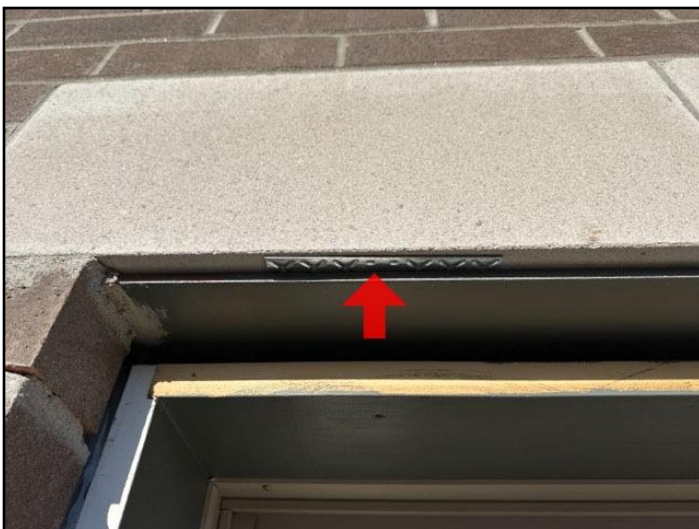
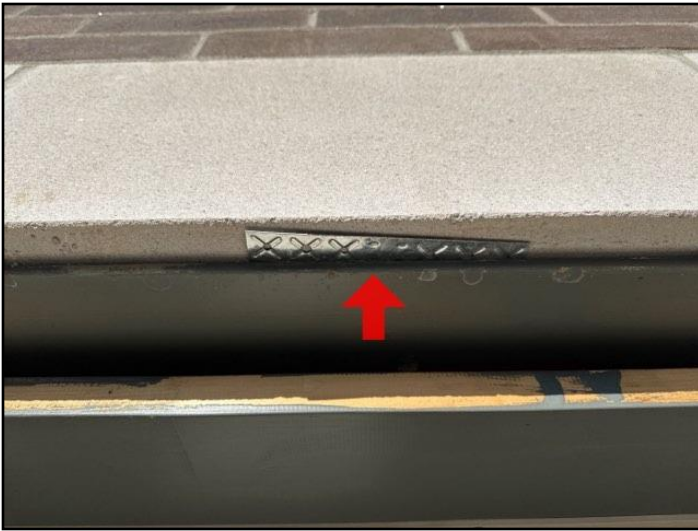
19. Condition: • [Masonry deterioration](#)

39. Masonry deterioration

Task: Repair

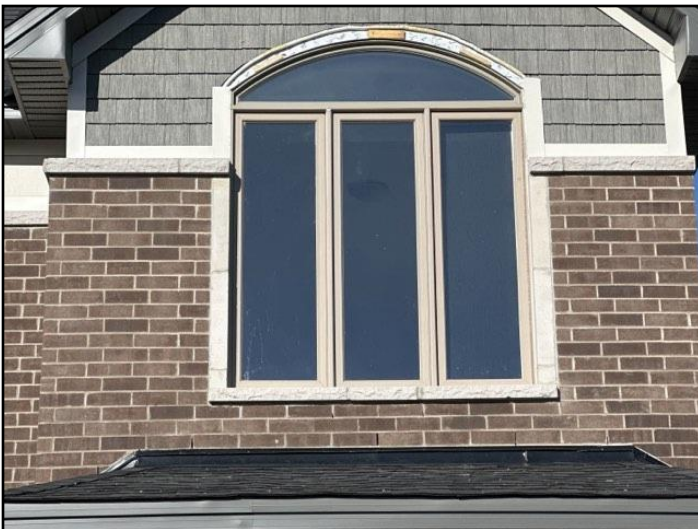
20. Condition: • [Masonry deterioration](#)

43. Masonry deterioration

Repair the chipped and out of plumb block and brick veneer around the front second floor windows.

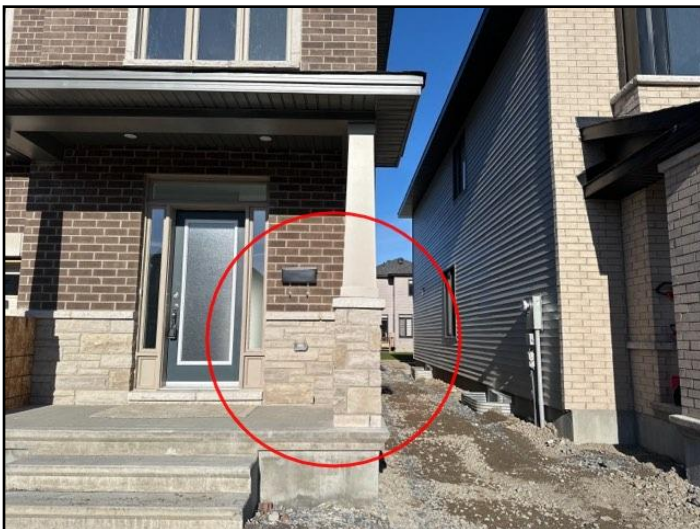
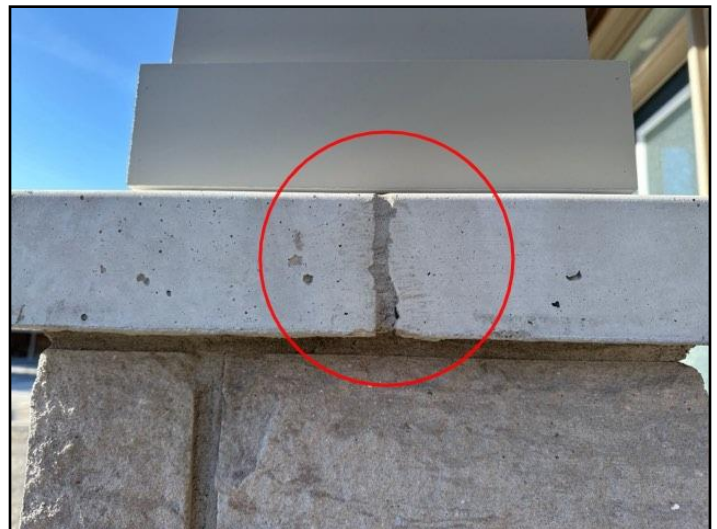
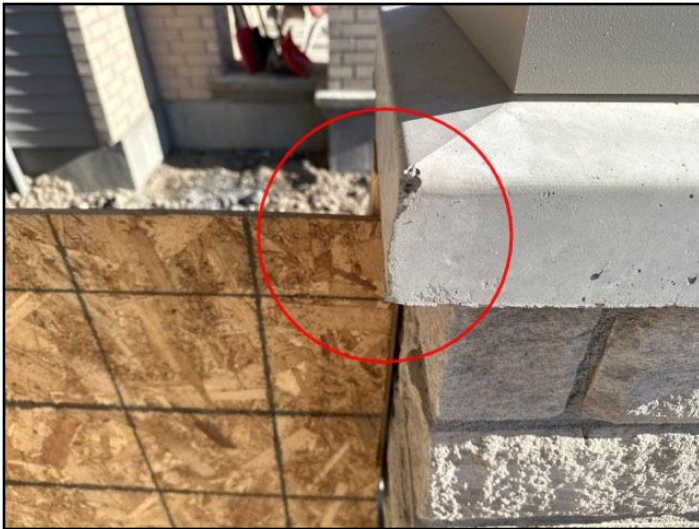
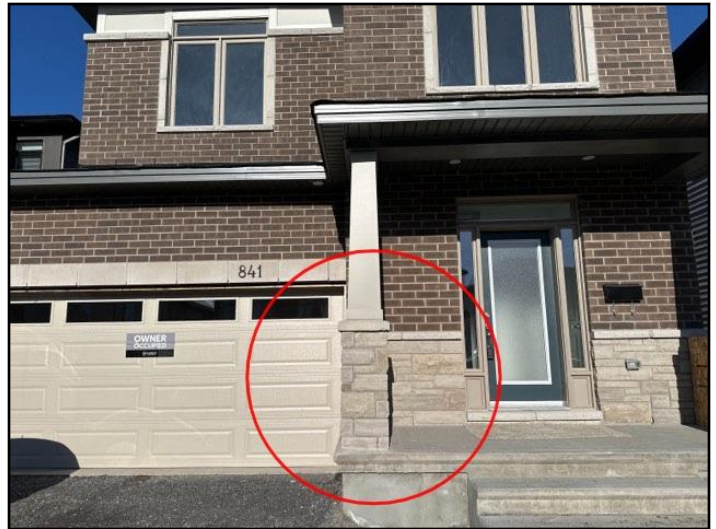
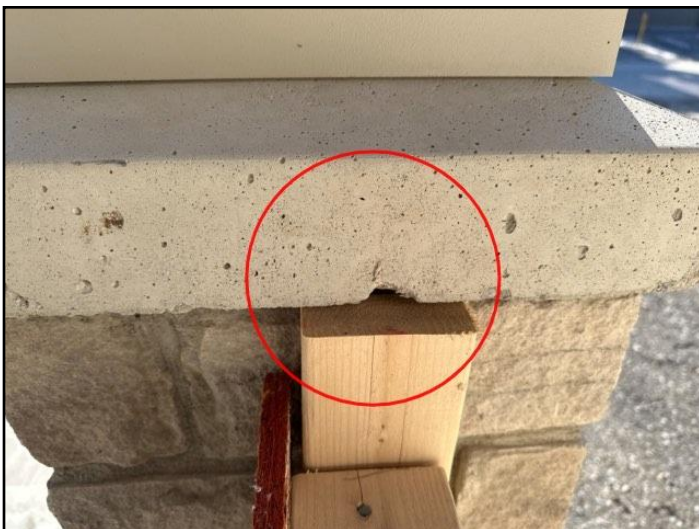
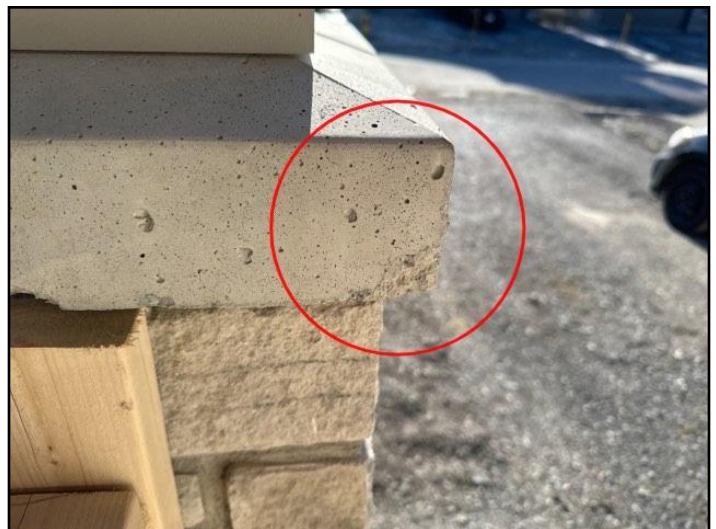
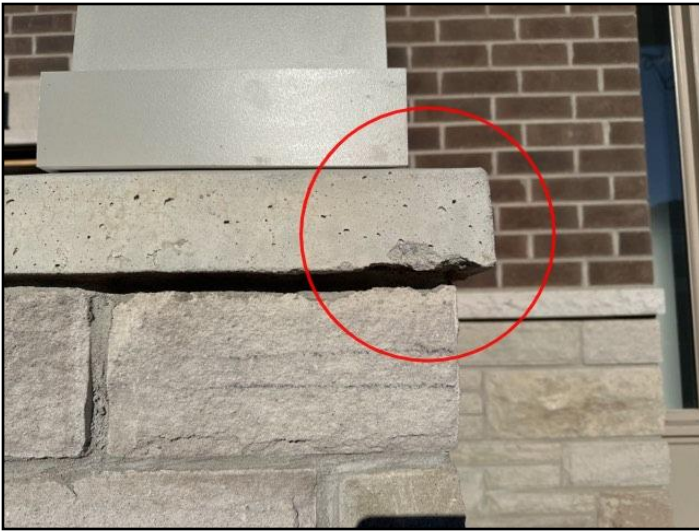
21. **Condition:** • Chipped

51. Chipped

Repair the chipped concrete caps on the front porch columns.

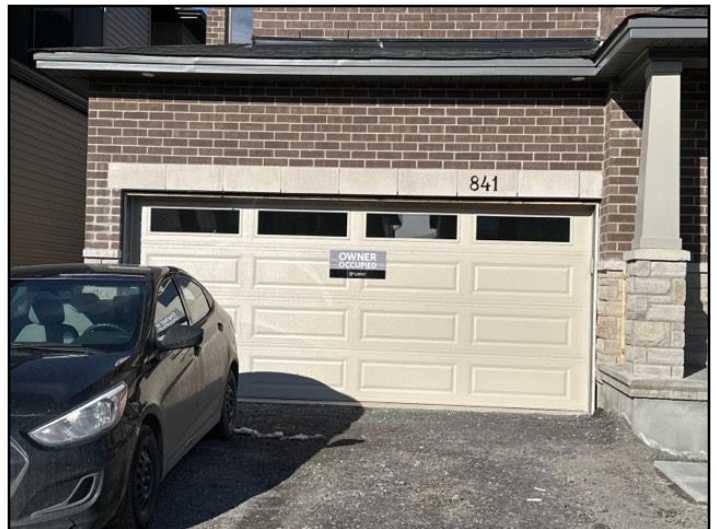
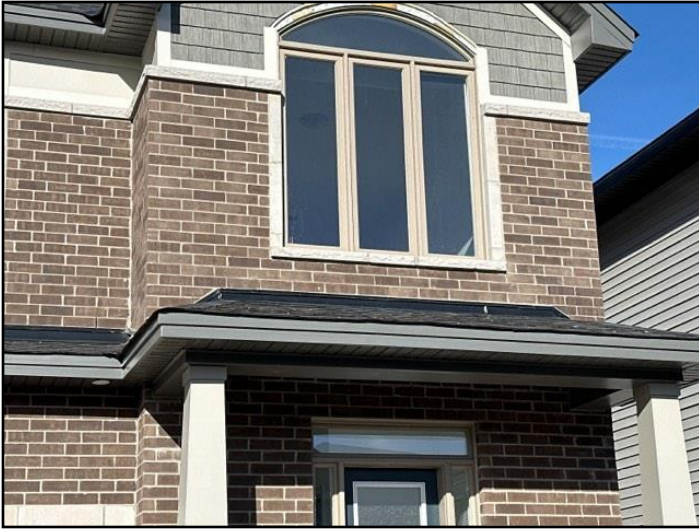
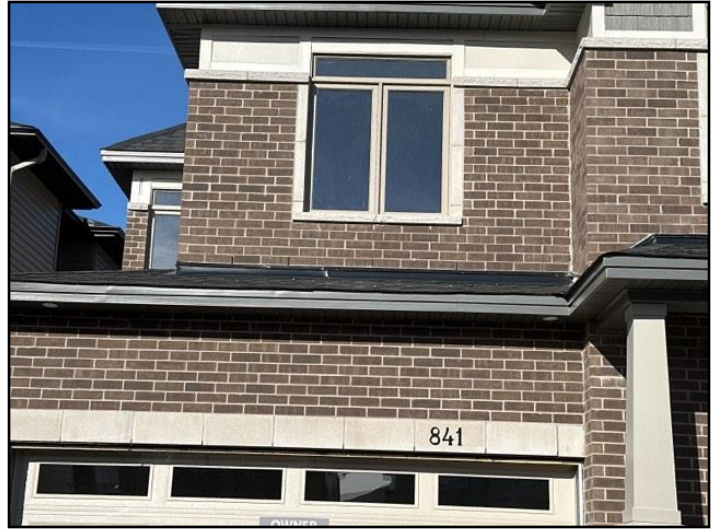
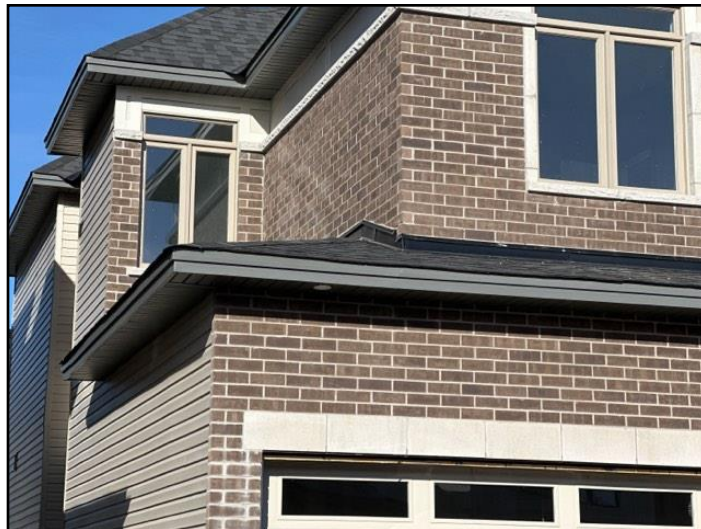
22. Condition: • Debris on brick

60. Debris on brick

61. Debris on brick

62. Debris on brick

63. Debris on brick

Repair the mortar splatter on the brick veneer walls on the south and west faces of the house that are visible from 6 meters away in natural light.

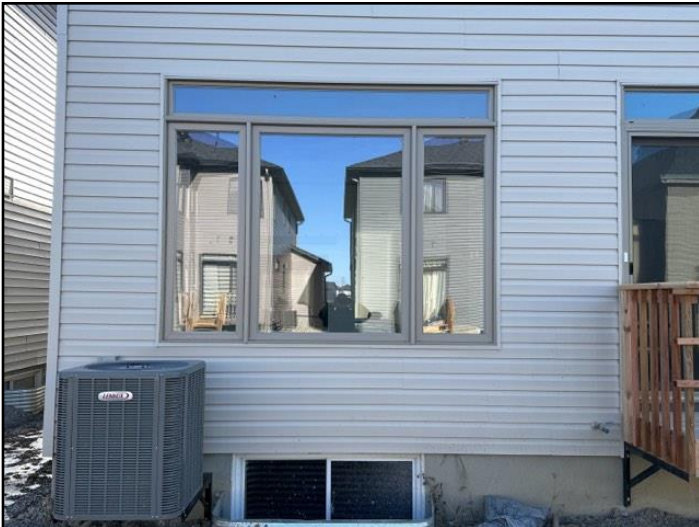
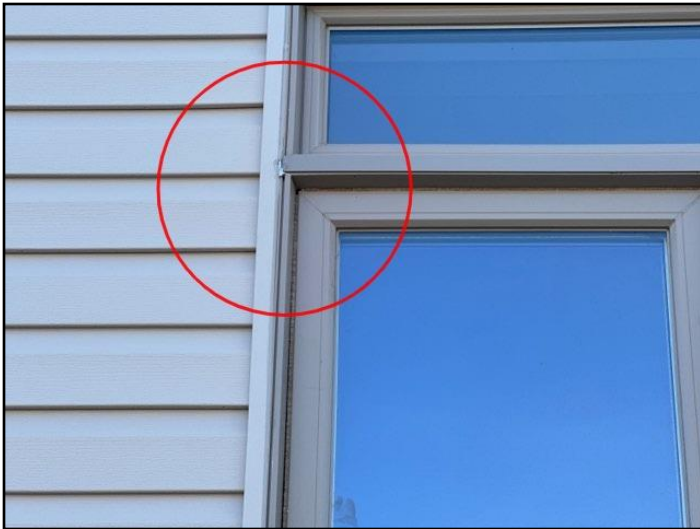
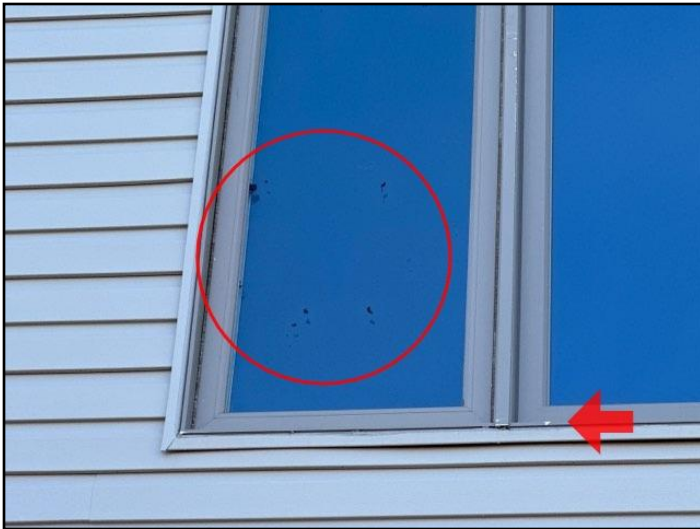
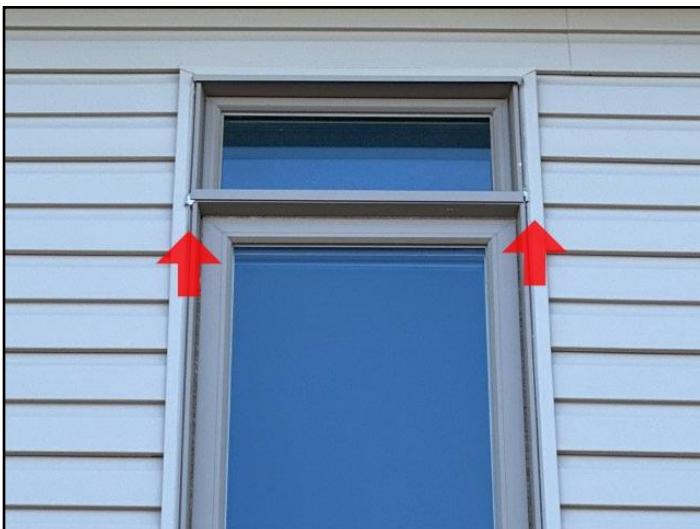
25. Condition: • Damage

72. Damage

74. Damage

76. Damage

78. Damage

80. Damage

Remove the spray foam, adhesive, and protective film from the windows on the north side of the house. Repair the scratches in the windows and frames.

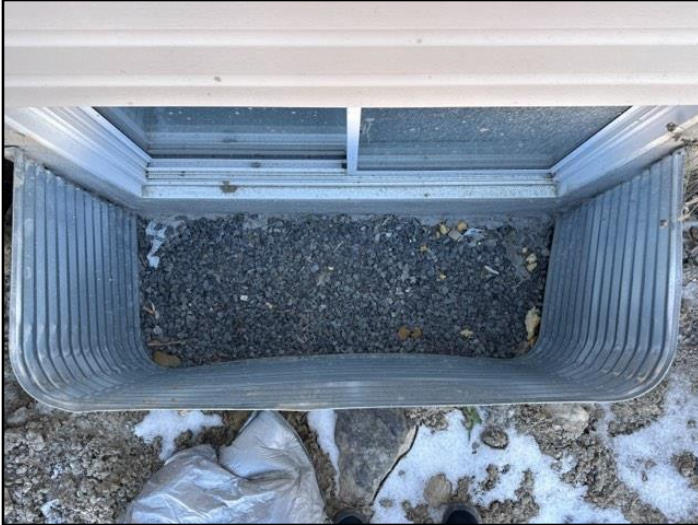
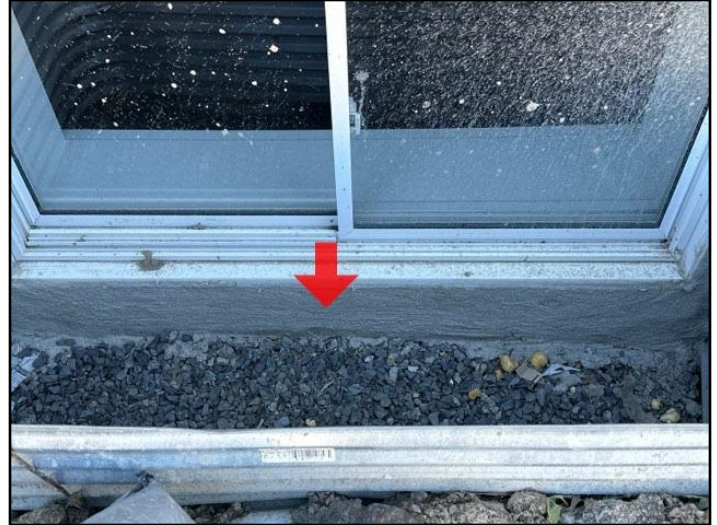
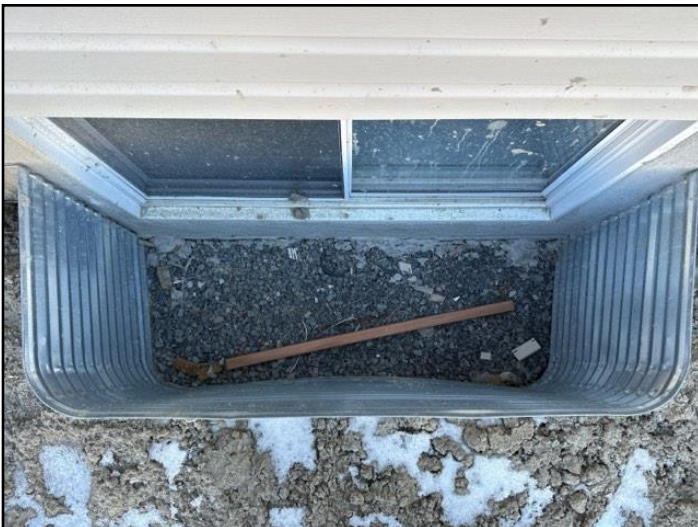
27. Condition: • Remove all debris from window well.

84. Remove all debris from window well.

85. Remove all debris from window well.

86. Remove all debris from window well.

Remove the construction debris from the window wells. Ensure the window well drains are not blocked and drain freely. Provide the missing gravel in the wells and ensure the foundation membrane is fully covered.

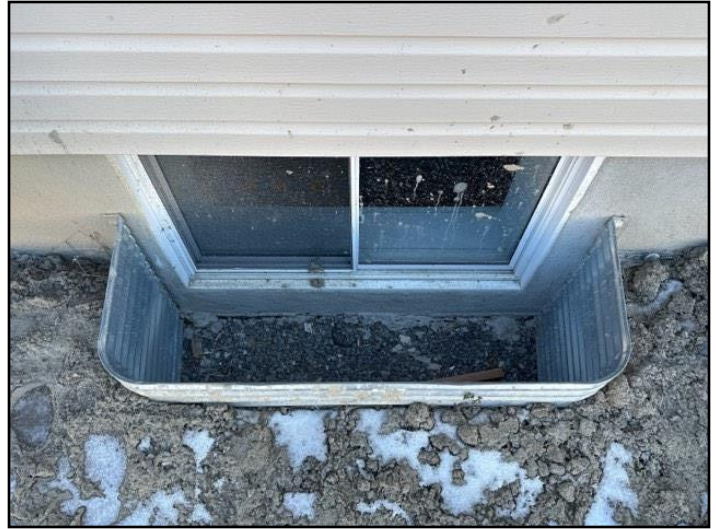
28. Condition: • Clean window well

88. Clean window well

89. Clean window well

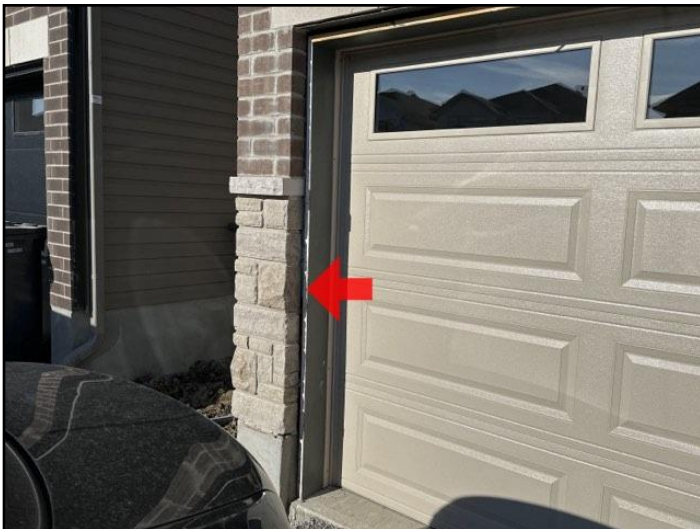
30. Condition: • [Missing](#)

Implication(s): Chance of damage to finishes and structure

98. Missing

Install the trim around the garage door frame. Cover the hole between the bottom east corner of the garage door frame and the foundation.

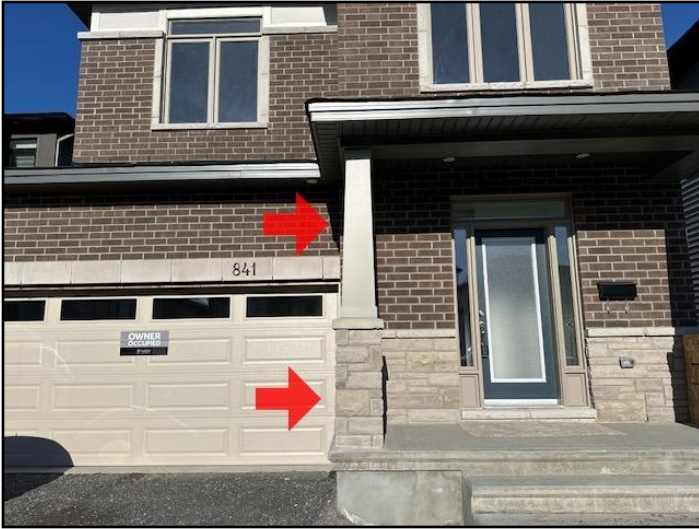
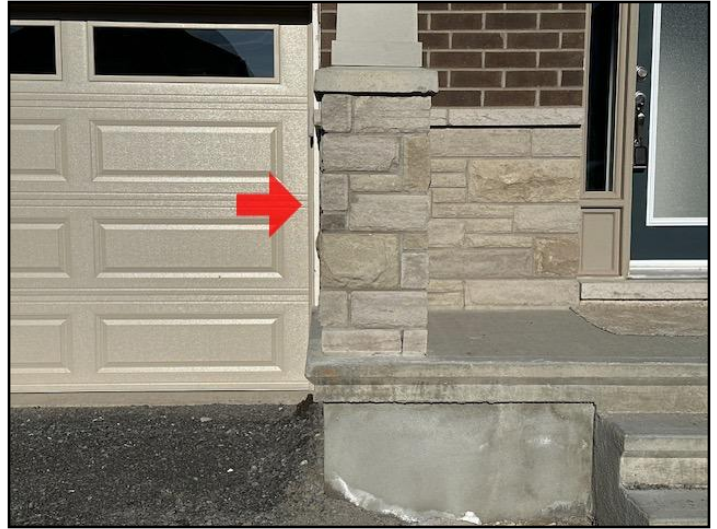
31. Condition: • [Leaning](#)

101. Leaning

102. Leaning

Repair the column at the southwest corner of the front porch installed out of plumb.

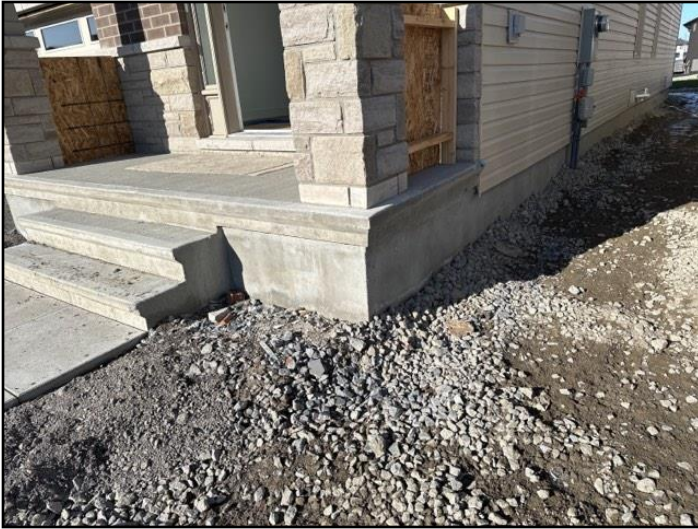
33. Condition: • [Missing](#)

Implication(s): Fall hazard

106. Missing

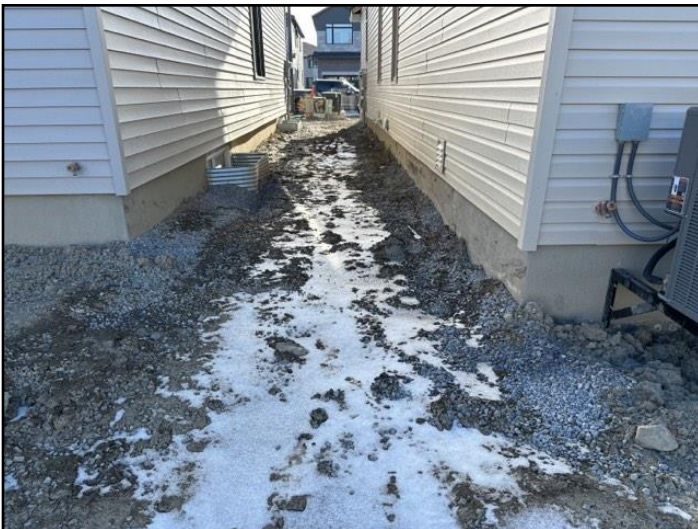
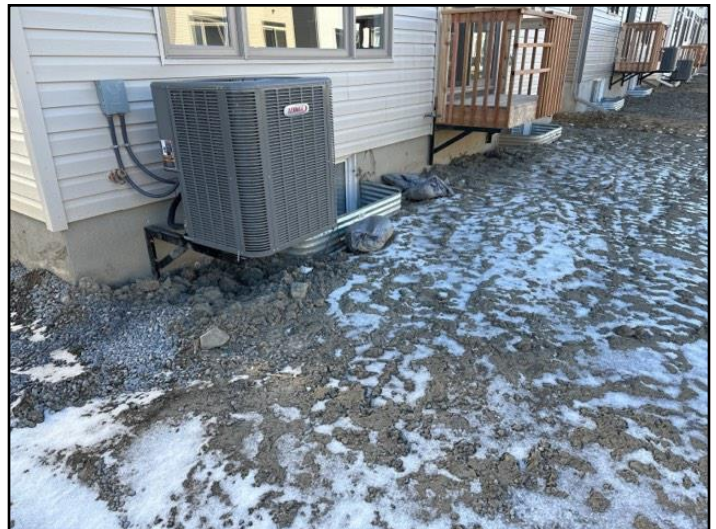
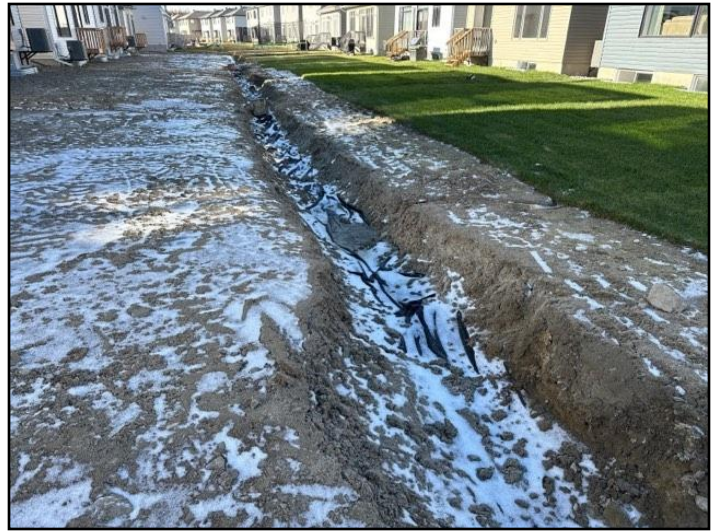
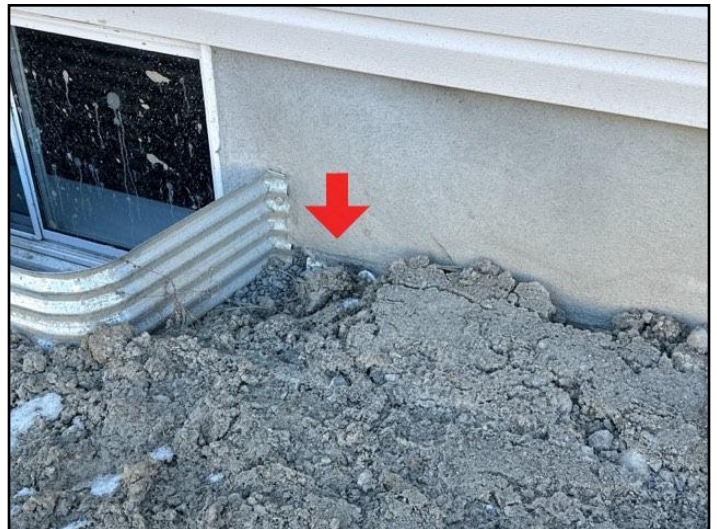
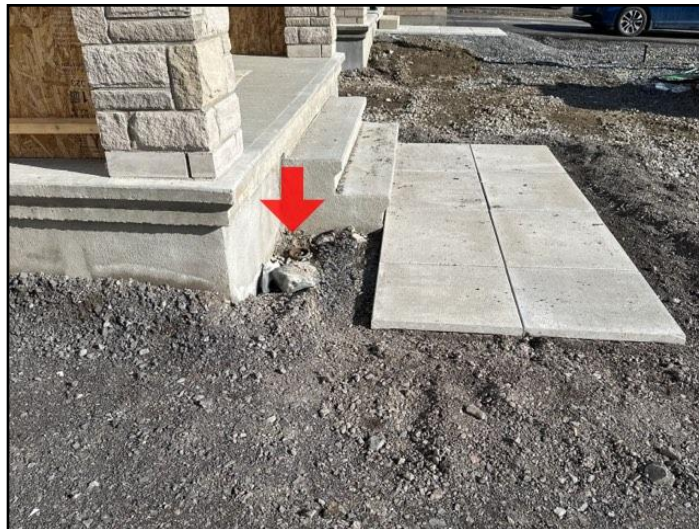
34. Condition: • Landscaping incomplete

108. Landscaping incomplete

109. Landscaping incomplete

110. Landscaping incomplete

111. Landscaping incomplete

112. Landscaping incomplete

113. Landscaping incomplete

114. Landscaping incomplete

115. Landscaping incomplete

116. Landscaping incomplete

Remove the construction debris from around the house. Complete the grading around the house ensuring the ground slopes away from the house, and the foundation membrane is covered.

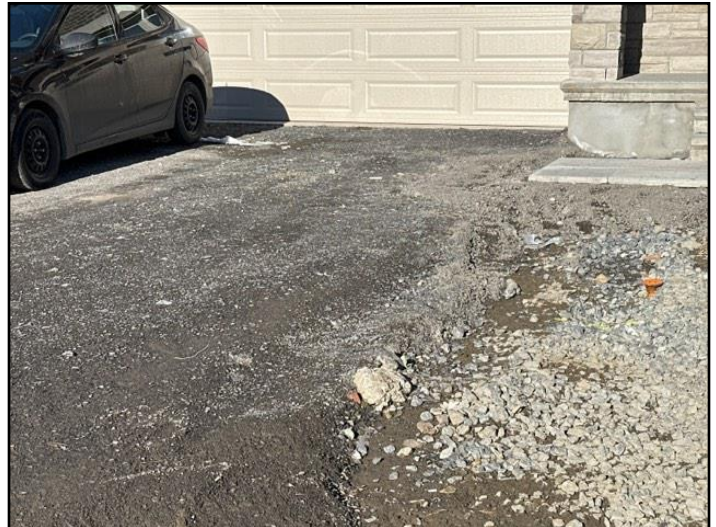
36. Condition: • Complete driveway

118. Complete driveway

119. Complete driveway

120. Complete driveway

121. Complete driveway

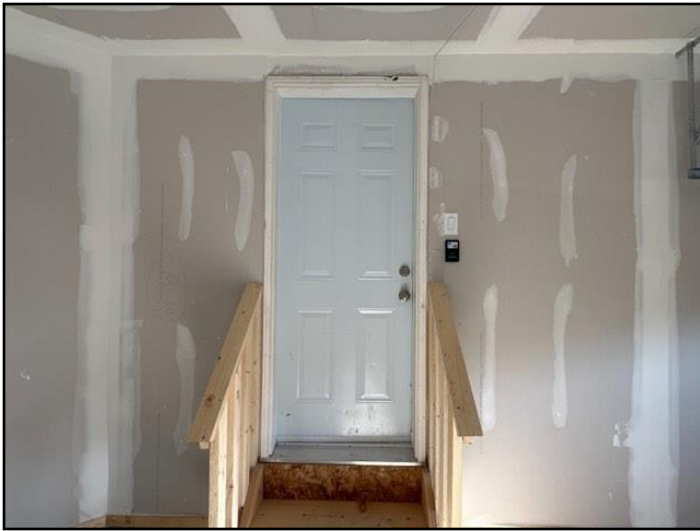
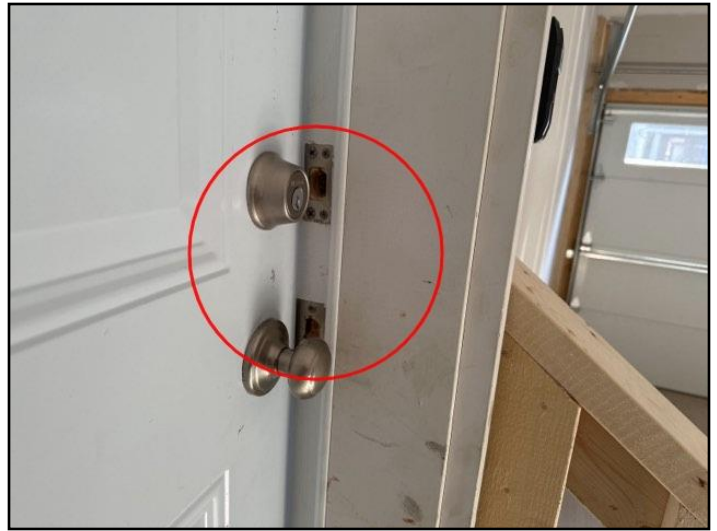
39. Condition: • [Does not close fully](#)

Implication(s): Hazardous combustion products entering home

127. Does not close fully

128. Does not close fully

Task: Repair

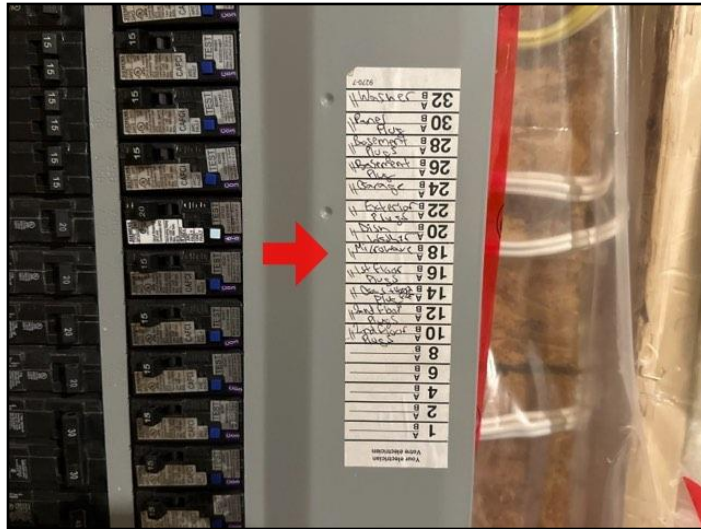
42. Condition: • Circuit labelling

131. Circuit labelling

132. Circuit labelling

133. Circuit labelling

Repair the circuit labels that have been installed upside down and do not align with the breakers.

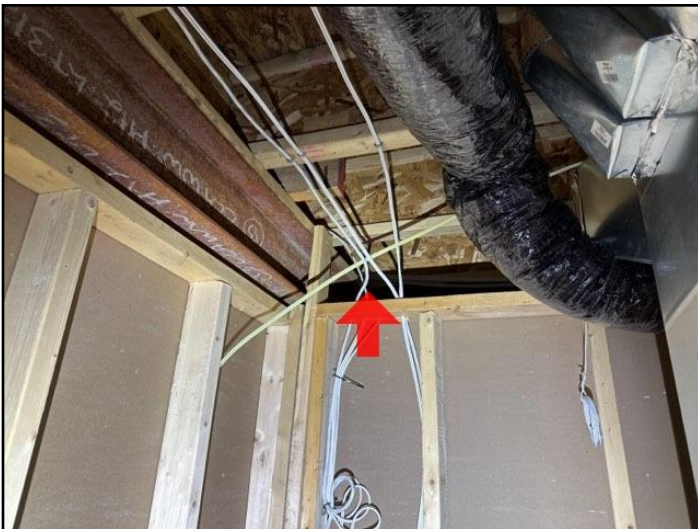
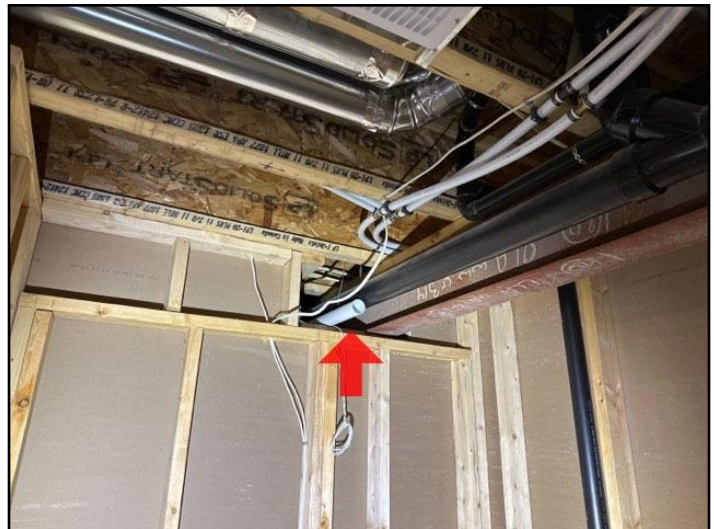
43. Condition: • [Not well secured](#)

Implication(s): Fire hazard | Electric shock

134. Not well secured

135. Not well secured

Secure the loose and hanging wires on the ceiling of the basement furnace room.

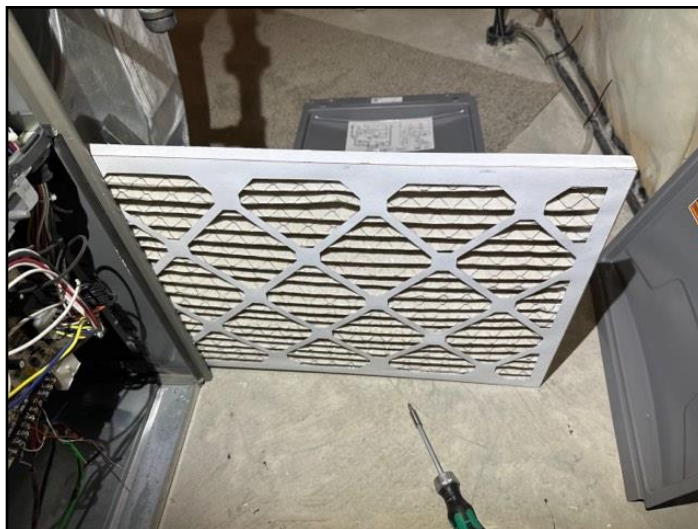
44. Condition: • [Dirty](#)

139. Dirty

Task: Replace

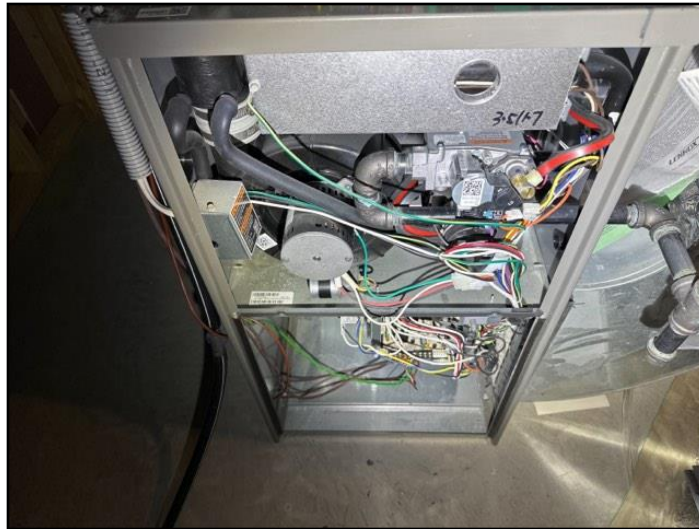
45. Condition: • Service Furnace

140. Service Furnace

Task: Service

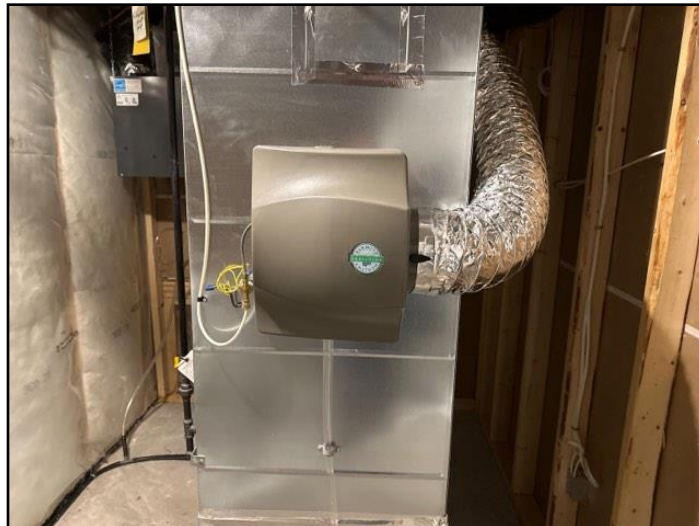
46. Condition: • [Dirty](#)

141. Dirty

The humidifier should be used when the furnace is operating. The humidifier filter should be changed in the spring after seasonal use.
