YOUR INSPECTION REPORT

1 INSPECTION WAY
Kanata, ON

Saturday, November 25, 2023

Report No. 3559, v.2

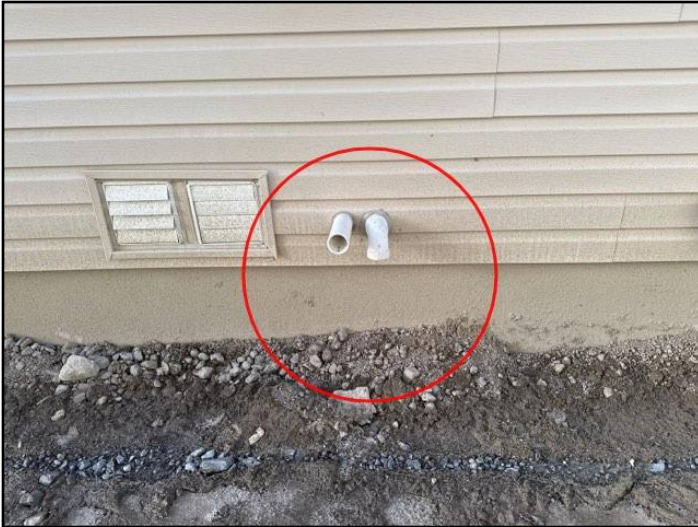
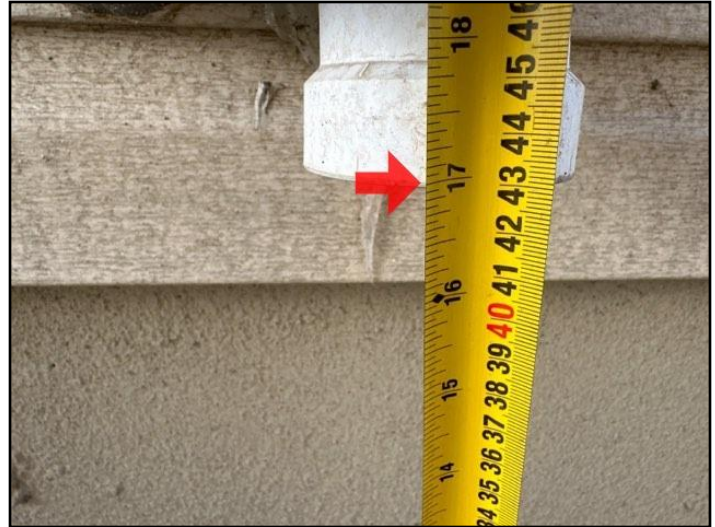
47. Condition: • Clearance to grade

142. Clearance to grade

143. Clearance to grade

144. Clearance to grade

145. Clearance to grade

Task: Repair

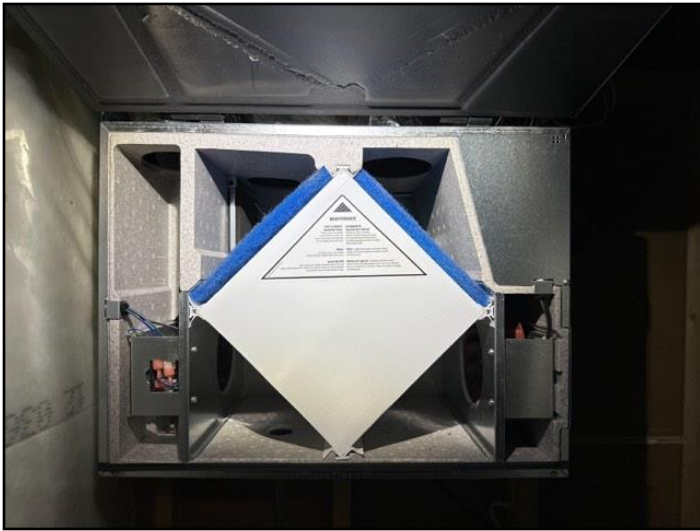
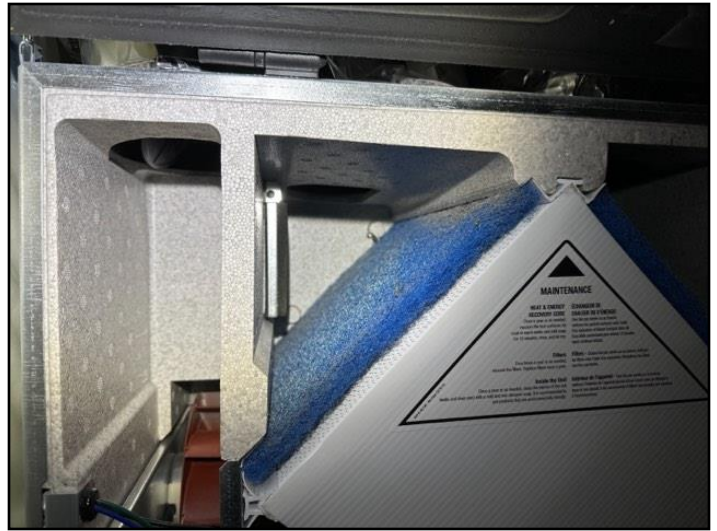
48. Condition: • Dirt in cabinet

146. *Dirt in cabinet*

147. *Dirt in cabinet*

148. *Dirt in cabinet*

Task: Clean

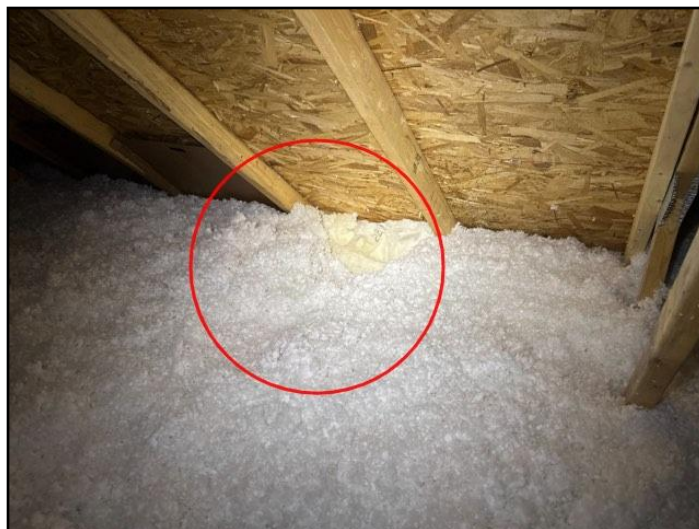
50. Condition: • [Gaps or voids](#)

151. Gaps or voids

Repair the low insulation on the west side of the attic where the birds were entering due to the lack of an exterior soffit.

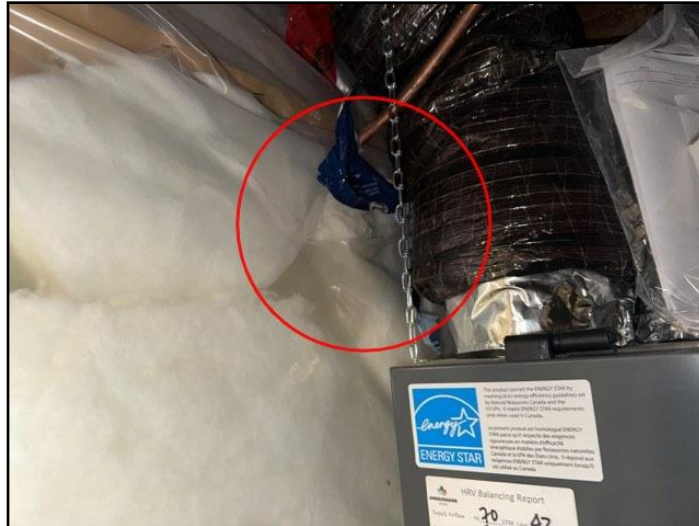
51. Condition: • [Loose, sagging or voids](#)

152. *Loose, sagging or voids*

Repair the hole in the vapour barrier on the east wall of the furnace room beside the HRV unit.

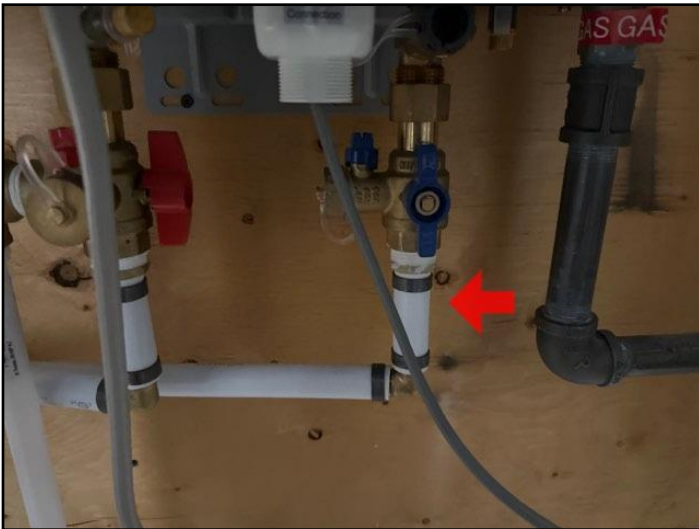
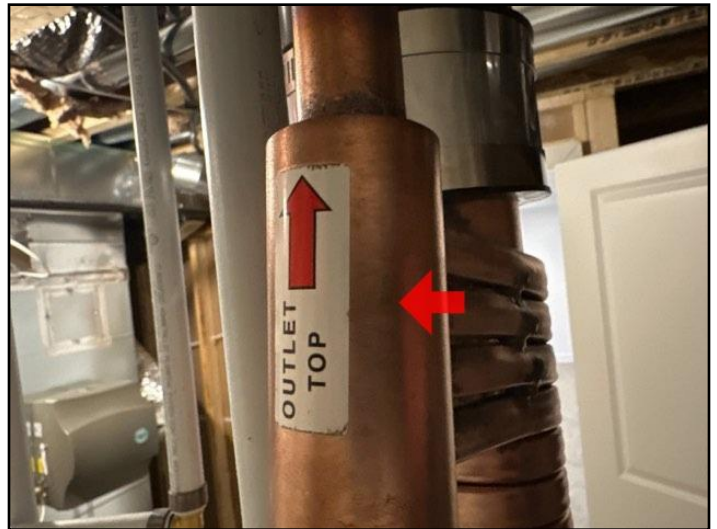
55. Condition: • [Cross connections](#)

161. Cross connections

162. Cross connections

163. Cross connections

164. Cross connections

Repair the water supply lines to the plumbing stack heat exchanger. The inlet line goes to the cold water supply to the water heater, and the outlet connects to the house's cold water lines.

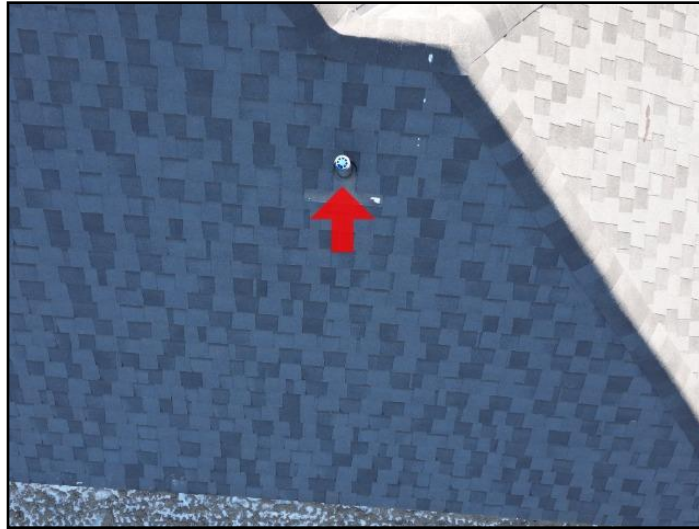
57. Condition: • [Vent termination problems](#)

167. Vent termination problems

Task: Repair

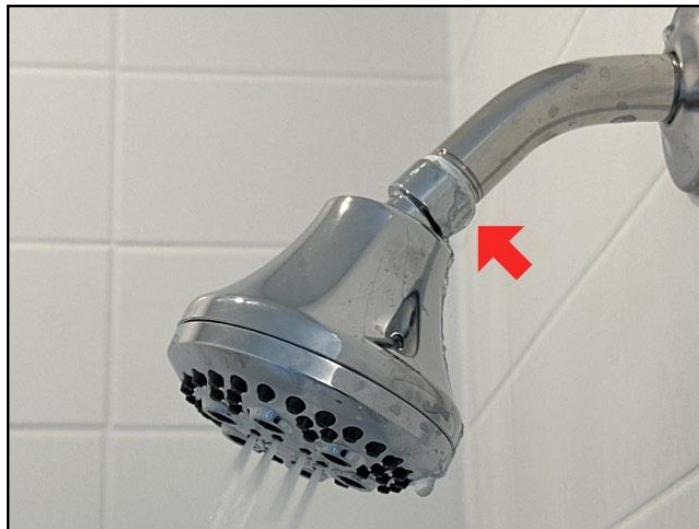
58. **Condition:** • [Drip, leak](#)

Implication(s): Chance of water damage to structure, finishes and contents

168. Drip, leak

Repair the leak from the ensuite bathroom shower stall head.

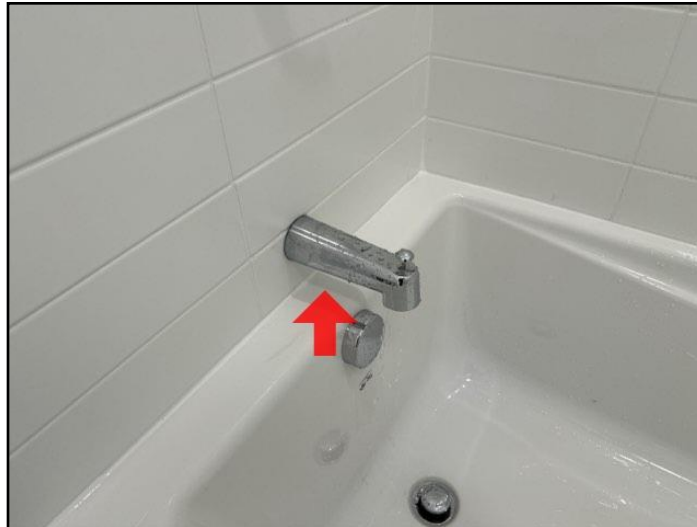
60. Condition: • [Loose](#)

Implication(s): Equipment failure

170. Loose

Repair the loose faucet in the main bathroom room bathtub enclosure.

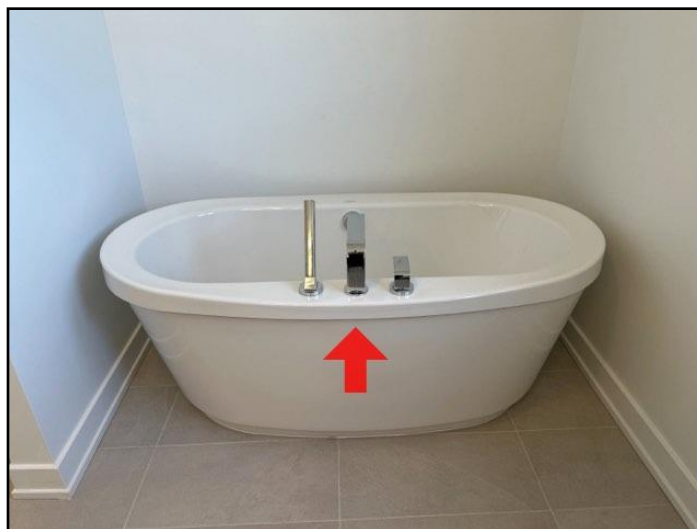
61. Condition: • [Loose or unstable](#)

Implication(s): Chance of water damage to structure, finishes and contents

171. Loose or unstable

Task: Repair

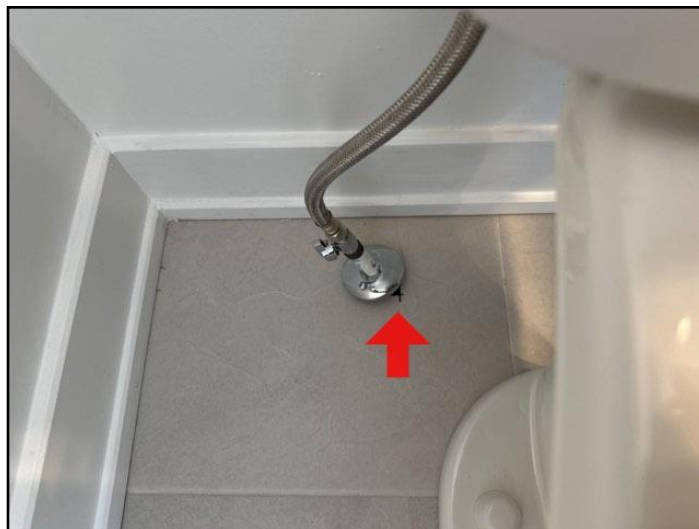
63. Condition: • [Tiles broken](#)

Implication(s): Trip or fall hazard

174. Tiles broken

Repair the hole in the tile below the toilet in the ensuite bathroom that is not covered by the water line flange.

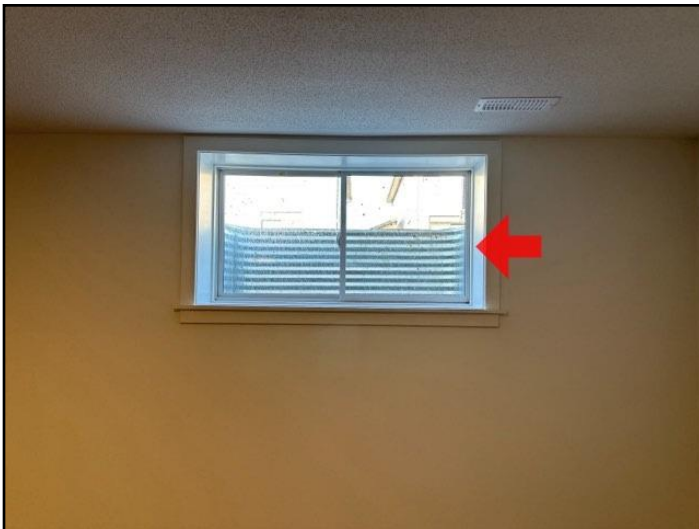
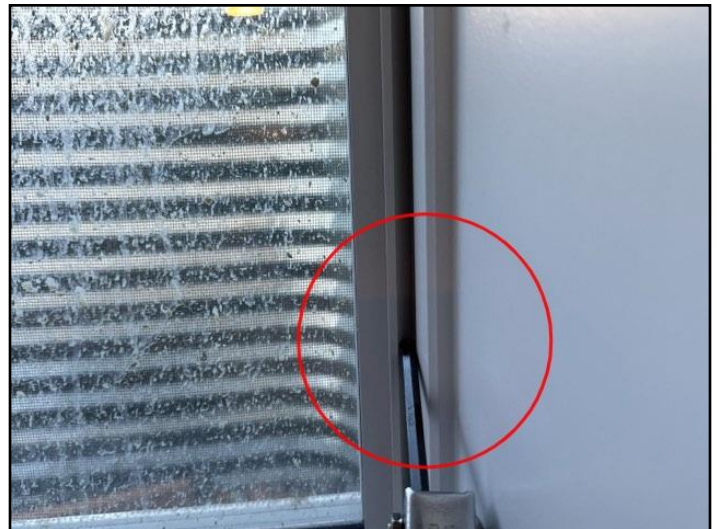
64. Condition: • Difficult to operate

Repair the rear basement family room windows. There is only 6.0 mm of clearance between the window flange and the trim on the west window, and there is only 2.5 mm of clearance between the window flange and the trim on the east window. There is insufficient room to grab the flange and push the window open.

175. Difficult to operate

176. Difficult to operate

Task: Repair

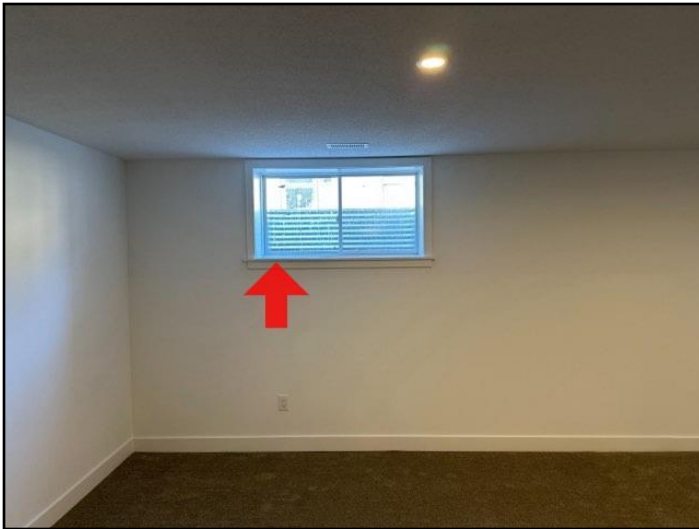
65. Condition: • [Cracked](#)

Replace the cracked glass on the west side of the rear basement window on the west end of the north exterior wall.

179. Cracked

Task: Repair

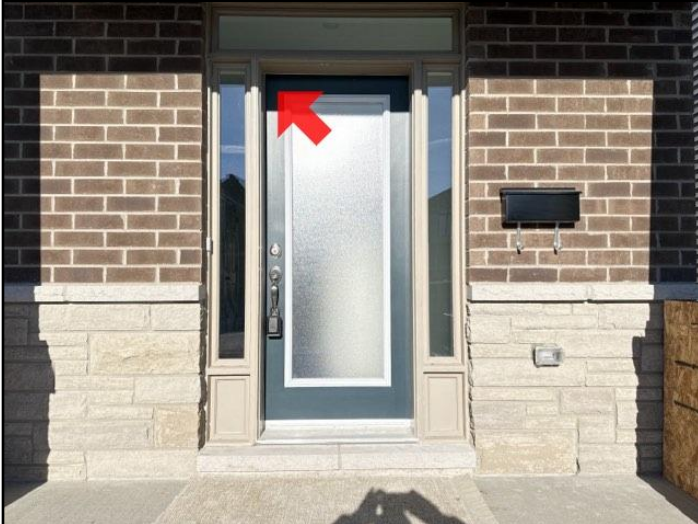
68. Condition: • [Weatherstripping missing or ineffective](#)

Repair the front door that does not seal to the weatherstripping at the top west corner.

186. Weatherstripping missing or ineffective

Task: Repair

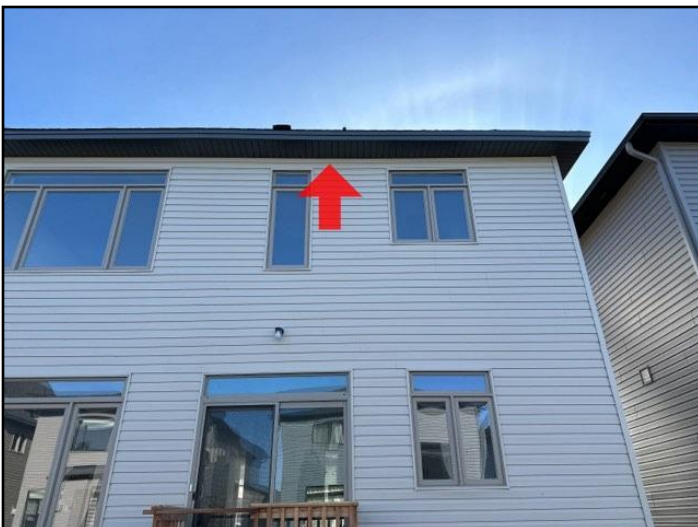
69. Condition: • Does not discharge to exterior

Repair the ensuite bathroom exhaust fan that does not vent to the exterior of the house.

Implication(s): Chance of condensation damage to finishes and/or structure | Poor ventilation can cause condensation.

188. Does not discharge to exterior

Task: Repair

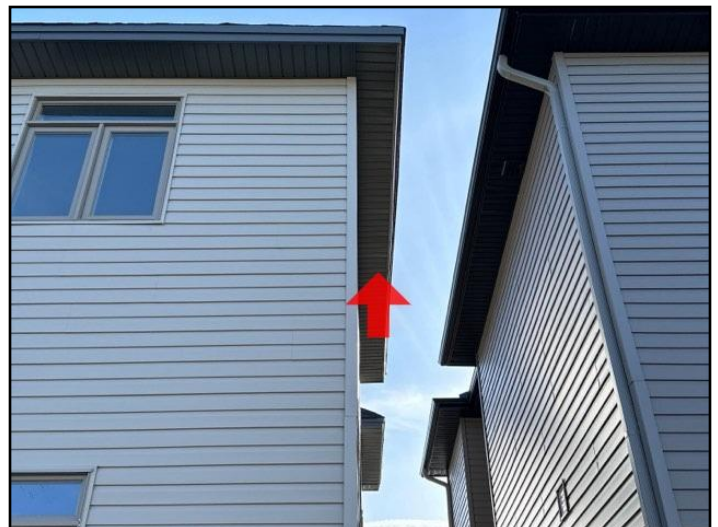
189. Does not discharge to exterior

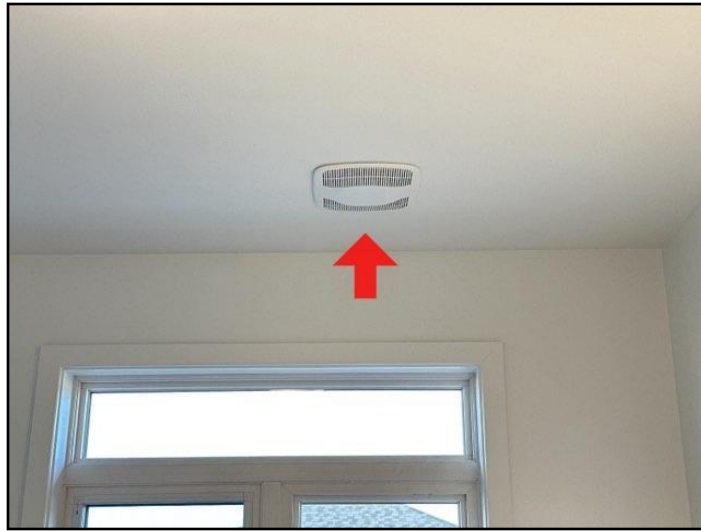
190. Does not discharge to exterior

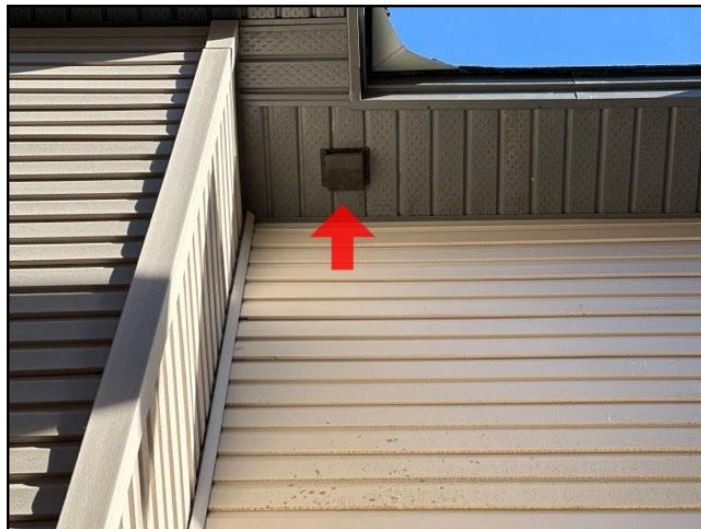
70. Condition: • Clean dryer vent
The dryer vent needs to be cleaned regularly.
Location: West Second Floor Soffit
Task: Clean
Time: Regular maintenance

191. Clean dryer vent
