# YOUR INSPECTION REPORT

1 INSPECTION WAY  
Arnprior, ON K7S 1X7

Friday, July 14, 2023

Report No. 3412, v.2

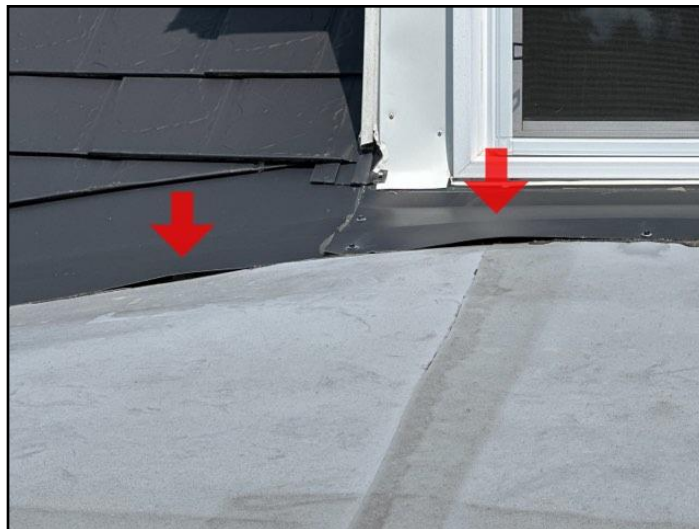
**1. Condition:** • Valley flashing lifting

Repair the lifting valley flashing at the transition between the rear third floor roof and the second floor low slope roof.

1. Valley flashing lifting

**Task:** Repair

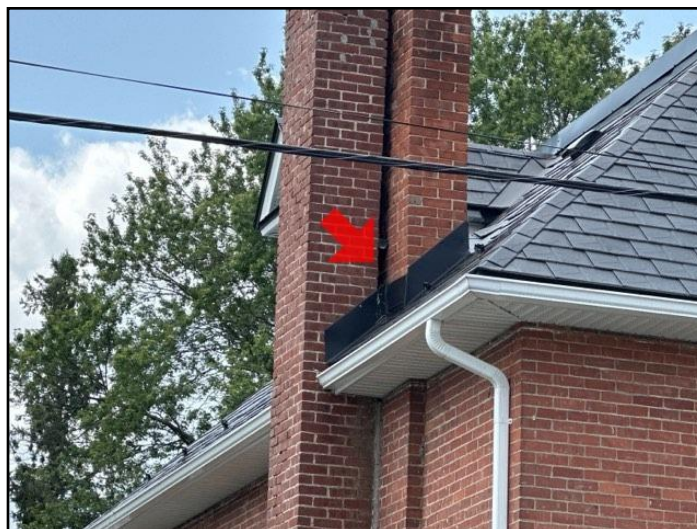
### 2. Condition: • [Not let into mortar joints](#)

2. Not let into mortar joints

**Task:** Repair

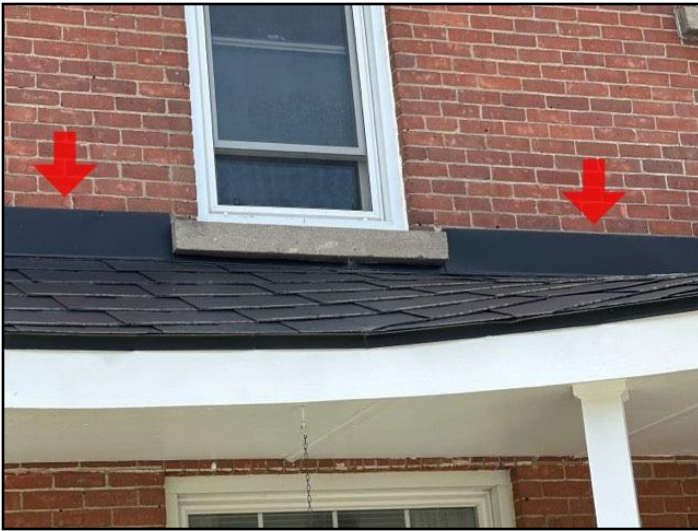
### 3. Condition: • [Not let into mortar joints](#)

5. Not let into mortar joints

**Task:** Repair

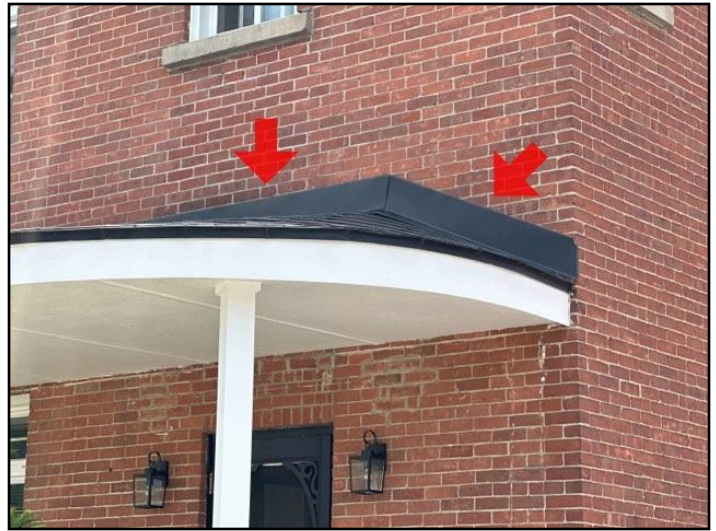
6. Not let into mortar joints

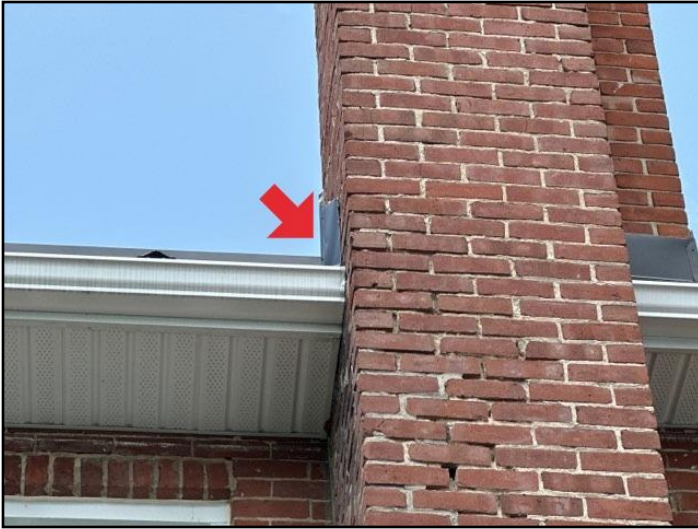
### 4. Condition: • [Kickout flashing - missing](#)

Provide the missing kick-out flashing at the base of wall flashing on the sides of the abandoned boiler chimney.

7. Kickout flashing - missing

**Task:** Provide

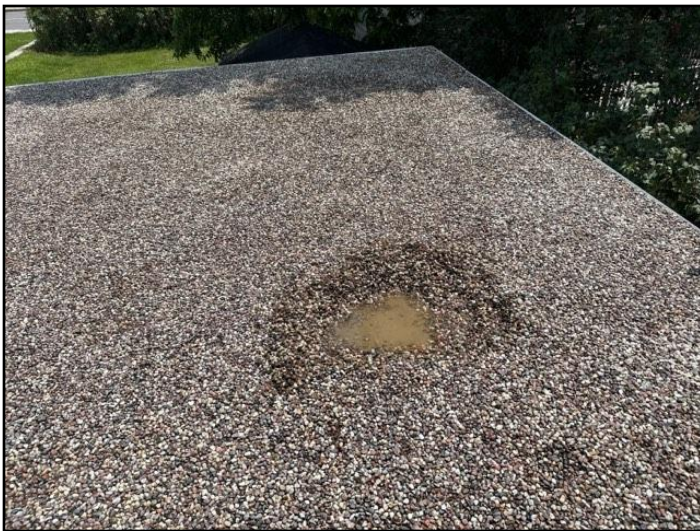
### 5. Condition: • [Ponding](#)

9. Ponding

**Task:** Repair

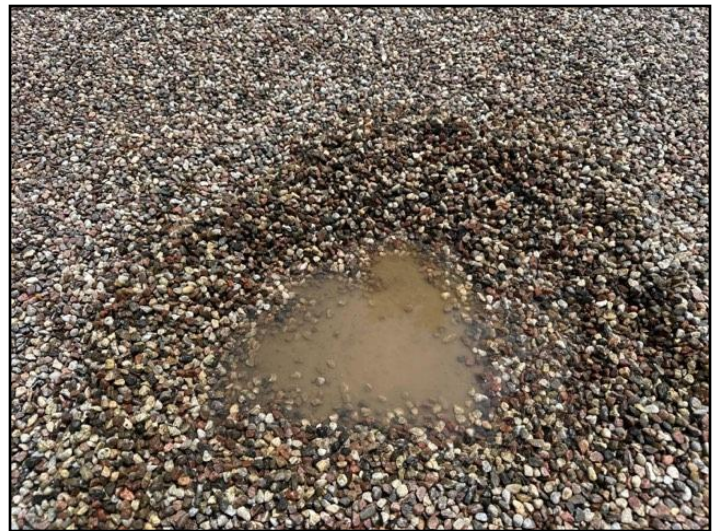
10. Ponding

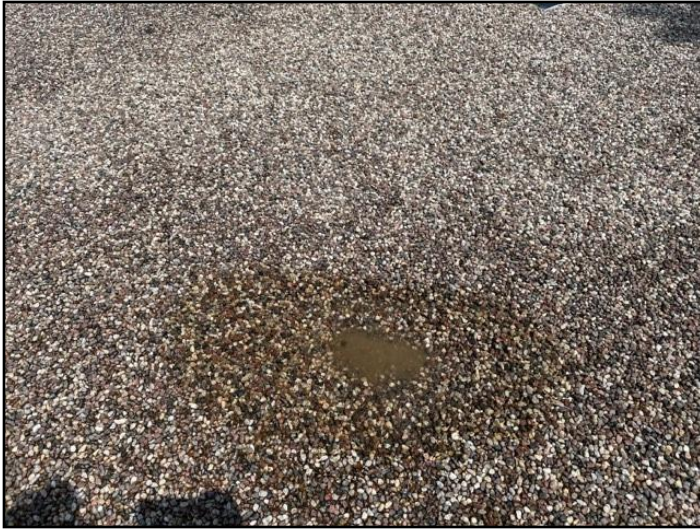
11. *Ponding*

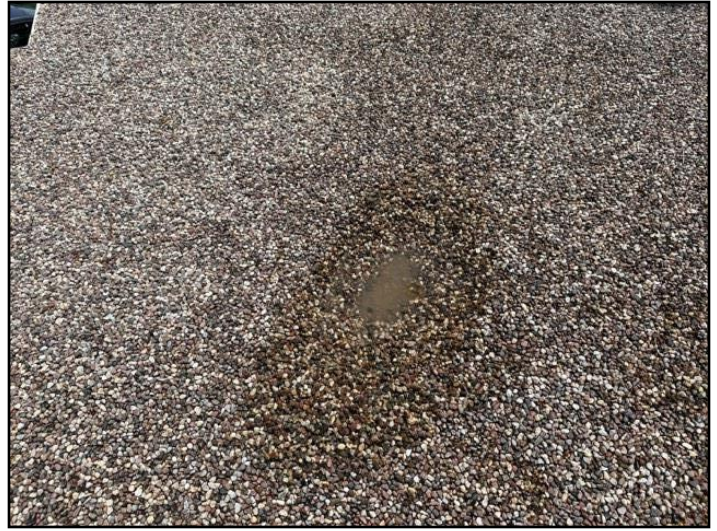
12. *Ponding*

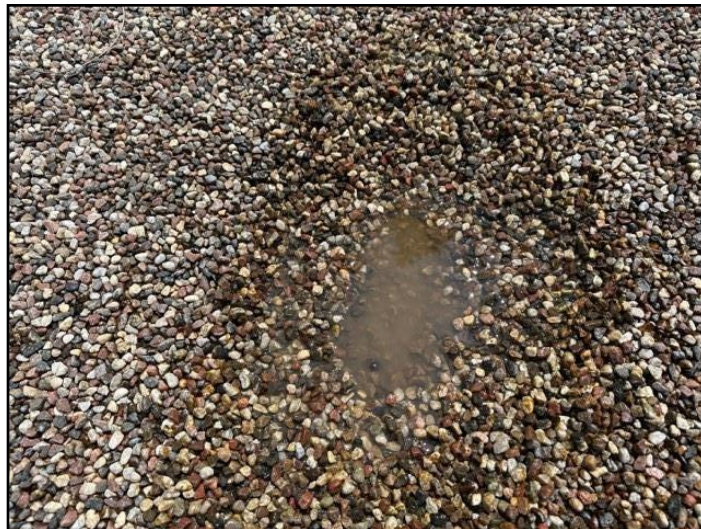
13. *Ponding*

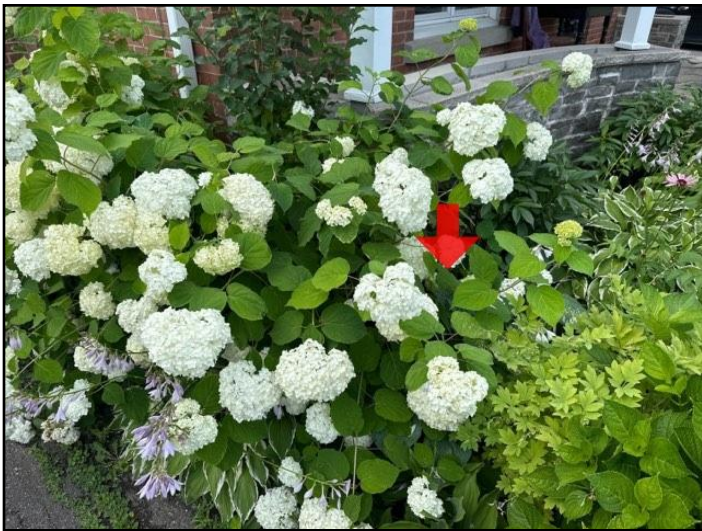
The downspouts should discharge a minimum of 6 feet from the foundation walls of the house and porch. This can be a contributing factor to basement moisture issues.

15. Should discharge 6 feet from building

**Task:** Improve  
**Time:** Before next winter

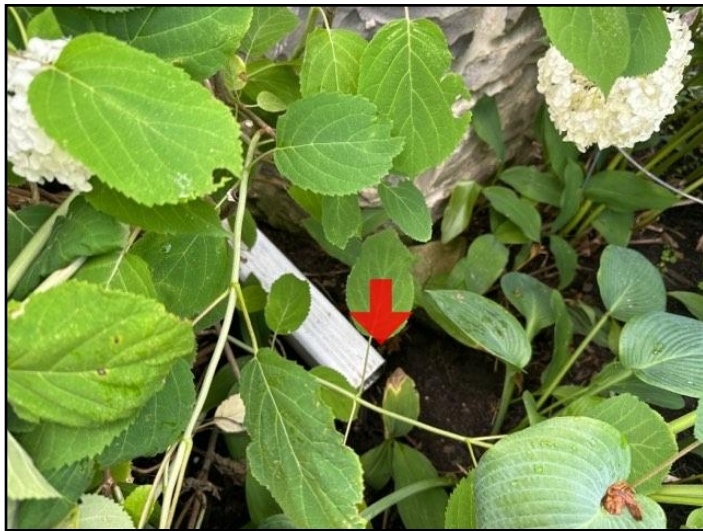
16. Should discharge 6 feet from building

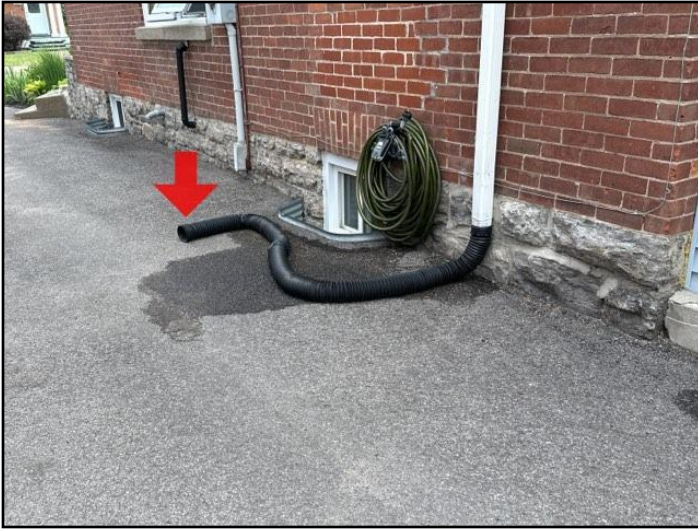
17. Should discharge 6 feet from building

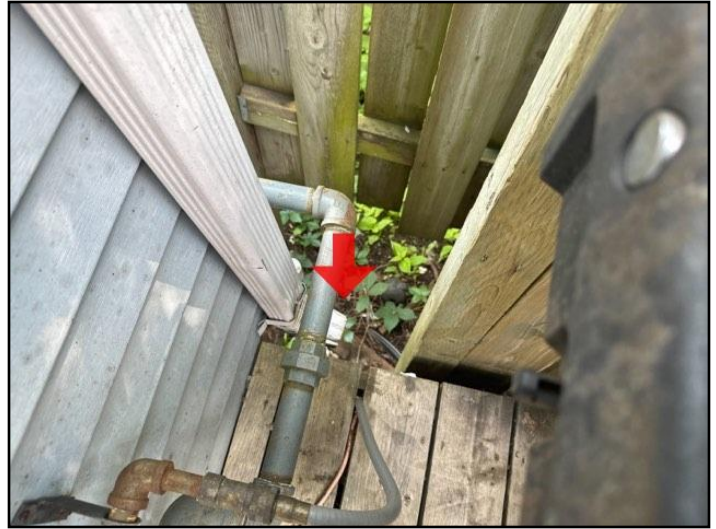
18. Should discharge 6 feet from building

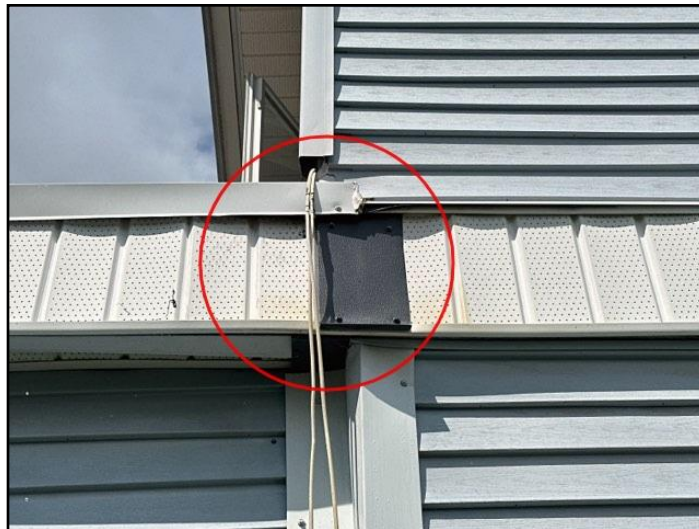
### 8. Condition: • [Loose or missing pieces](#)

19. Loose or missing pieces

**Task:** Repair

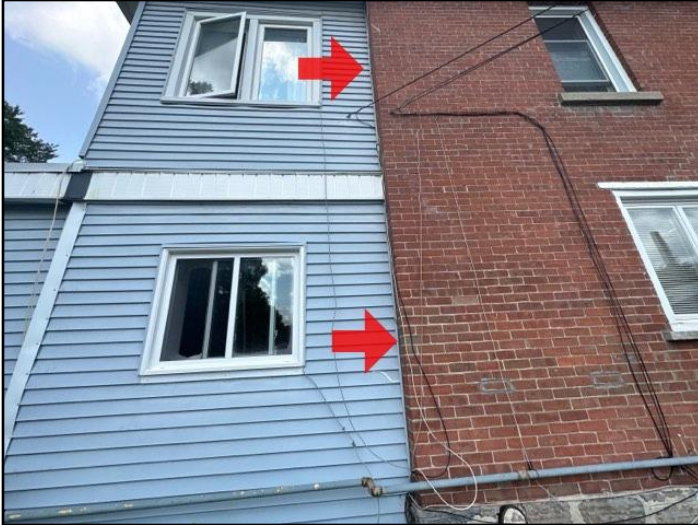
20. Caulking missing or ineffective

**Task:** Provide

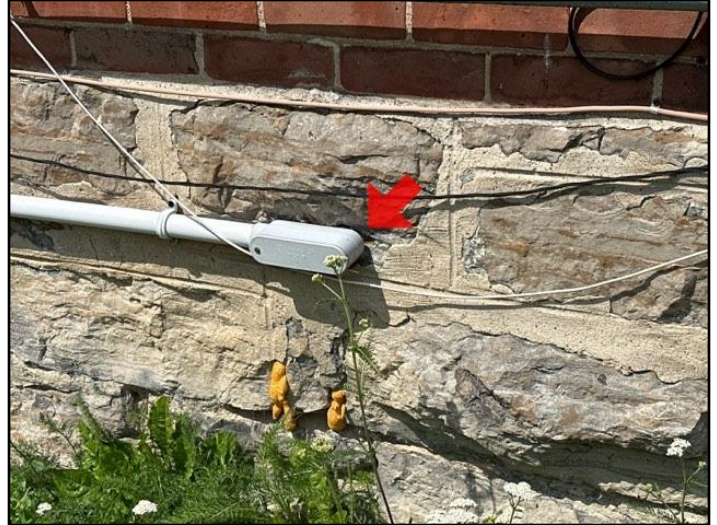
21. Caulking missing or ineffective

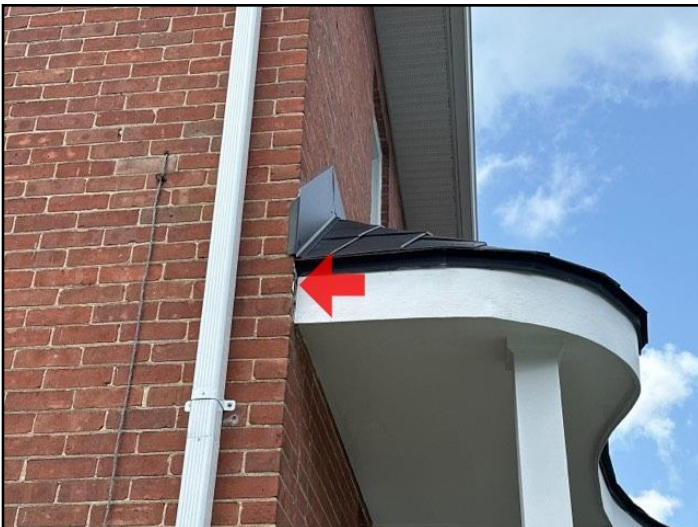
22. Caulking missing or ineffective

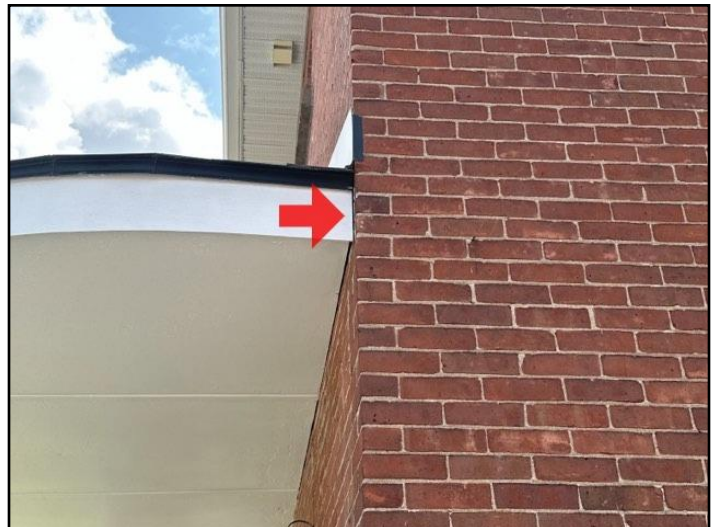
23. Caulking missing or ineffective

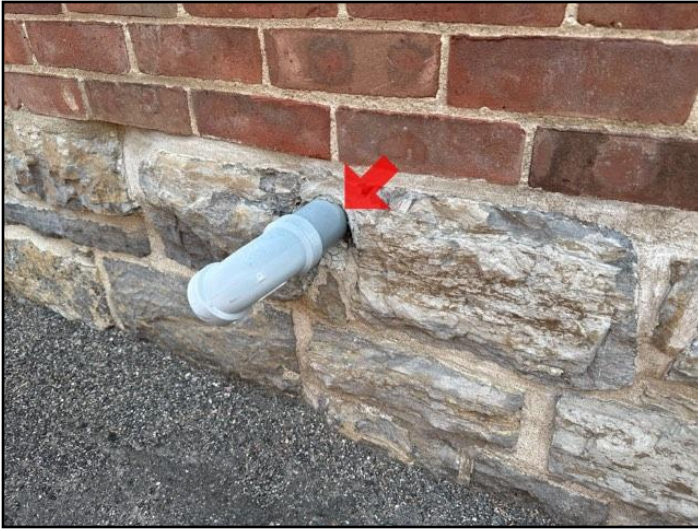
24. Caulking missing or ineffective

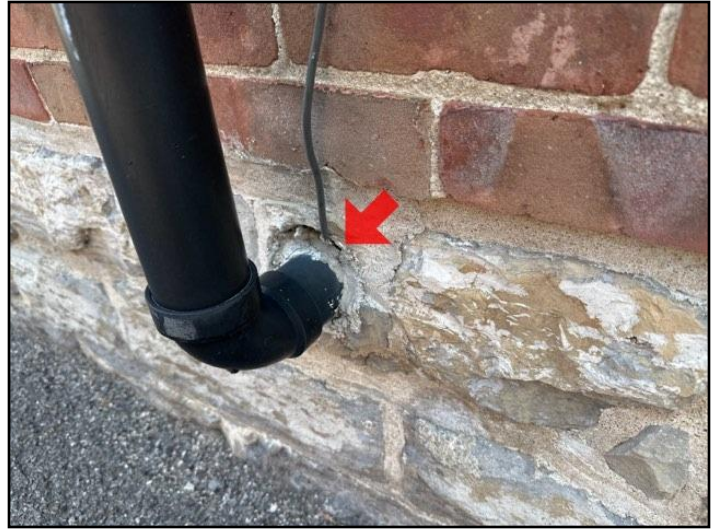
25. Caulking missing or ineffective

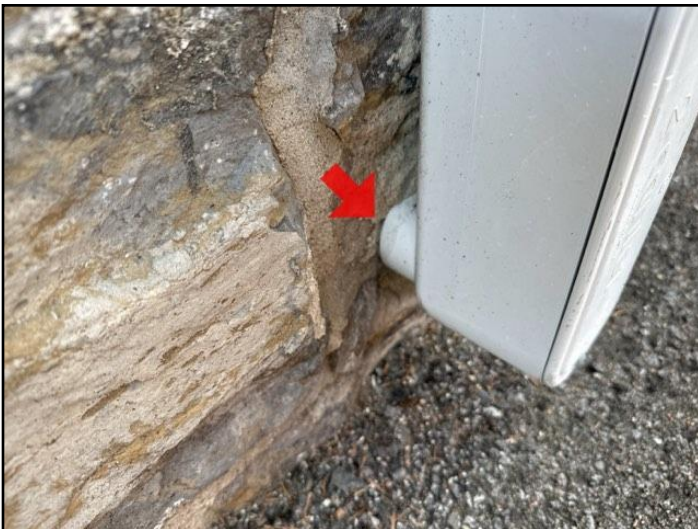
26. Caulking missing or ineffective

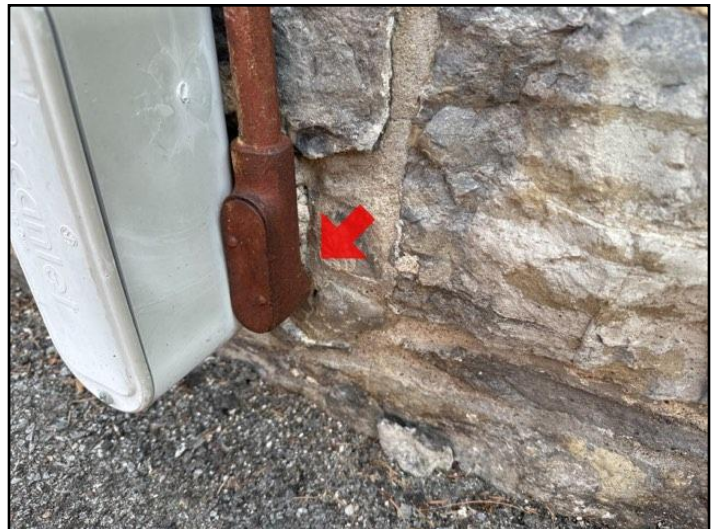
27. Caulking missing or ineffective

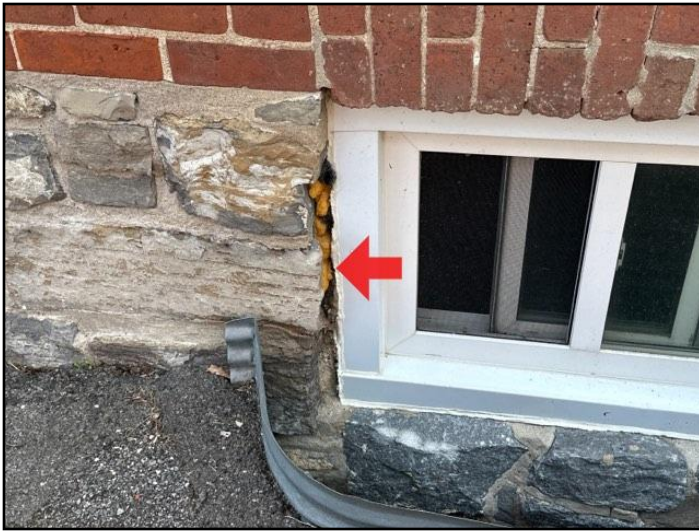
28. Caulking missing or ineffective

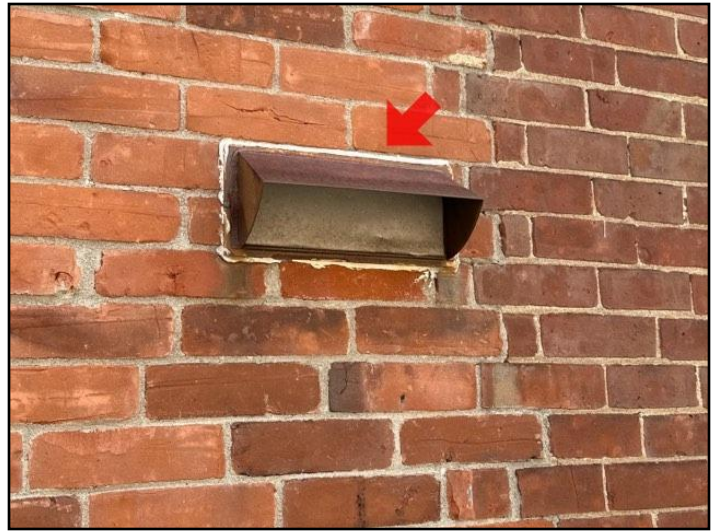
29. Caulking missing or ineffective

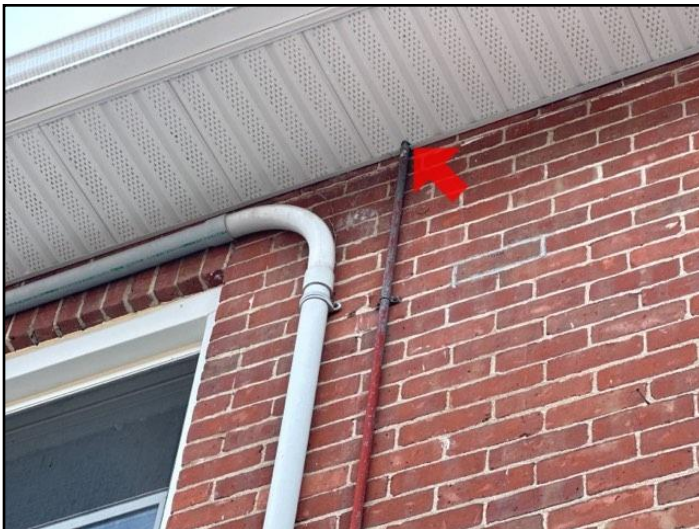
30. Caulking missing or ineffective

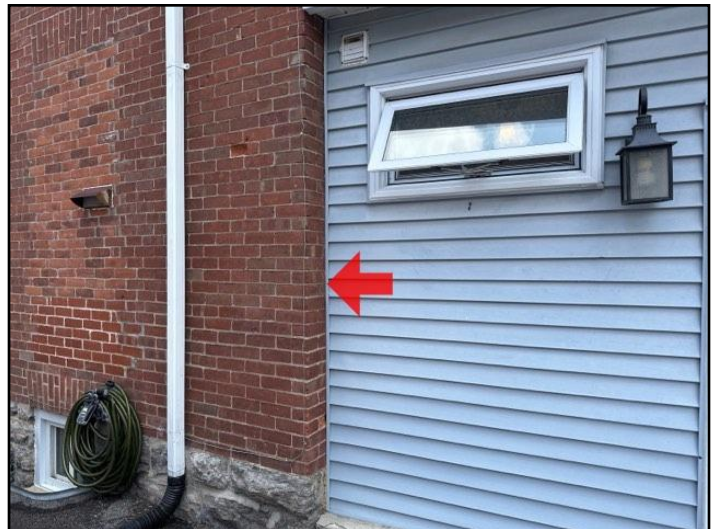
31. Caulking missing or ineffective

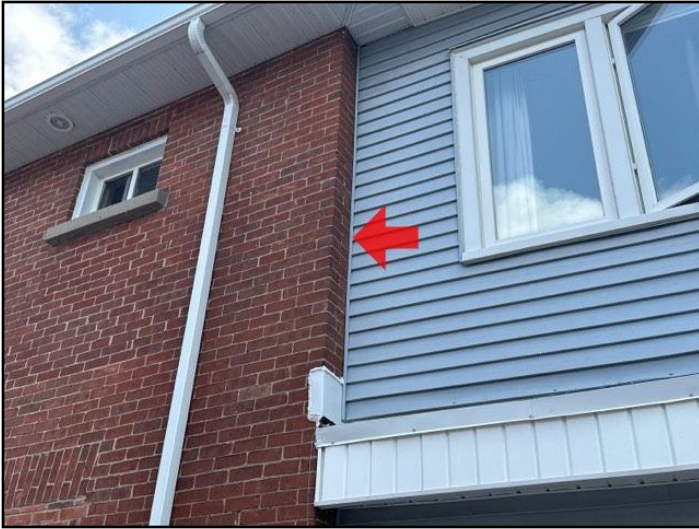
32. Caulking missing or ineffective

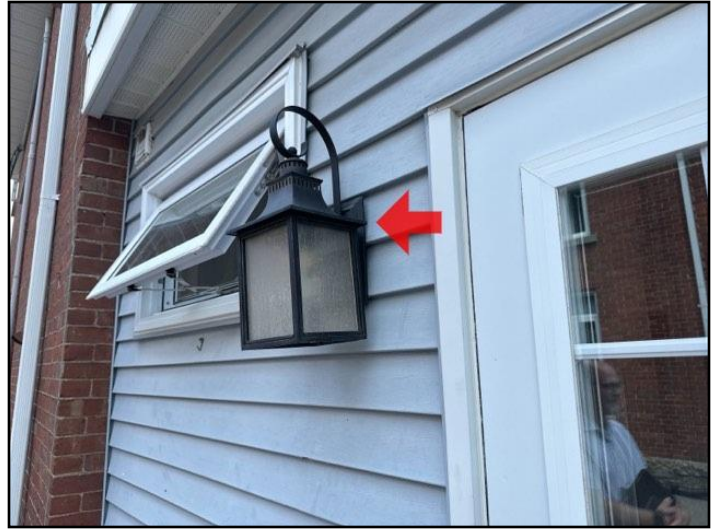
33. Caulking missing or ineffective

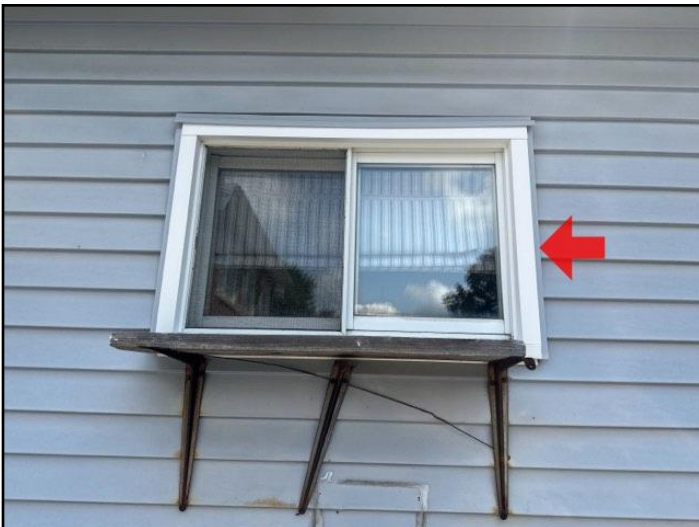
34. Caulking missing or ineffective

Provide the missing caulking on the exterior of the house at the transition between materials.

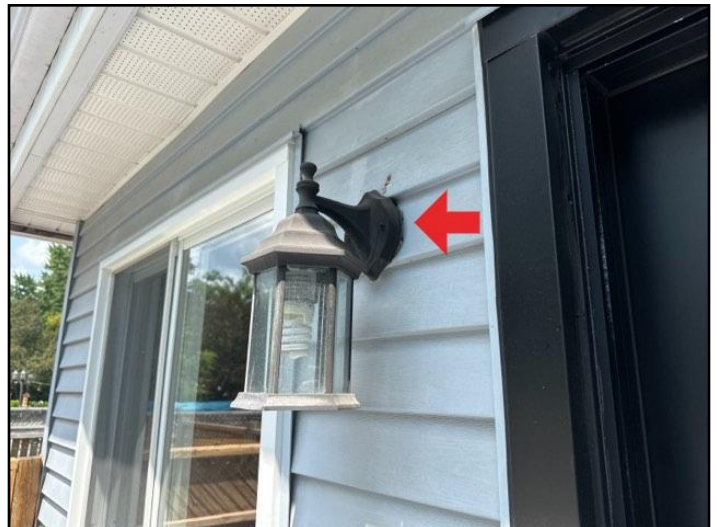
35. Caulking missing or ineffective

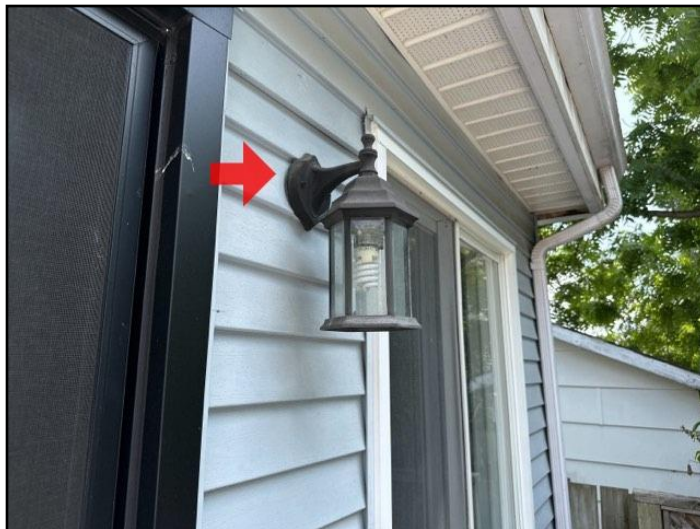
36. Caulking missing or ineffective

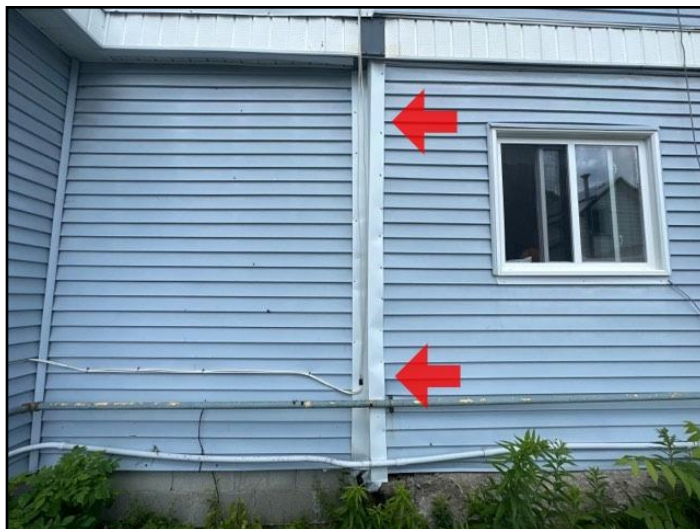
10. Condition: • [Mechanical damage](#)

37. Mechanical damage

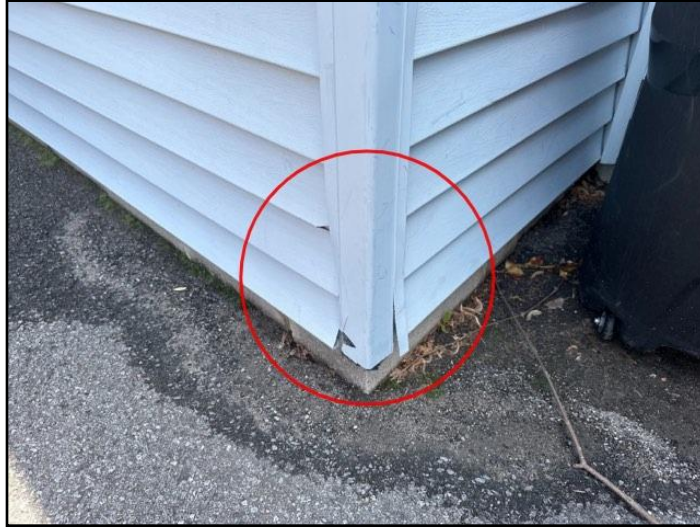
11. Condition: • [Mechanical damage](#)

38. Mechanical damage

Repair the damaged siding at the bottom corner of the addition at the driveway.

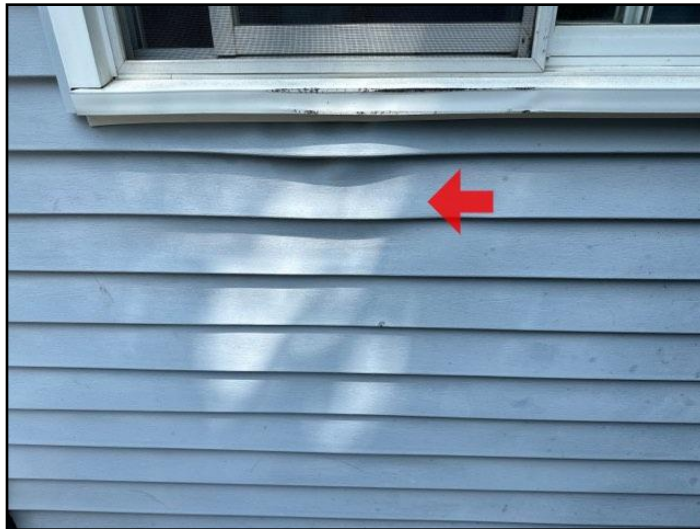
**12. Condition:** • [Buckled or wavy](#)

39. Buckled or wavy

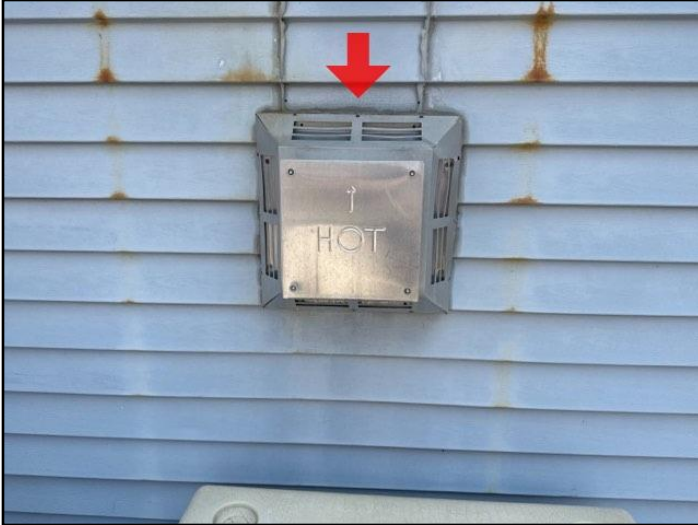
**13. Condition:** • [Loose or missing pieces](#)

40. Loose or missing pieces

Provide the missing "J" trim around the gas fireplace vent at the transition to the vinyl siding.

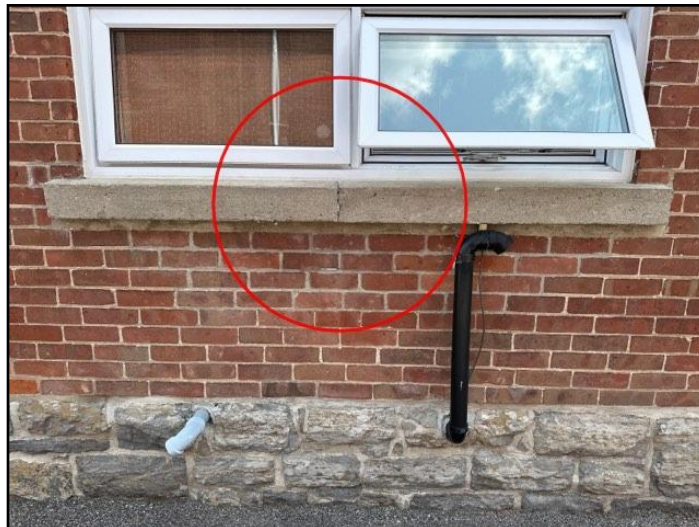
14. Condition: • [Cracked](#)

42. Cracked

Repair the cracked concrete window sill on the side of the house below the kitchen window.

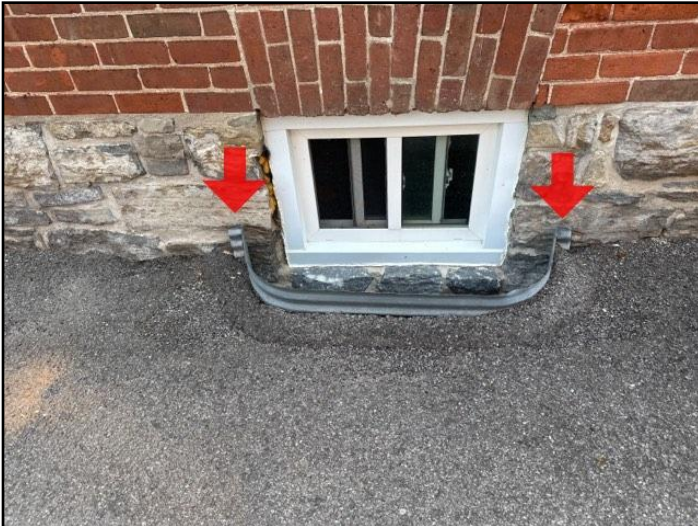
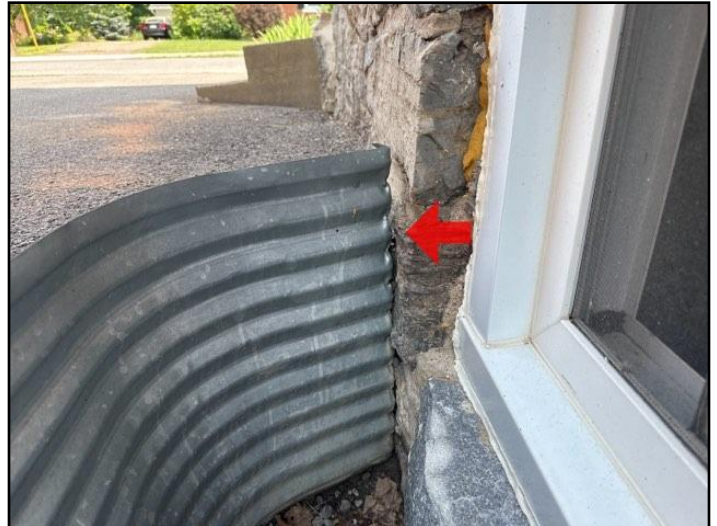
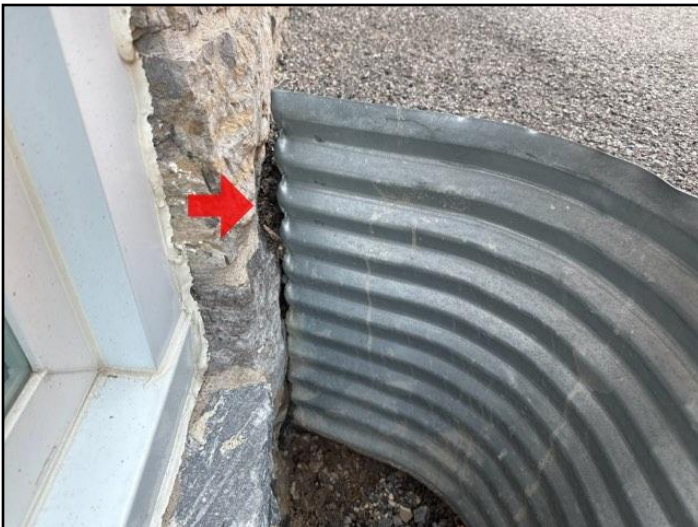
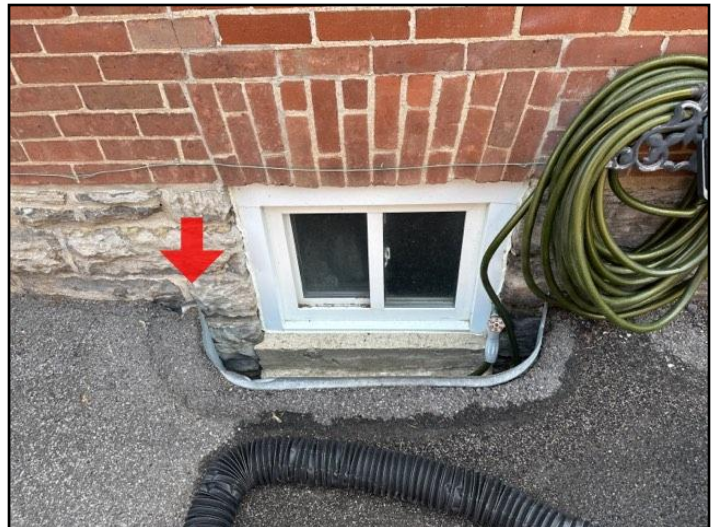
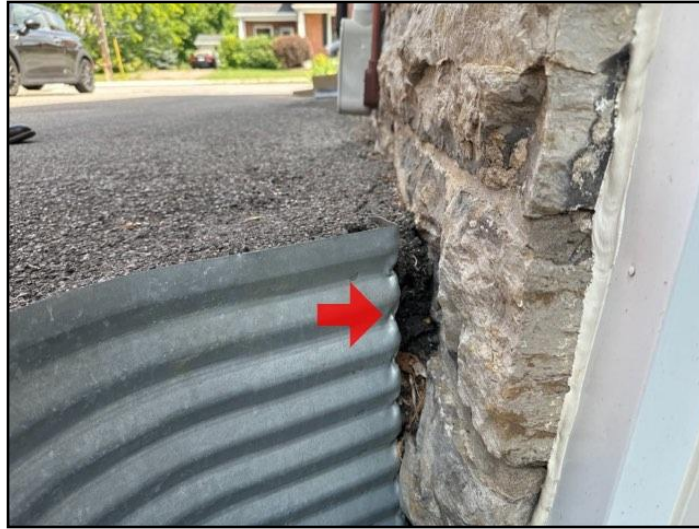
**16. Condition:** • Loose

44. Loose

45. Loose

46. Loose

47. Loose

48. Loose

Secure the window wells to the foundation on the west side of the house.

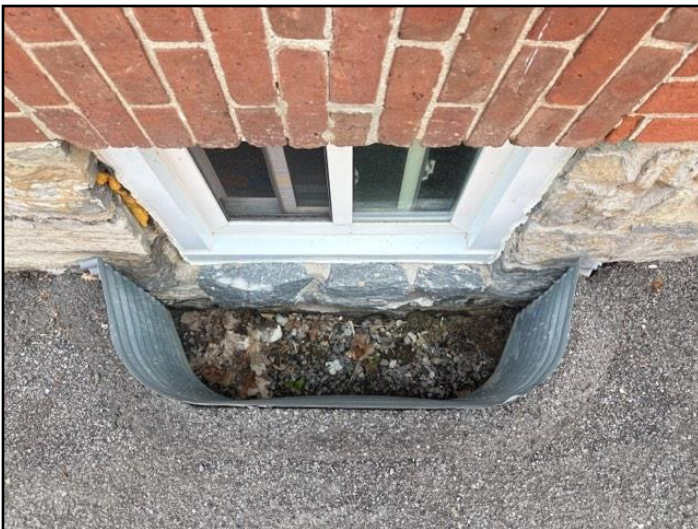
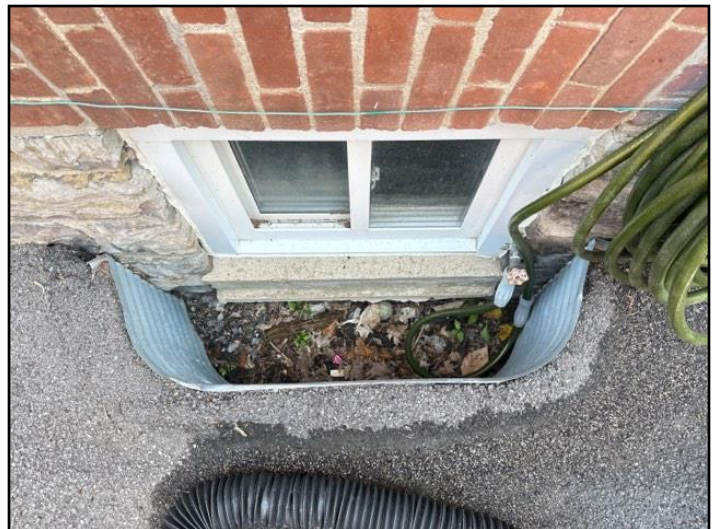
**17. Condition:** • Clean window well

49. Clean window well

50. Clean window well

Remove all the dirt and debris from the window wells. Ensure that the window well drains are not blocked. The window wells should not be used for storage. This can be a contributing factor to basement moisture issues.

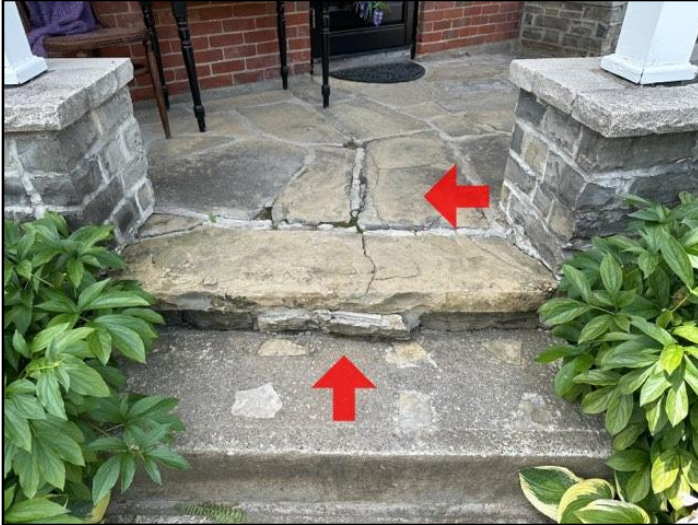
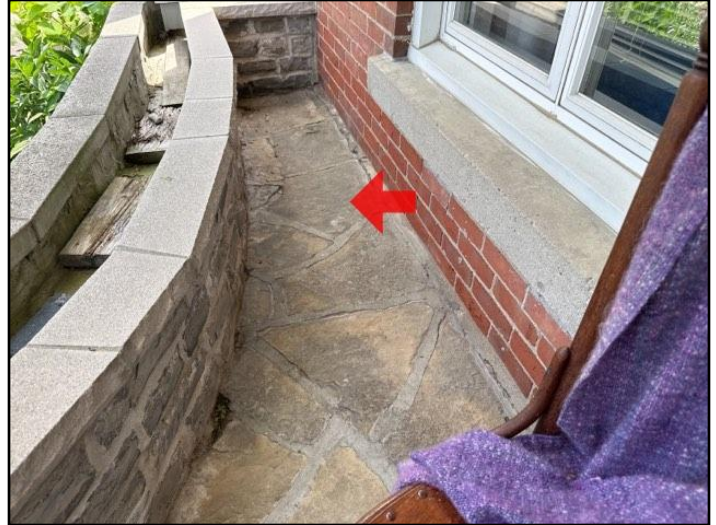
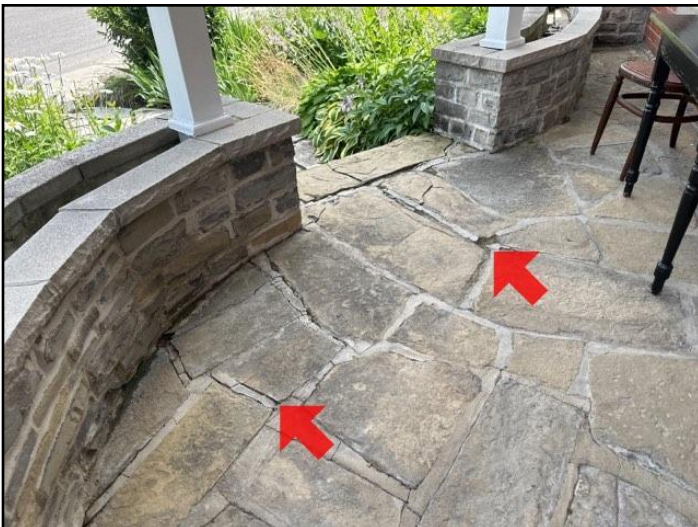
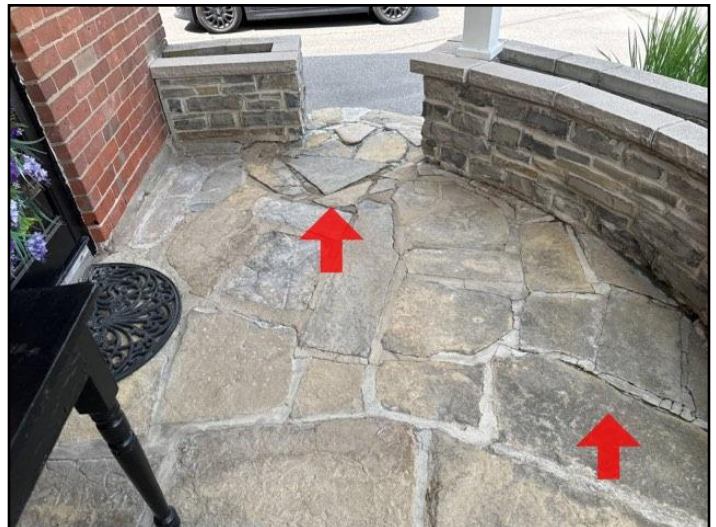
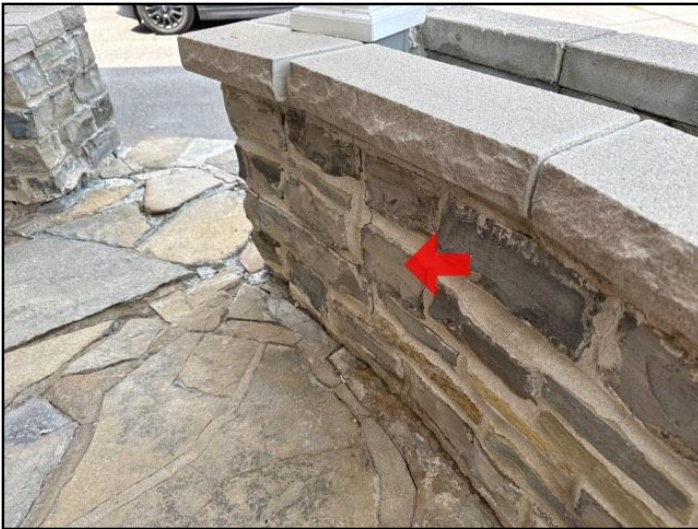
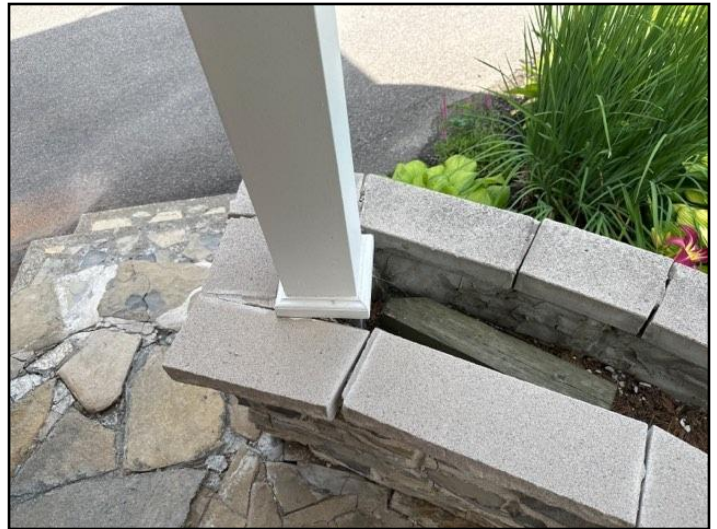
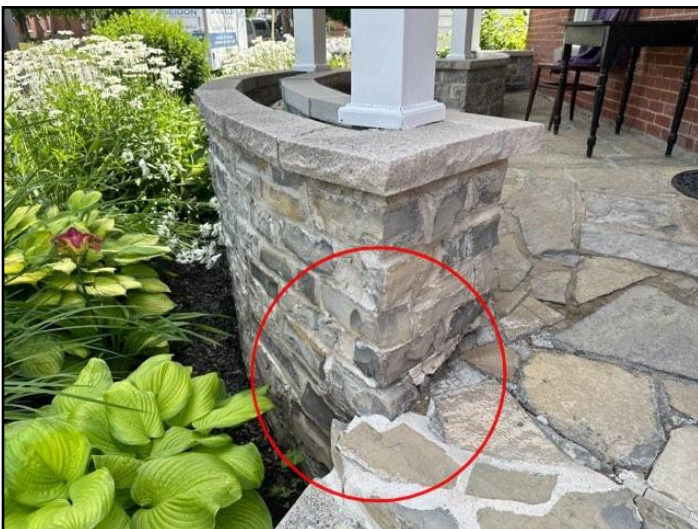
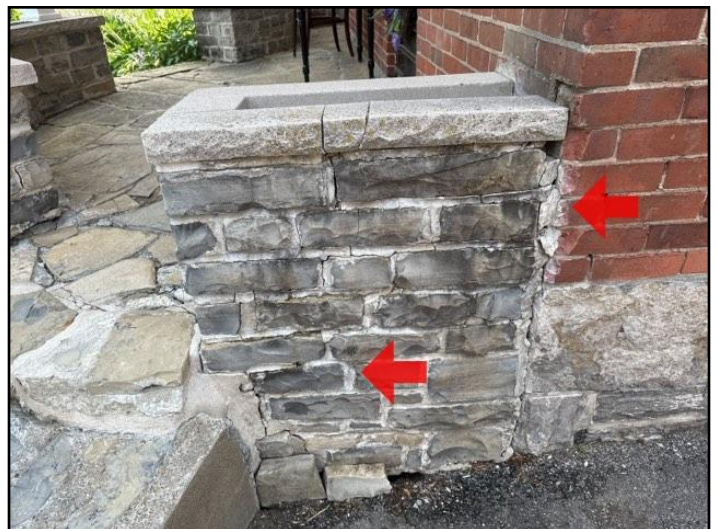
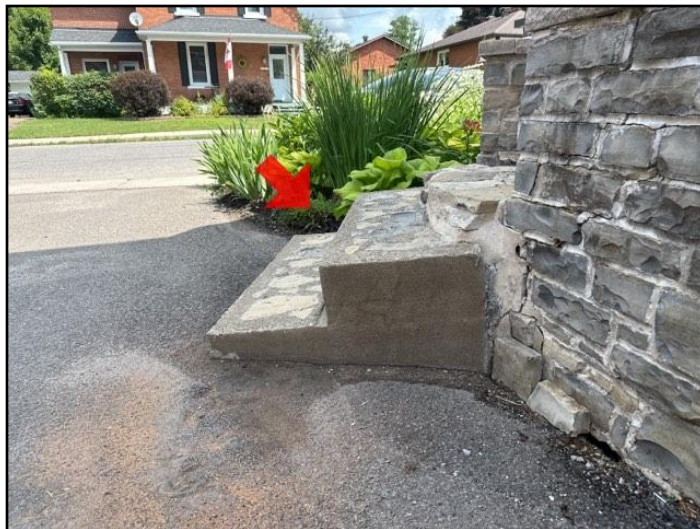
The stone base of the front porch is poorly built and is settling. The base of the porch and steps should be budgeted for replacement within 2 years.

51. Poorly built

52. Poorly built

53. Poorly built

54. Poorly built

55. Poorly built

56. Poorly built

57. Poorly built

58. Poorly built

59. Poorly built

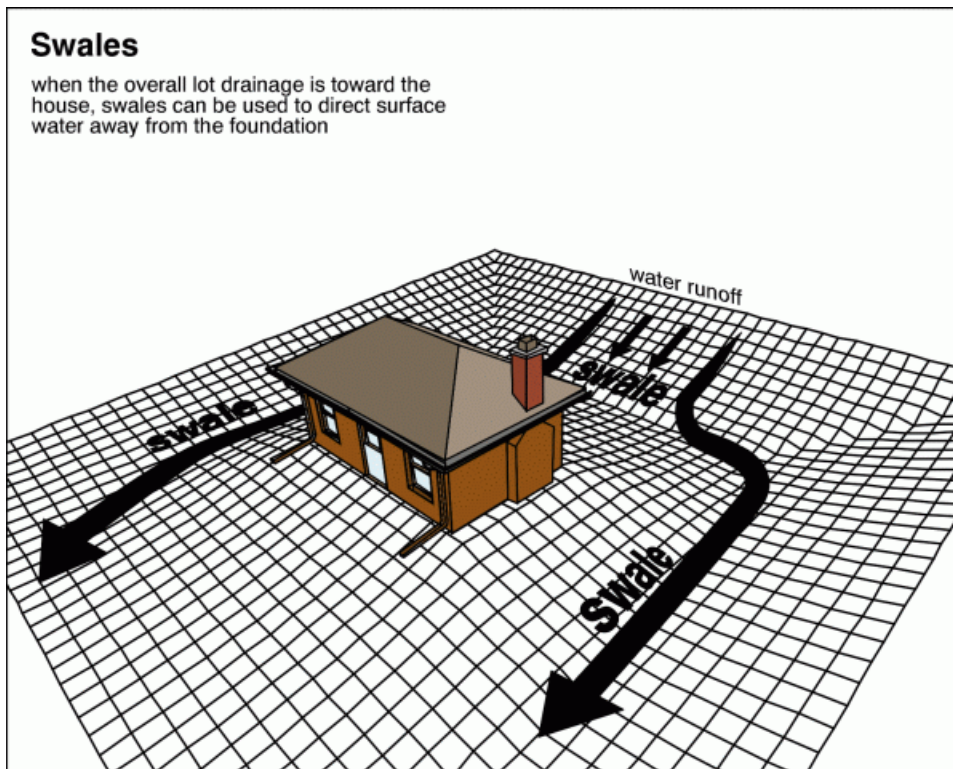
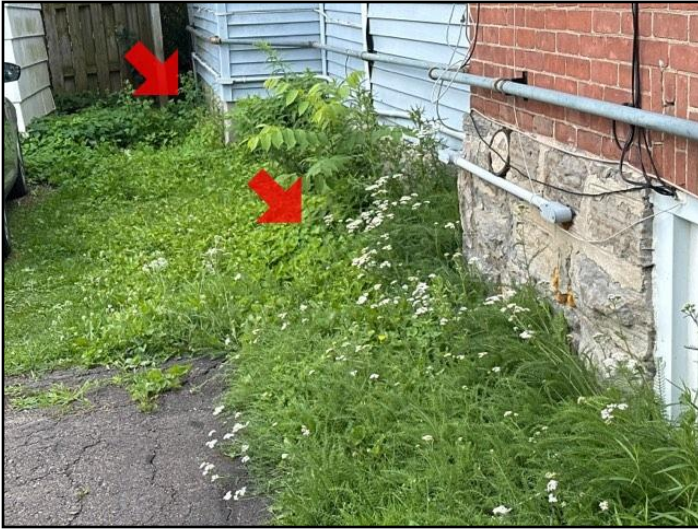
19. Condition: • [Improper slope or drainage](#)

60. Improper slope or drainage

Repair the slope of the ground along the east side of the house to limit the amount of water that accumulates against the foundation walls. This can be a contributing factor to basement moisture issues.

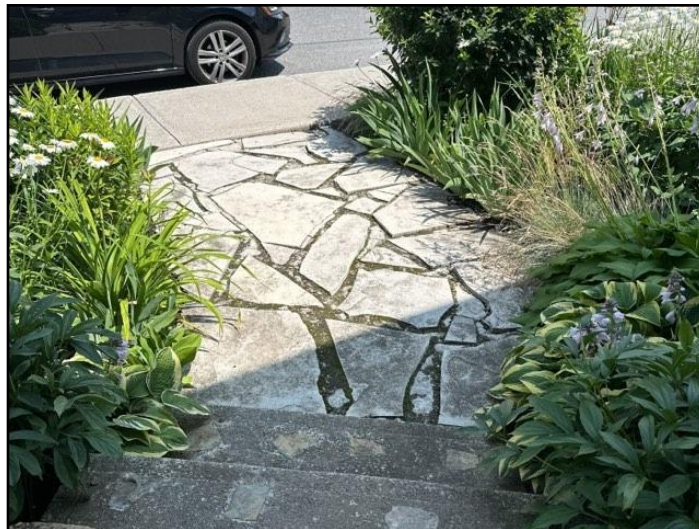
20. Condition: • [Uneven \(trip hazard\)](#)

62. Uneven (trip hazard)

The front walkway needs to be repaired to correct the unevenness in the surface, which is currently a trip hazard.
