# YOUR INSPECTION REPORT

1 INSPECTION WAY  
Arnprior, ON K7S 1X7

Friday, July 14, 2023

Report No. 3412, v.2

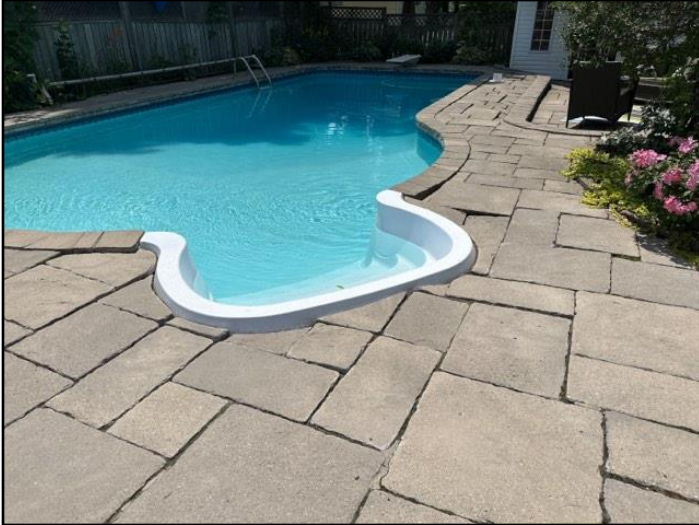
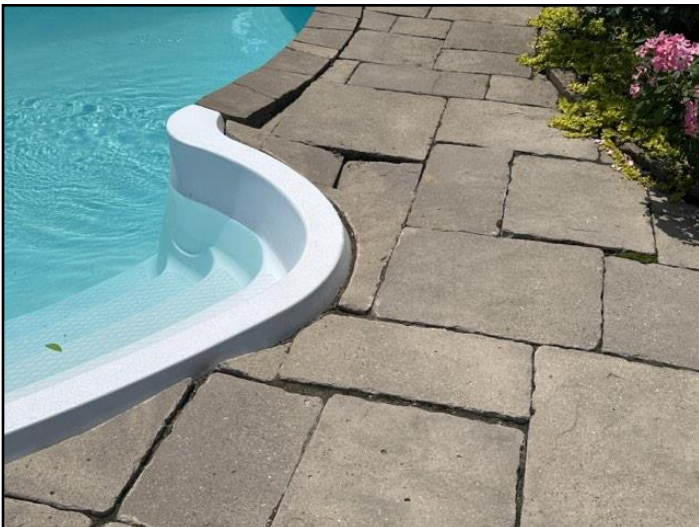
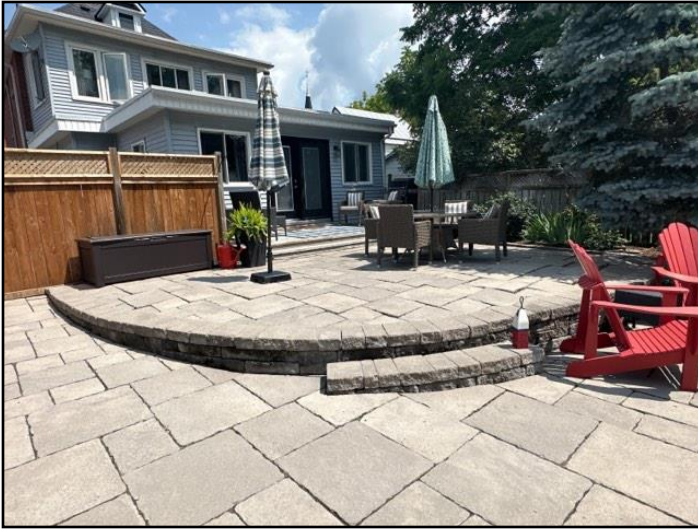
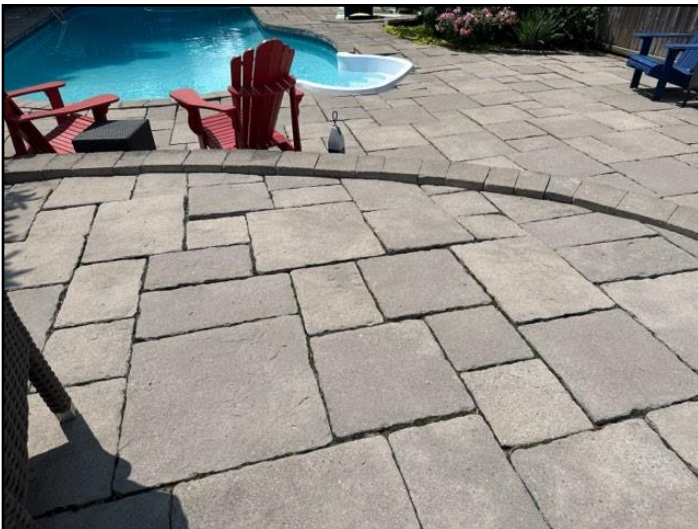
21. Condition: • Uneven (trip hazard)

63. Uneven (trip hazard)

65. Uneven (trip hazard)

67. Uneven (trip hazard)

69. Uneven (trip hazard)

The complete rear patio needs to be repaired to correct the unevenness in the surface, which is currently a trip hazard.

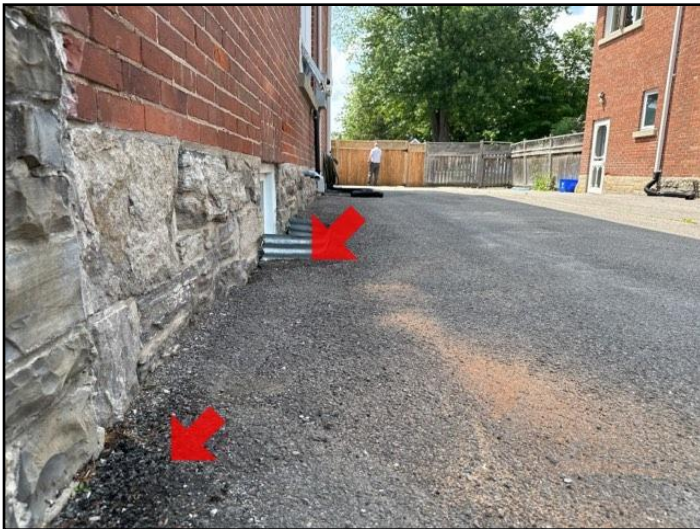
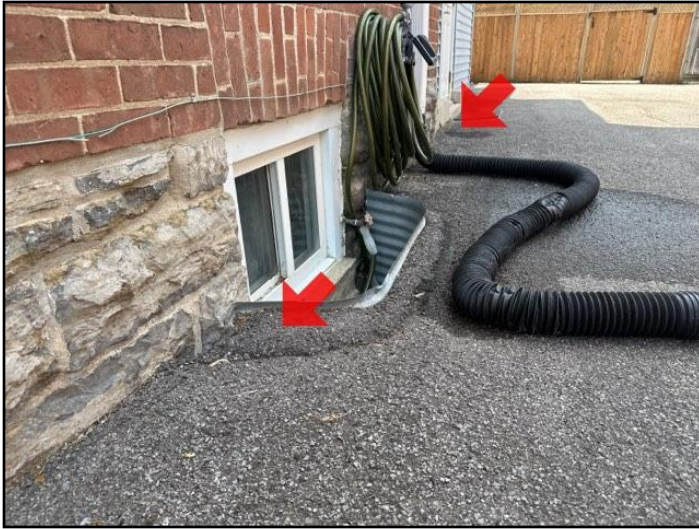
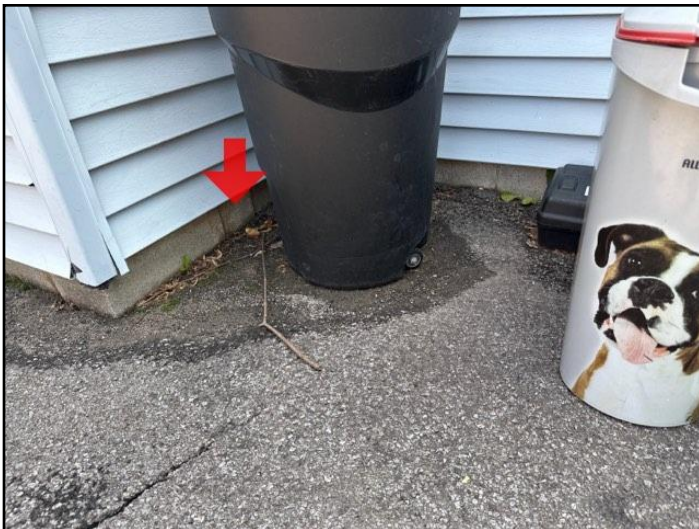
**22. Condition:** • [Improper slope or drainage](#)

71. Improper slope or drainage

73. Improper slope or drainage

75. Improper slope or drainage

Repair the slope of the driveway along the west foundation wall. Any gaps between the driveway and foundation need to be sealed. Correct the unevenness in the driveway, which is currently a trip hazard.

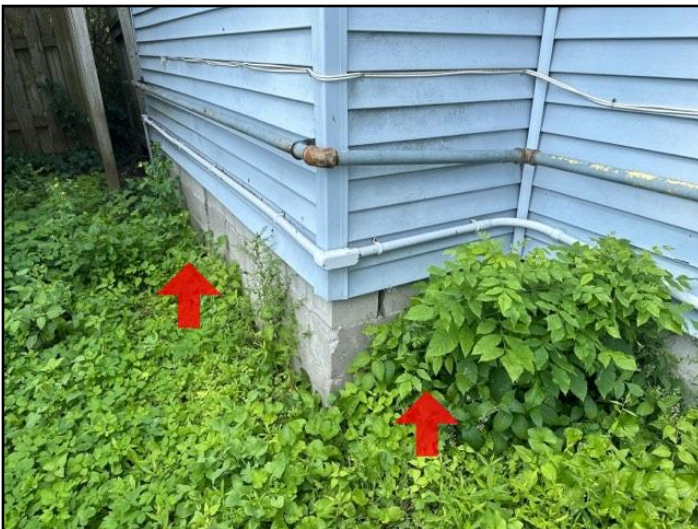
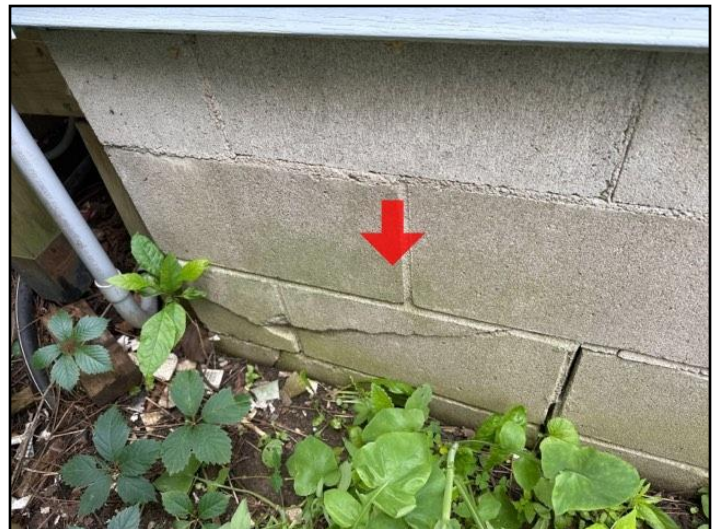
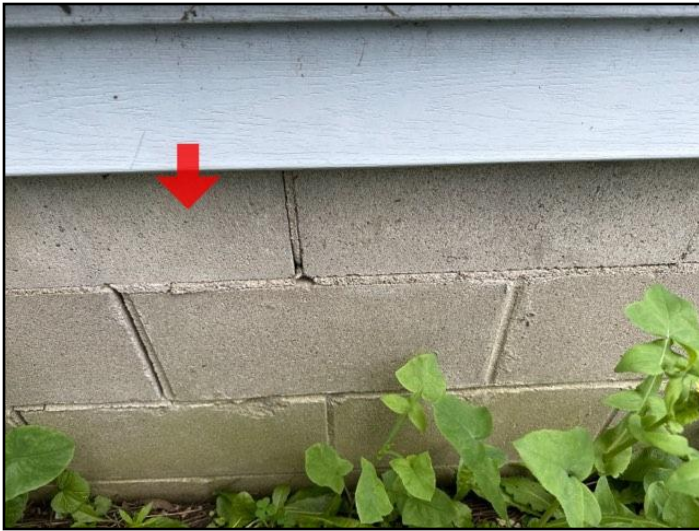
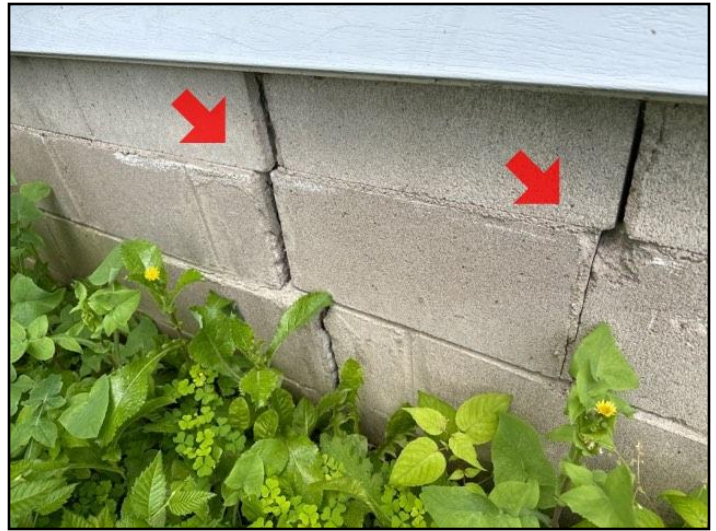
**23. Condition:** • [Settled](#)

Further evaluation required of the major settlement visible in the concrete block foundation of the additions to determine the cause, scope of work and the cost to repair the issue. There is shifting noted on the first and second floors of the additions.

79. Settled

80. Settled

81. Settled

82. Settled

**Task:** Further evaluation by a structural contractor

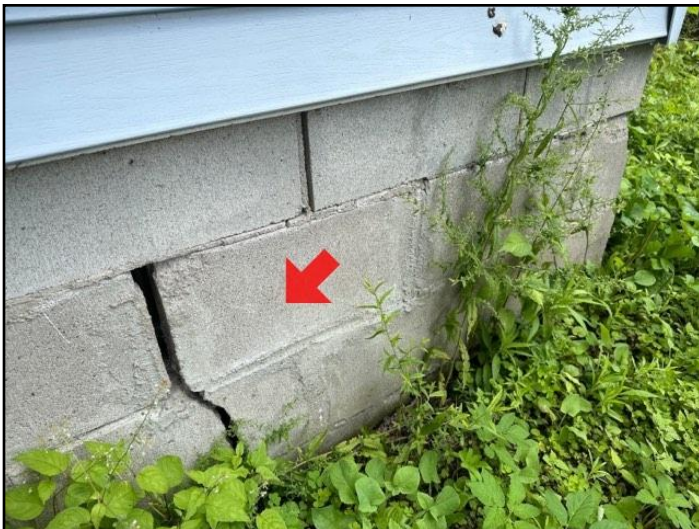
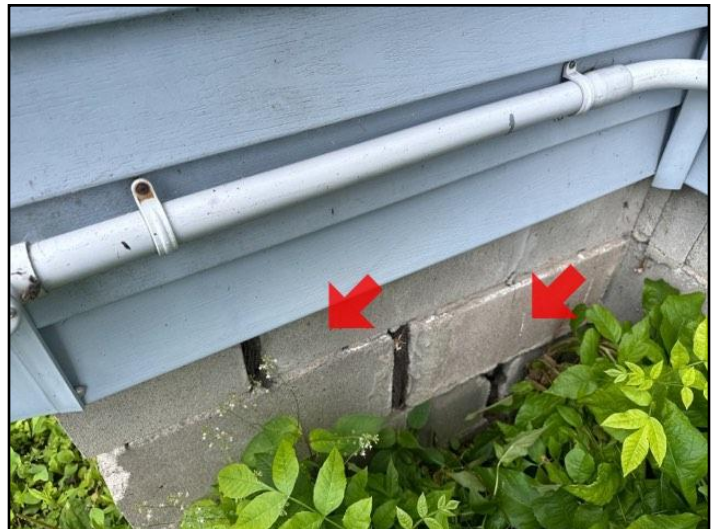
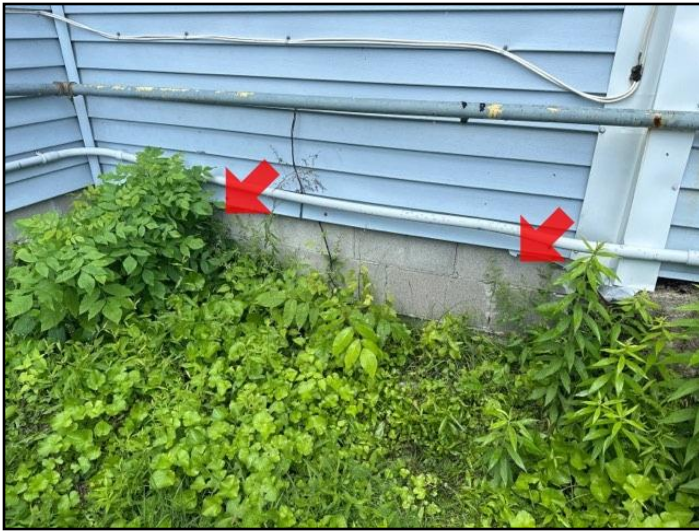
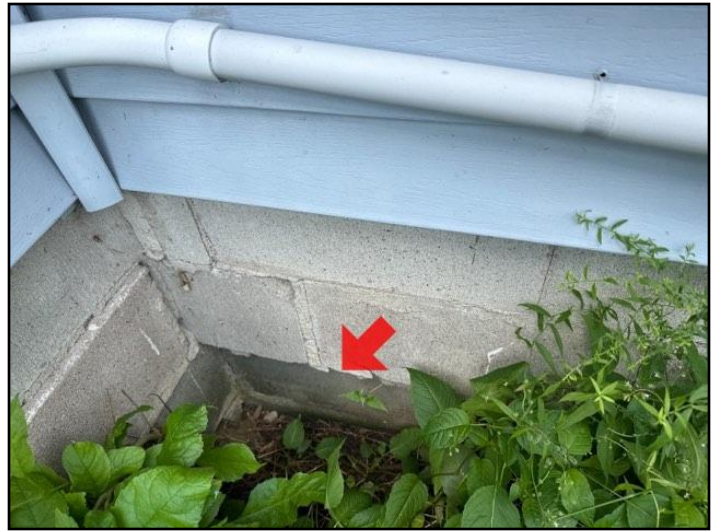
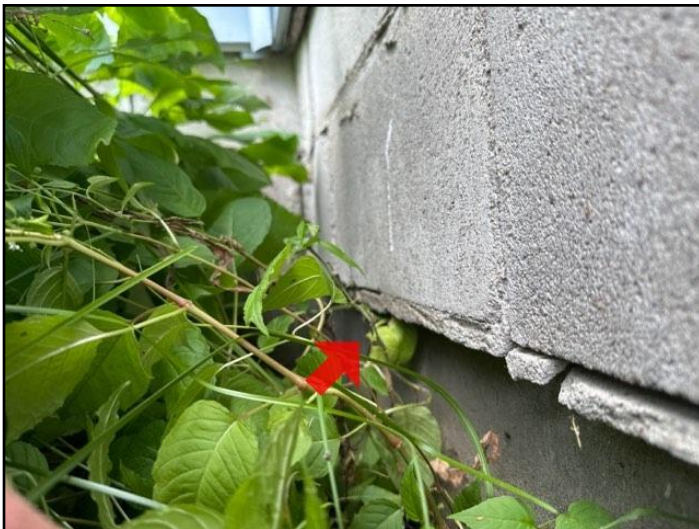
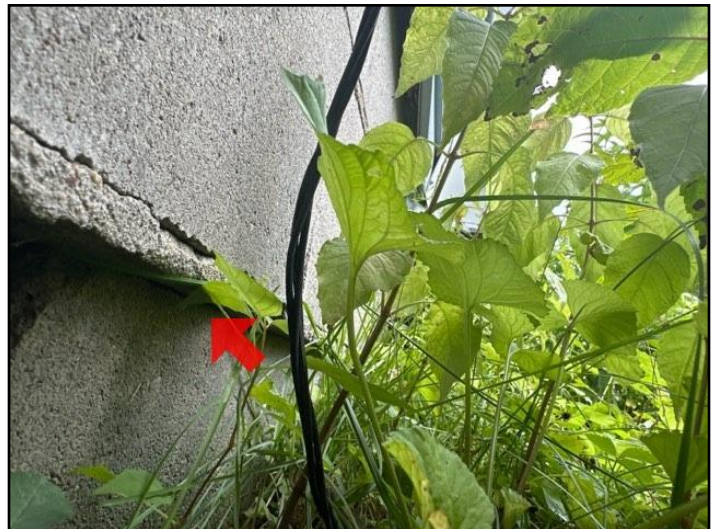
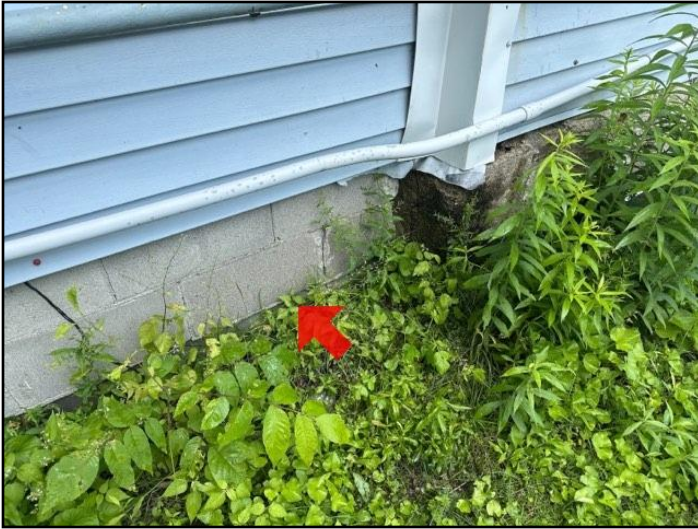
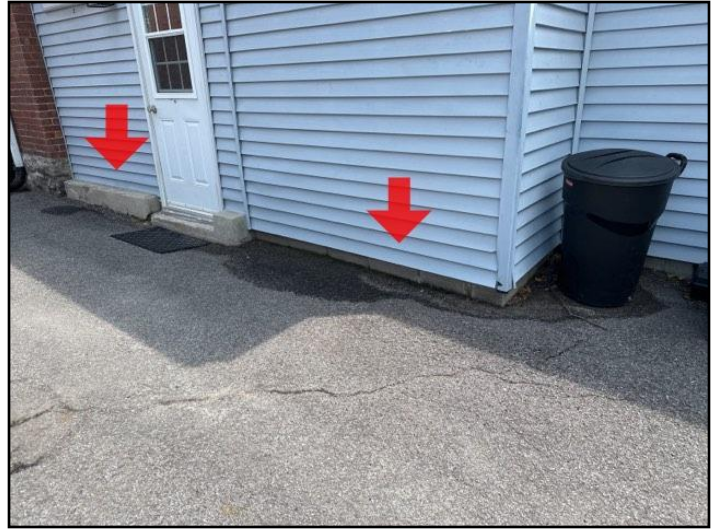
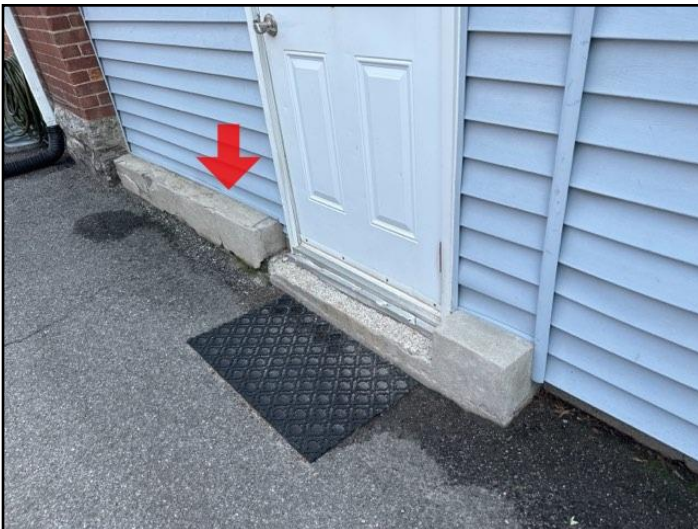
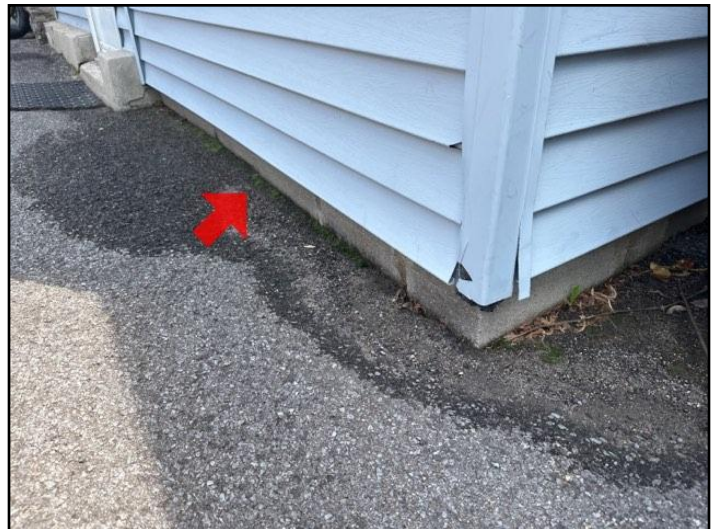
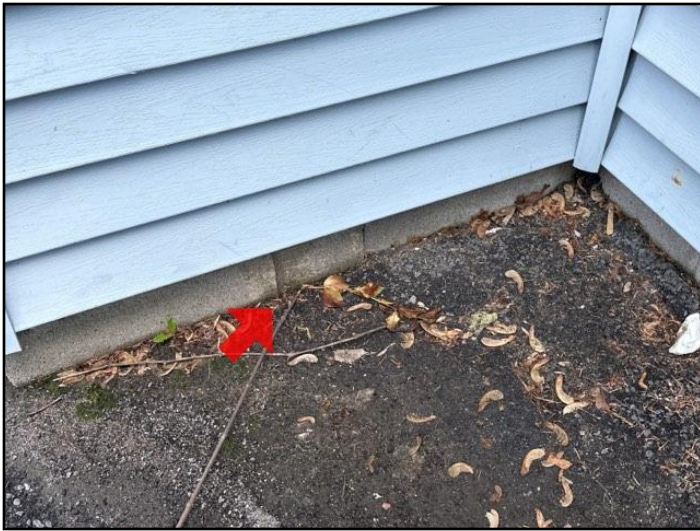
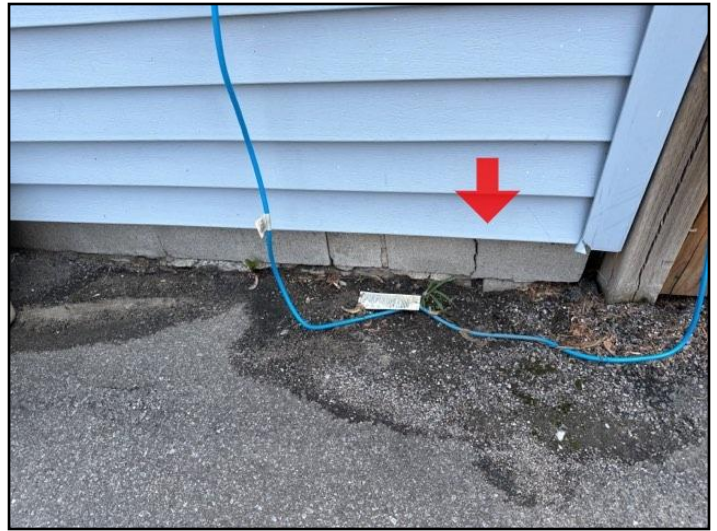
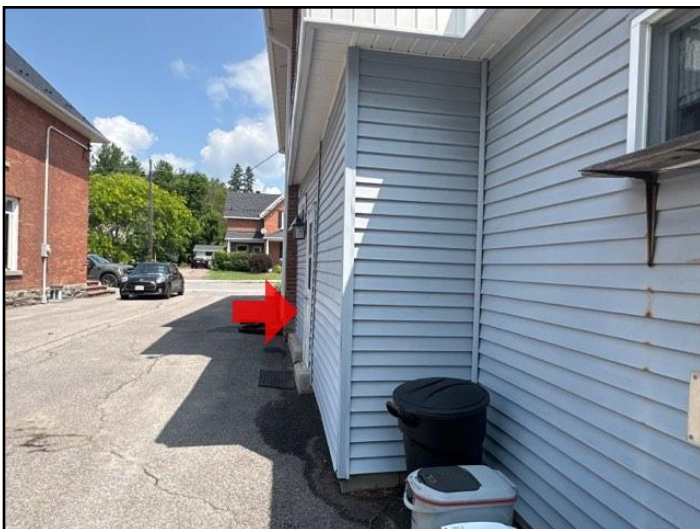
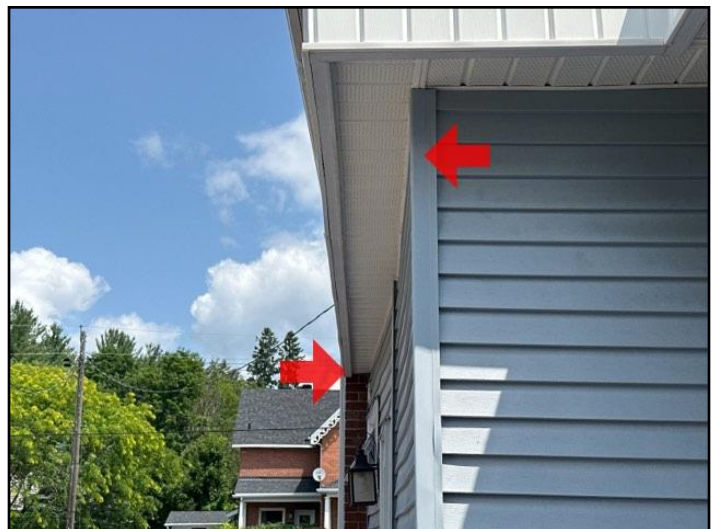
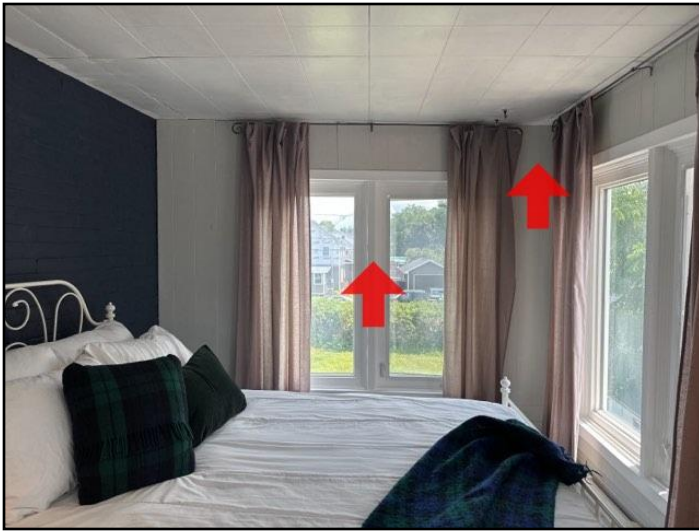
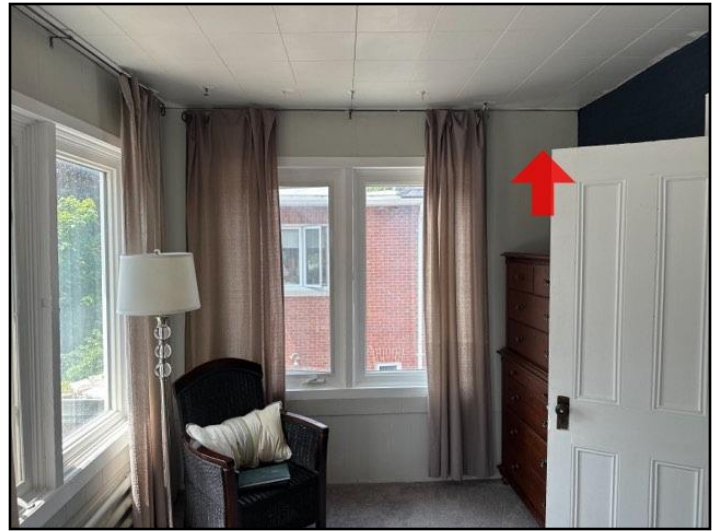
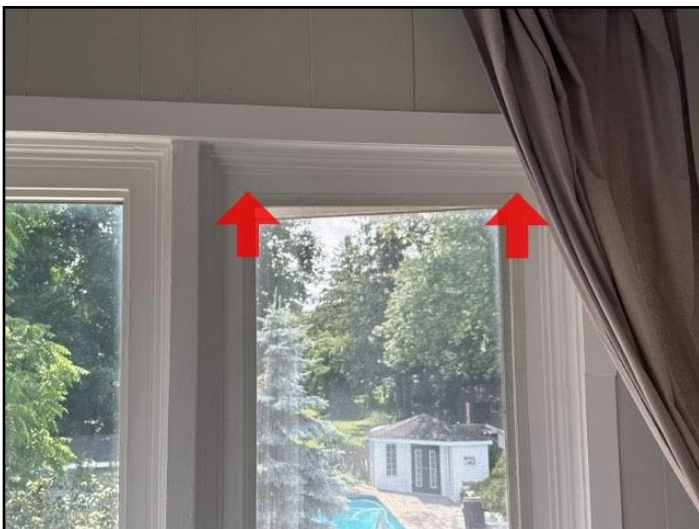
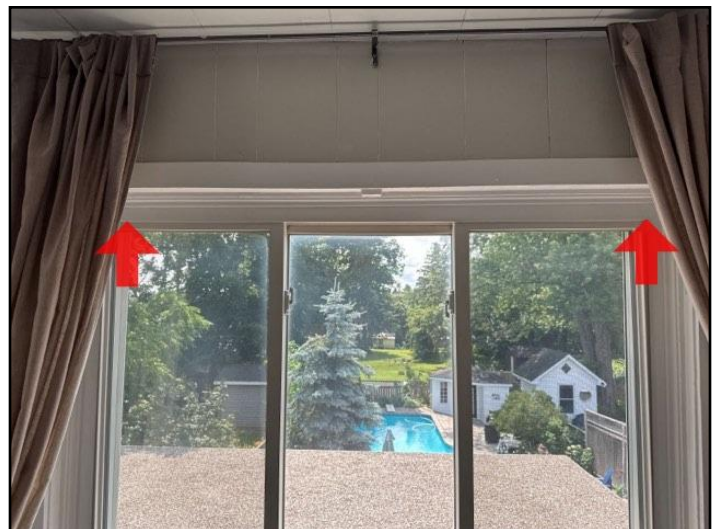
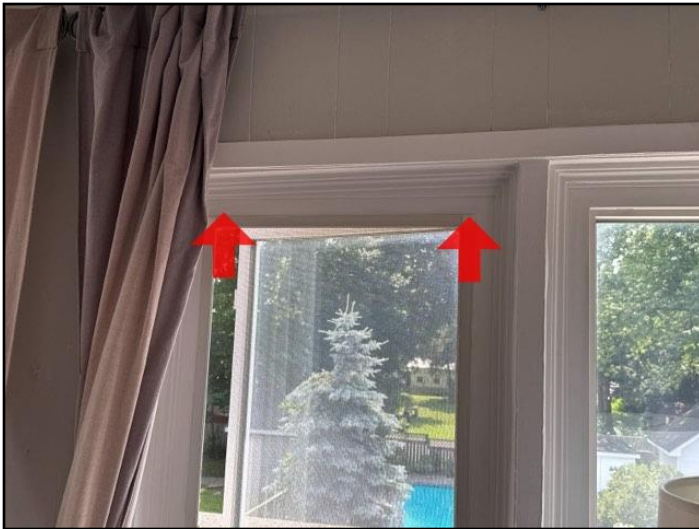
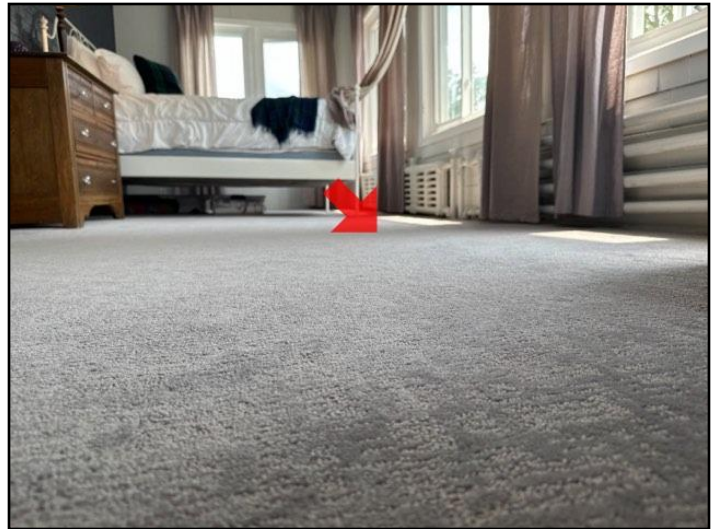
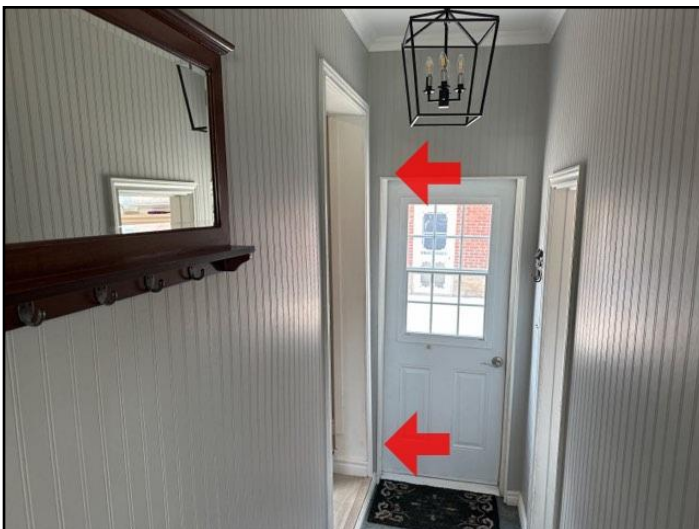
**Location:** South Addition Foundations

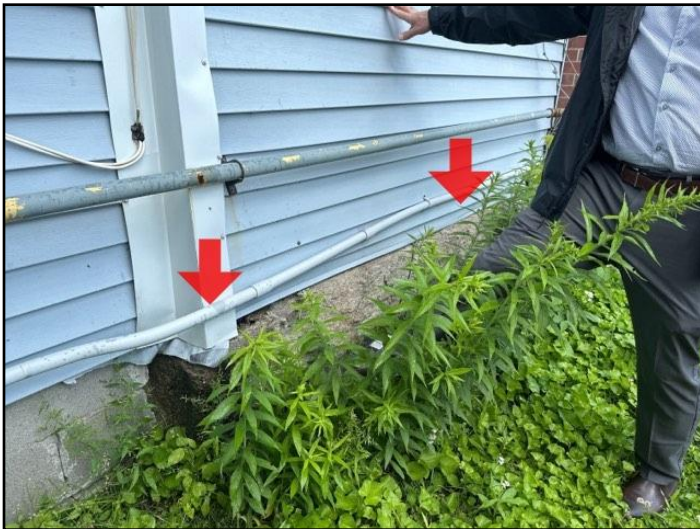
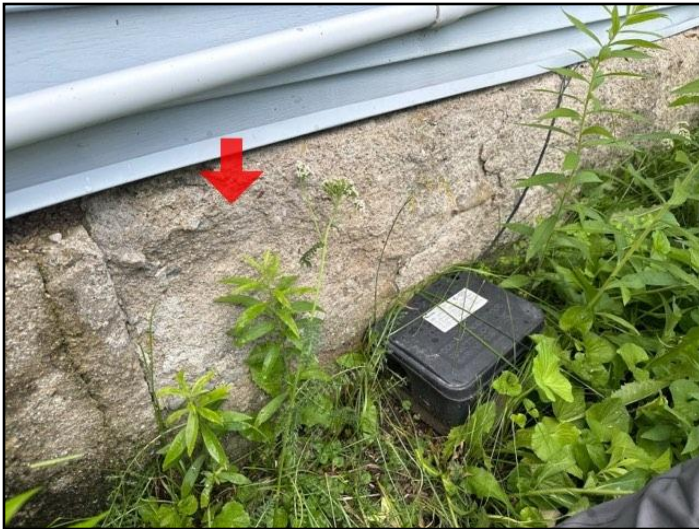
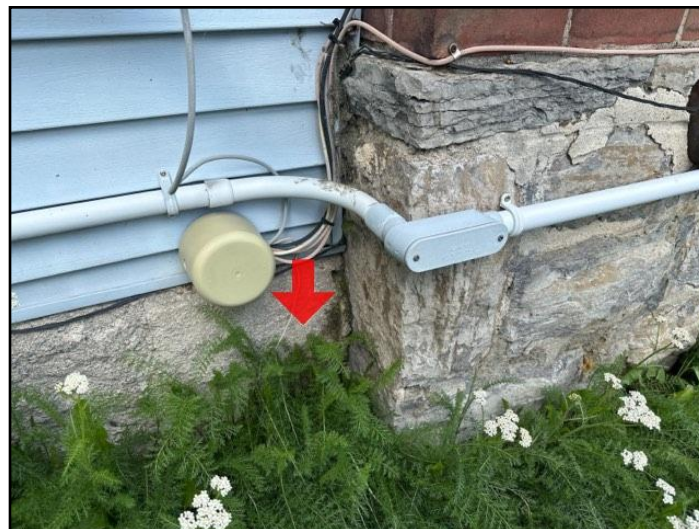
Repair the spalling of the addition that is visible on the east side of the house. The foundation should be evaluated when the rear and side addition block foundations are being inspected.

**Location:** Middle Addition Foundation

**Task:** Further evaluation by a foundation contractor

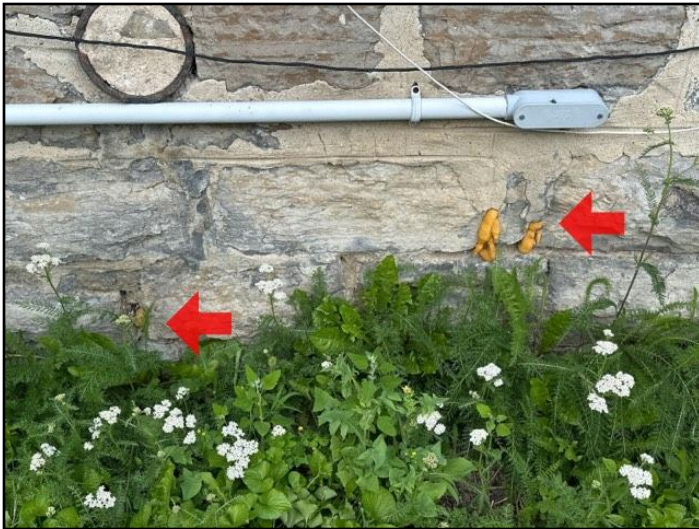
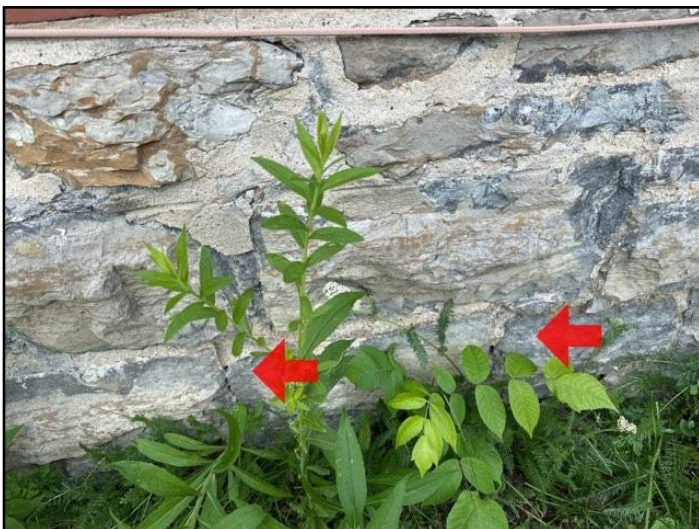
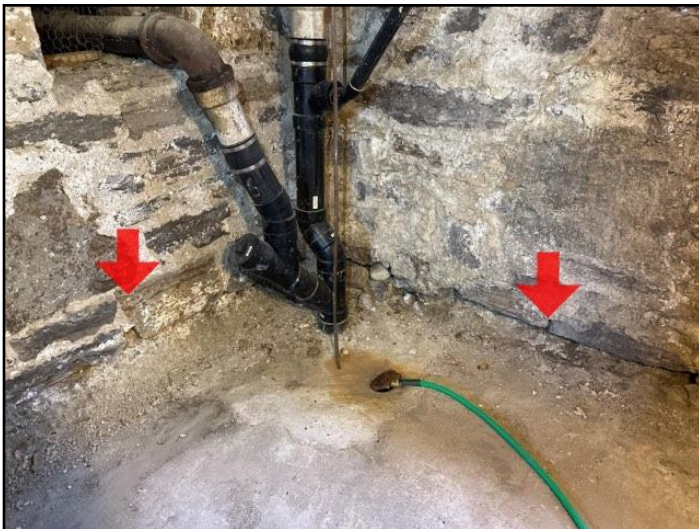
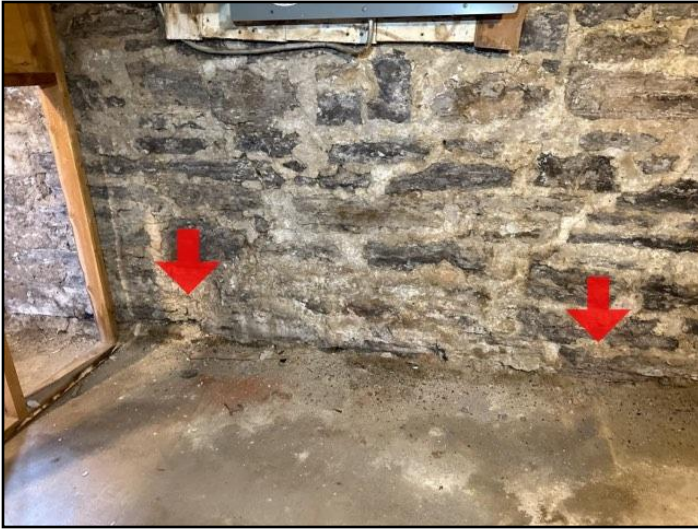
Areas of the stone foundation have loose or voids in the mortar joints. This is common for a stone foundation and is a regular occurrence. Stone foundation need ongoing maintenance/re-pointing of the mortar joints. There is some maintenance required of the stone foundation at this time. The foundation should be monitored for further maintenance.

**Location:** Various Exterior Foundation

**Task:** Repair

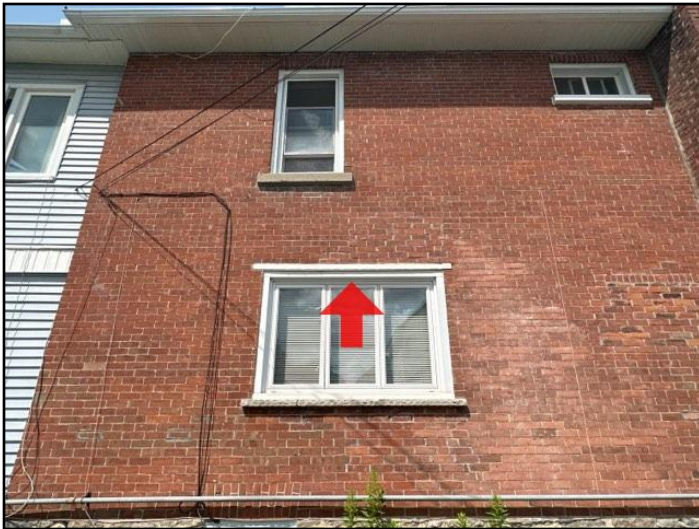
128. Lintel sagging

Repair the sagging lintel over the first floor dining room window on the east side of the house.

**Task:** Repair

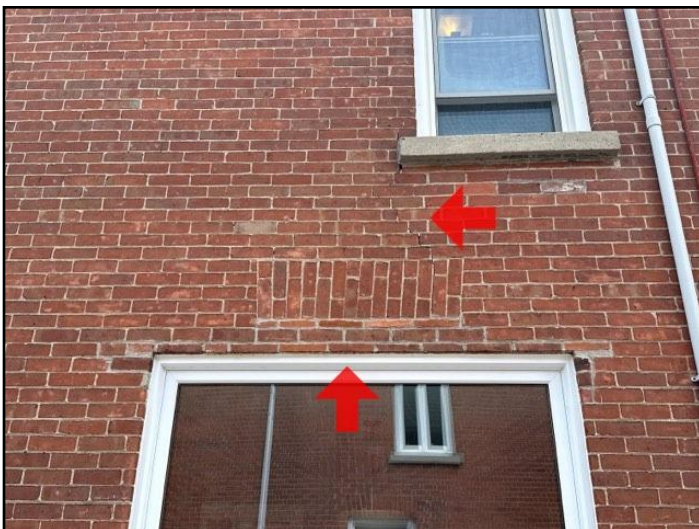
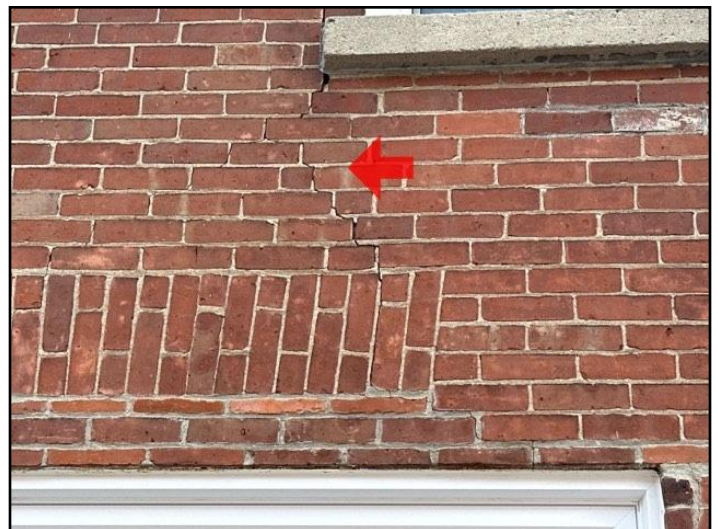
**28. Condition:** • [Lintel sagging](#)

Repair the hairline crack in the brick above the first floor kitchen window on the west side of the house. Monitor the lintel for sagging or the brick for cracks.

130. Lintel sagging

131. Lintel sagging

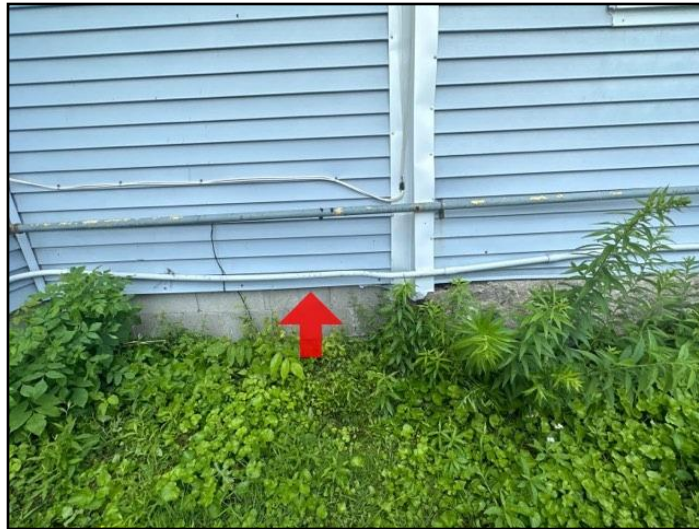
**29. Condition:** • [Not well secured](#)

**Implication(s):** Electric shock | Fire hazard

132. Not well secured

Secure the loose electrical conduit run along the east side of the house.

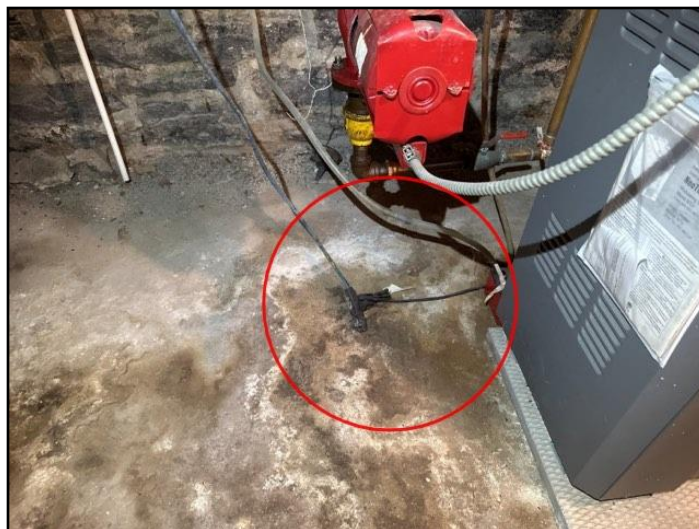
**30. Condition:** • [Extension cord used as permanent wiring](#)

**Implication(s):** Electric shock | Fire hazard

133. Extension cord used as permanent wiring

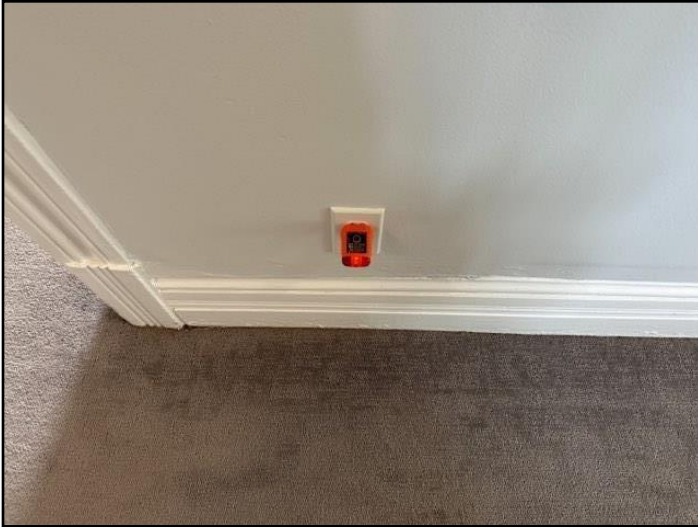
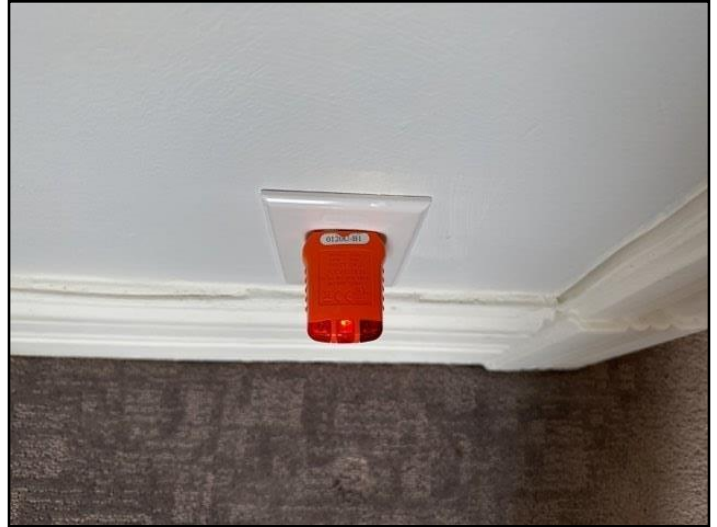
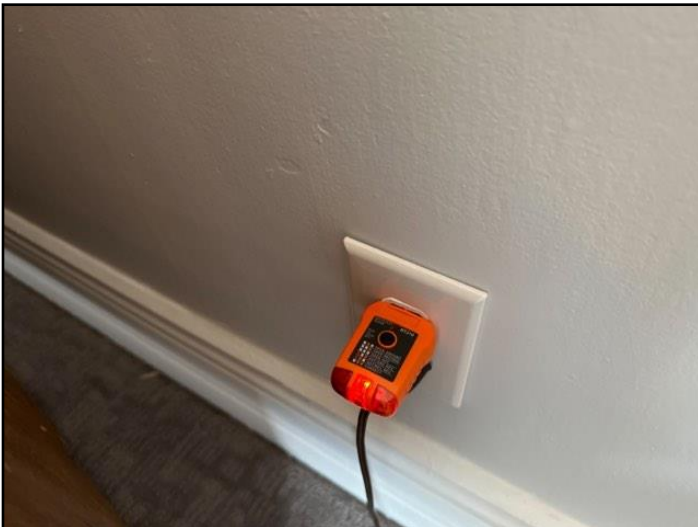
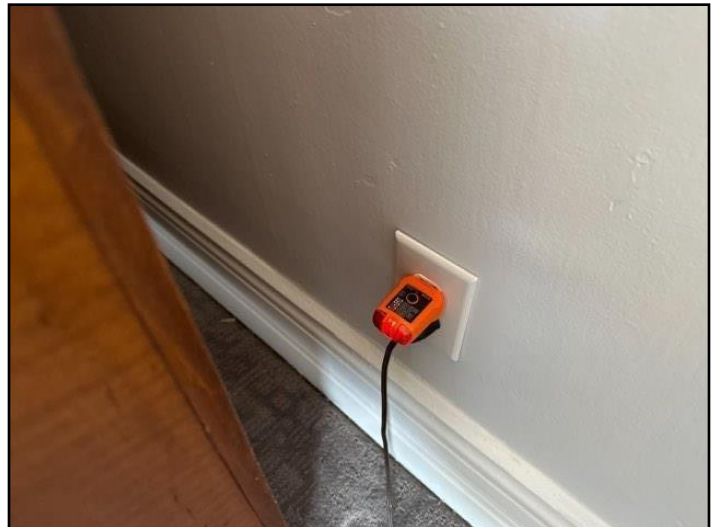
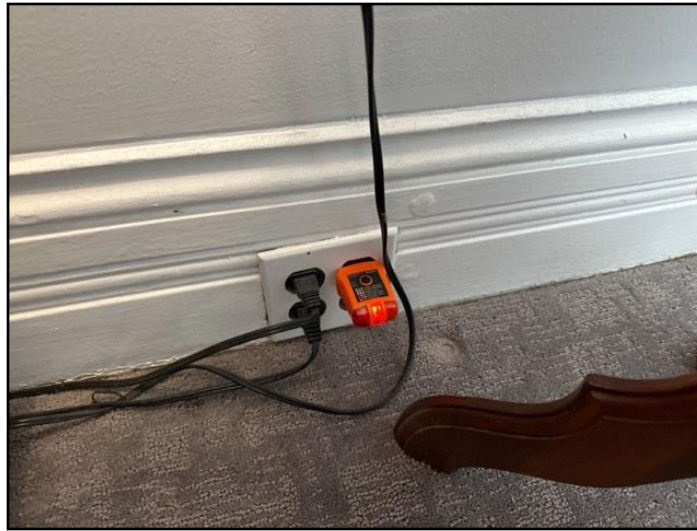
**31. Condition:** • [Ground needed for 3-slot outlet](#)

134. Ground needed for 3-slot outlet

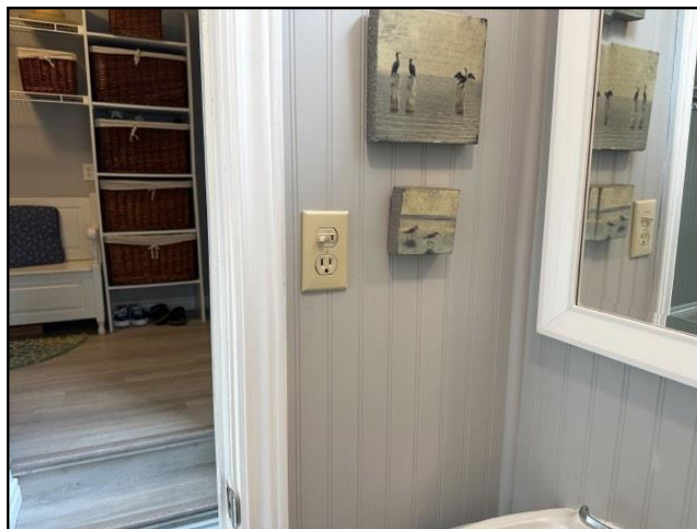
**32. Condition:** • [GFCI/GFI needed \(Ground Fault Circuit Interrupter\)](#)

139. GFCI/GFI needed (Ground Fault Circuit...

Provide the missing GFCI outlet in the first floor bathroom.

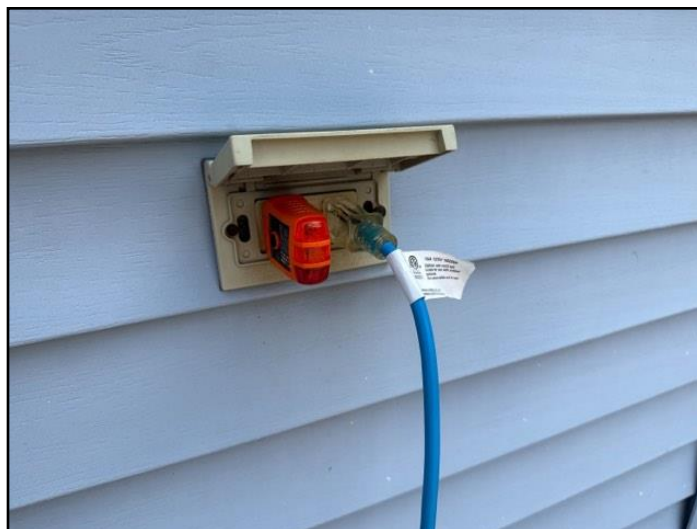
**33. Condition:** • [Test faulty on GFCI/GFI \(Ground Fault Circuit Interrupter\)](#)

140. Test faulty on GFCI/GFI (Ground Fault...

Replace the inoperative GFCI outlet on the side exterior wall.

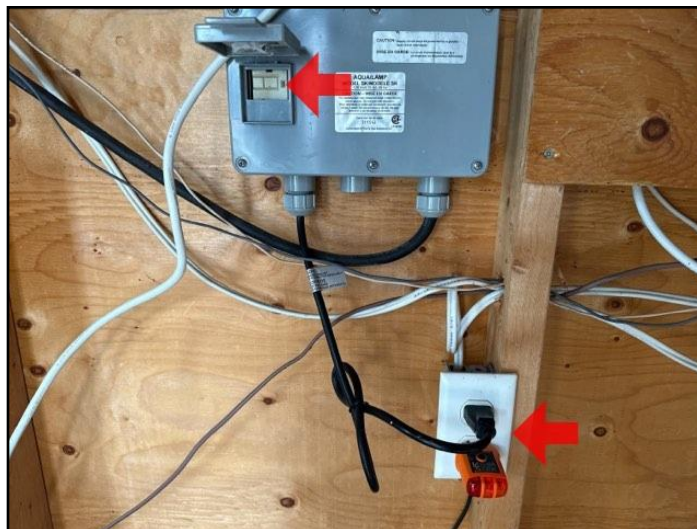
**34. Condition:** • [Test faulty on GFCI/GFI \(Ground Fault Circuit Interrupter\)](#)

141. Test faulty on GFCI/GFI (Ground Fault...

Replace the inoperative GFCI outlet for the pool lights.

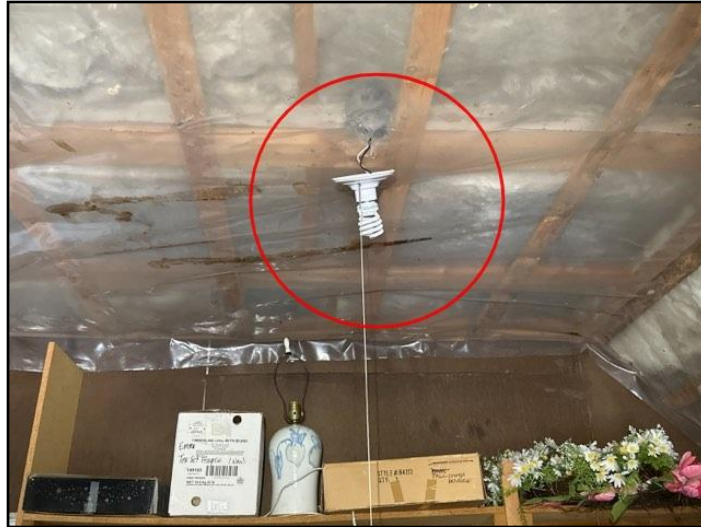
**35. Condition:** • [Loose](#)

**Implication(s):** Electric shock | Fire hazard

142. Loose

Secure the loose light in the third floor storage room.

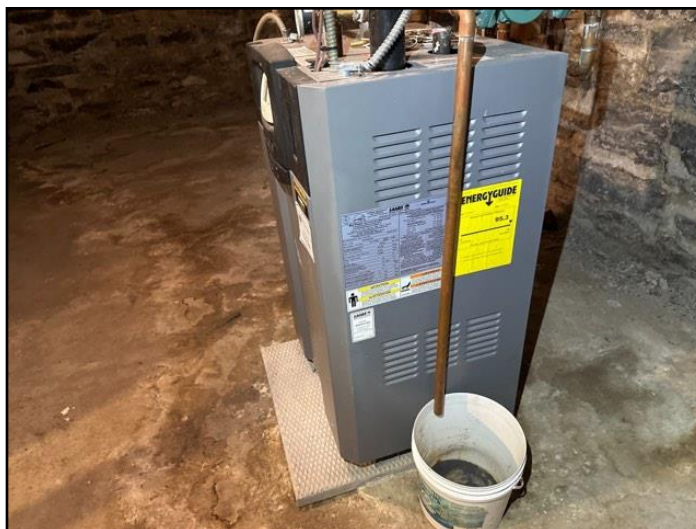
**37. Condition:** • [Near end of life expectancy](#)

**Implication(s):** Equipment failure | No heat for building

145. Near end of life expectancy

Budget to replace the boiler in the future. The average life span of a high-efficiency condensing boiler is 15-20 years.

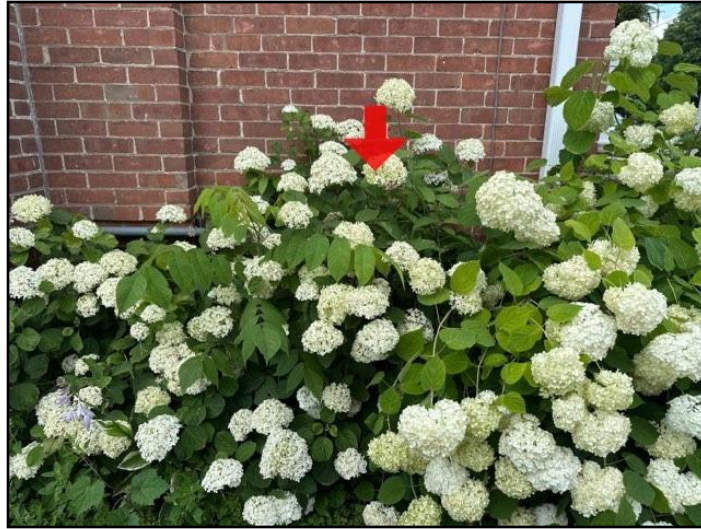
**38. Condition:** • [Poor access](#)

146. Poor access

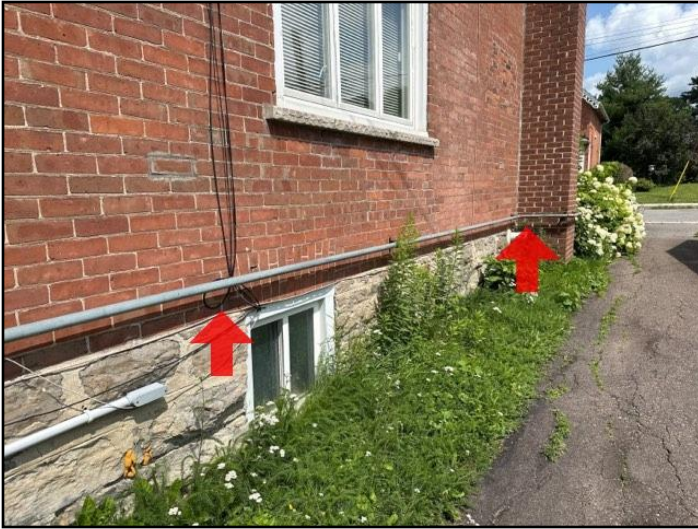
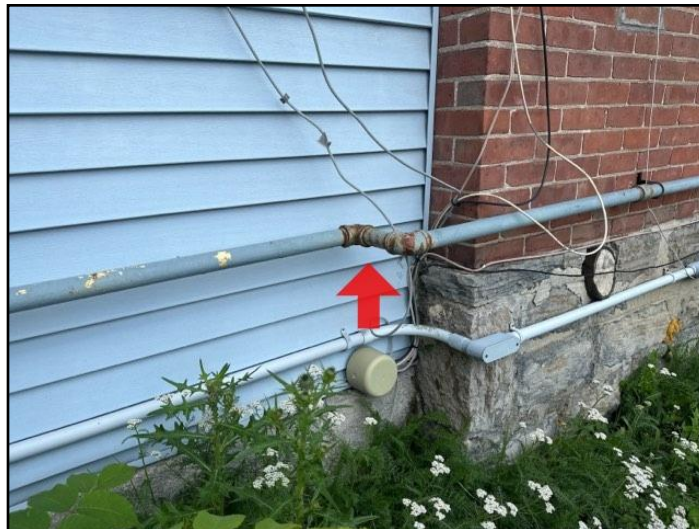
### **39. Condition:** • [Inadequate support](#)

149. Inadequate support

151. Inadequate support

Provide additional support for the loose gas supply line along the east side of the house. Supports are required every 10' on centre. The gas line is for the BBQ and pool heater.

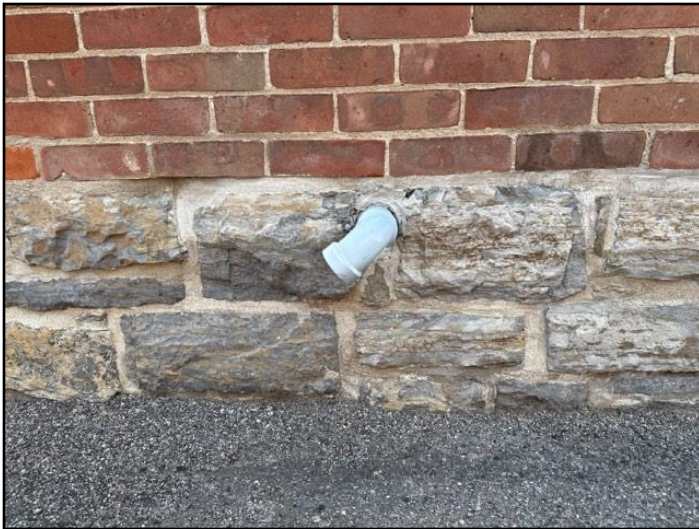
**40. Condition:** • [Rust, dirty, obstructed](#)

**Implication(s):** Hazardous combustion products entering home

152. Rust, dirty, obstructed
