# YOUR INSPECTION REPORT

1 INSPECTION WAY  
Arnprior, ON K7S 1X7

Friday, July 14, 2023

Report No. 3412, v.2

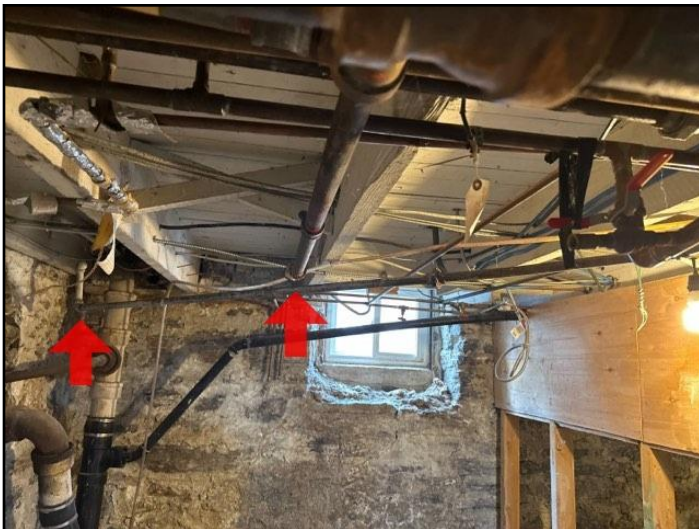
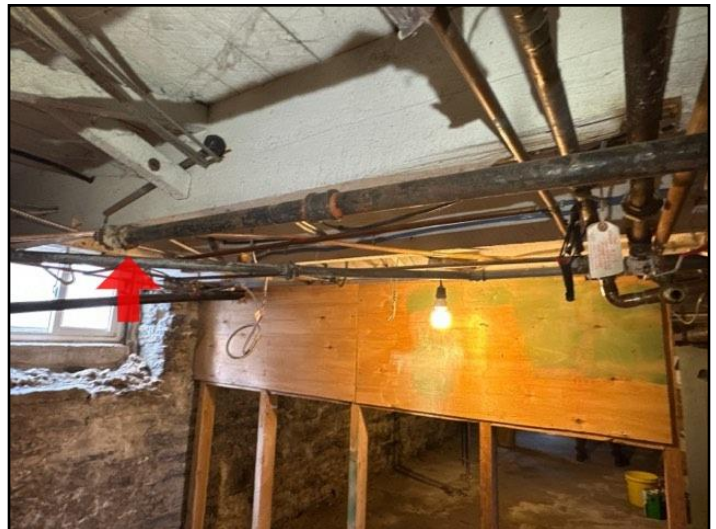
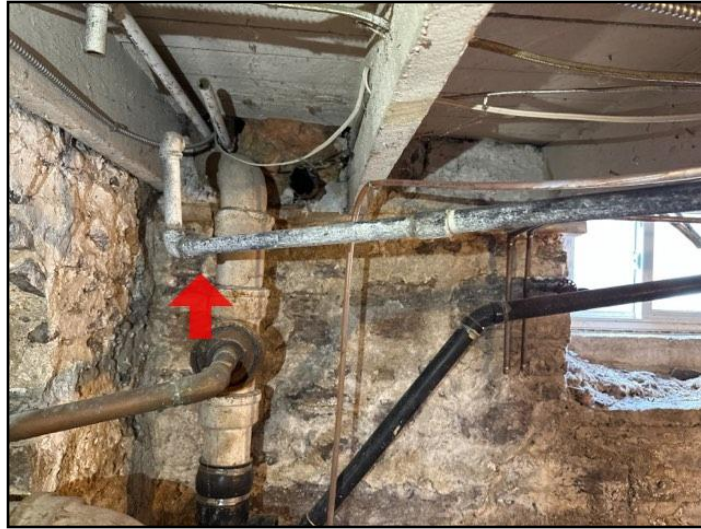
41. Condition: • [Poor support](#)

**Implication(s):** Chance of water damage to structure, finishes and contents

154. Poor support

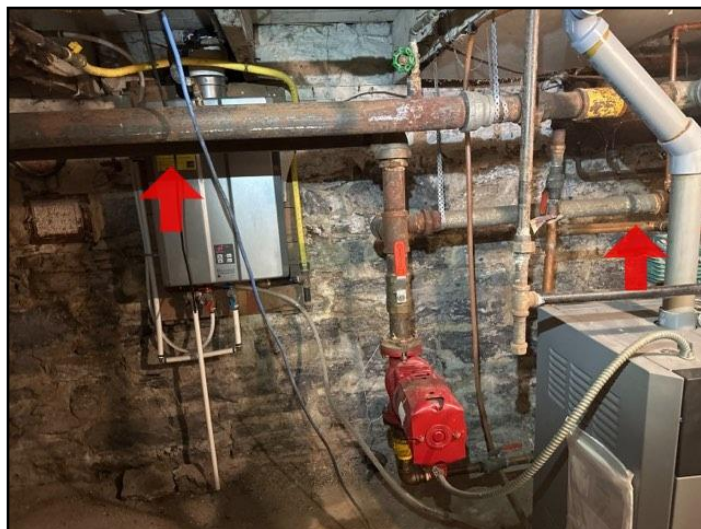
**42. Condition:** • [Poor support](#)

**Implication(s):** Chance of water damage to structure, finishes and contents

157. Poor support

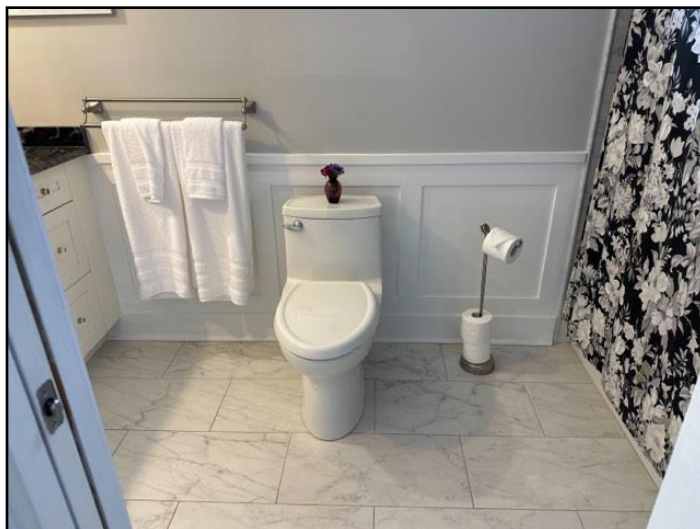
**43. Condition:** • [Missing](#)

158. Missing

Provide the missing radiator for the main second floor bathroom.

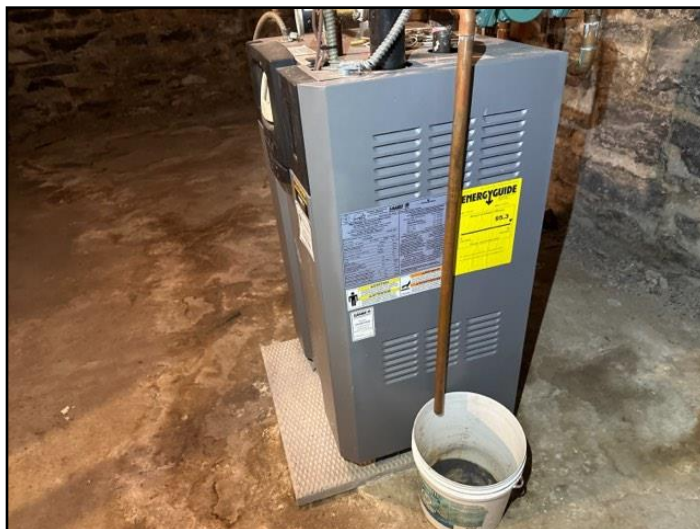
**44. Condition:** • The boiler needs to be serviced

159. Near end of life expectancy

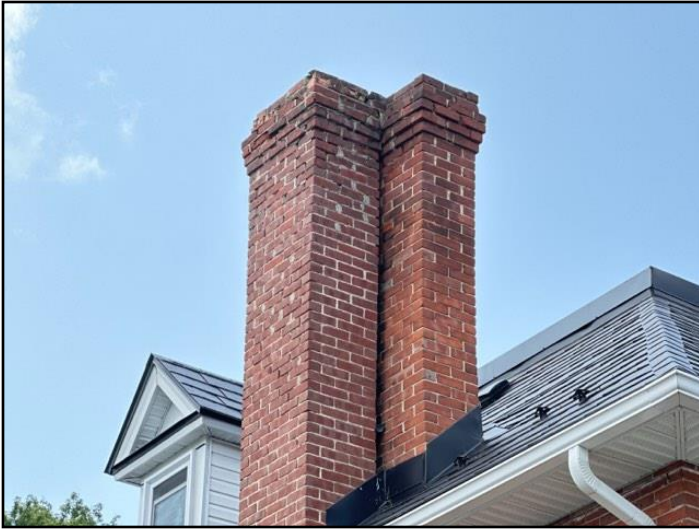
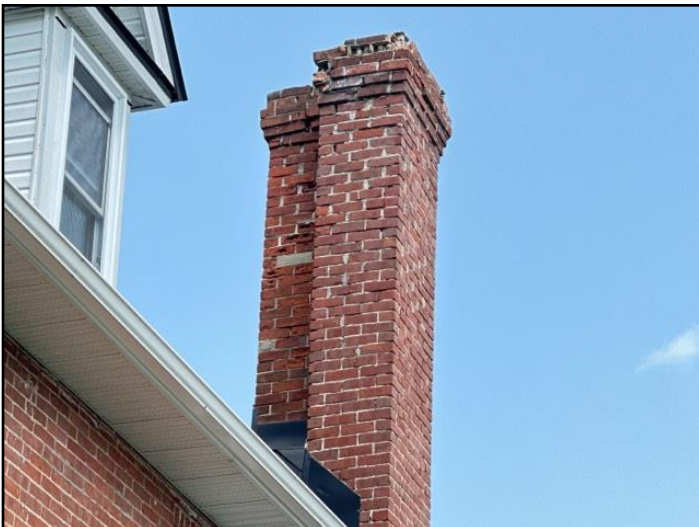
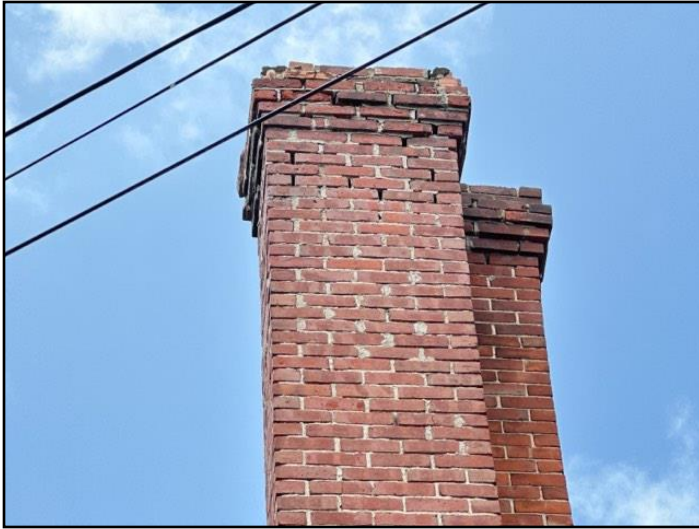
**45. Condition:** • [Loose, missing or deteriorated masonry](#)

**Implication(s):** Material deterioration

160. Loose, missing or deteriorated masonry

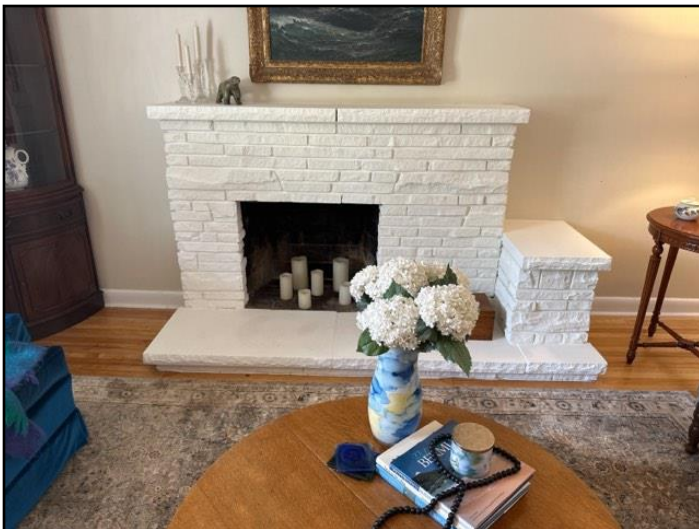
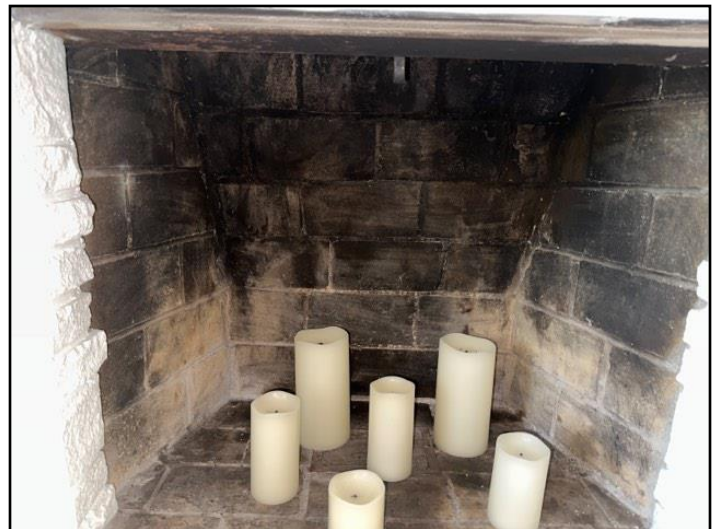
46. Condition: • Not functional

The fireplace in the house is decorative only and can not be used for a fire. There is no visible chimney liner, the chimney is severely deteriorated and is missing a cap.

Implication(s): System inoperative

166. Not functional

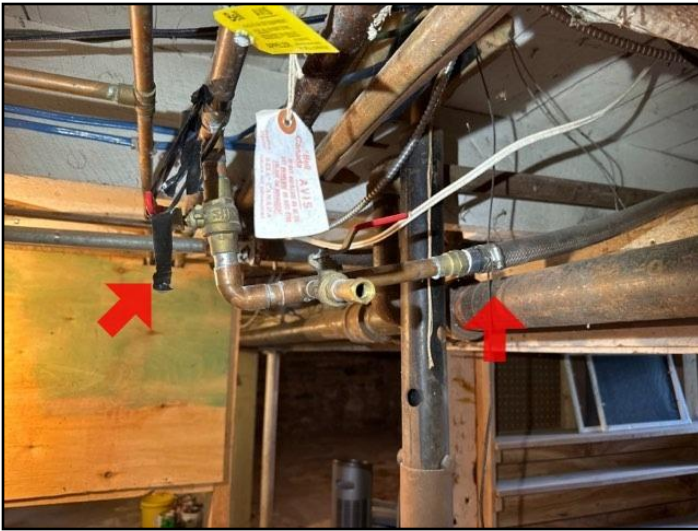
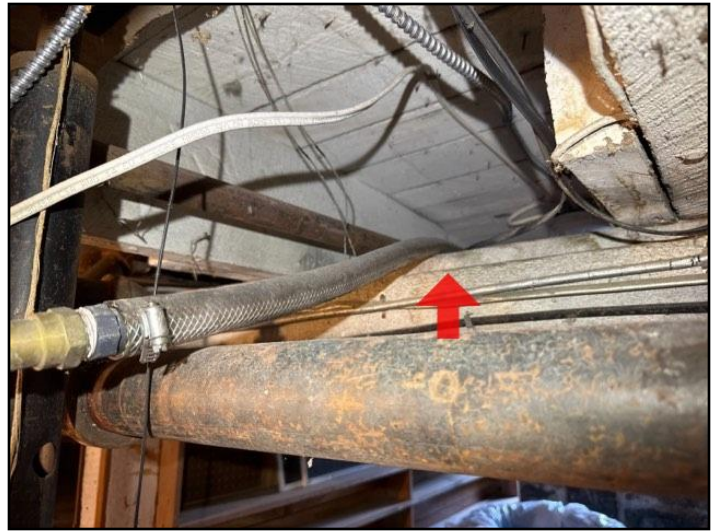
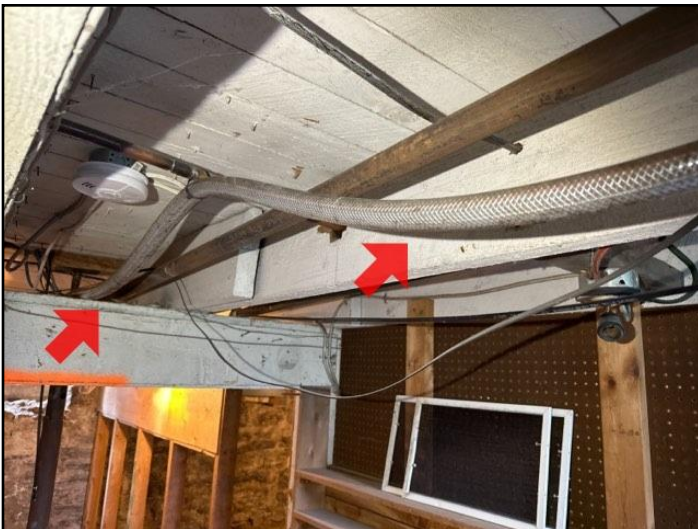
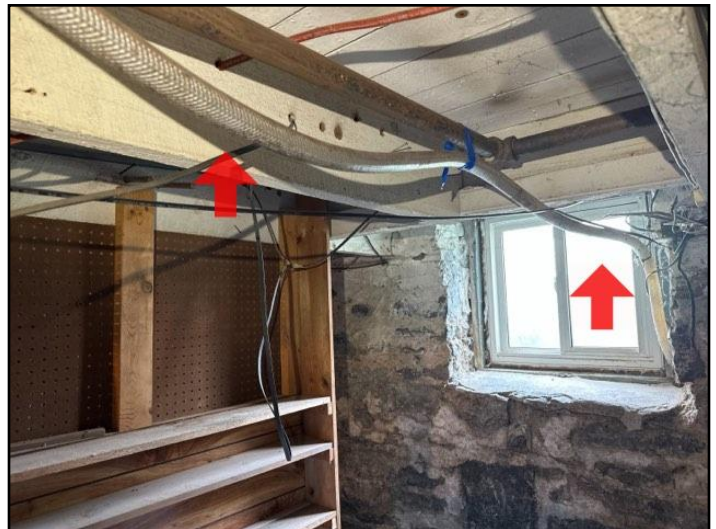
**47. Condition:** • [Non-standard material](#)

**Implication(s):** Chance of water damage to structure, finishes and contents | Reduced system life expectancy | No water

170. Non-standard material

Replace the spa-flex line that has been used as a water supply line and run through the east basement window opening. Secure the loose shut-off valves at the connection to the spa-flex line.

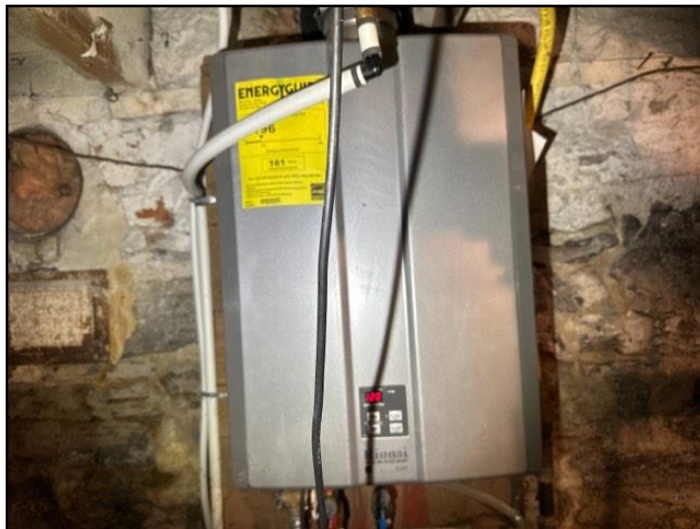
48. Condition: • [Near end of life expectancy](#)

174. Near end of life expectancy

The water heater should be budgeted for replacement due to the age of the unit. The average life span of an on demand water heater is 13-17 years.

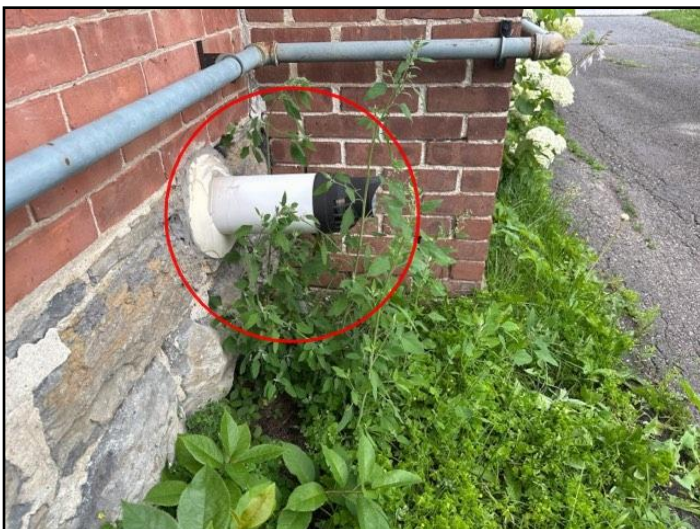
49. Condition: • [Rust, dirty, obstructed](#)

**Implication(s):** Equipment not operating properly | Hazardous combustion products entering home

175. Rust, dirty, obstructed

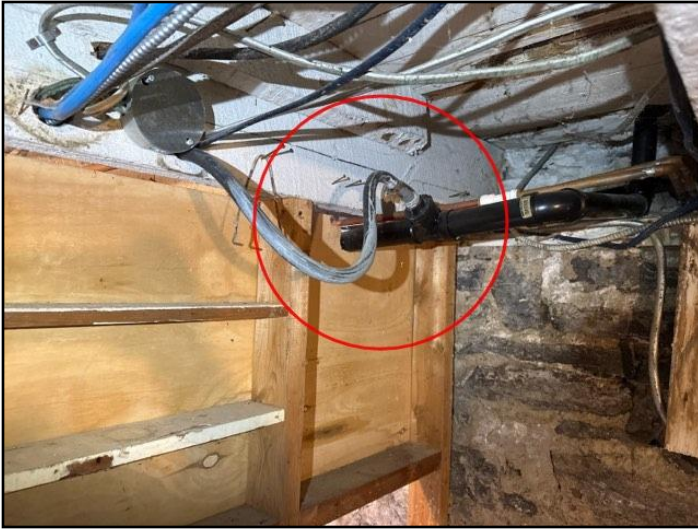
178. Dishwasher drain connections

**51. Condition:** • [Dishwasher drain connections](#)

**Implication(s):** Chance of water damage to structure, finishes and contents

**Task:** Repair

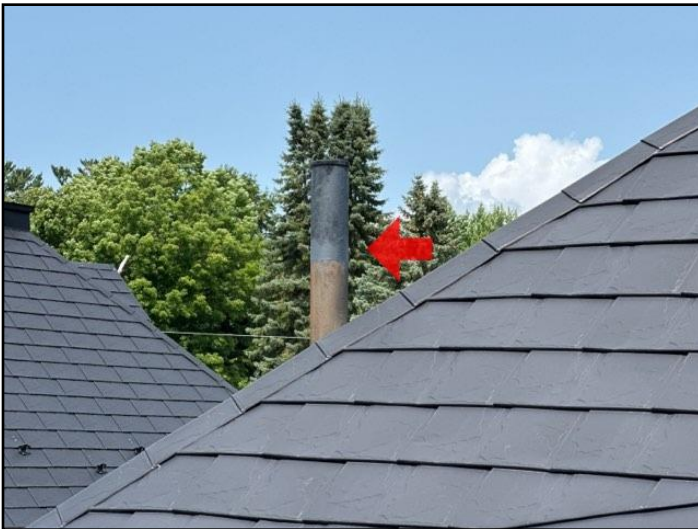
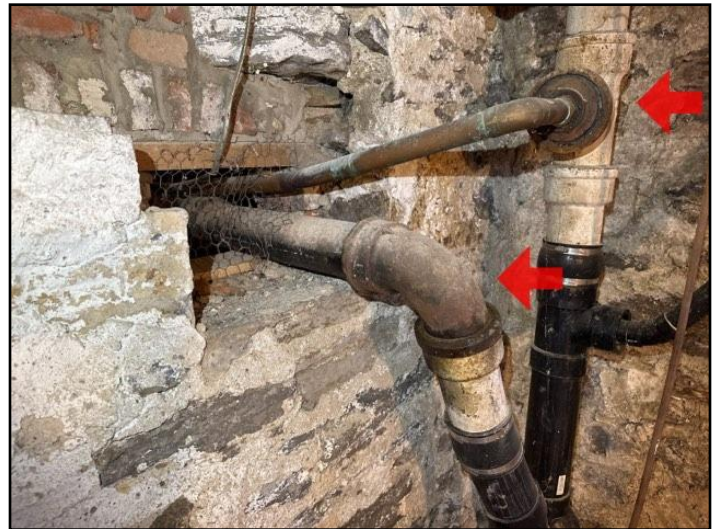
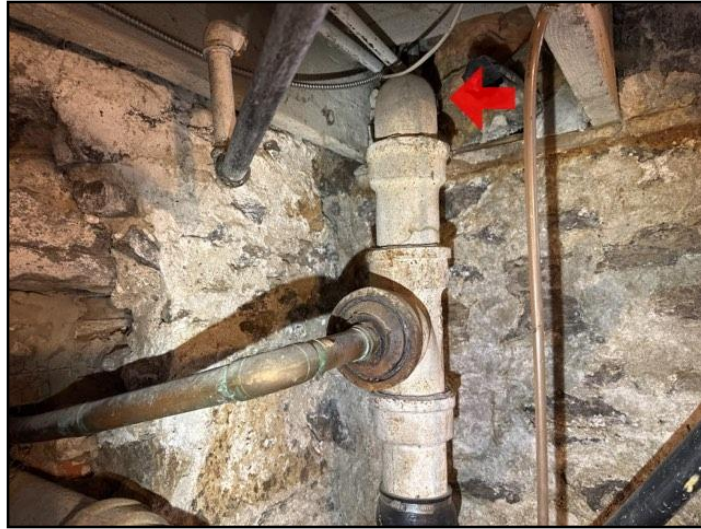
**52. Condition:** • Old piping

Cast iron waste plumbing piping was used regularly in residential construction into the late 1960s. The typical life span of cast iron is approximately 50 years. Some insurance companies are requiring it to be scoped. It is recommended that you contact your insurance provider and request their policy on cast iron waste plumbing pipes. It is recommended that you have the cast iron drains scoped at this time.

**Task:** Request disclosure from insurance provider

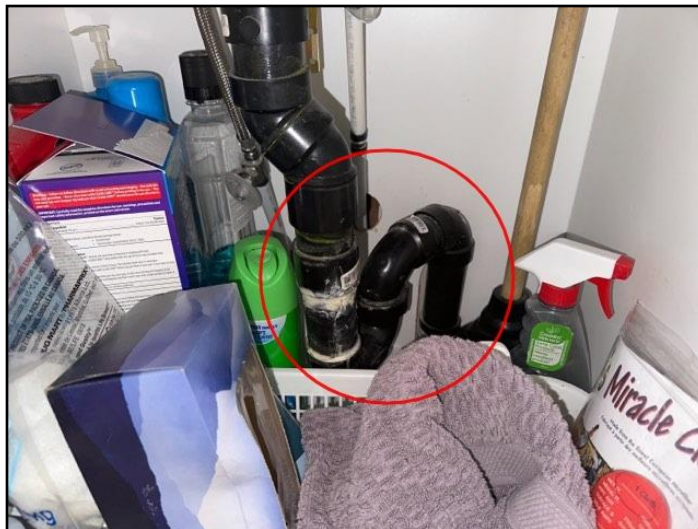
183. Wrong type

53. Condition: • [Wrong type](#)

Replace the "S" trap below the second floor bathroom sink with the proper "P" trap.

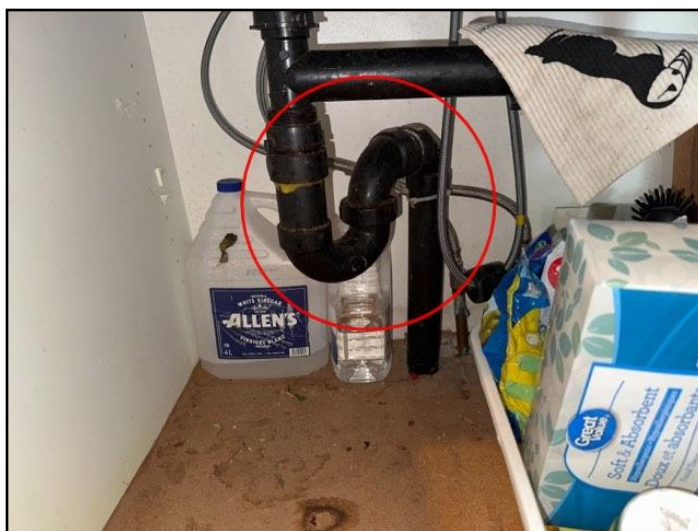
184. Wrong type

**54. Condition:** • [Wrong type](#)

Replace the "S" trap below the first floor kitchen sink with the proper "P" trap.

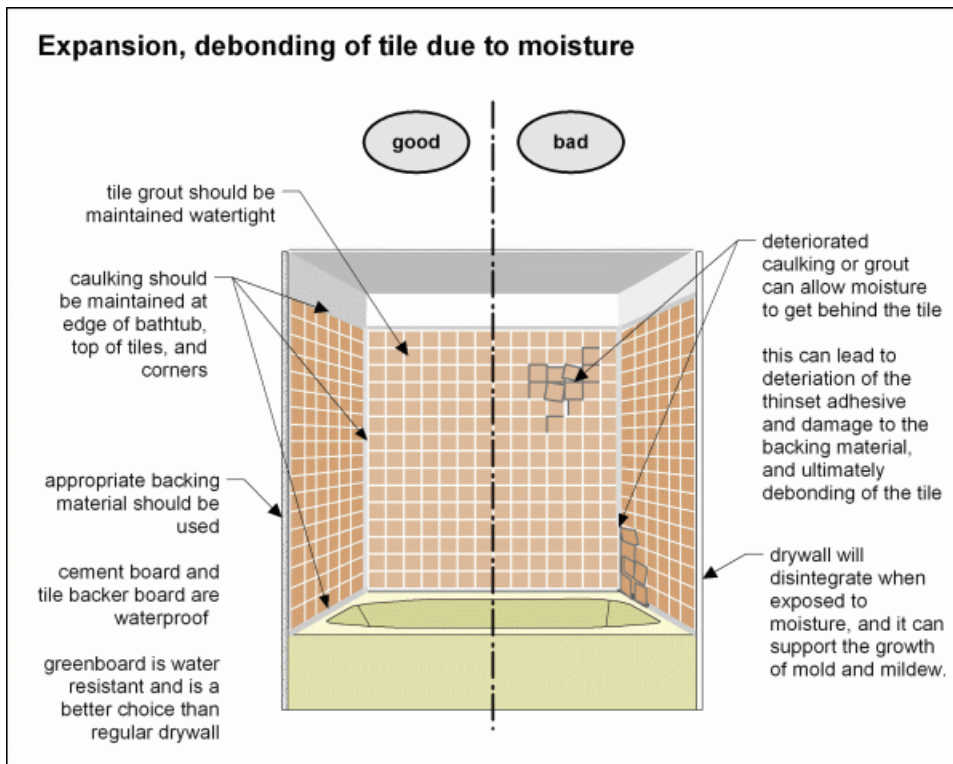
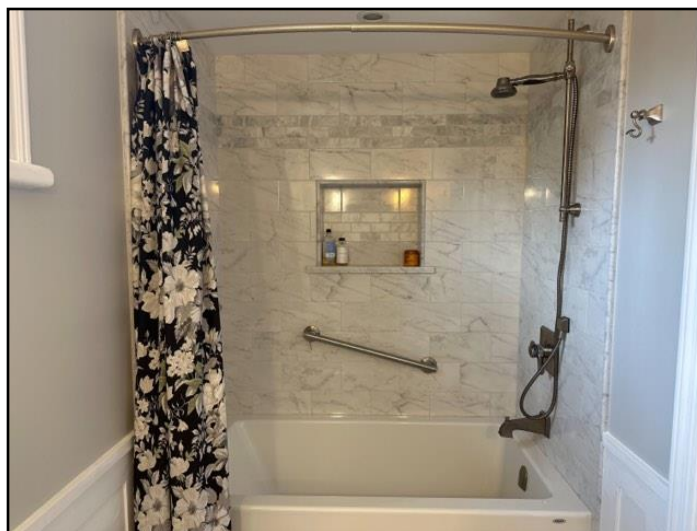
185. Caulking loose, missing or deteriorated

**55. Condition:** • [Caulking loose, missing or deteriorated](#)

**Implication(s):** Chance of water damage to structure, finishes and contents

Provide the missing caulking at the tile intersections of the main second floor bathroom bathtub enclosure.

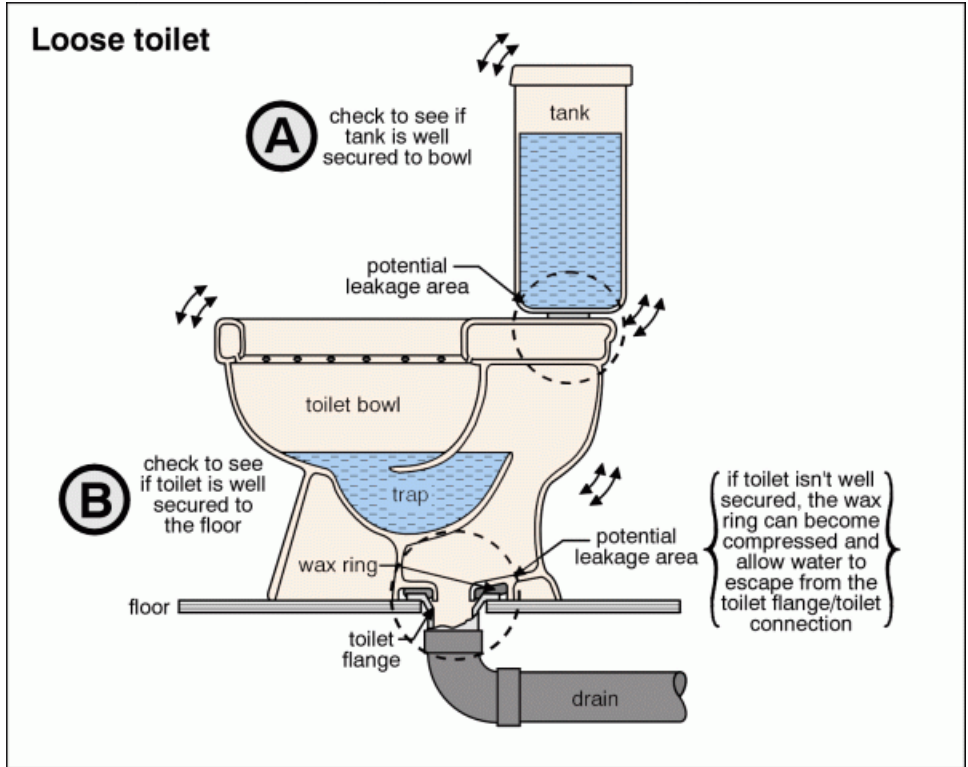
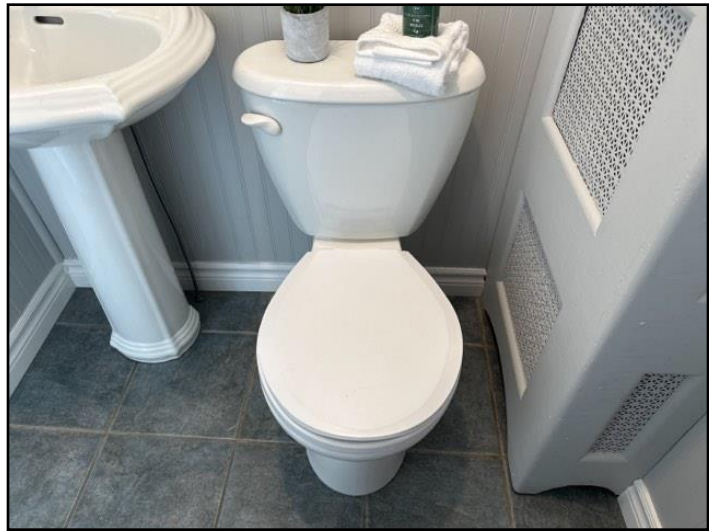
186. Loose

**56. Condition:** • [Loose](#)

**Implication(s):** Chance of water damage to structure, finishes and contents | Sewage entering the building | Possible hidden damage

Secure the loose toilet in the first floor bathroom.

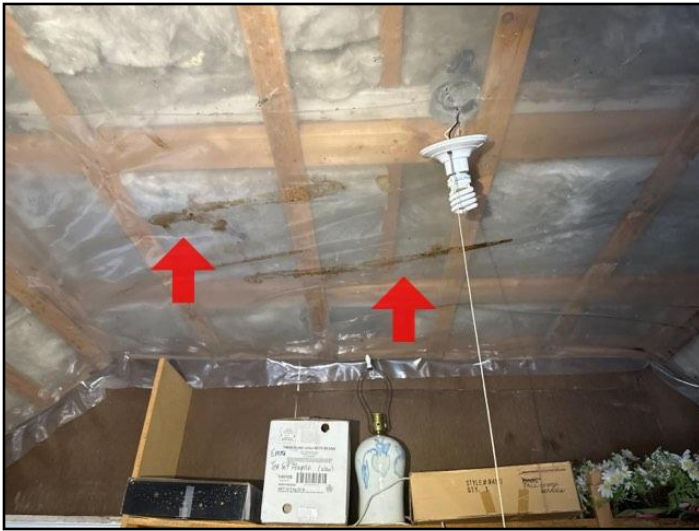
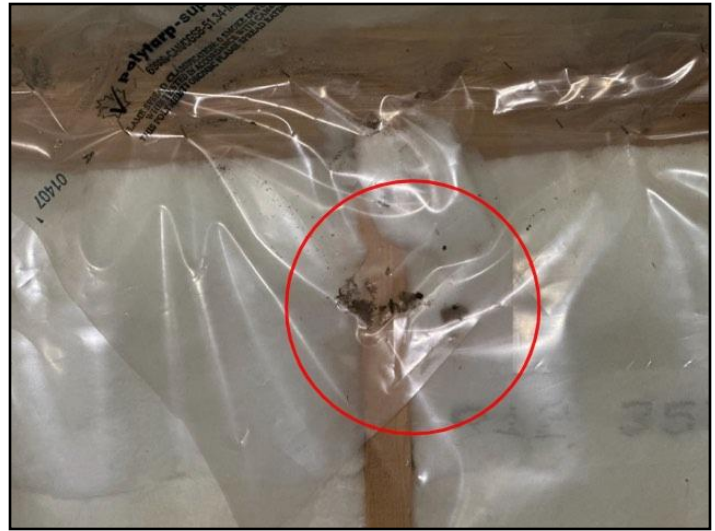
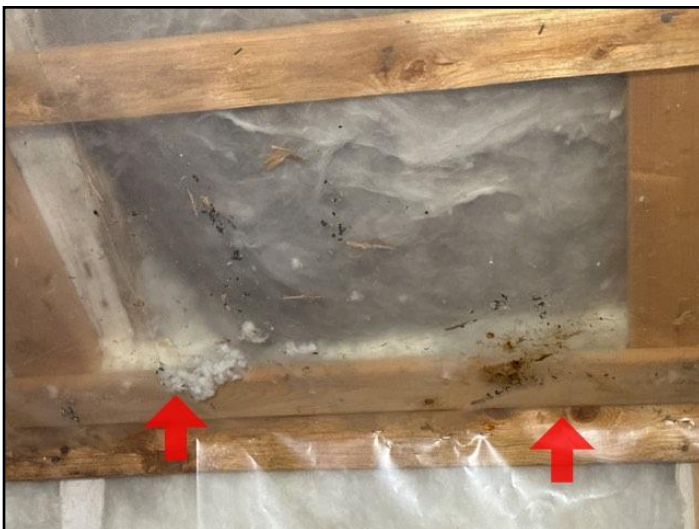
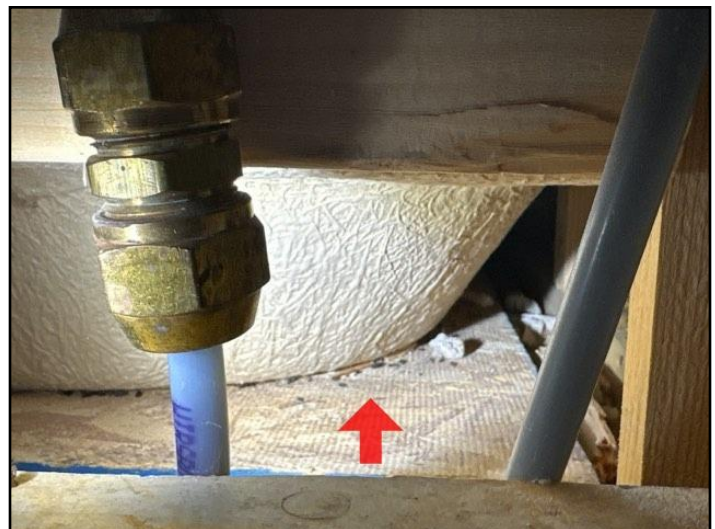
**57. Condition:** • [Pest activity evident](#)

Further evaluation is required of the pest activity observed in the attic and below the ensuite bathroom shower stall.

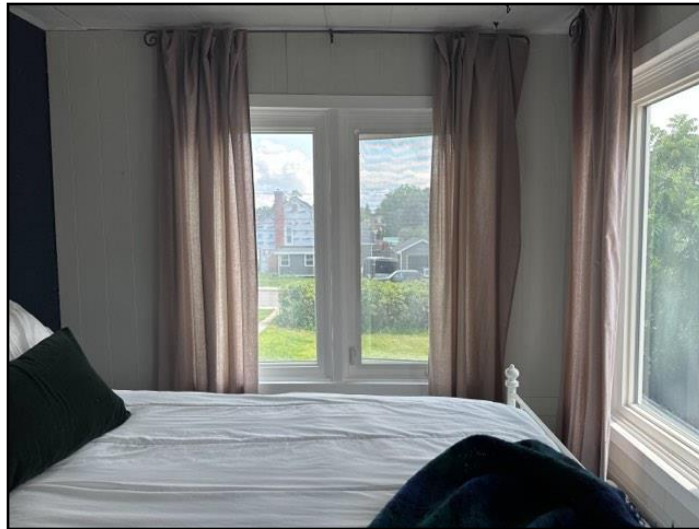
191. Inoperative

58. Condition: • [Inoperative](#)

**Task:** Repair

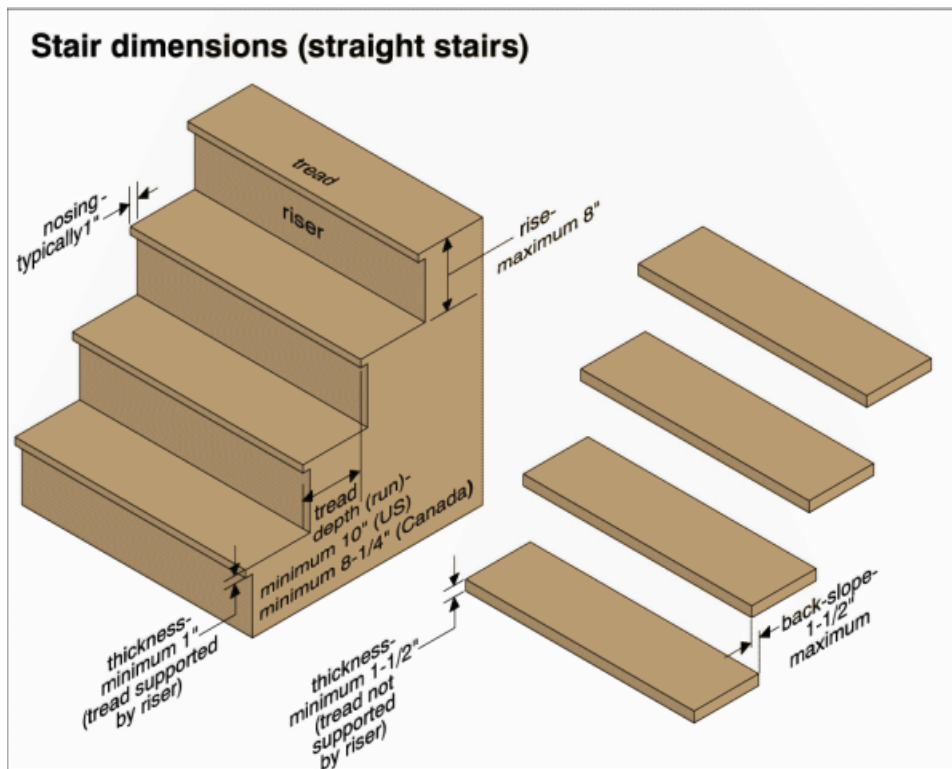
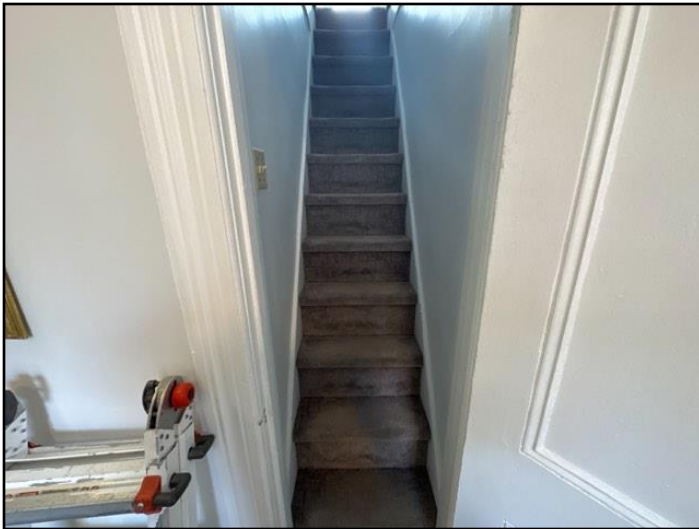
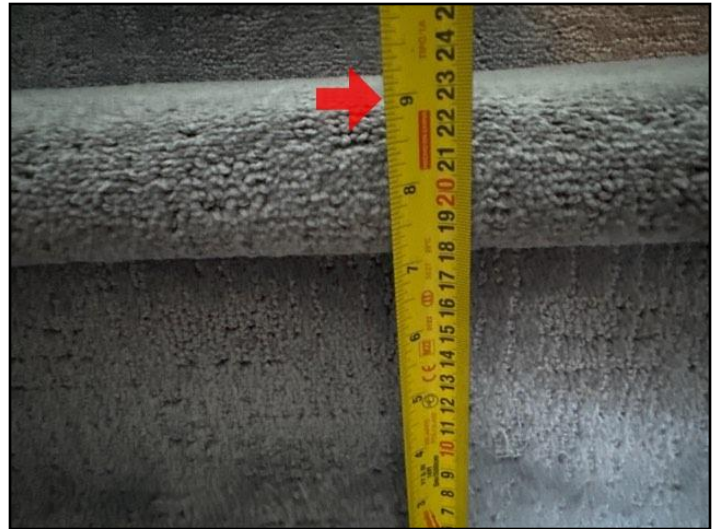
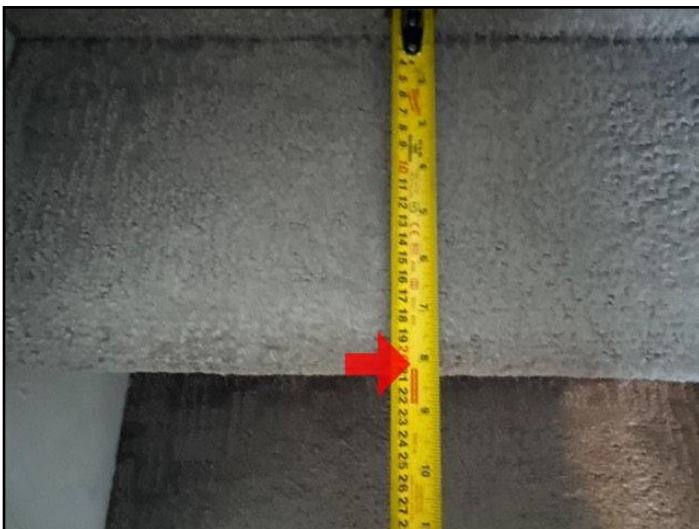
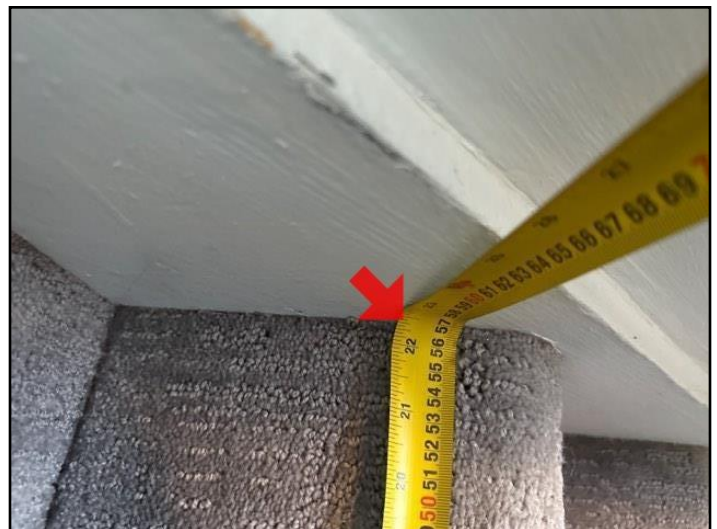
### 59. Condition: • [Rise excessive](#)

**Implication(s):** Trip or fall hazard

**Task:** Monitor

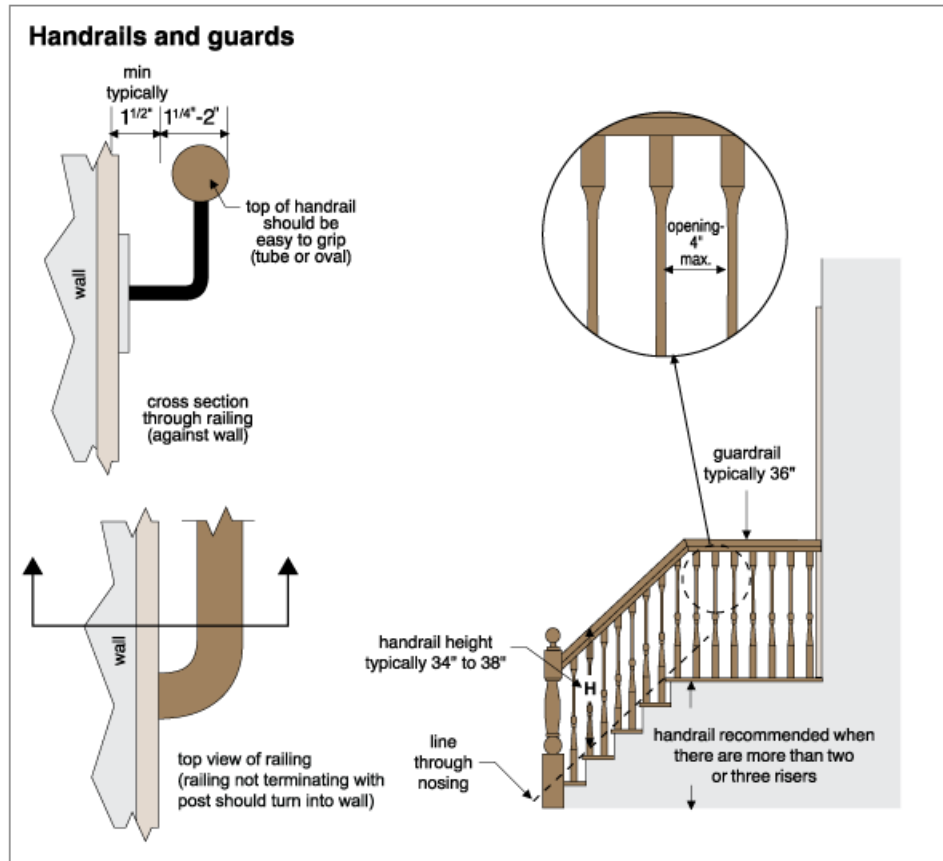
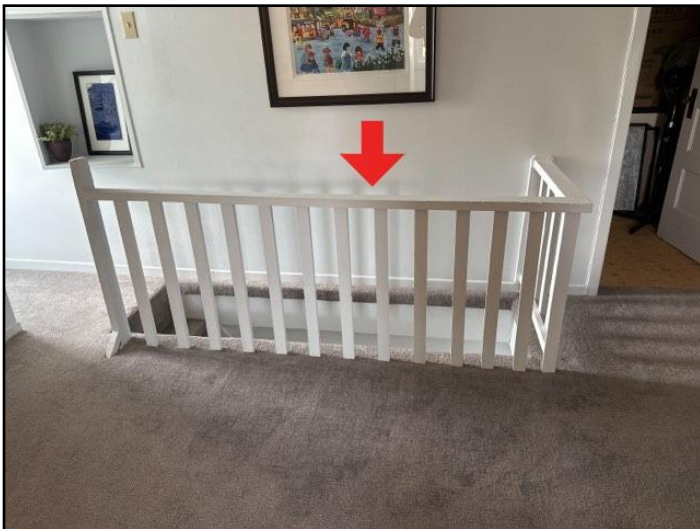
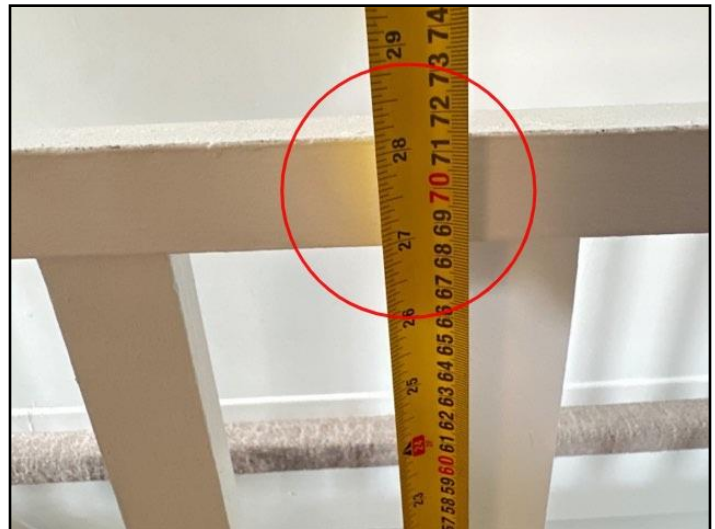
60. Condition: • [Too low](#)

**Implication(s):** Fall hazard

**Task:** Repair

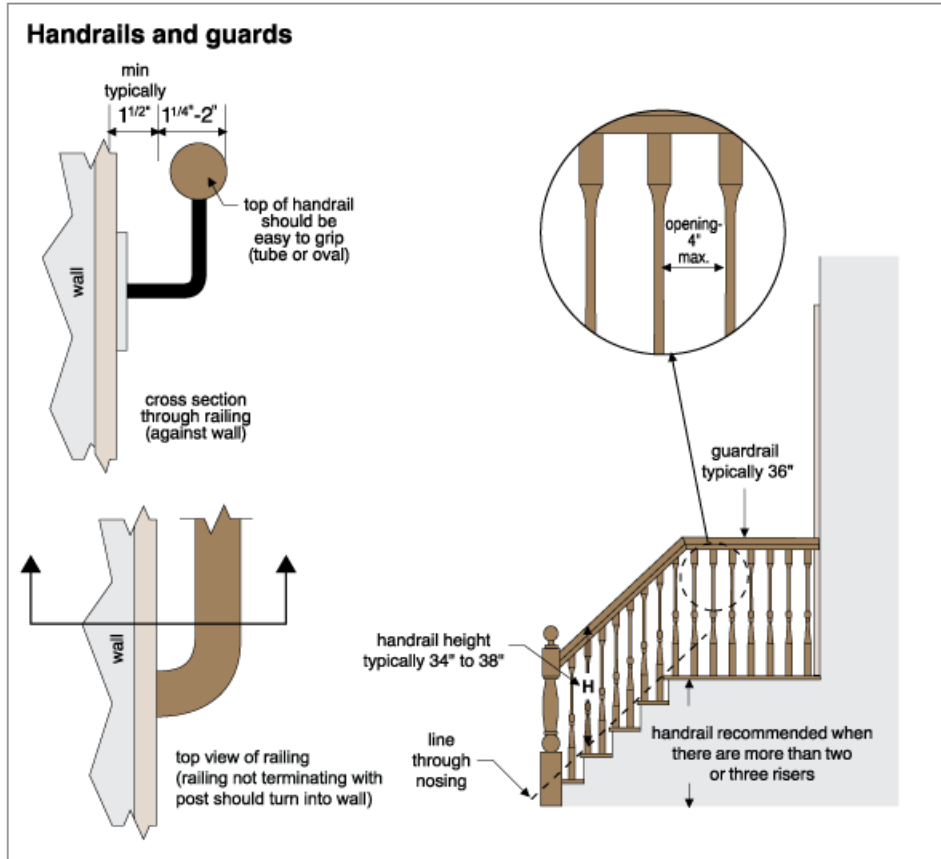
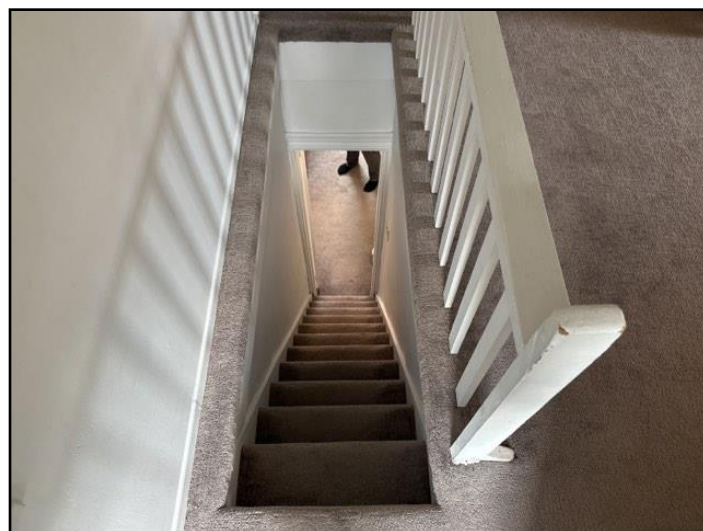
198. Missing

61. Condition: • [Missing](#)

Implication(s): Fall hazard

Install the missing handrail for the third floor stairs.

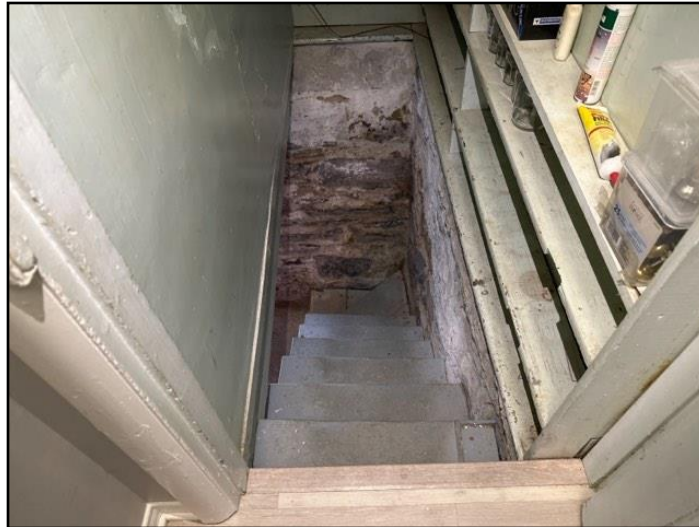
199. Missing

**62. Condition:** • [Missing](#)

**Implication(s):** Fall hazard

Provide the missing handrail for the basement stairs.

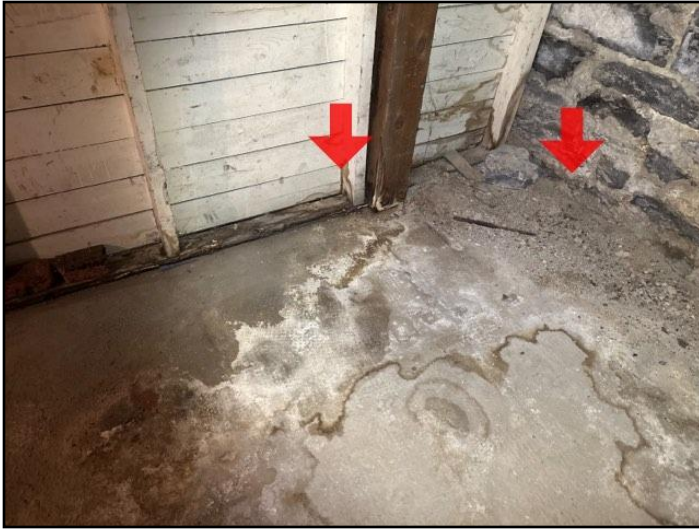
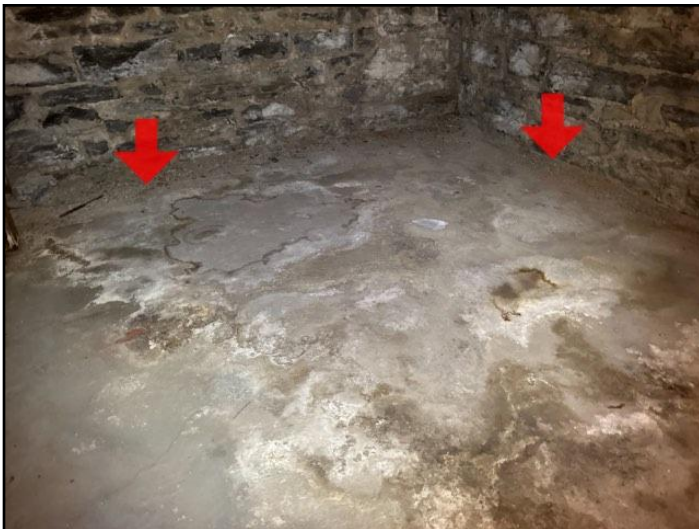
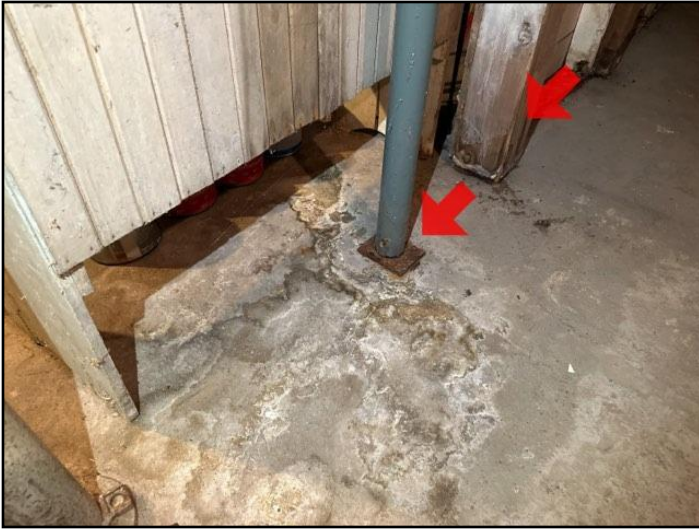
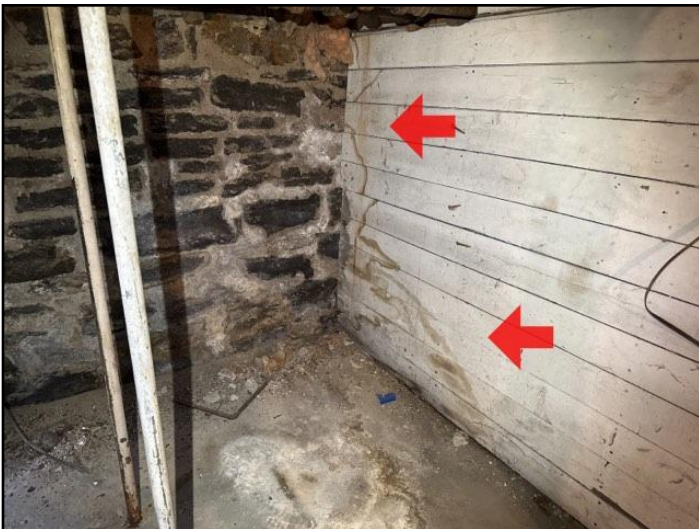
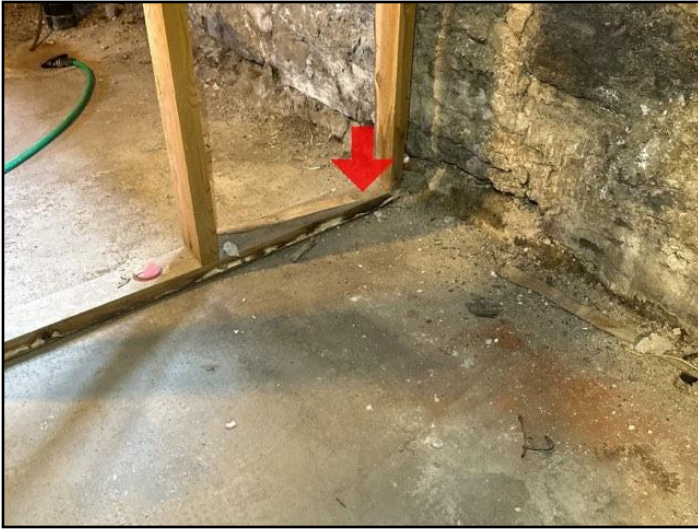
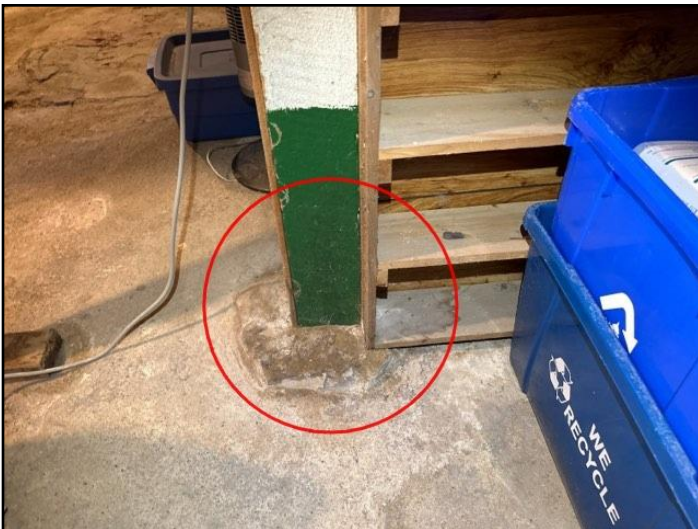
**63. Condition:** • [Stains](#)

There are signs of regular flooding in the basement. The basement should not be used for storage. The steel posts will need to be checked regularly for rust and required replacement. The basement will need constant airflow and a dehumidifier to remove some of the dampness. It is common to have water problems in a basement with a stone foundation.

**Implication(s):** Chance of water damage to structure, finishes and contents

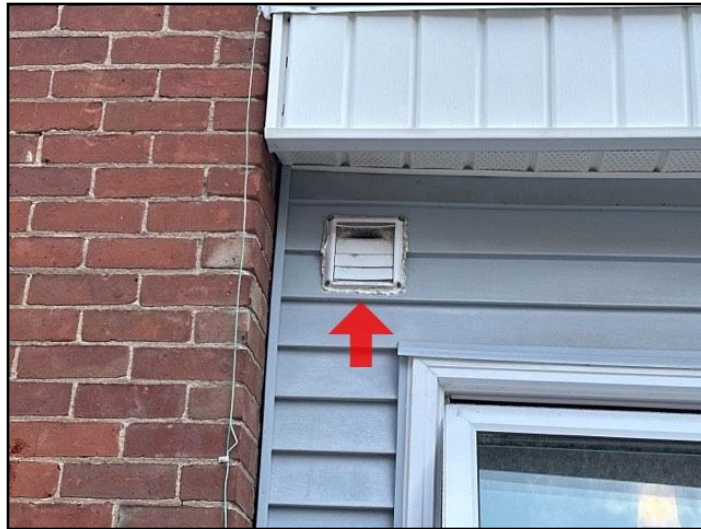
212. Clean dryer vent

**64. Condition:** • Clean dryer vent

**Task:** Regular maintenance
