YOUR INSPECTION REPORT

1 INSPECTION WAY
Kanata, ON

Saturday, November 25, 2023

Report No. 3559, v.2

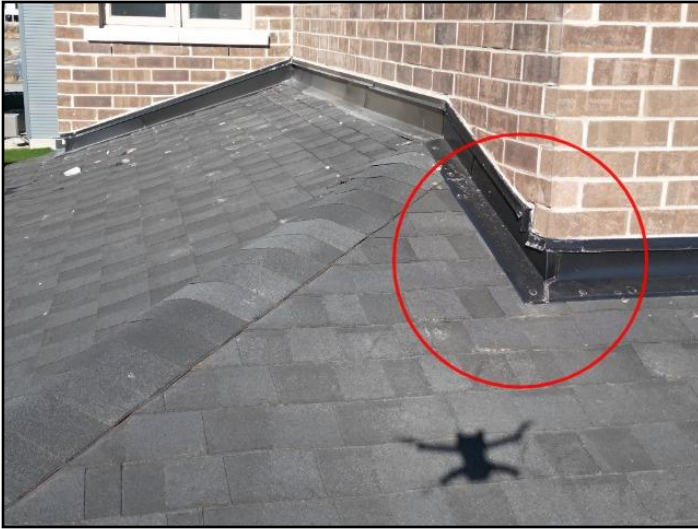
4. Condition: • [Damage, loose, open seams, patched](#)

10. Damage, loose, open seams, patched

Repair the loose and open seams in the roof-to-wall flashing on the garage and porch roofs. Repair the wall flashing at the transition from the garage to the porch roof that is not high enough above the porch roof.

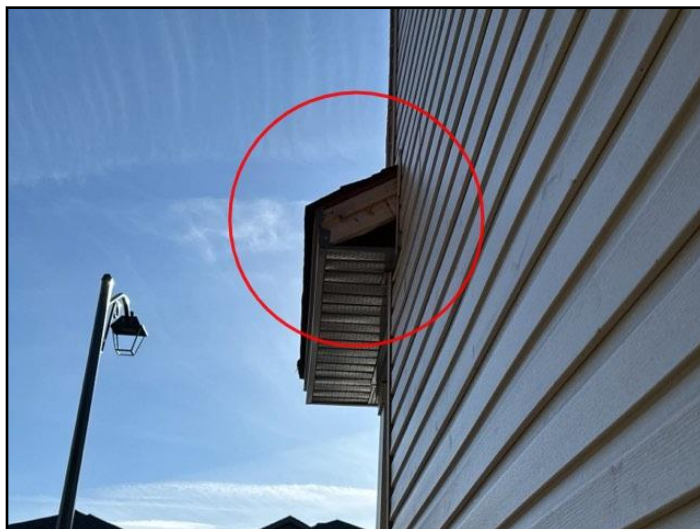
7. Condition: • [Loose or missing pieces](#)

17. *Loose or missing pieces*

Install the missing north facing fascia on the east side of the front porch roof.

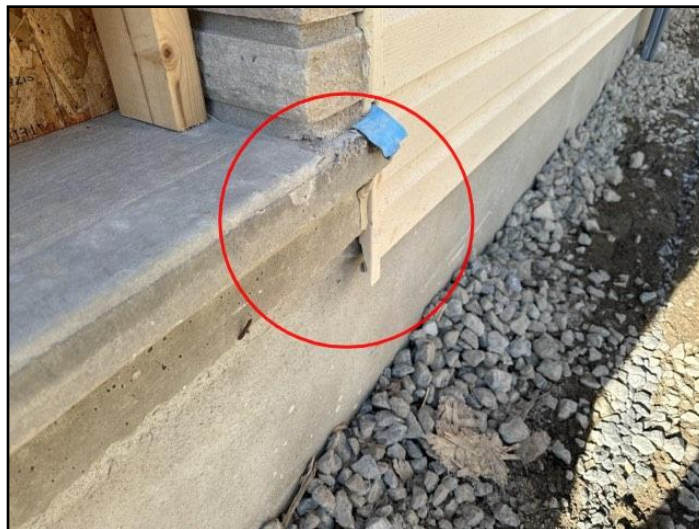
12. Condition: • [Caulking missing or ineffective](#)

23. Caulking missing or ineffective

Provide the missing caulking at the transition between the siding and foundation on the east side of the house below the front porch slab.

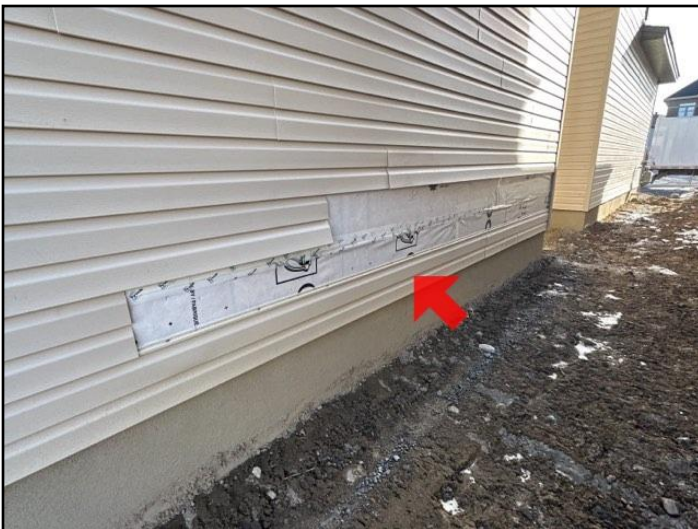
15. Condition: • [Loose or missing pieces](#)

26. Loose or missing pieces

Install the missing siding on the west wall of the house.

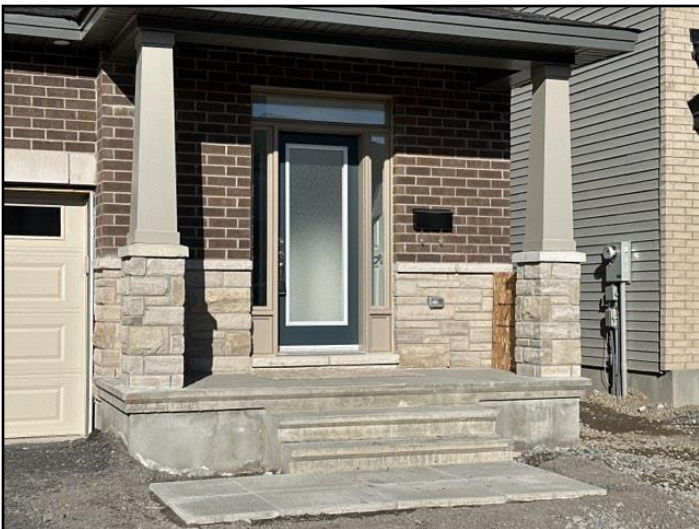
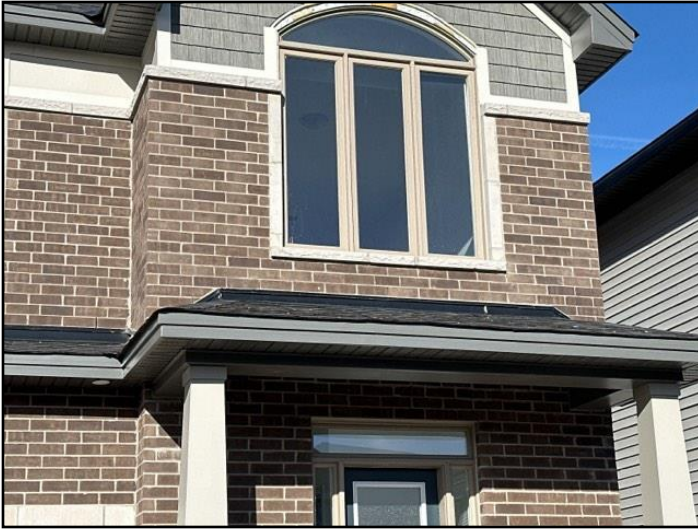
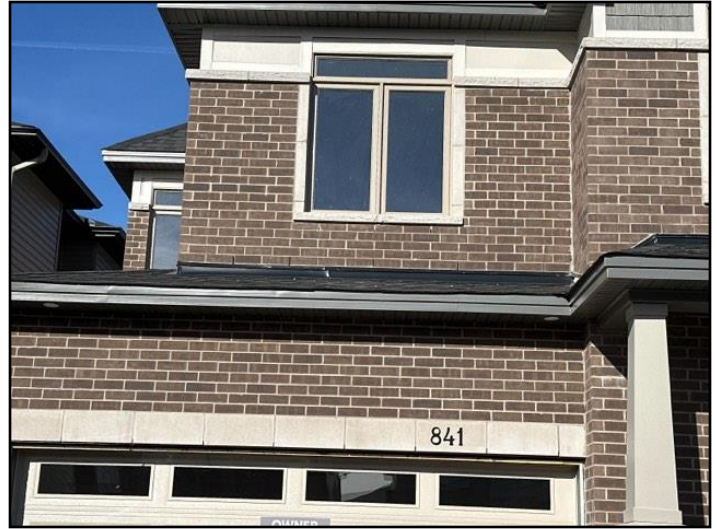
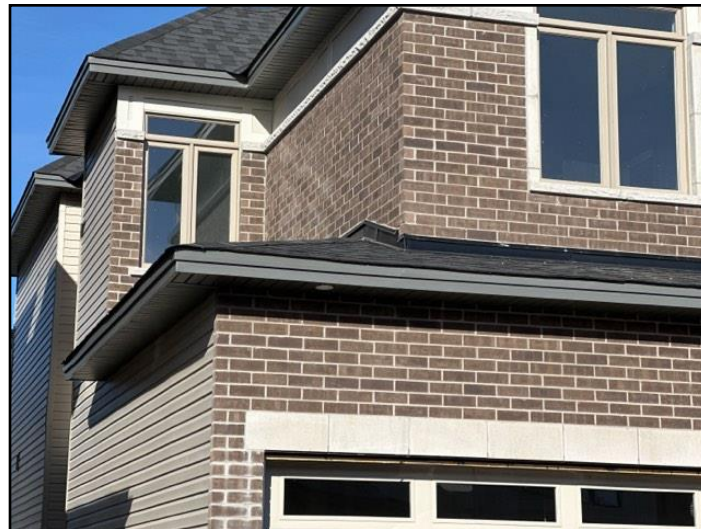
22. Condition: • Debris on brick

Repair the mortar splatter on the brick veneer walls on the south and west faces of the house that are visible from 6 meters away in natural light.

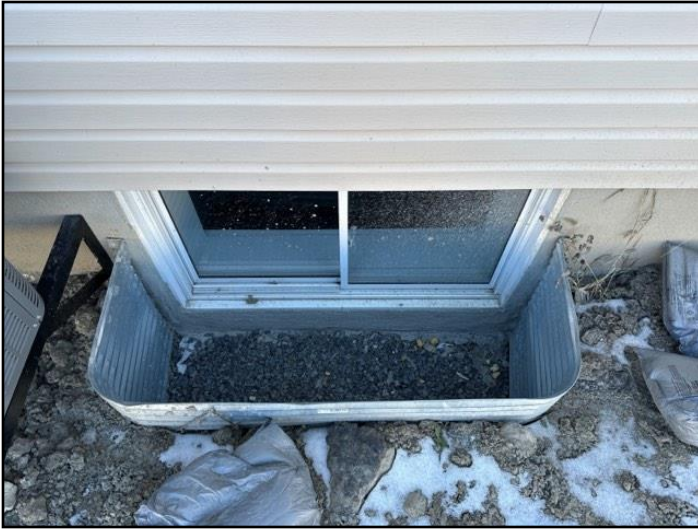
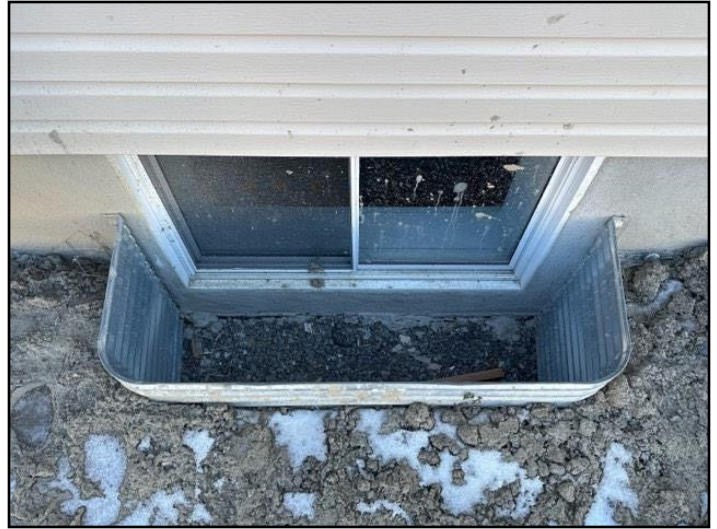
28. Condition: • Clean window well

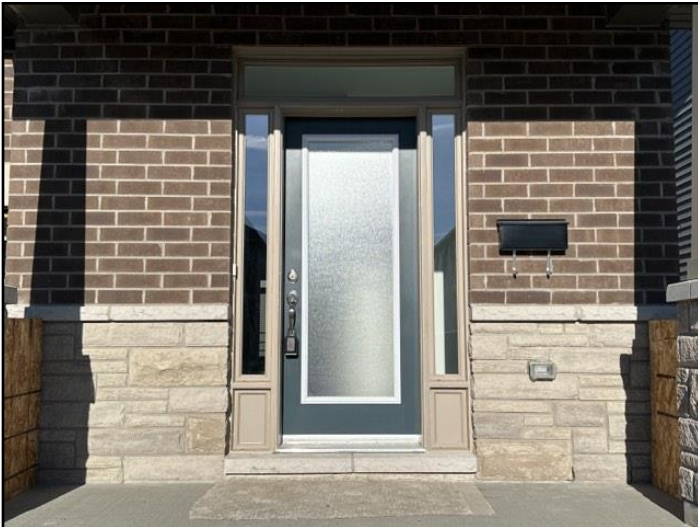
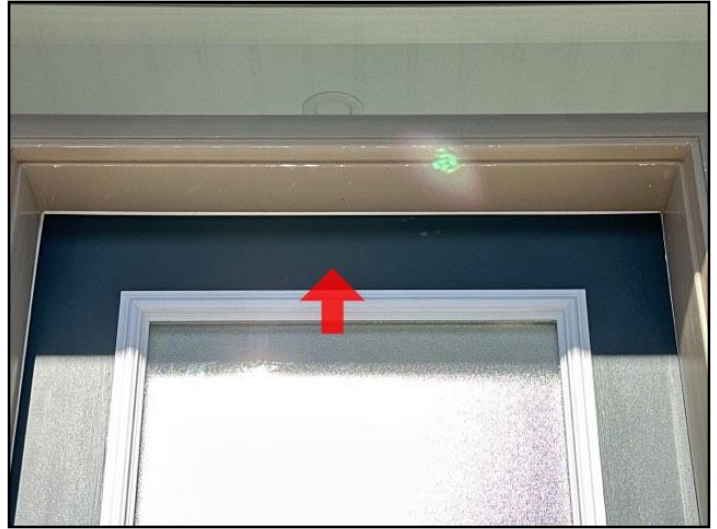
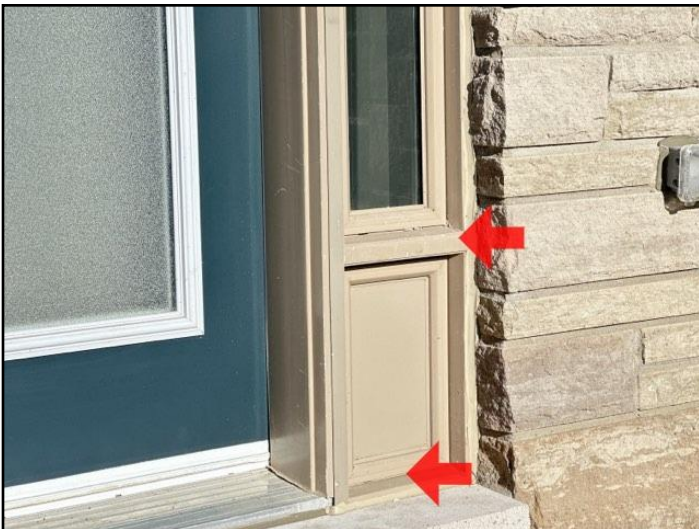
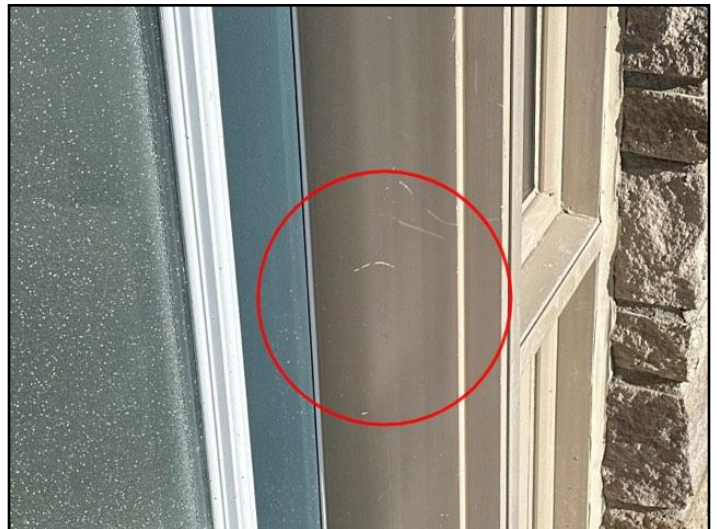
29. Condition: • [Damaged, cracked or loose](#)

Implication(s): Chance of damage to finishes and structure

Repair the scratches and chips in the front entrance door frame.

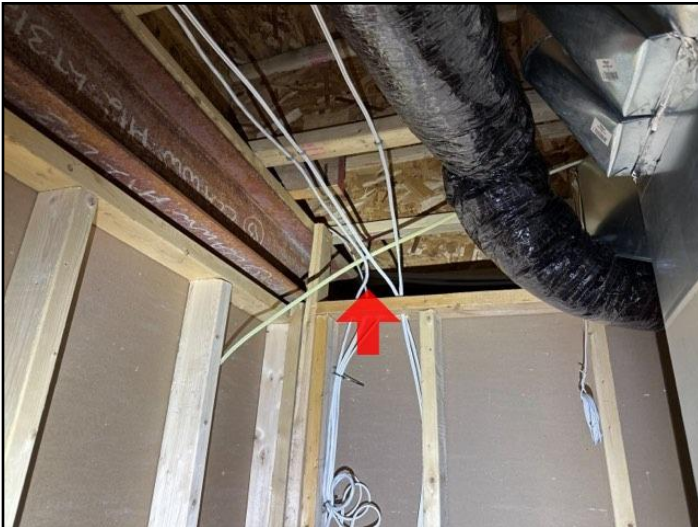
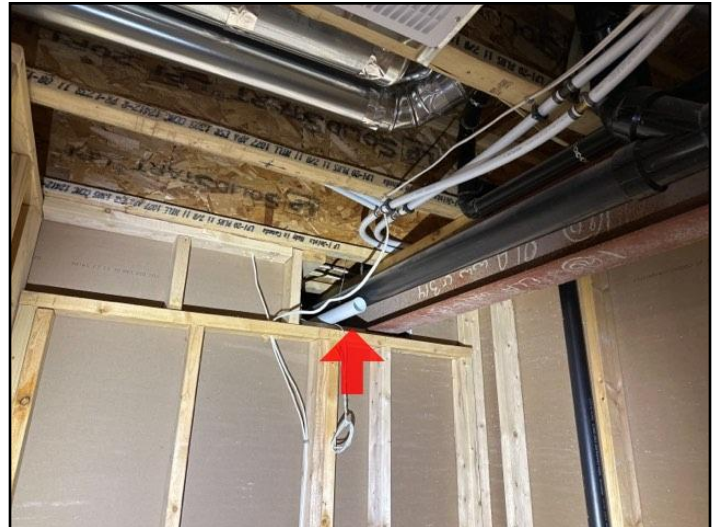
43. Condition: • [Not well secured](#)

Implication(s): Fire hazard | Electric shock

Secure the loose and hanging wires on the ceiling of the basement furnace room.

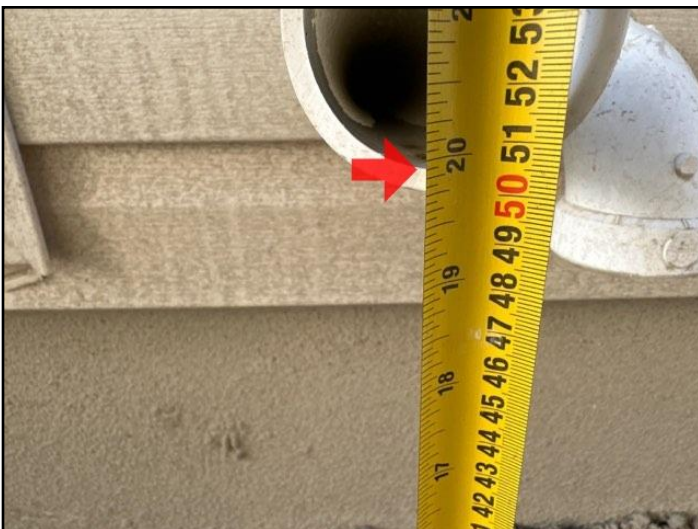
47. Condition: • Clearance to grade

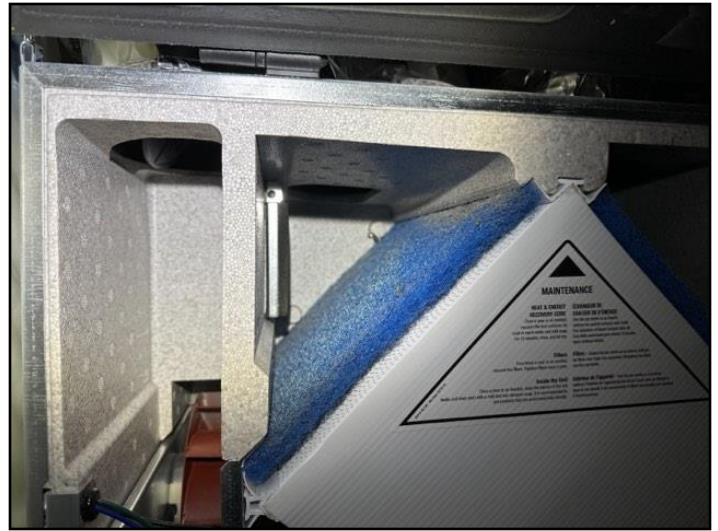
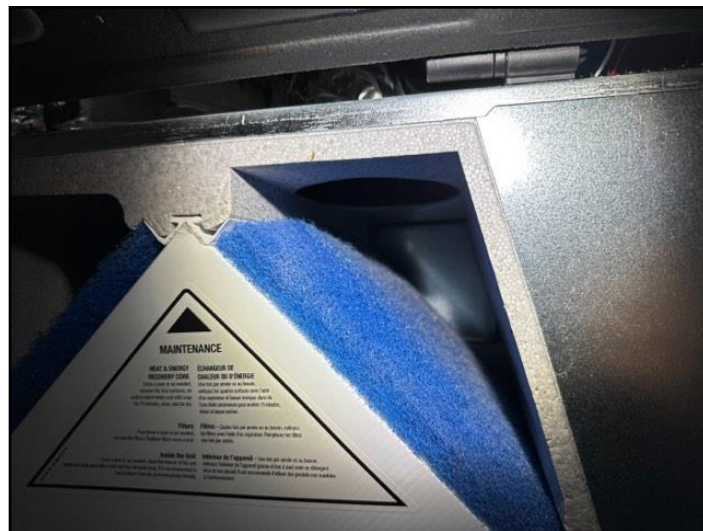
48. Condition: • Dirt in cabinet

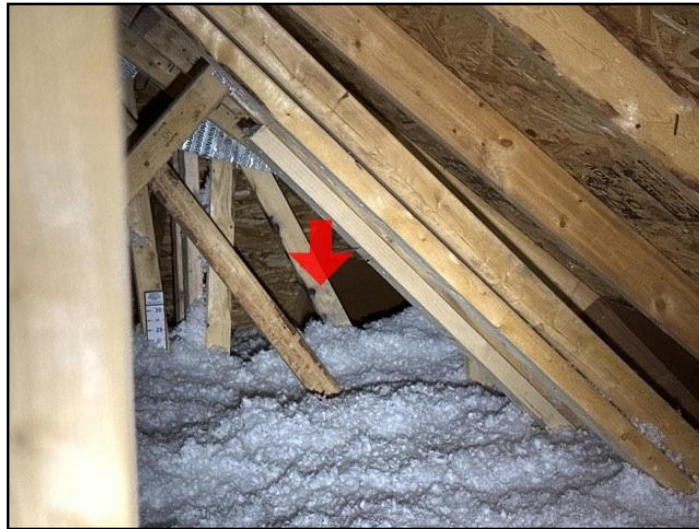
150. Gaps or voids

50. Condition: • [Gaps or voids](#)

Repair the low insulation on the west side of the attic where the birds were entering due to the lack of an exterior soffit.

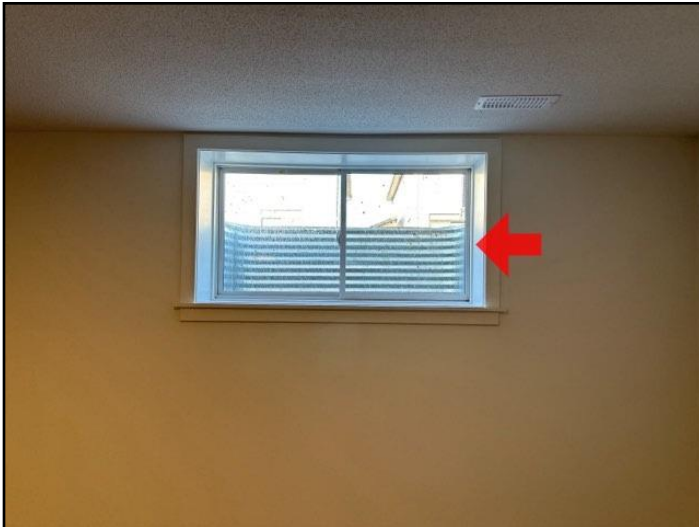
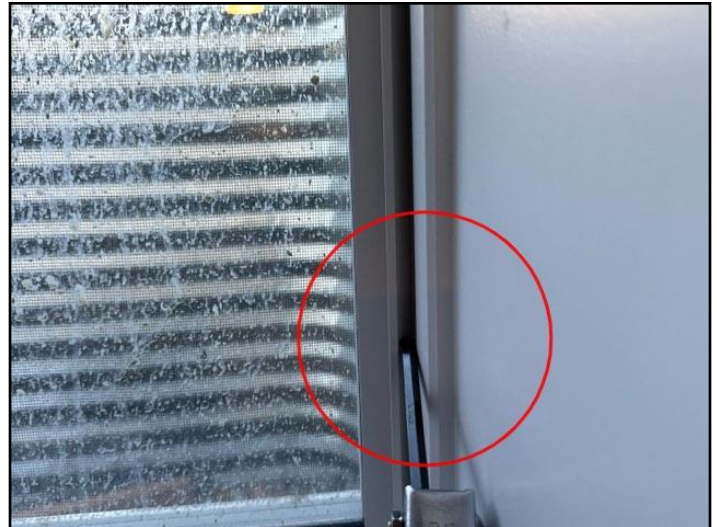
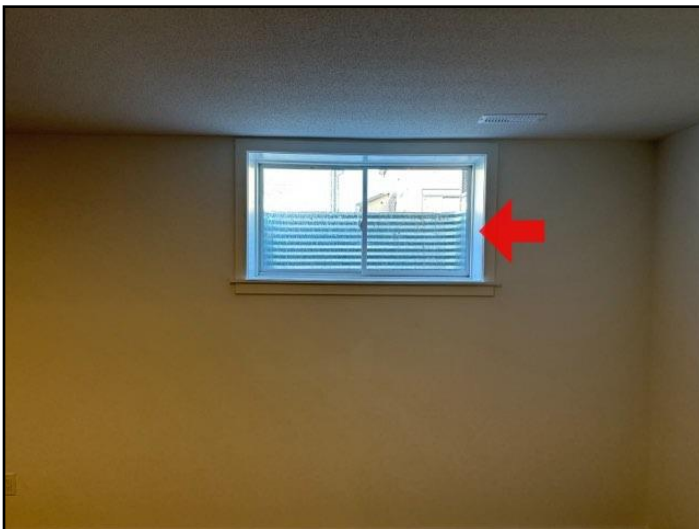
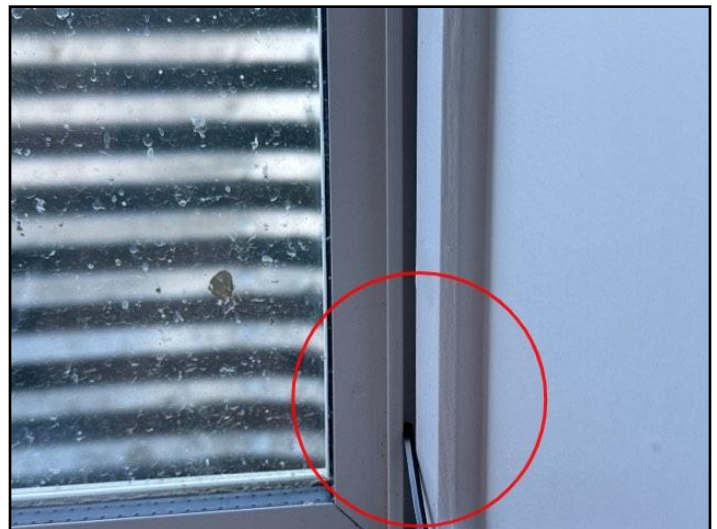
64. Condition: • Difficult to operate

Repair the rear basement family room windows. There is only 6.0 mm of clearance between the window flange and the trim on the west window, and there is only 2.5 mm of clearance between the window flange and the trim on the east window. There is insufficient room to grab the flange and push the window open.

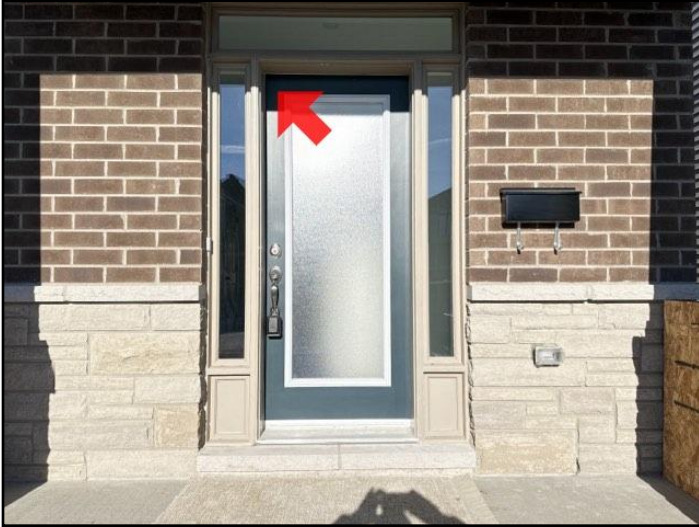
186. Weatherstripping missing or ineffective

68. Condition: • [Weatherstripping missing or ineffective](#)

Repair the front door that does not seal to the weatherstripping at the top west corner.

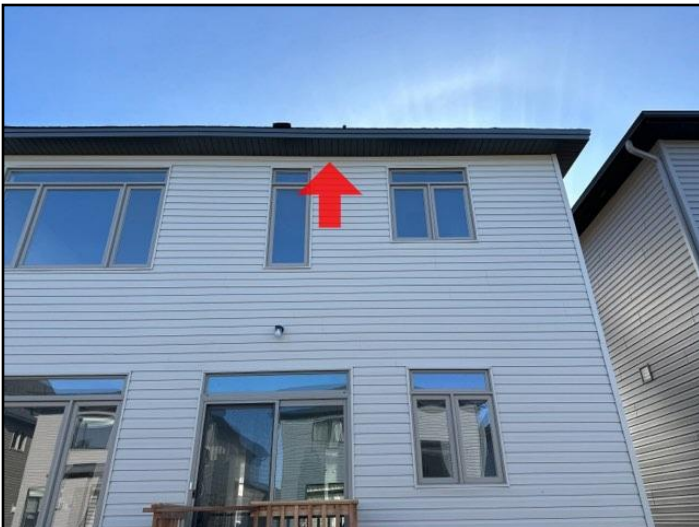
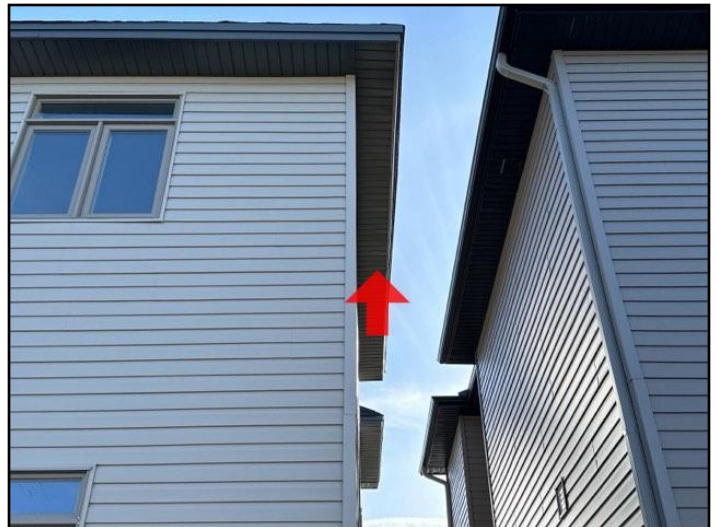
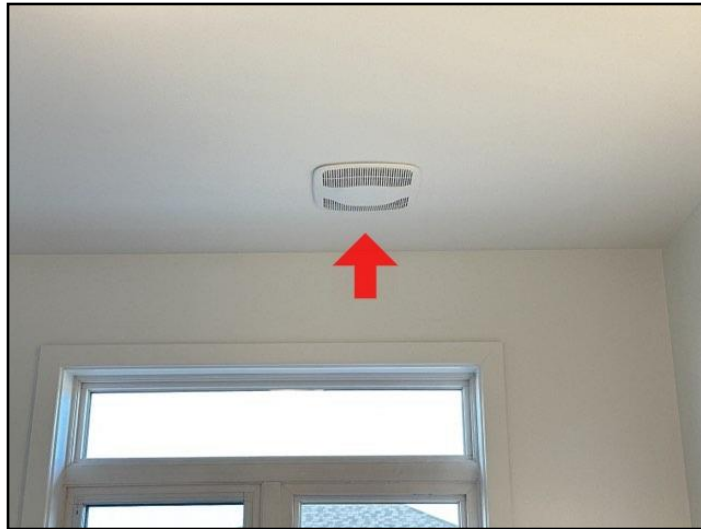
69. Condition: • Does not discharge to exterior

Repair the ensuite bathroom exhaust fan that does not vent to the exterior of the house.

Implication(s): Chance of condensation damage to finishes and/or structure | Poor ventilation can cause condensation.

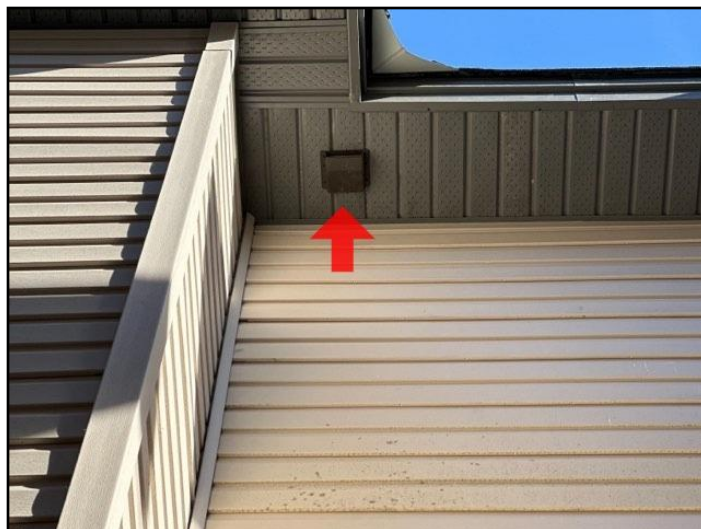
191. Clean dryer vent

70. Condition: • Clean dryer vent
The dryer vent needs to be cleaned regularly.
Location: West Second Floor Soffit
Task: Clean
Time: Regular maintenance
