# YOUR INSPECTION REPORT

1 INSPECTION WAY

Thursday, September 21, 2023

Report No. 3484, v.2

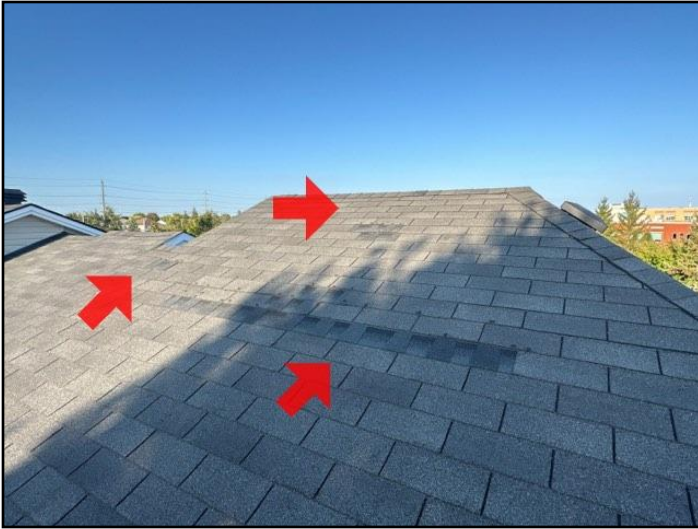
1. Patched

Monitor the patches to the roof on the west side of the house. The patches are present in good condition.

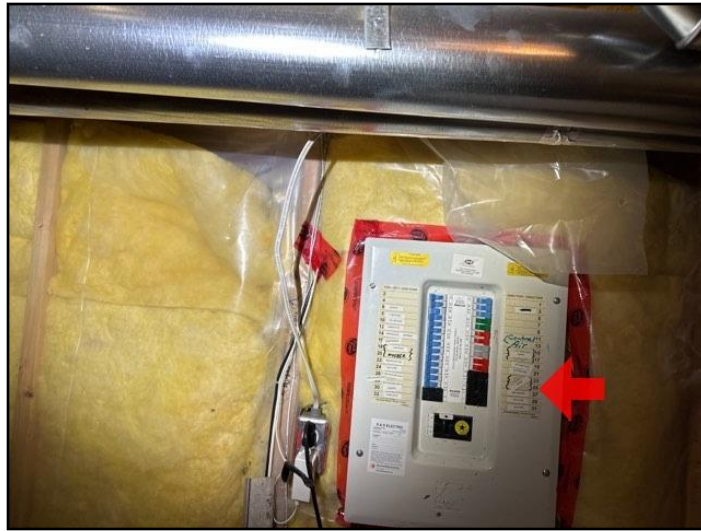
46. The house is equipped with a Federal Pacifi...

**Condition:** • [The house is equipped with a Federal Pacific Electrics Stab-Lok circuit breakers.](#)

The house is equipped with a Federal Pioneer Electric's "Stab-Lok" breaker panel. The breakers on these panels should be tested to determine that they are functioning properly. If the breakers are not functioning properly, they may fail to trip.

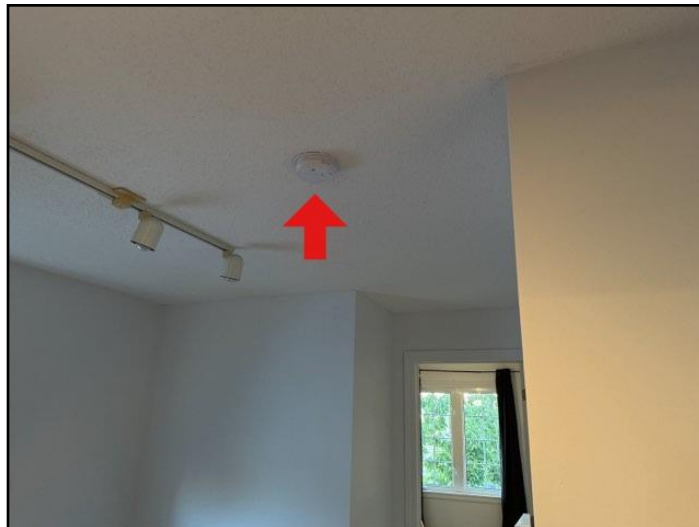
Replace the second floor electrically interconnected smoke detector with a combination smoke/CO detector.

62. None

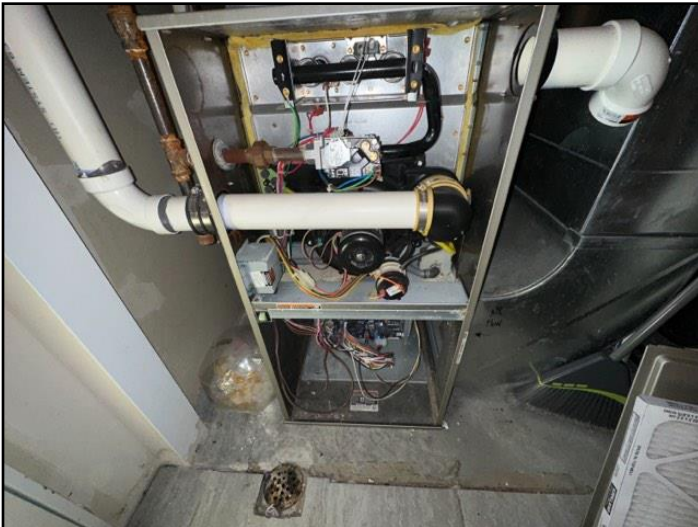
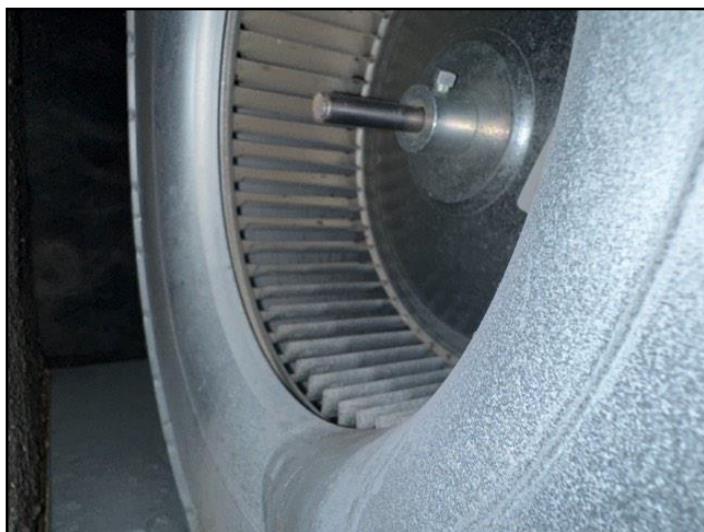
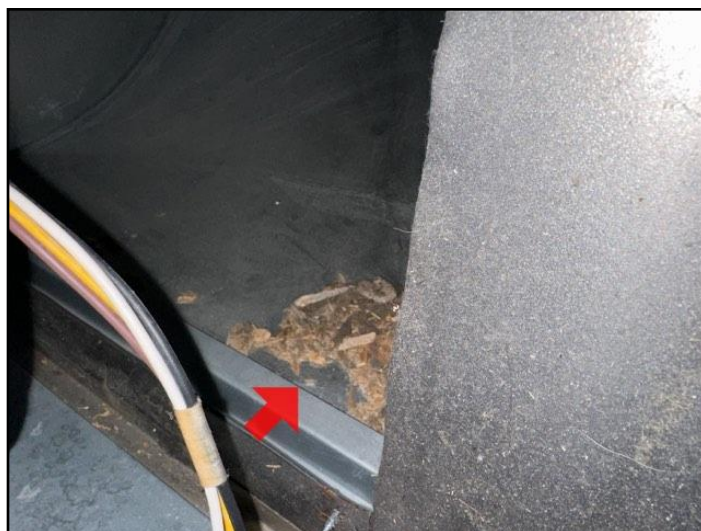
**26. Condition:** • Service Furnace

The furnace has been lacking maintenance and is full of dust and debris. There are signs of a condensation leak at the front of the furnace. The furnace needs to be serviced at this time. The furnace should be serviced annually in the fall before the start of the heating season going forward.

64. Service Furnace

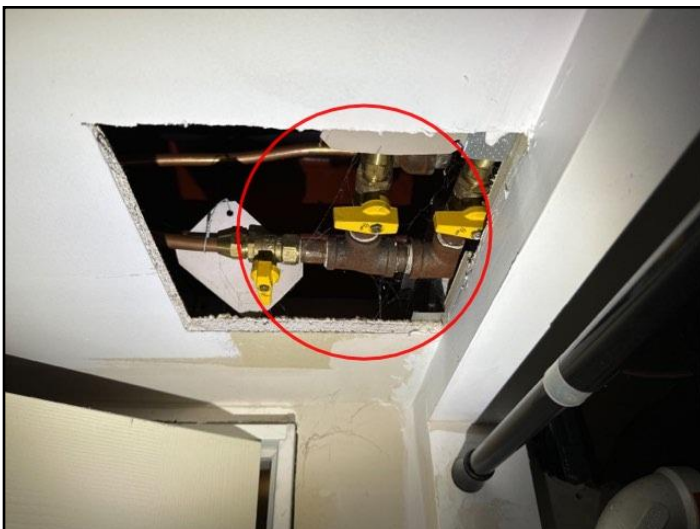
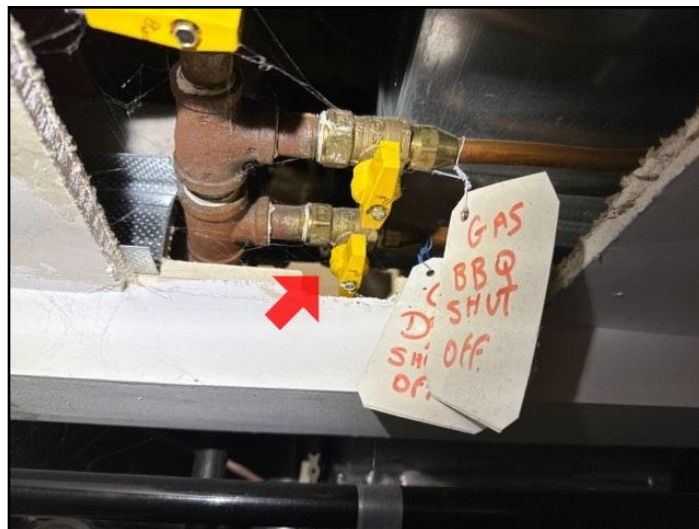
**28. Condition:** • Gas lines can only be modified by a gas fitter

70. Gas line can not be modified by person othe...

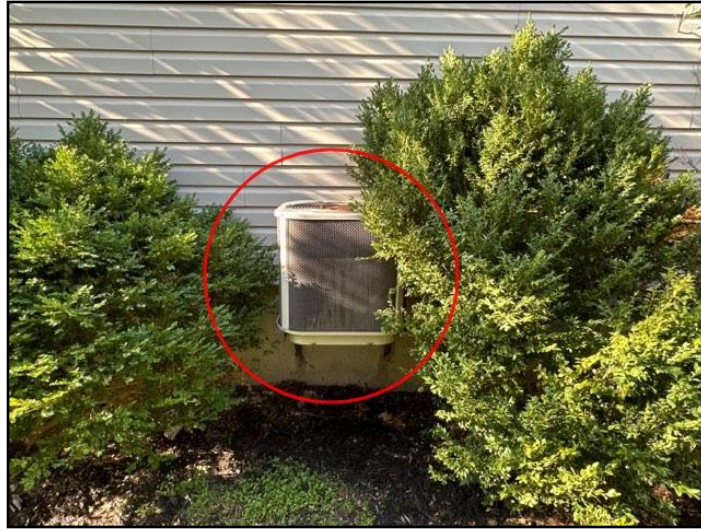
**32. Condition:** • Poor access

76. Poor access

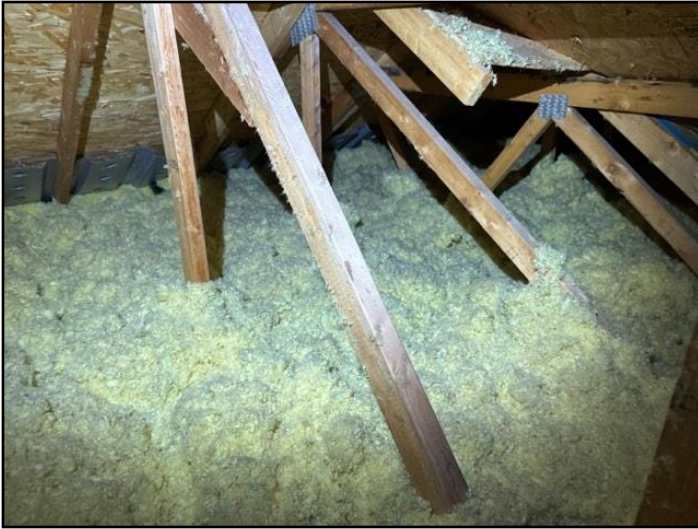
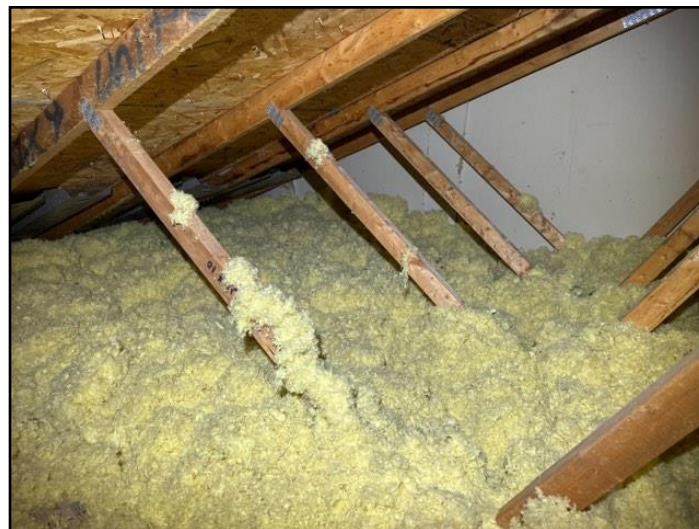
**33. Condition:** • [Compressed](#)

77. Compressed

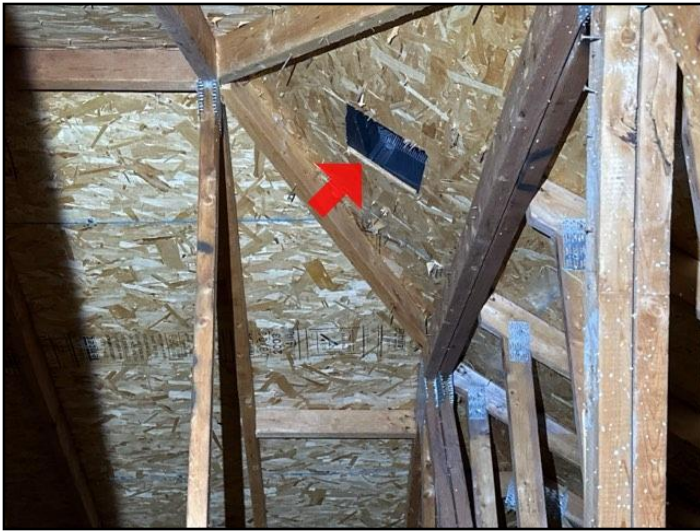
34. Condition: • [Obstructed](#)

80. *Obstructed*

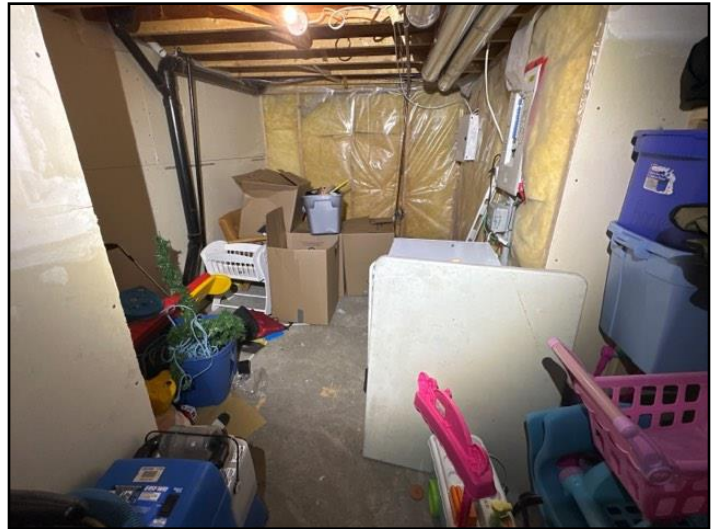
- Carpet
- Storage/furnishings

98. Storage/furnishings

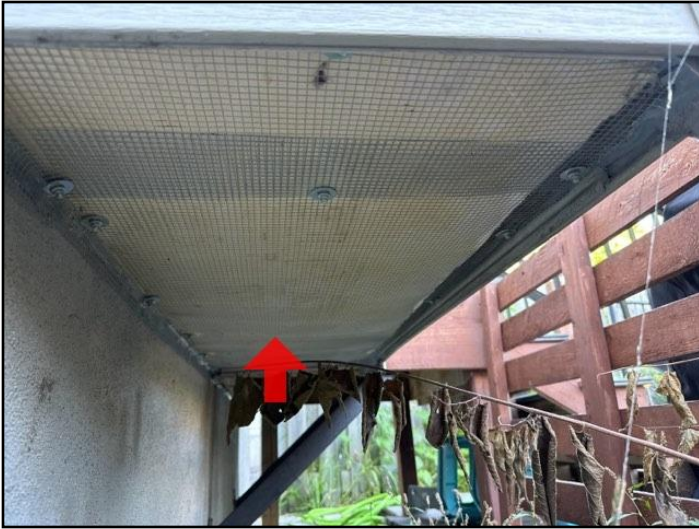
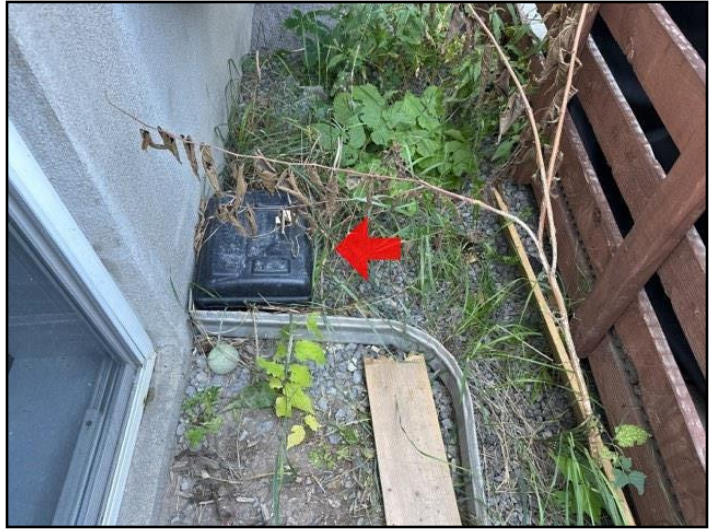
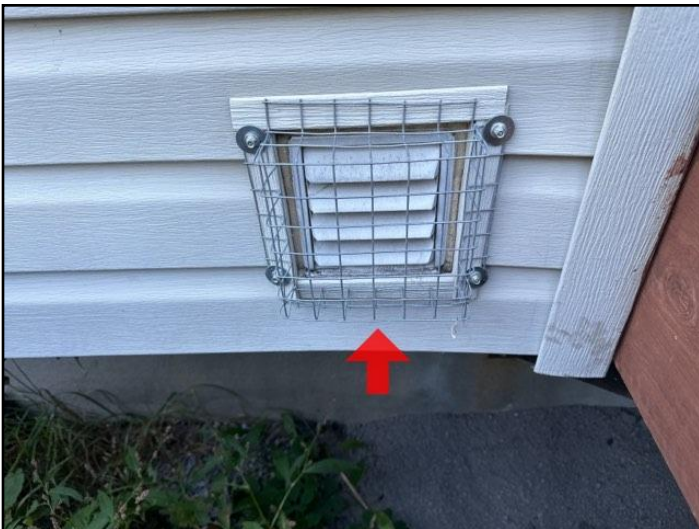
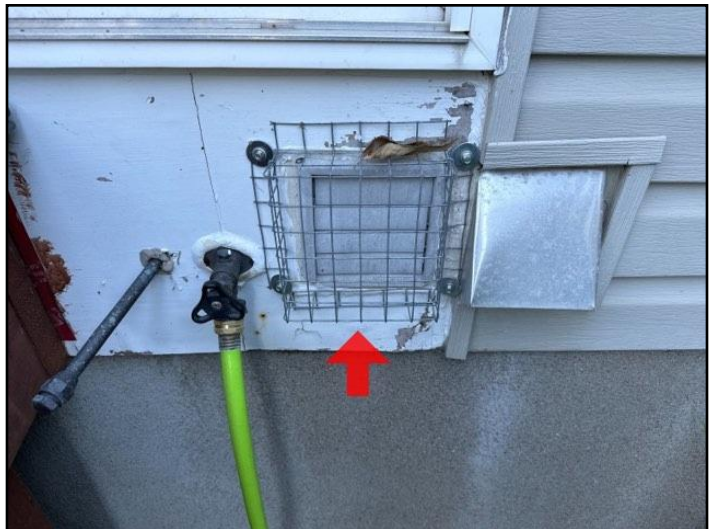
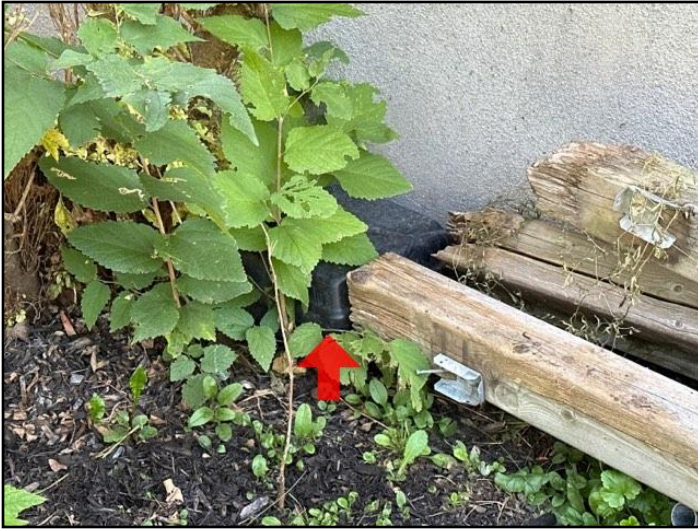
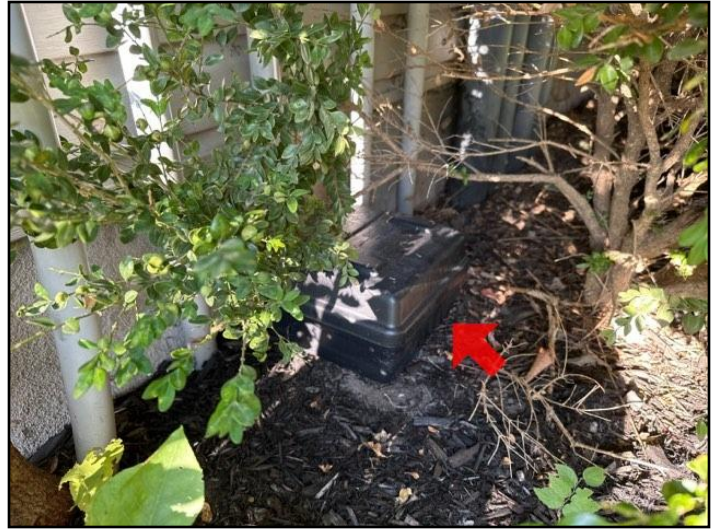
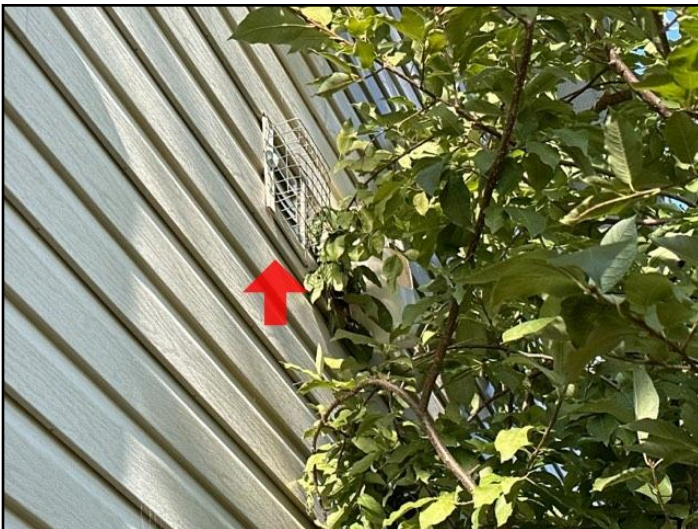
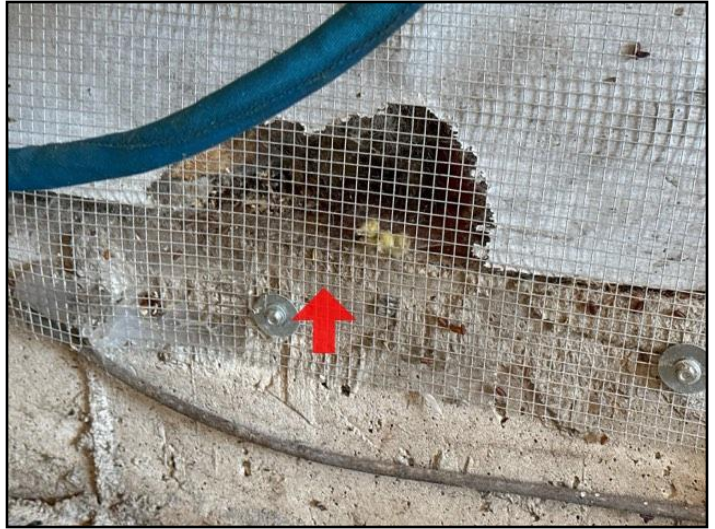
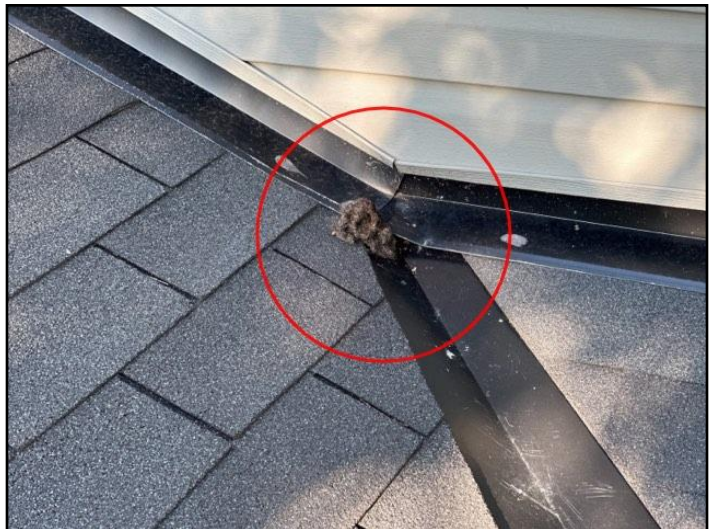
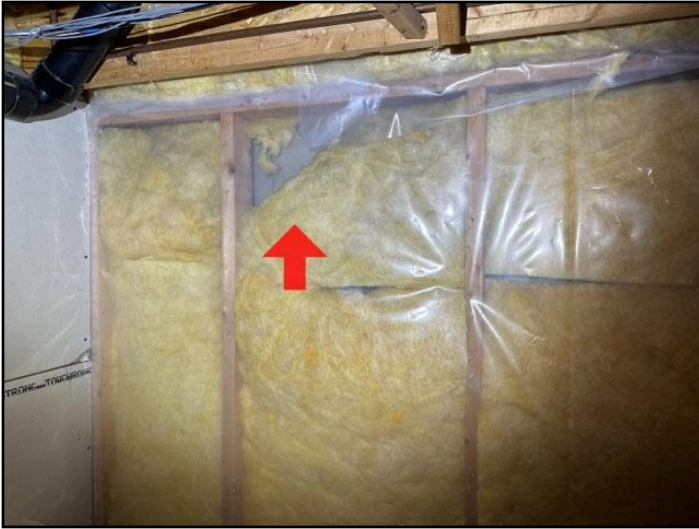
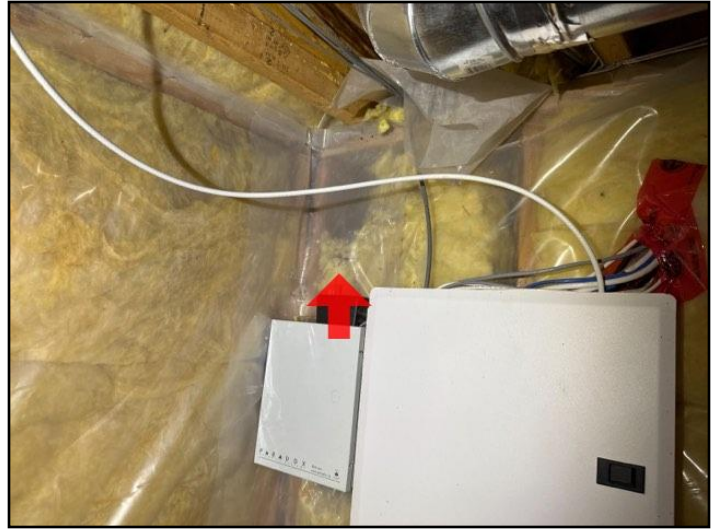
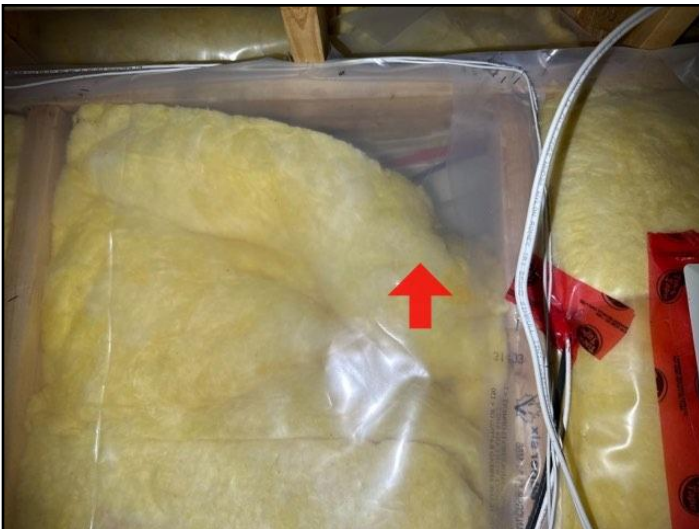
#### **45. Condition:** • [Pest activity evident](#)

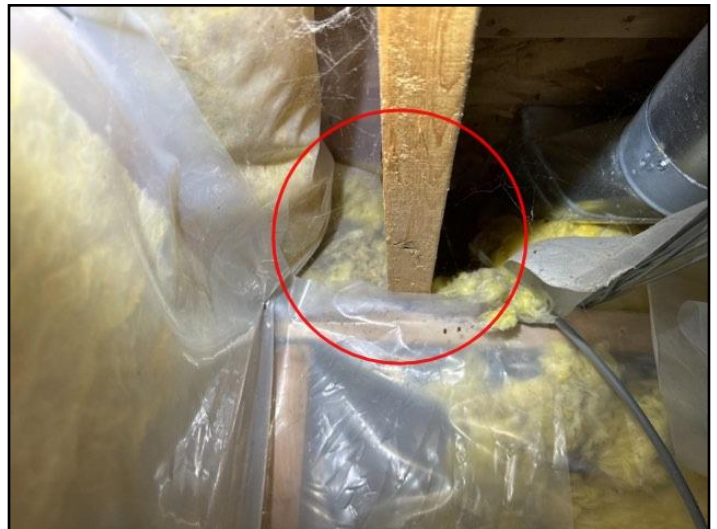
117. Pest activity evident

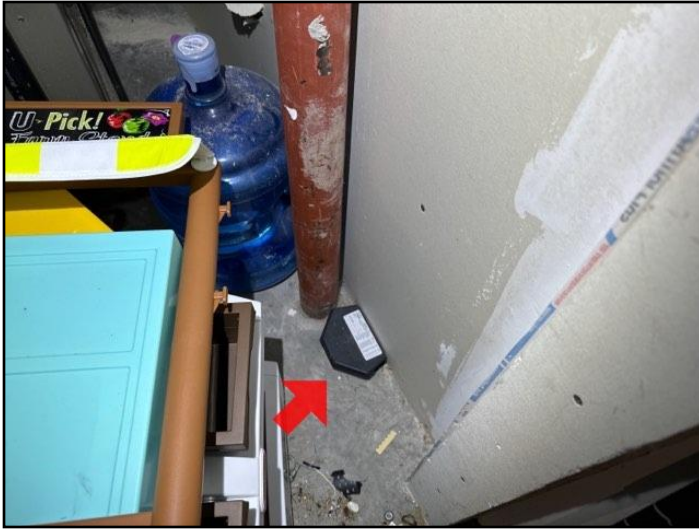
118. Pest activity evident

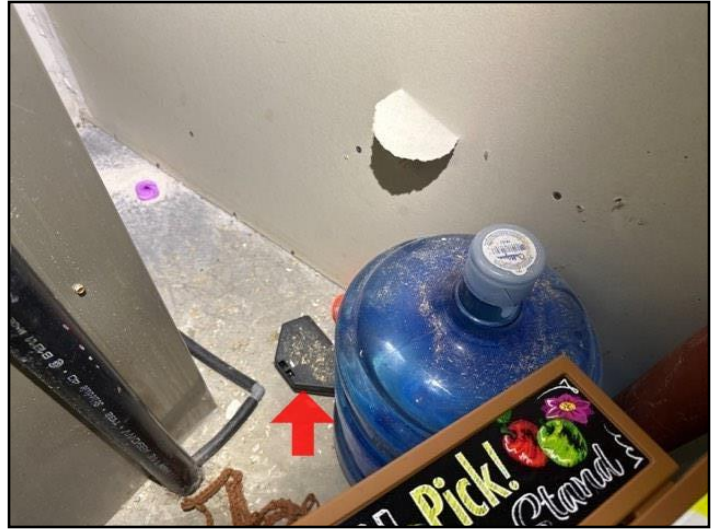
119. Pest activity evident

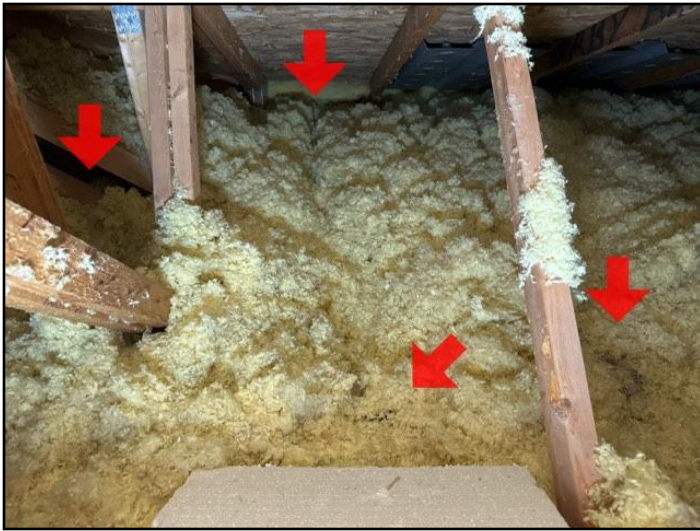
122. Pest activity evident

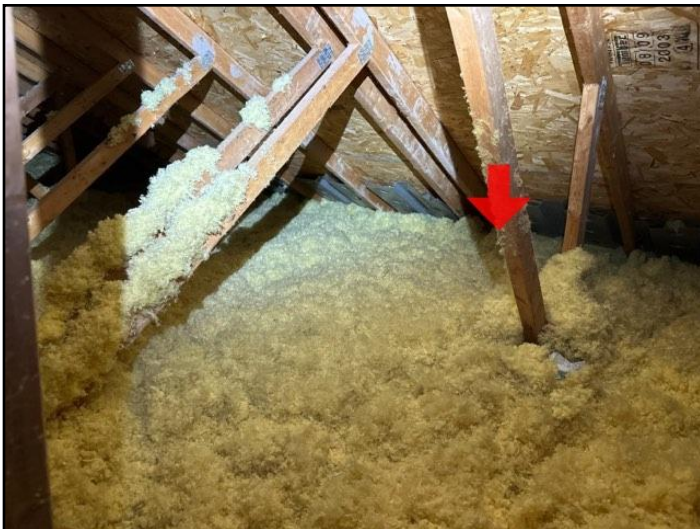
124. Pest activity evident

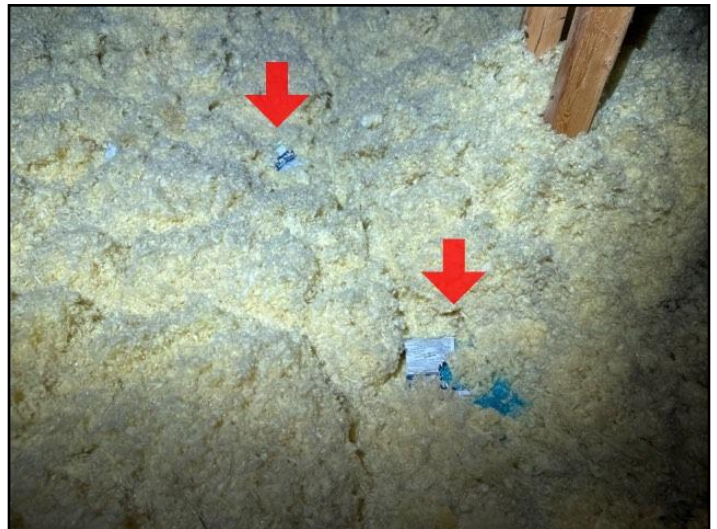
125. Pest activity evident

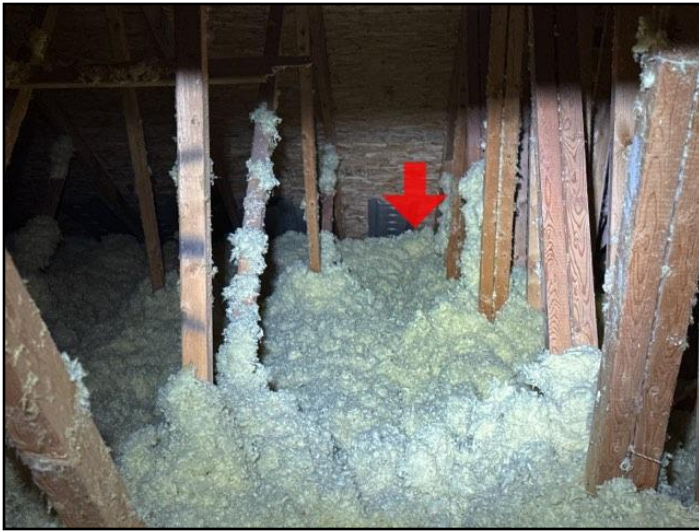
126. Pest activity evident

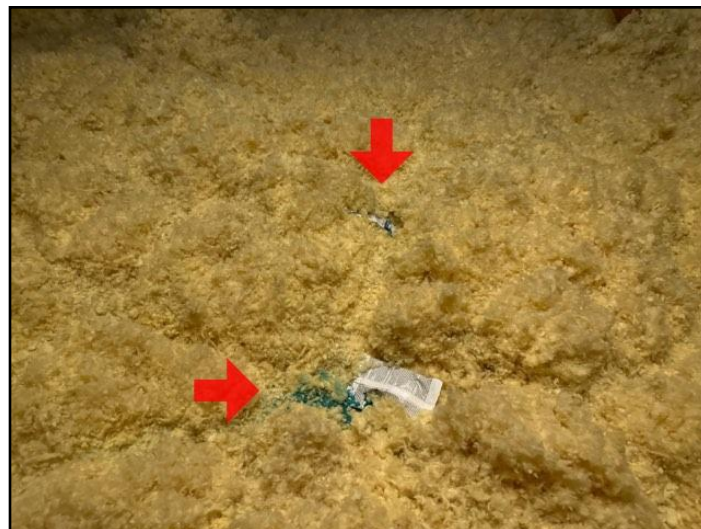
128. Pest activity evident

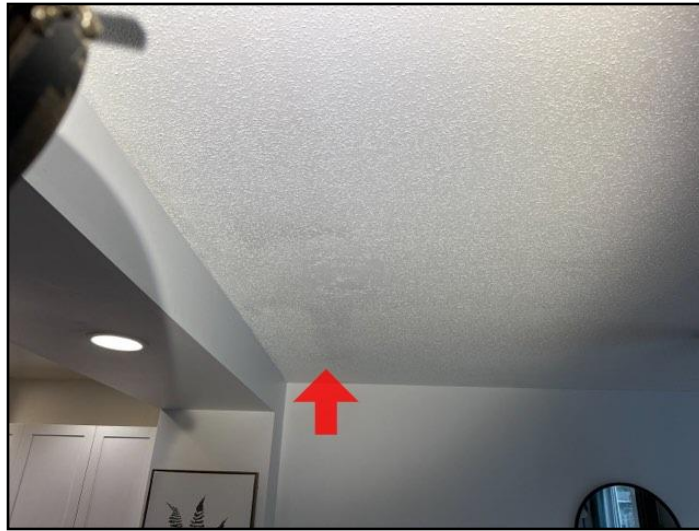
**46. Condition:** • Patched

**Implication(s):** Chance of damage to contents, finishes and/or structure

129. Patched

**Task:** Request information
