YOUR INSPECTION REPORT

1 INSPECTION WAY
Kanata, ON

Saturday, November 25, 2023

Report No. 3559, v.2

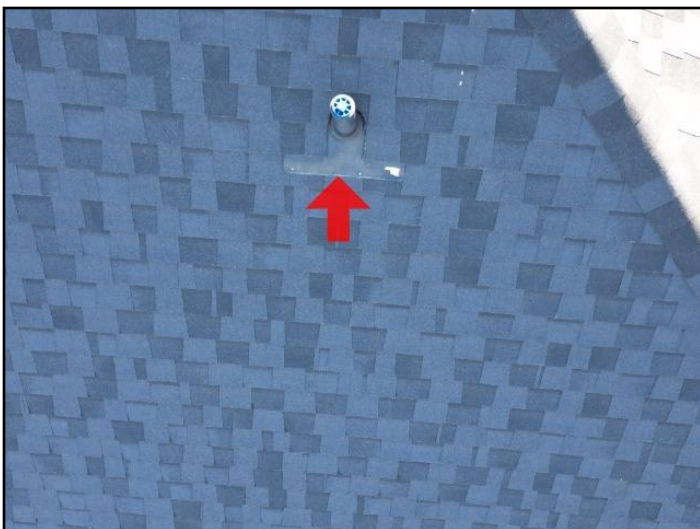
1. Condition: • [Exposed fasteners](#)

1. Exposed fasteners

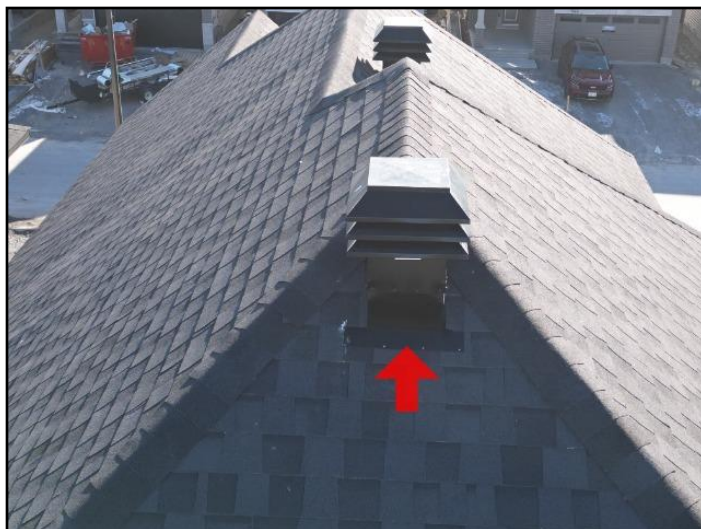
2. Exposed fasteners

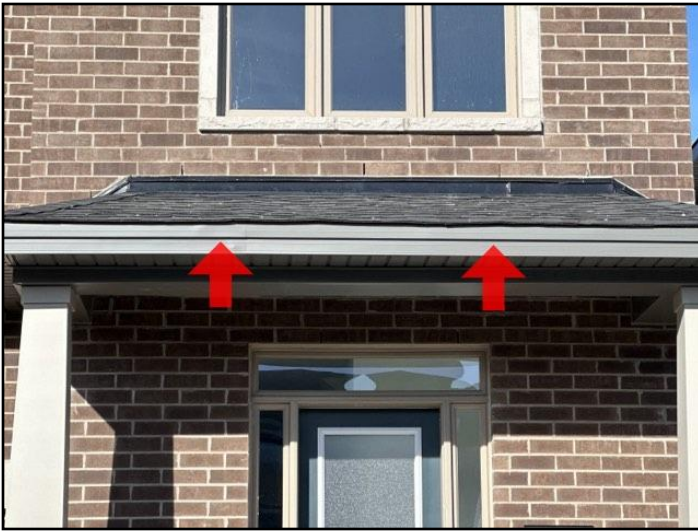
3. **Condition:** • Shingles uneven

6. Shingles uneven

Repair the visible ridges in the garage and porch roof shingles.

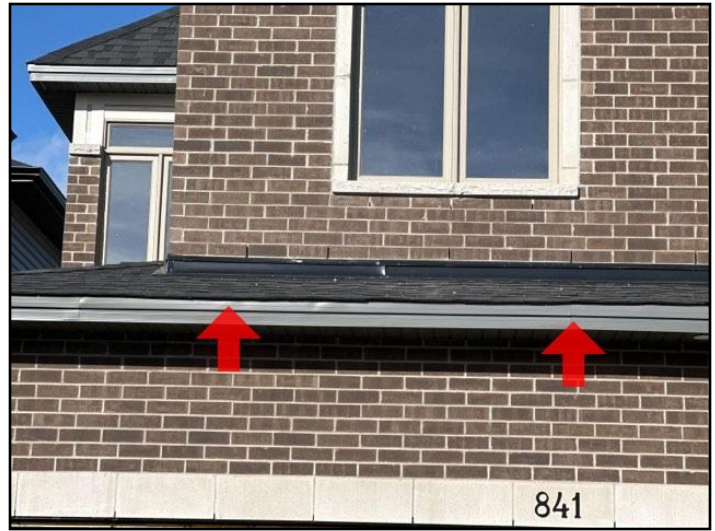
7. Shingles uneven

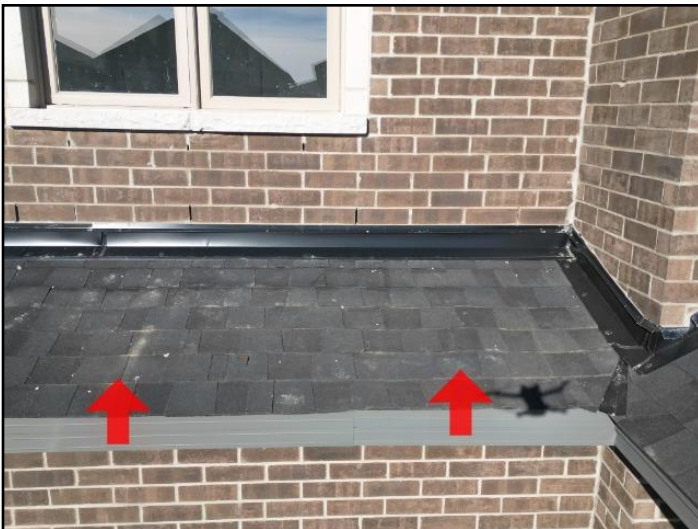
8. Shingles uneven

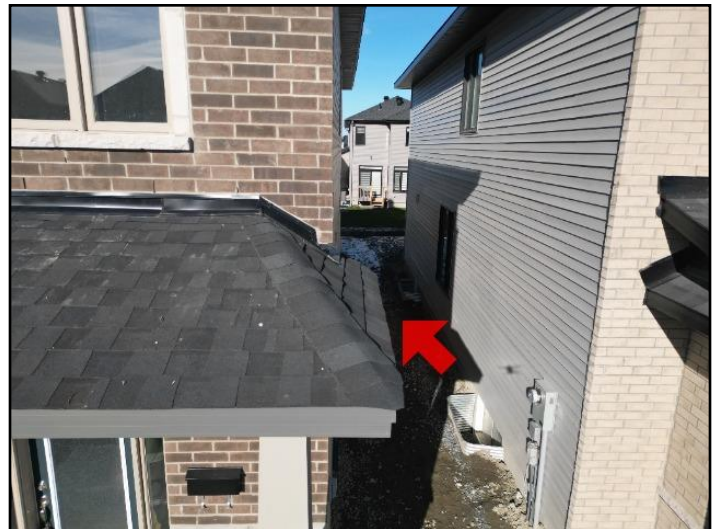
9. Shingles uneven

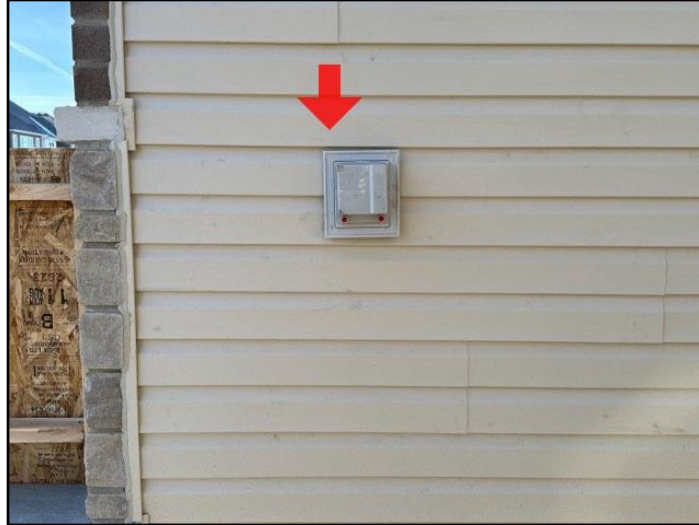
11. Condition: • Not level

22. Not level

Repair the water metre transmitter on the east side of the house at the south corner that has been installed out of level.

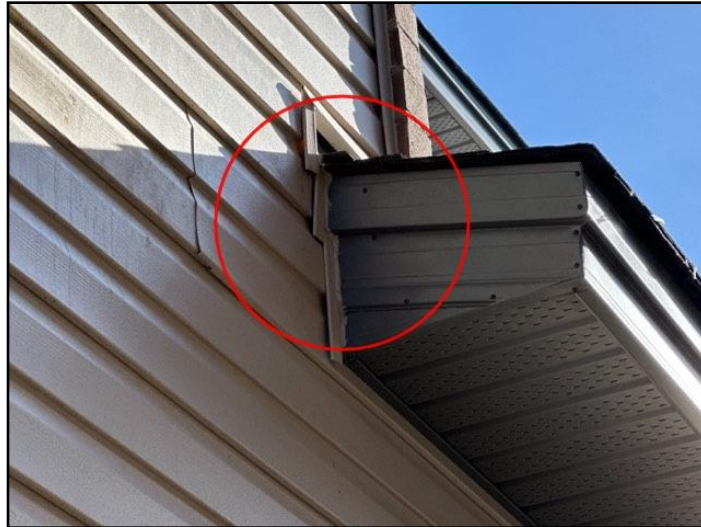
13. Condition: • [Mechanical damage](#)

24. Mechanical damage

Repair the uneven "J" trim on the west side of the house at the north face of the garage roof. Repair the gaps and unevenness in the "J".

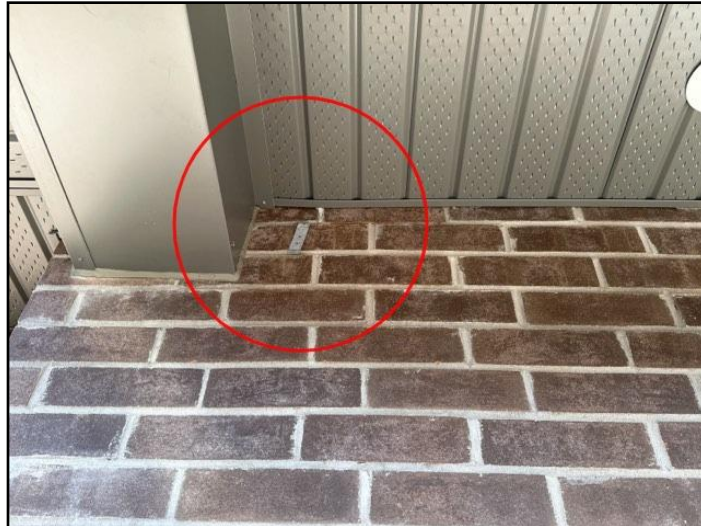
16. Condition: • [Mechanical damage](#)

28. Mechanical damage

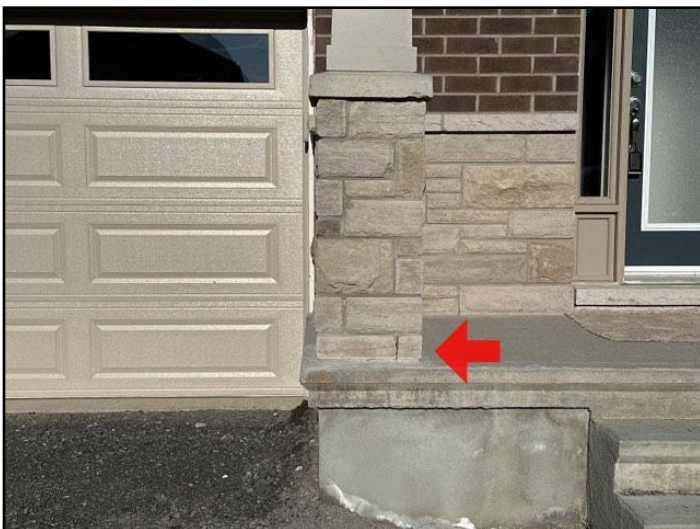
17. **Condition:** • [Masonry deterioration](#)

29. Masonry deterioration

Repair the bricks at the base of the front porch columns that have not been installed level or plumb.

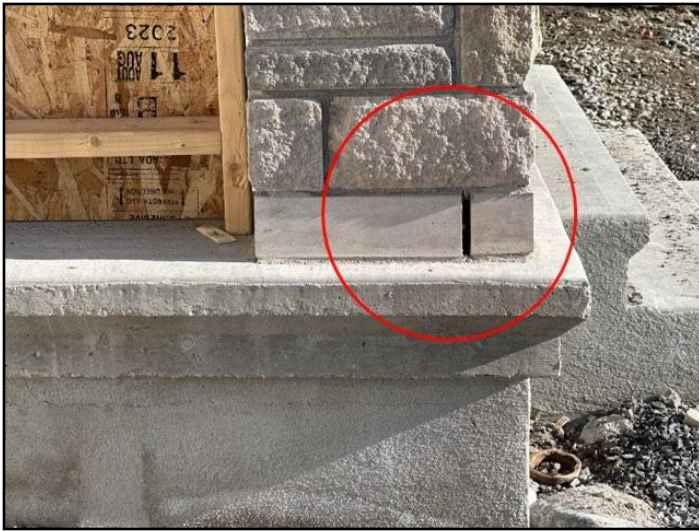
31. Masonry deterioration

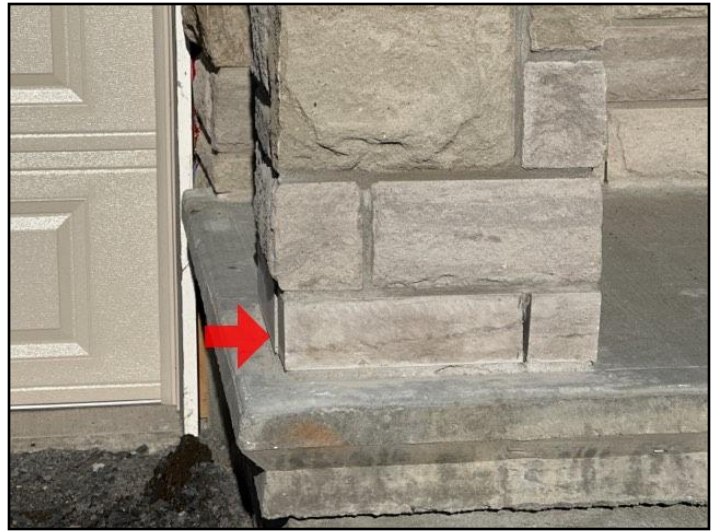
32. Masonry deterioration

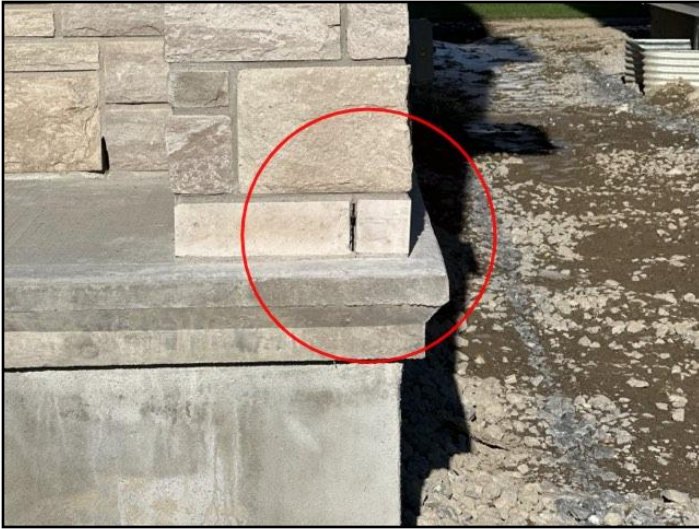
35. Masonry deterioration

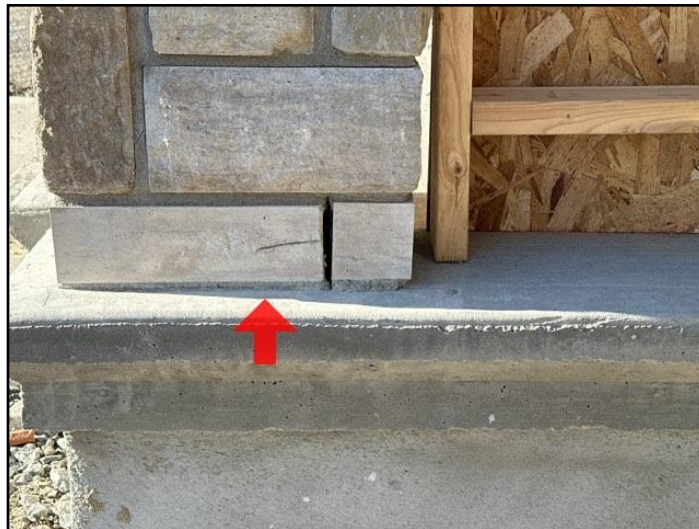
37. Masonry deterioration

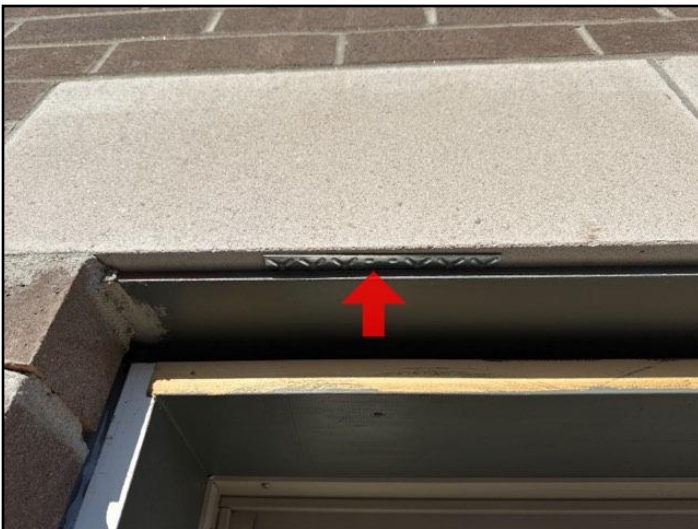
19. Condition: • [Masonry deterioration](#)

39. Masonry deterioration

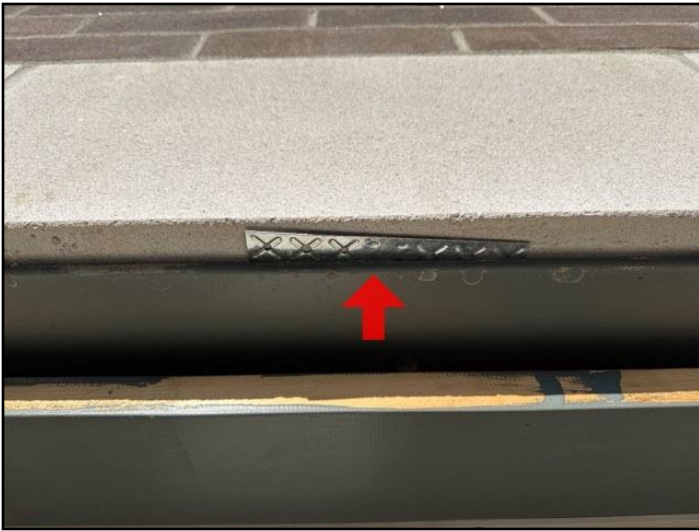
41. Masonry deterioration

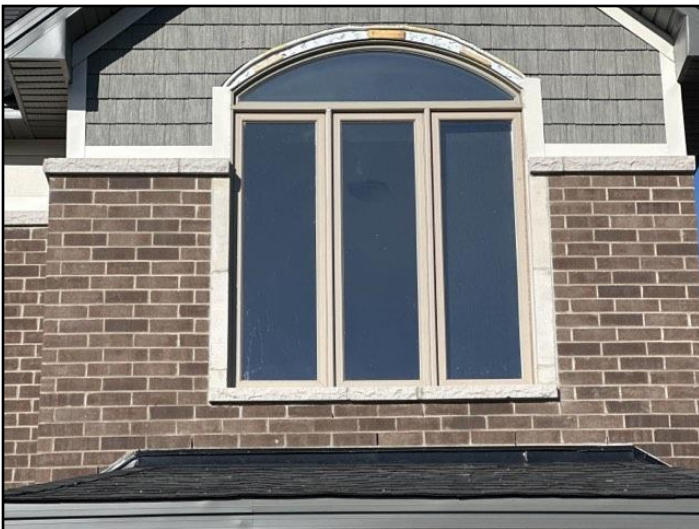
20. Condition: • [Masonry deterioration](#)

43. Masonry deterioration

Repair the chipped and out of plumb block and brick veneer around the front second floor windows.

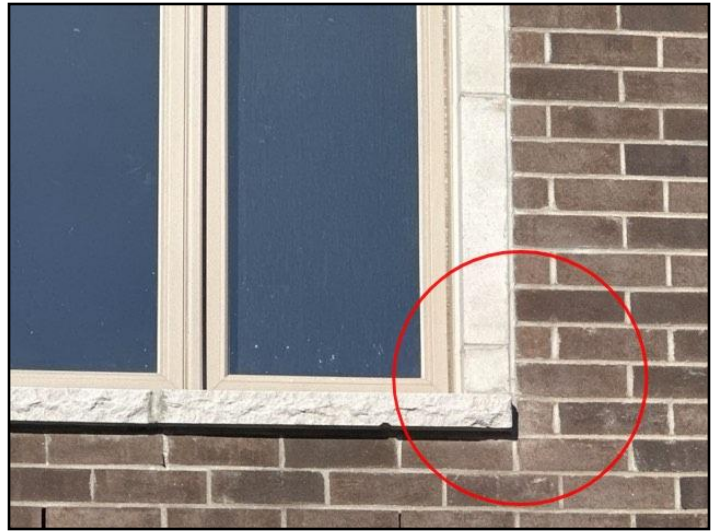
46. Masonry deterioration

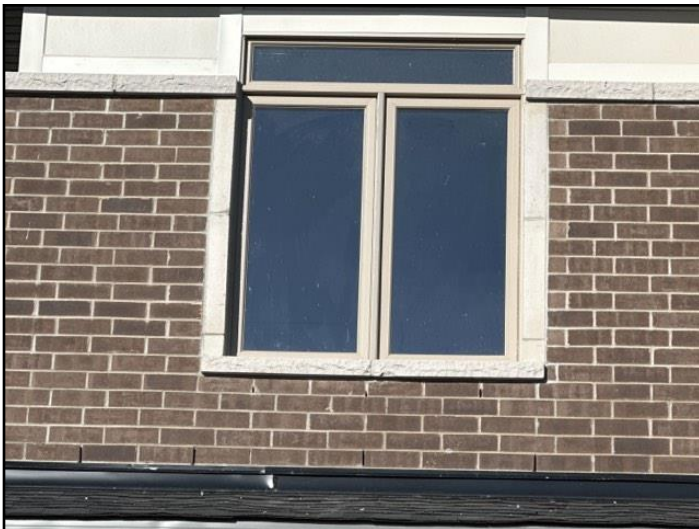
47. Masonry deterioration

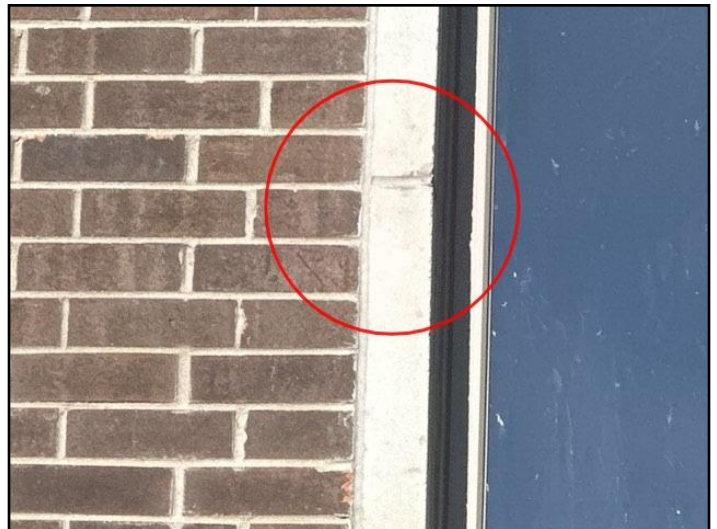
48. Masonry deterioration

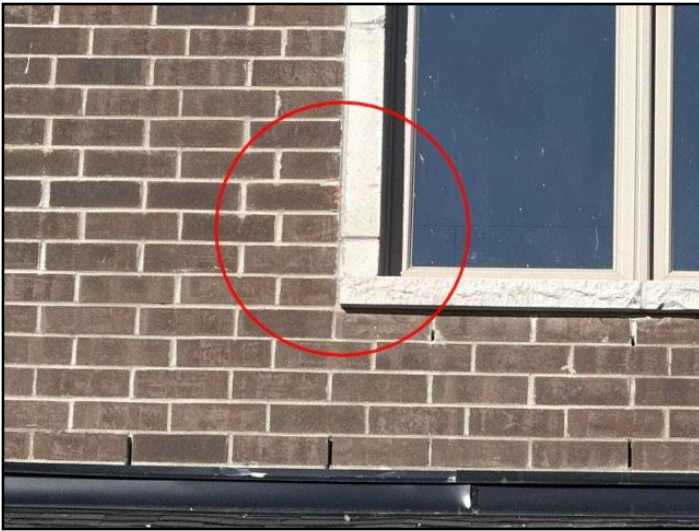
49. Masonry deterioration

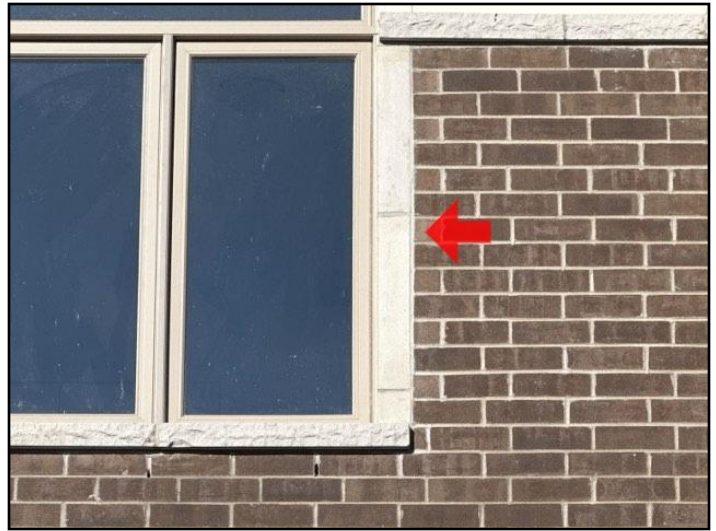
50. Masonry deterioration

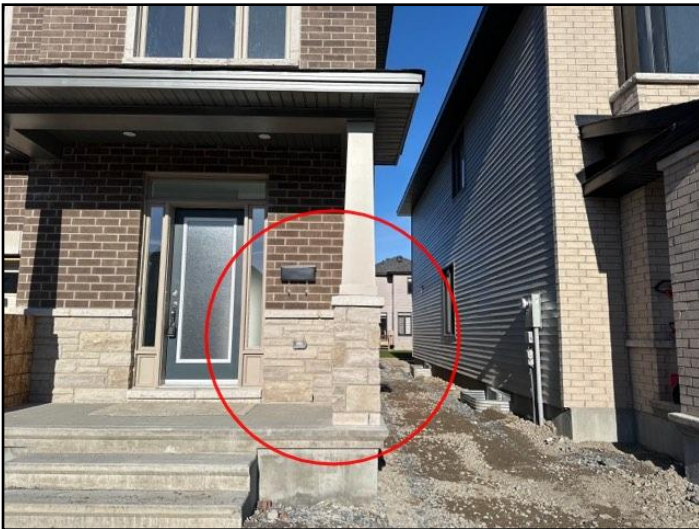
21. Condition: • Chipped

51. Chipped

Repair the chipped concrete caps on the front porch columns.

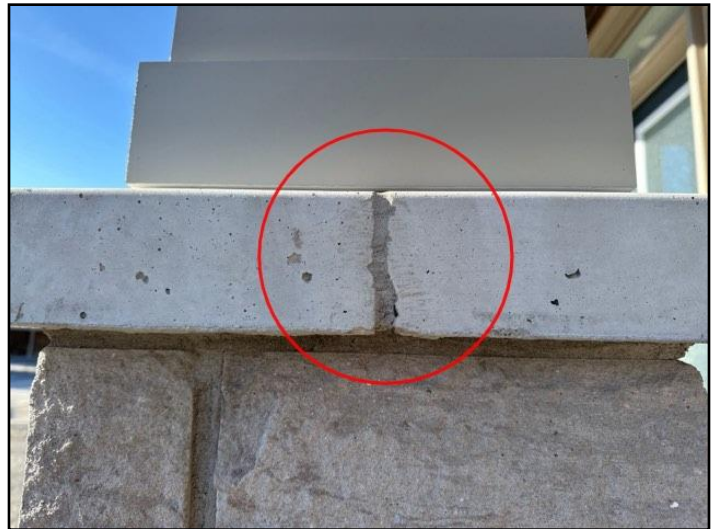
52. Chipped

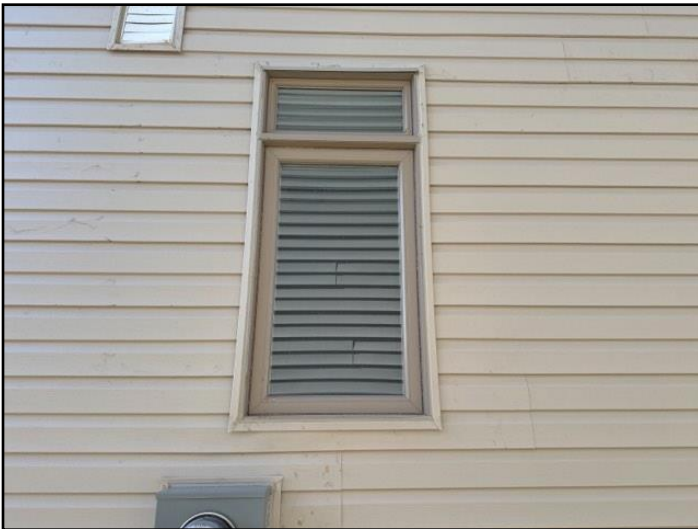
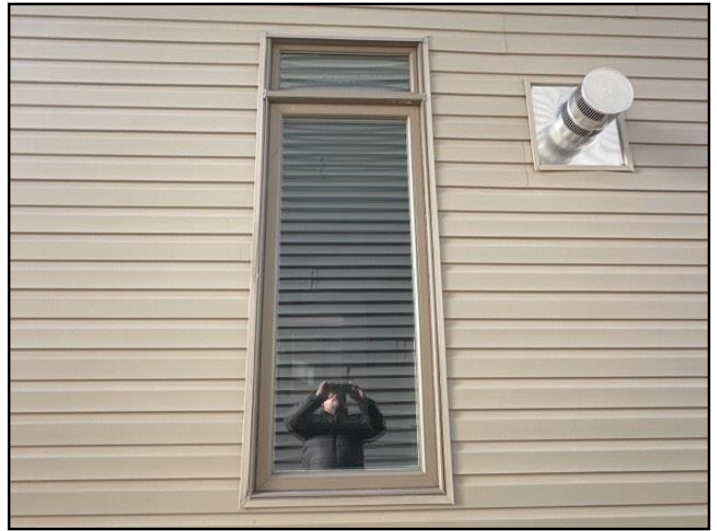
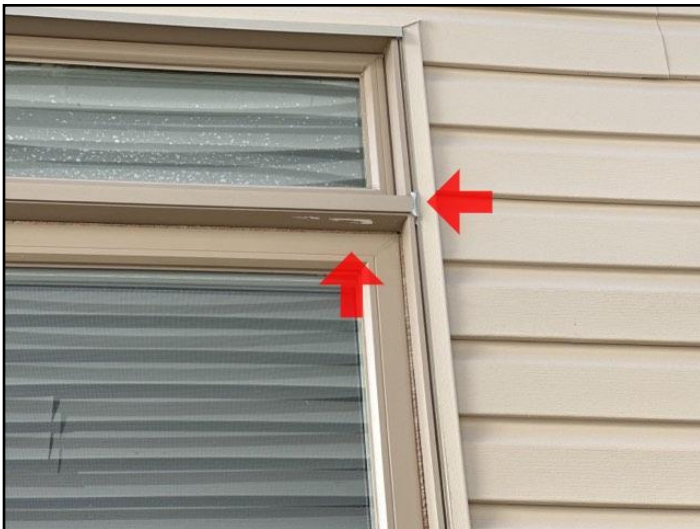
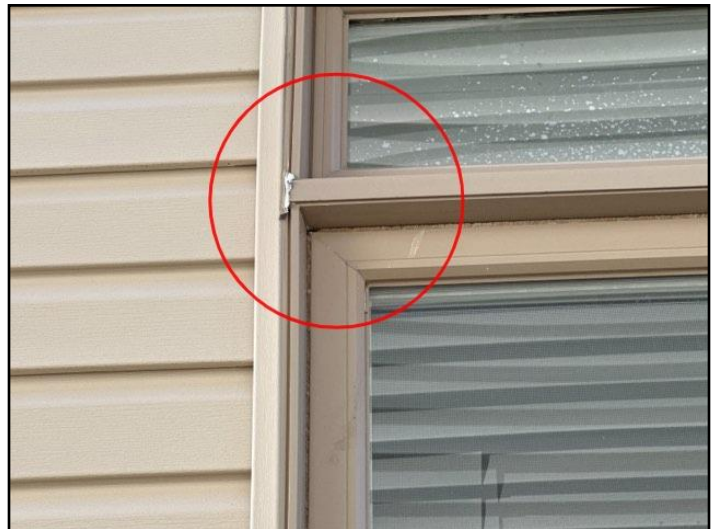
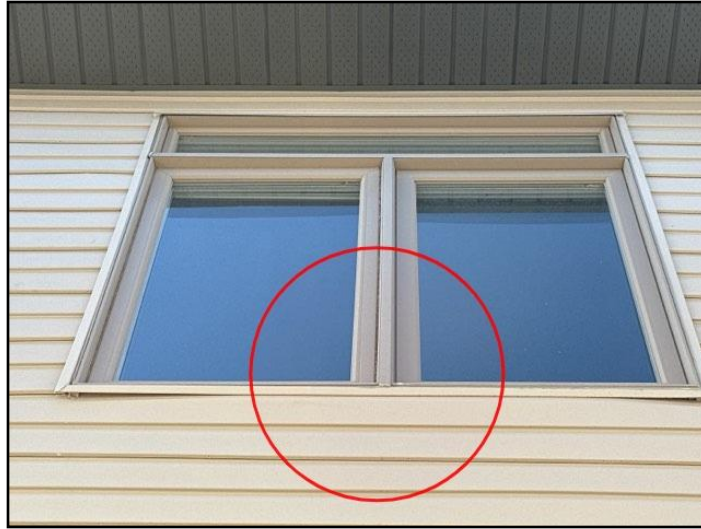
24. Condition: • Damage

Remove the spray foam and protective film from the windows on the east side of the house. Repair the scratches in the windows and frames.

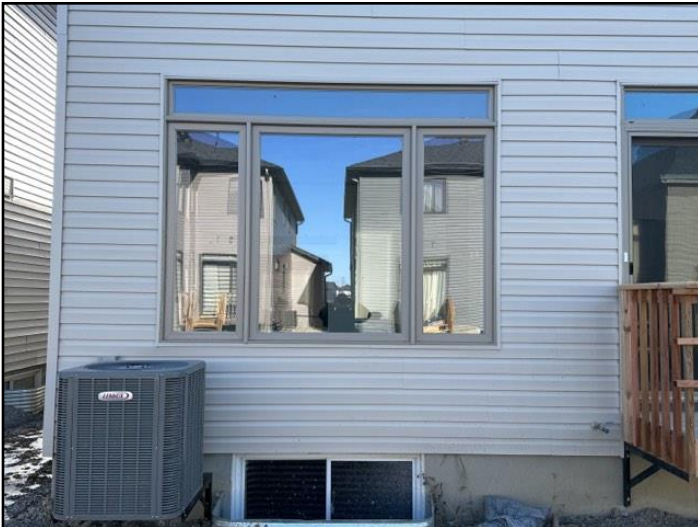
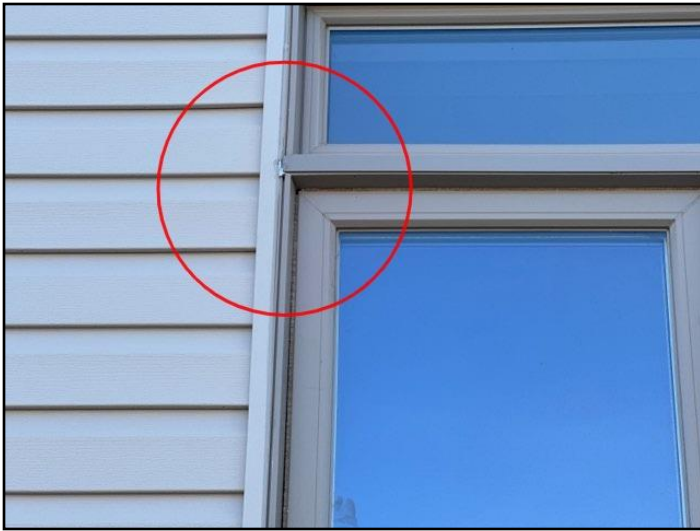
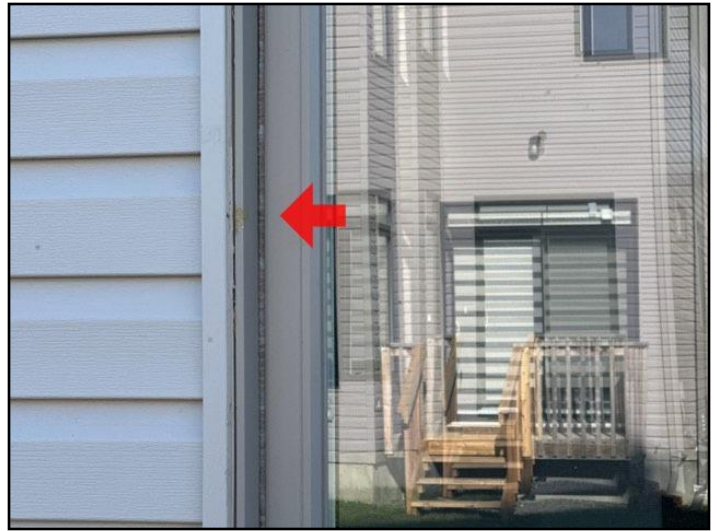
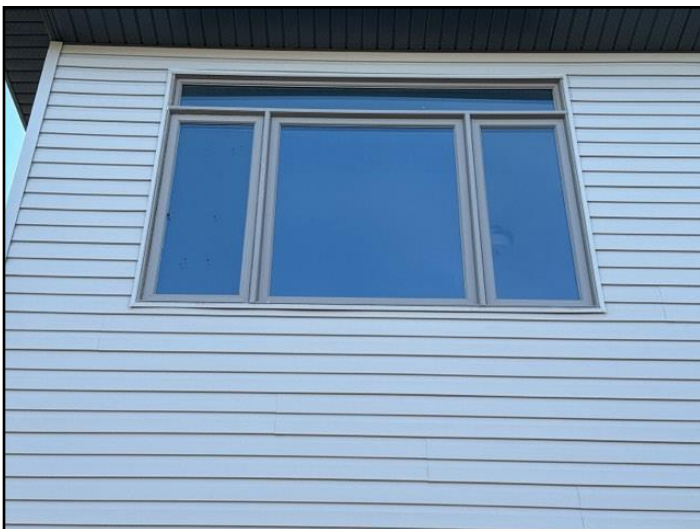
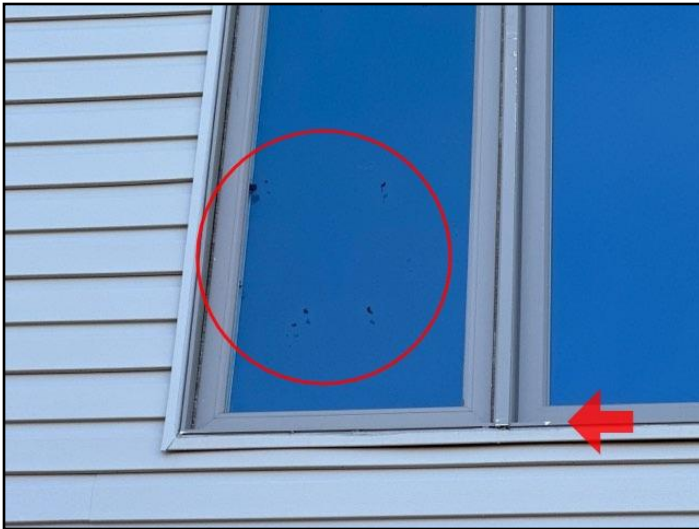
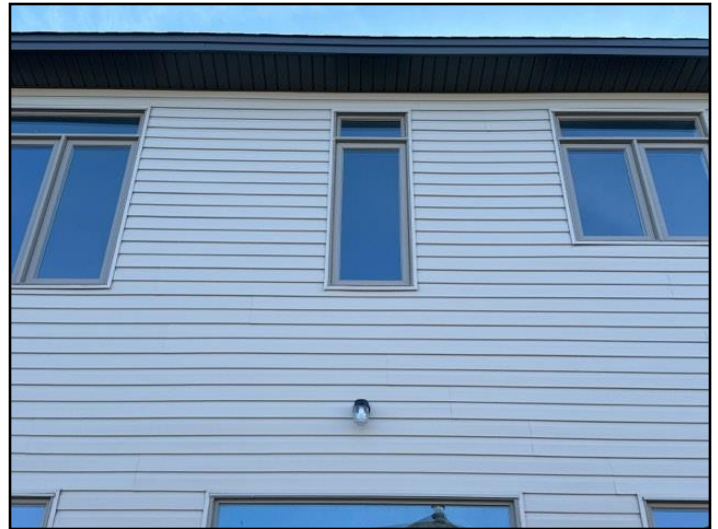
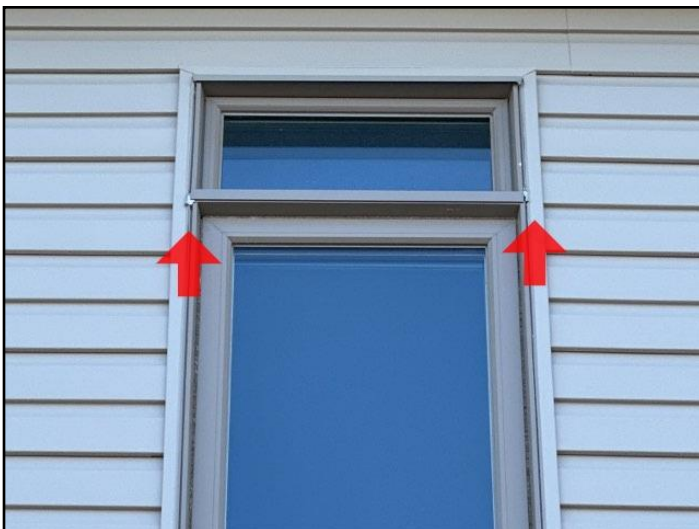
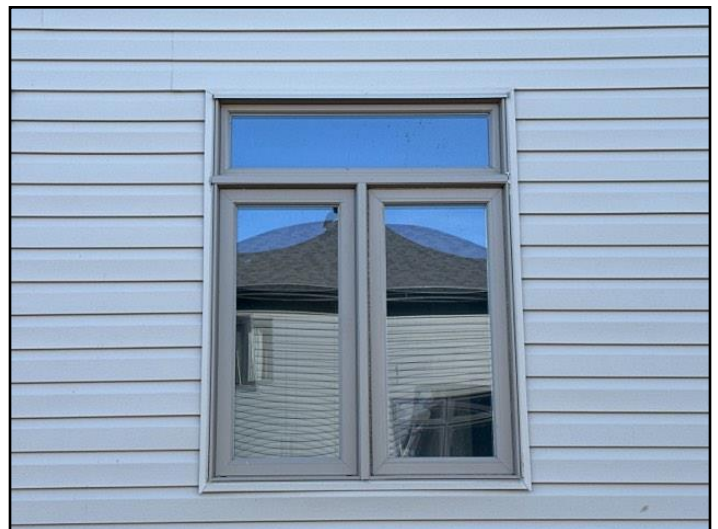
25. Condition: • Damage

Remove the spray foam, adhesive, and protective film from the windows on the north side of the house. Repair the scratches in the windows and frames.

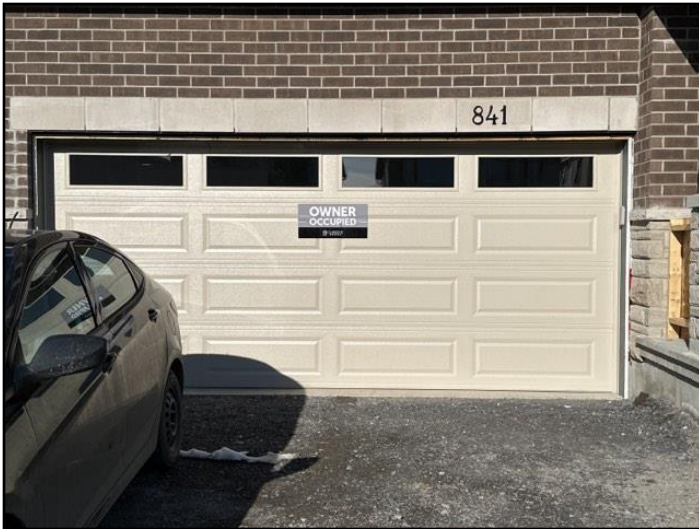
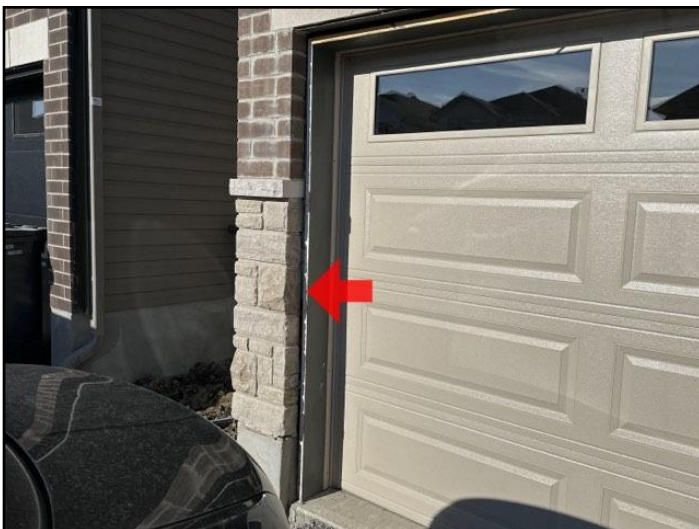
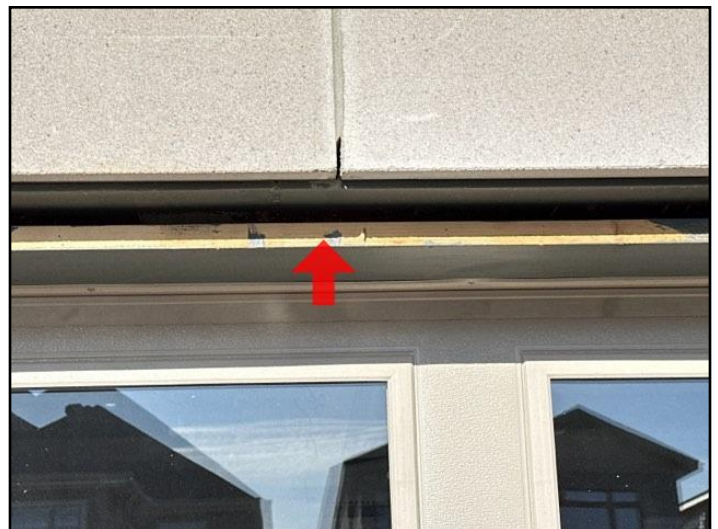
30. Condition: • [Missing](#)

Implication(s): Chance of damage to finishes and structure

Install the trim around the garage door frame. Cover the hole between the bottom east corner of the garage door frame and the foundation.

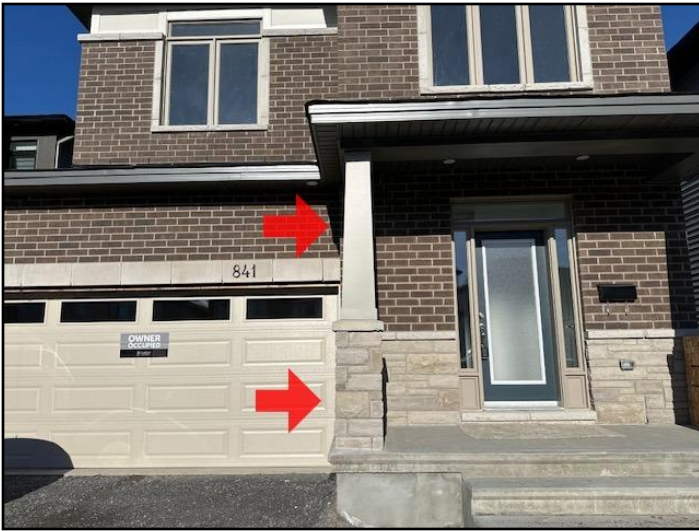
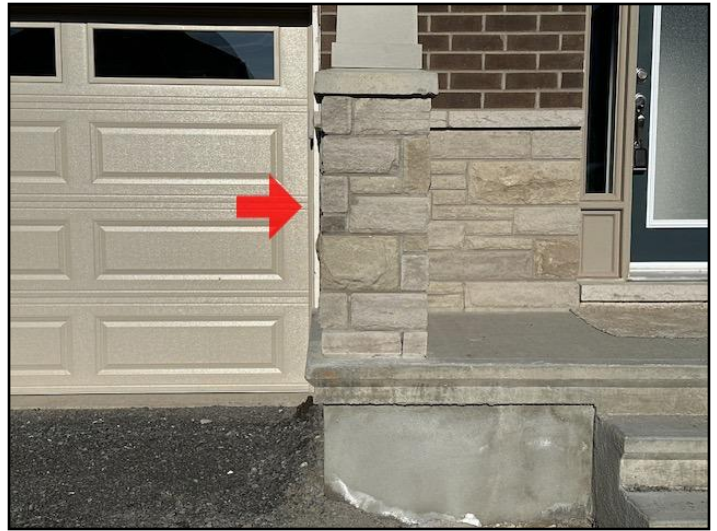
31. Condition: • [Leaning](#)

Repair the column at the southwest corner of the front porch installed out of plumb.

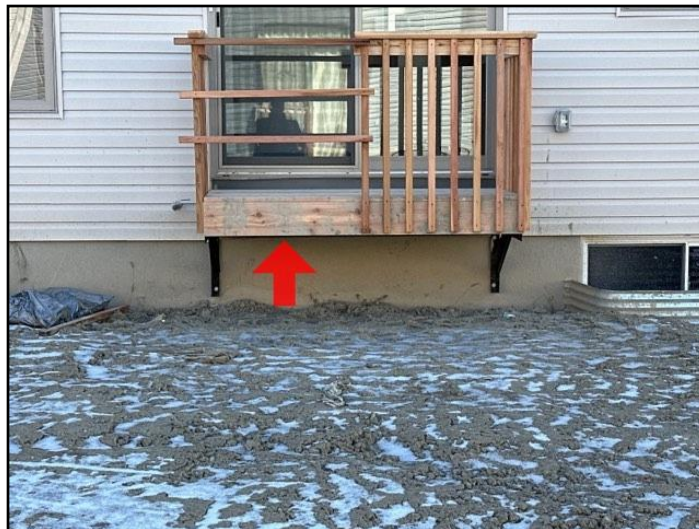
32. Condition: • Missing

Provide the missing step and handrail for the rear deck.

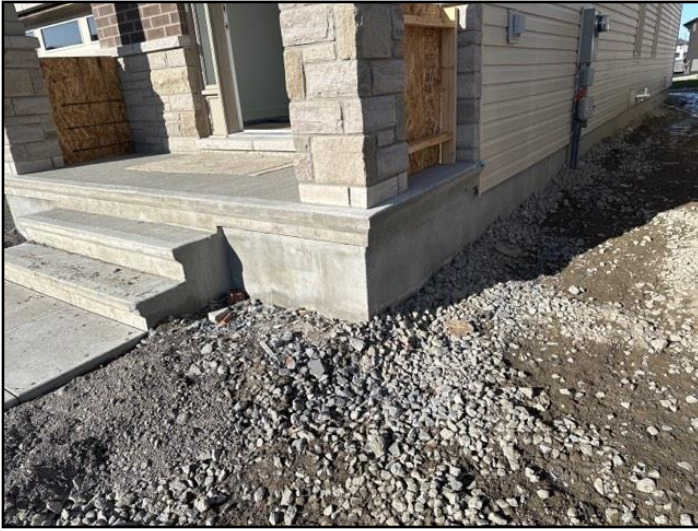
33. Condition: • [Missing](#)

Implication(s): Fall hazard

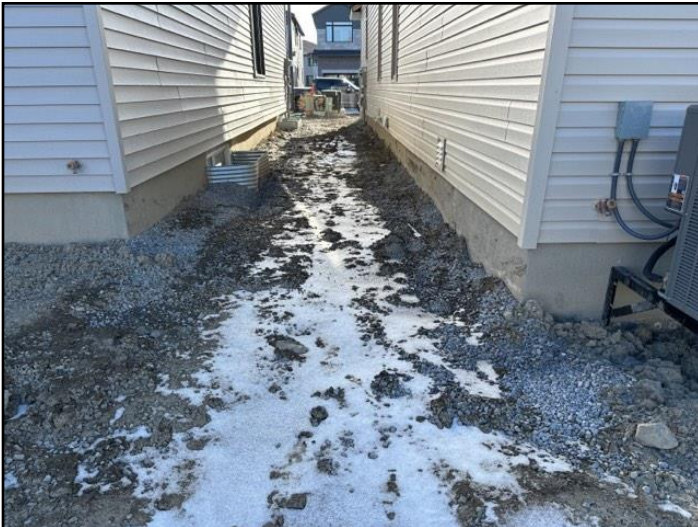
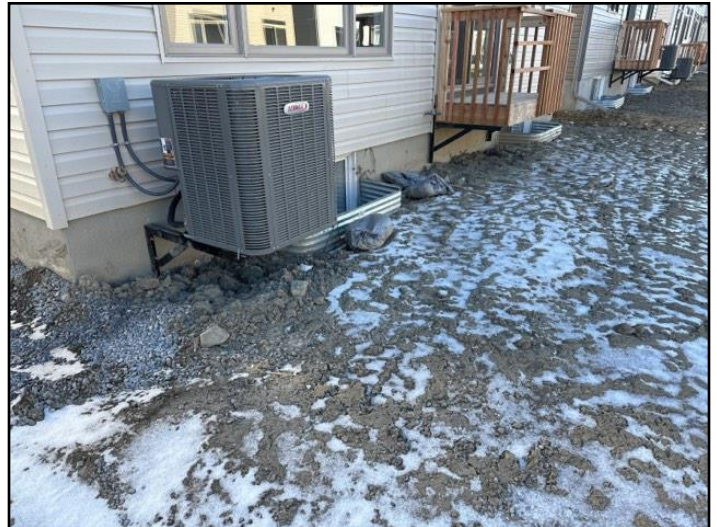
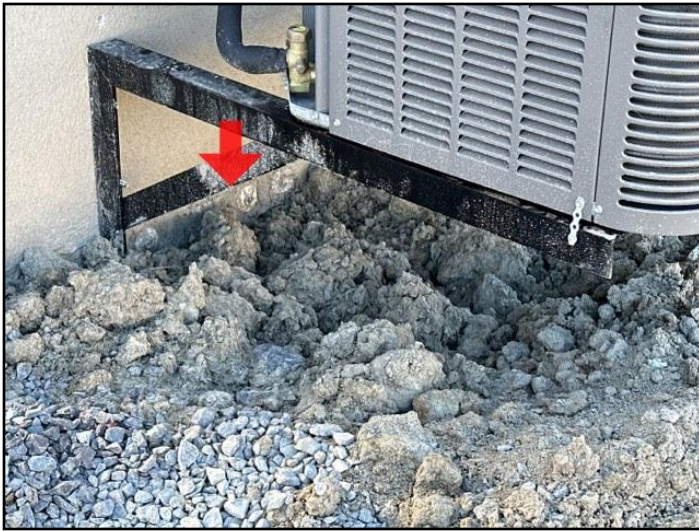
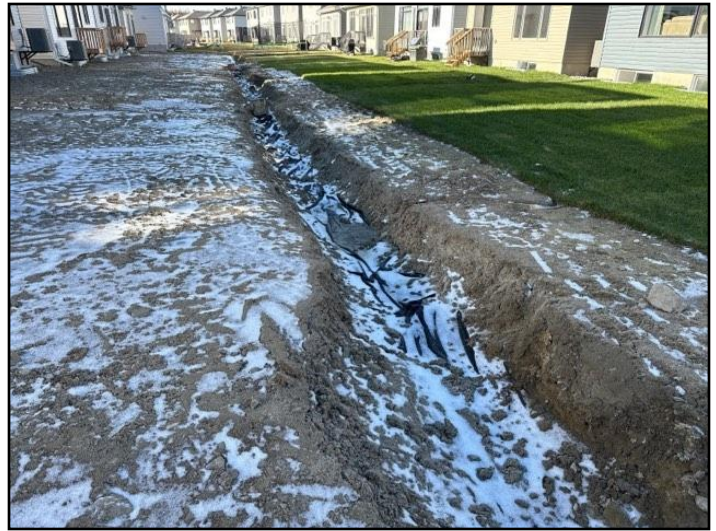
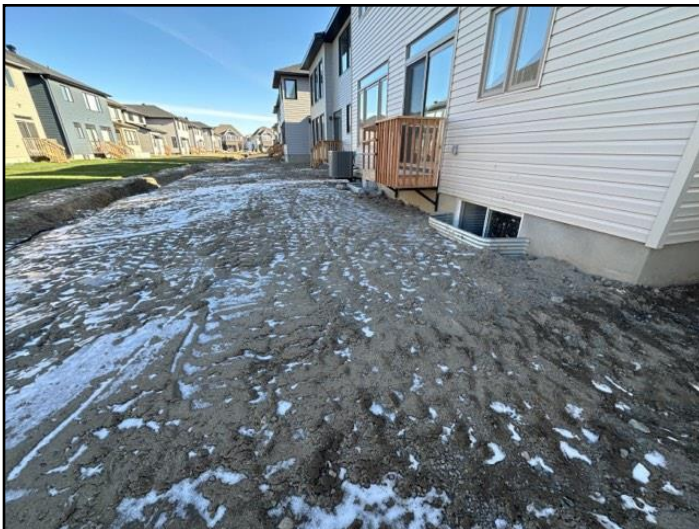
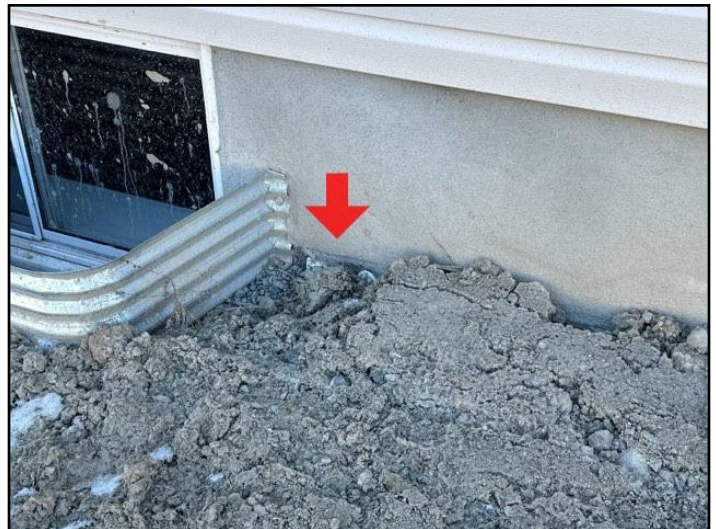
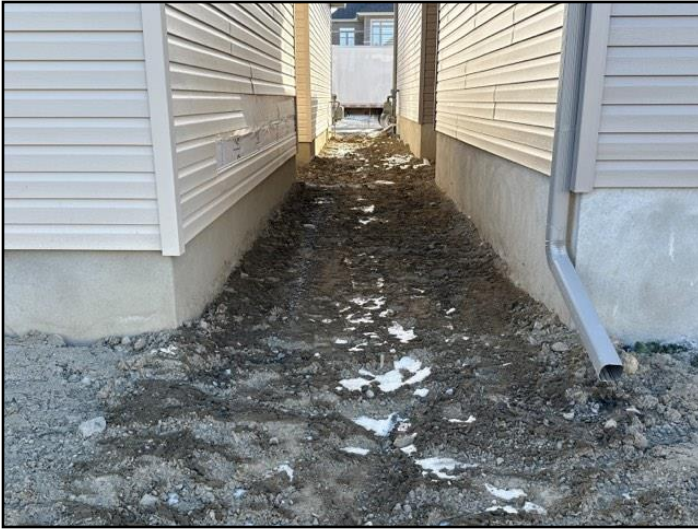
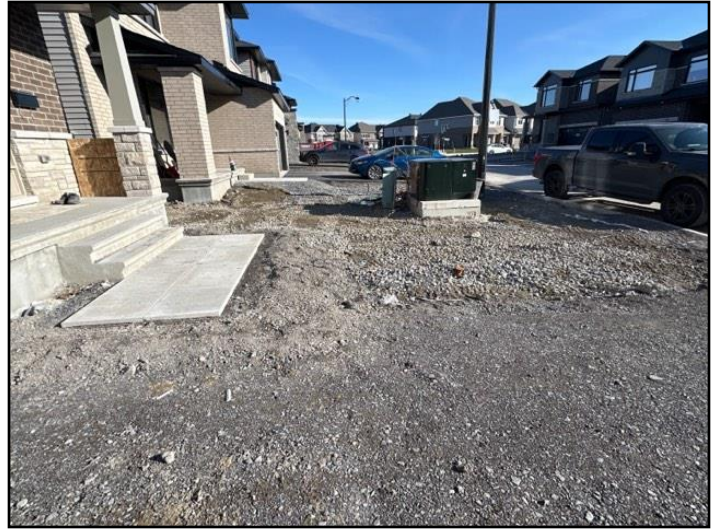
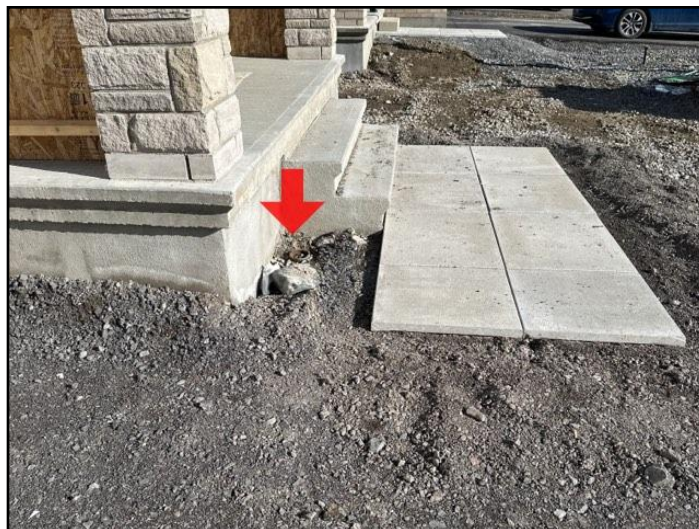
34. Condition: • Landscaping incomplete

Remove the construction debris from around the house. Complete the grading around the house ensuring the ground slopes away from the house, and the foundation membrane is covered.

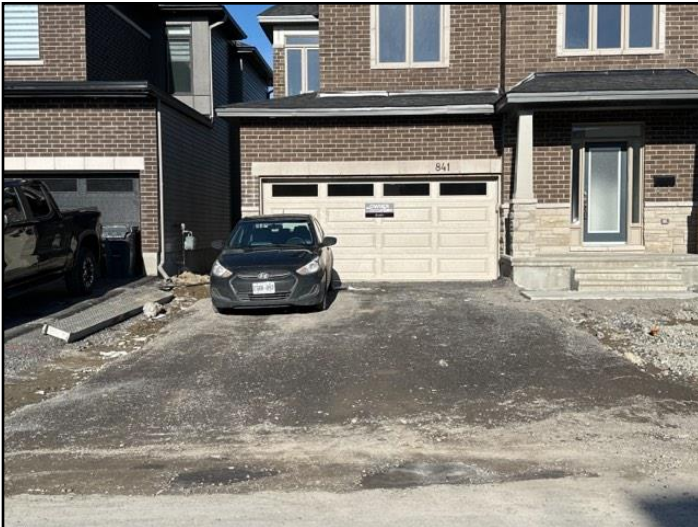
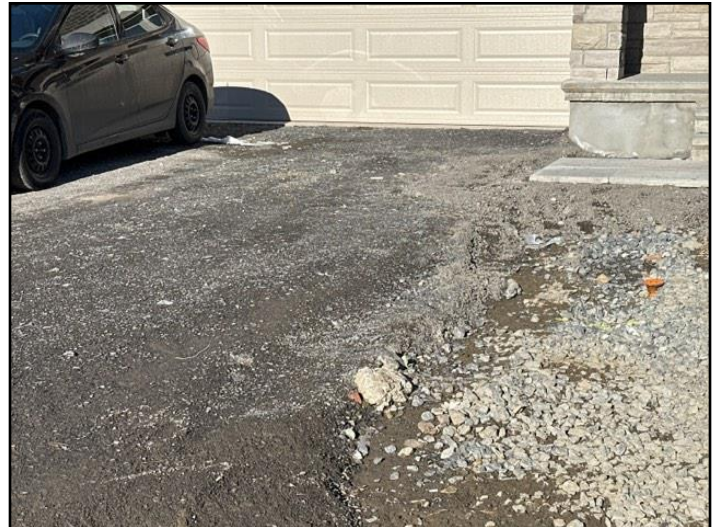
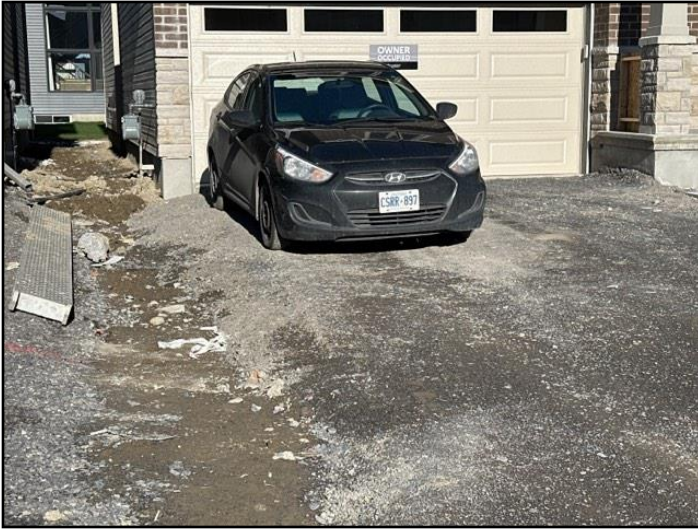
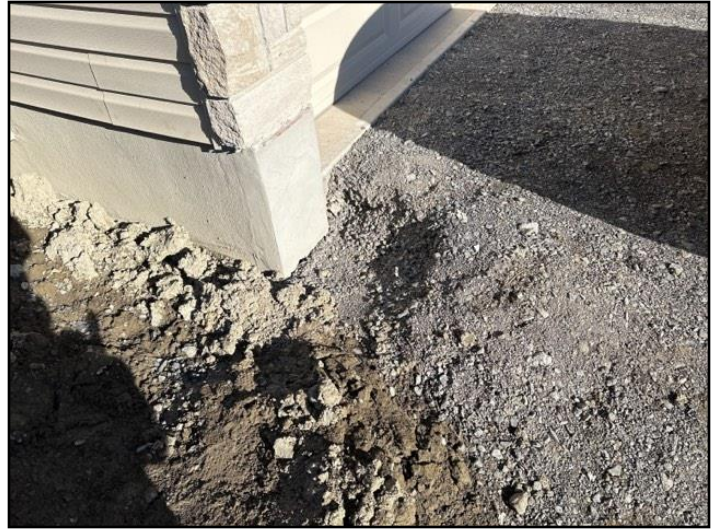
36. Condition: • Complete driveway

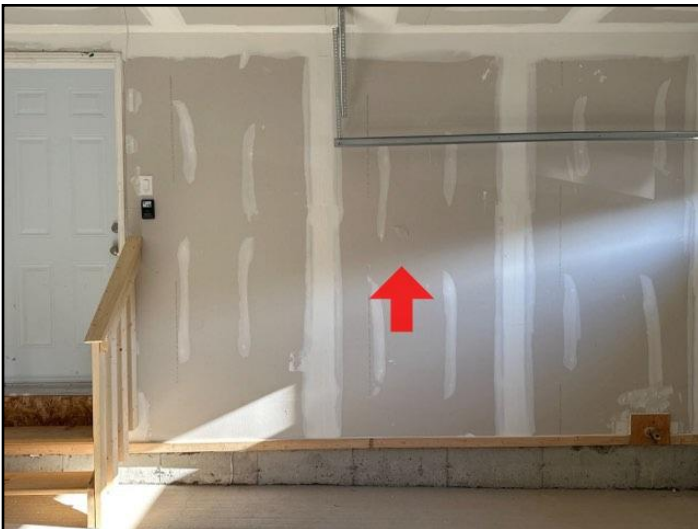
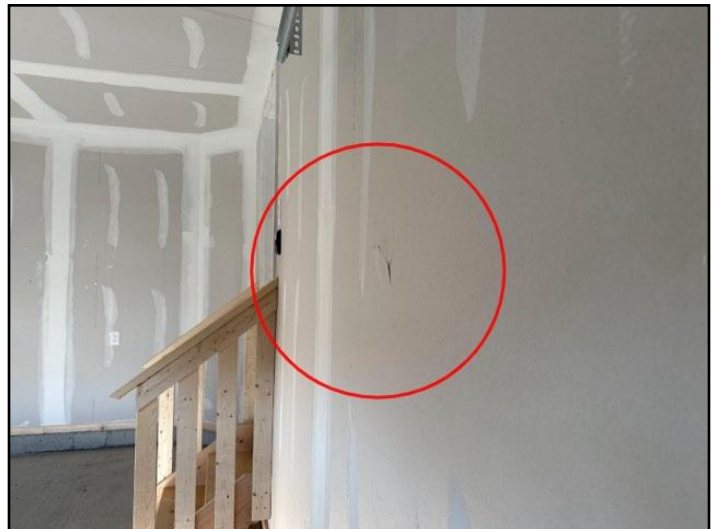
37. Condition: • Not gastight

Implication(s): Hazardous combustion products entering home

Repair the damaged drywall on the west wall of the garage on the south side of the entry door to the house.
