YOUR INSPECTION REPORT

1 INSPECTION WAY
Kanata, ON

Saturday, November 25, 2023

Report No. 3559, v.2

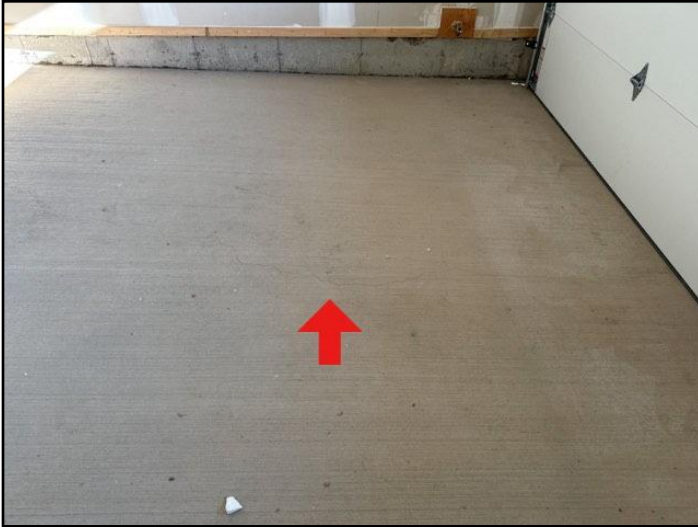
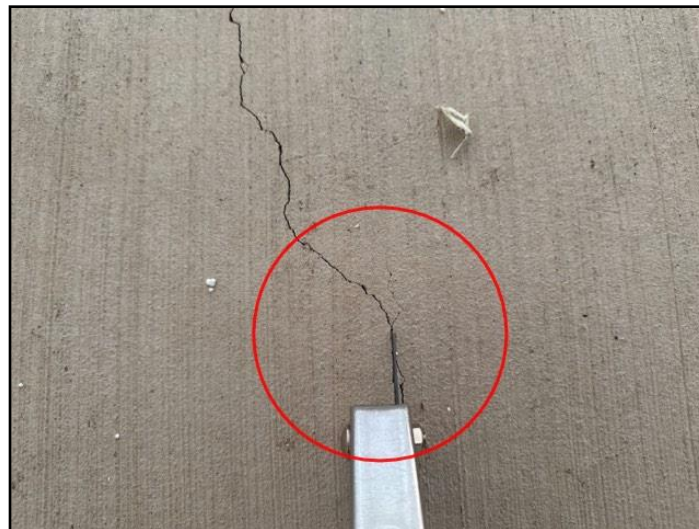
38. Condition: • [Cracked](#)

Monitor the hairline shrinkage crack in the garage floor slab. The crack is not wide enough to insert a 1.5 mm allen key. If the width of the crack increases to 6 mm, they will need to be repaired.

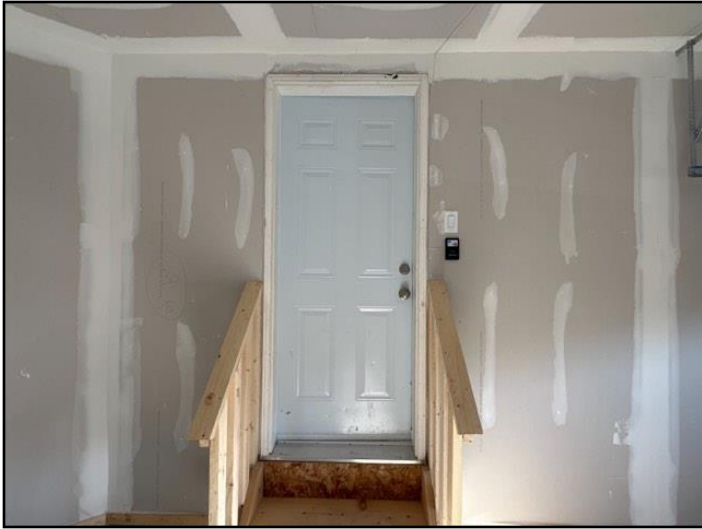
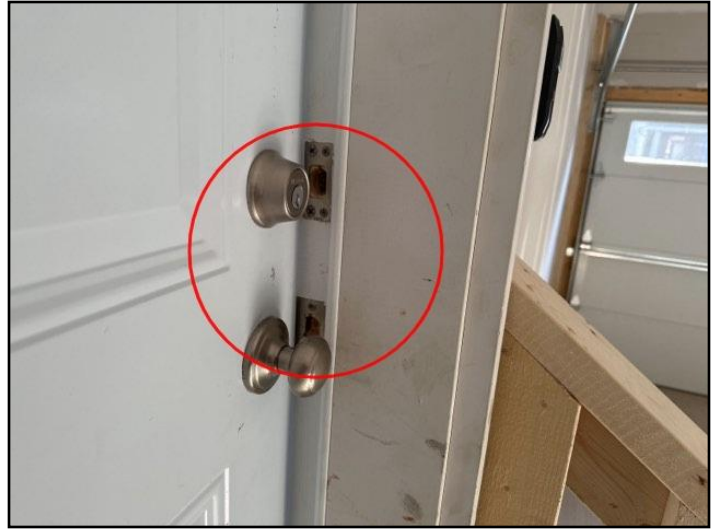
39. Condition: • [Does not close fully](#)

Implication(s): Hazardous combustion products entering home

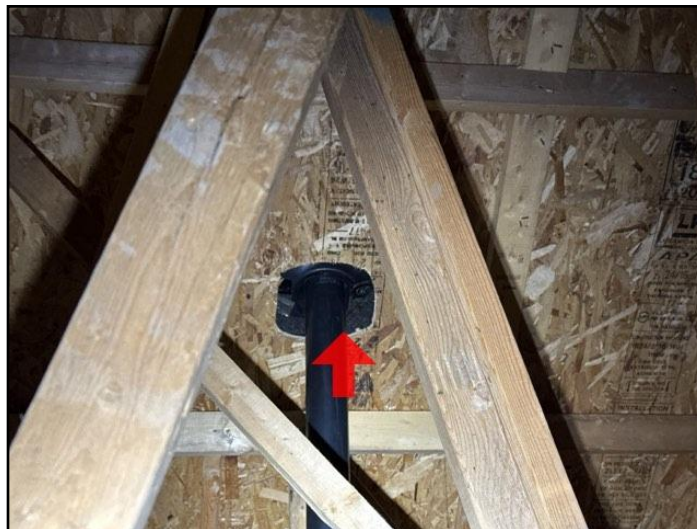
129. Edge support for sheathing

40. Condition: • Edge support for sheathing

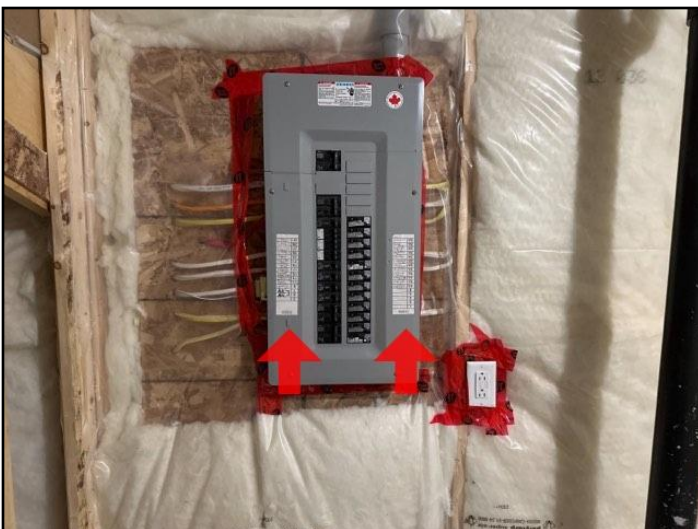
42. Condition: • Circuit labelling

Repair the circuit labels that have been installed upside down and do not align with the breakers.

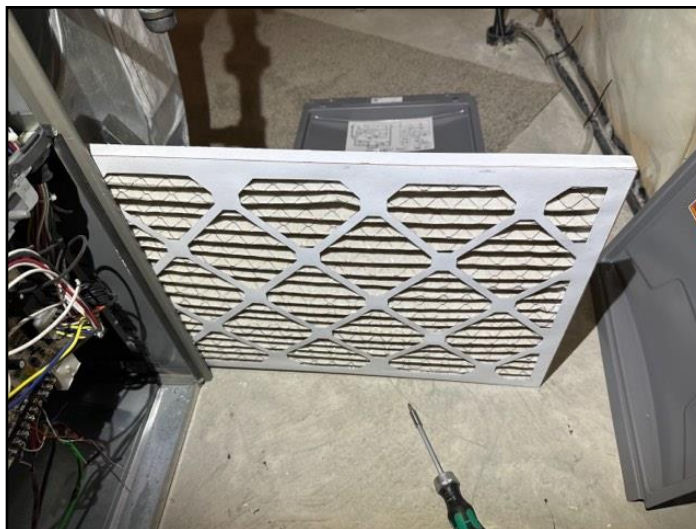
139. Dirty

44. Condition: • [Dirty](#)

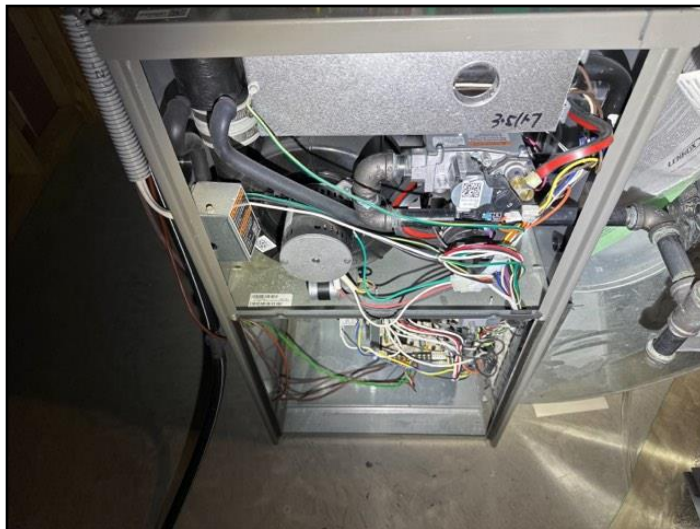
140. Service Furnace

45. Condition: • Service Furnace

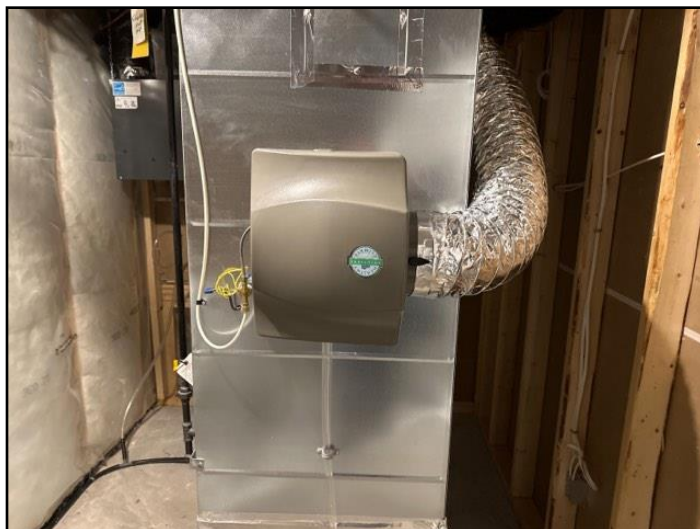
141. Dirty

46. Condition: • [Dirty](#)

The humidifier should be used when the furnace is operating. The humidifier filter should be changed in the spring after seasonal use.

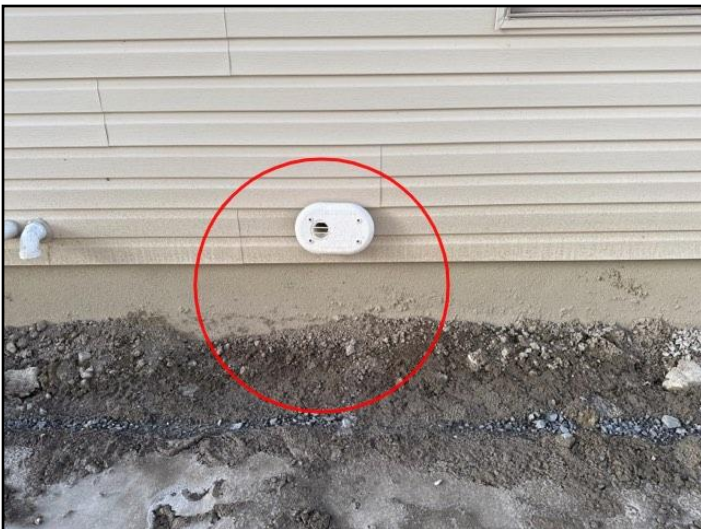
53. Condition: • Clearance to grade

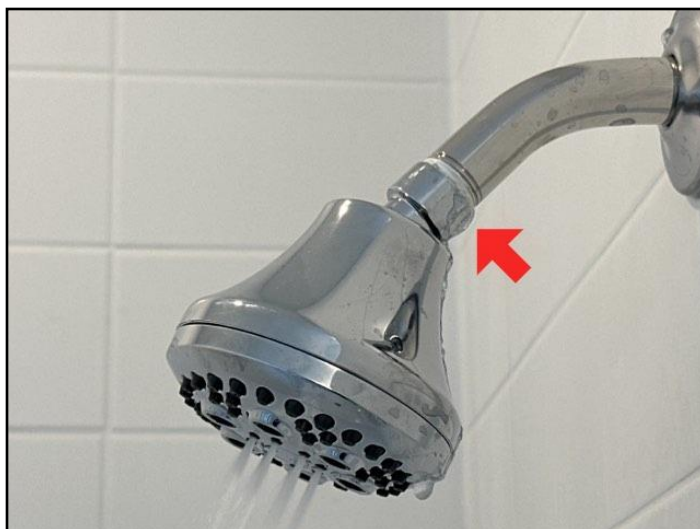
168. Drip, leak

58. **Condition:** • [Drip, leak](#)

Repair the leak from the ensuite bathroom shower stall head.

Implication(s): Chance of water damage to structure, finishes and contents

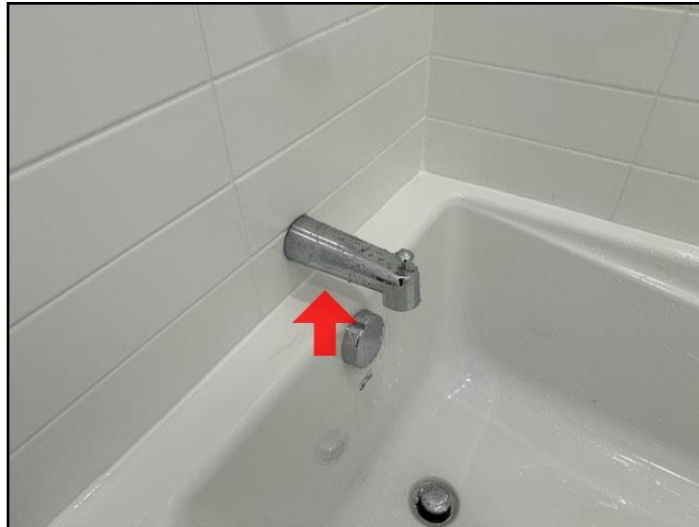
170. Loose

60. Condition: • [Loose](#)

Repair the loose faucet in the main bathroom room bathtub enclosure.

Implication(s): Equipment failure

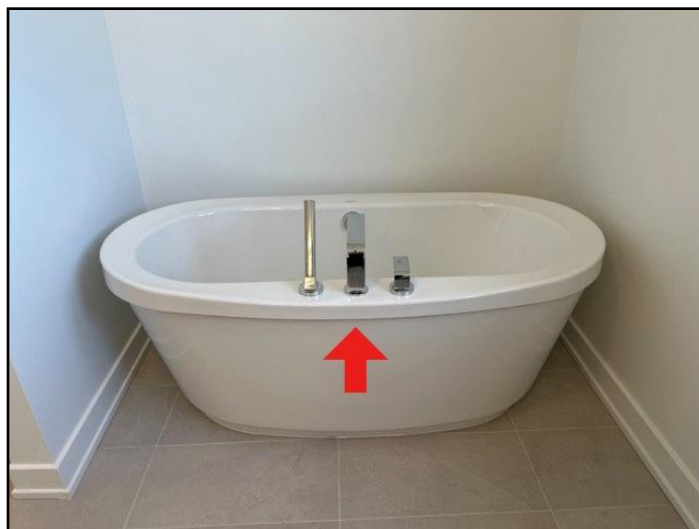
171. Loose or unstable

61. Condition: • [Loose or unstable](#)

Implication(s): Chance of water damage to structure, finishes and contents

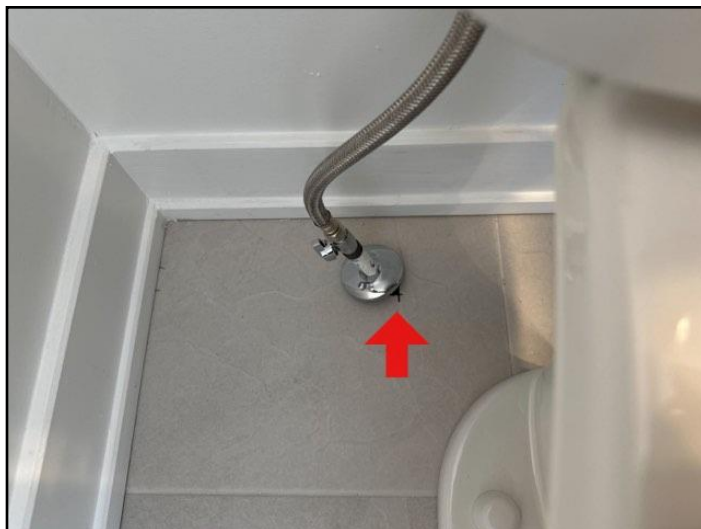
174. Tiles broken

63. Condition: • [Tiles broken](#)

Repair the hole in the tile below the toilet in the ensuite bathroom that is not covered by the water line flange.

Implication(s): Trip or fall hazard

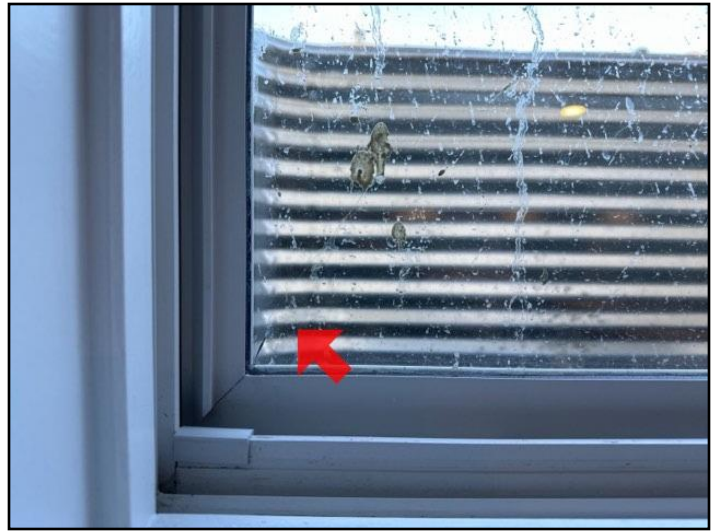
180. Cracked

65. Condition: • [Cracked](#)

Replace the cracked glass on the west side of the rear basement window on the west end of the north exterior wall.

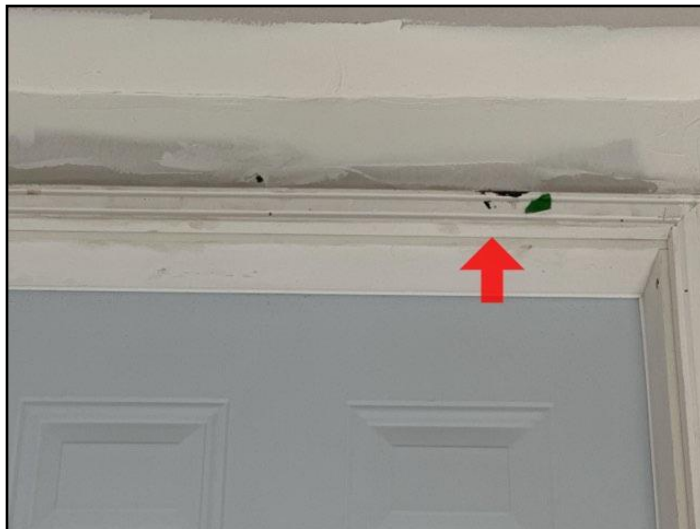
66. Condition: • Damage

Repair the dents and remove the adhesive and paint from the door and frame at the entrance to the house from the garage.
